# PROPERTY REPORT AND NEGOTIATION DOCUMENT

Eversholt  
Bedfordshire  
MK17 XXX

We have been instructed to inspect and prepare a Property Report and Schedule of Condition for:

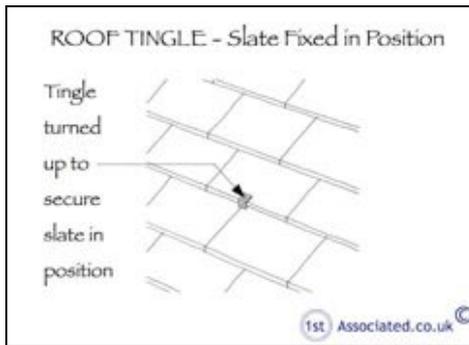
The main slate roof needs some repair. We can see lead tingles and can also see some displaced slates.

Lead tingle

Our concern is that the roof may have early signs of nail sickness, although it is very difficult to be certain at this stage. This is where the nails rust away. We can see what looks to be a very level, true and flat slate roof but there are slates that have come away, usually indicating that the nails have rusted away.

**ACTION REQUIRED:** Maintenance will be an ongoing thing, but we would suggest you initially have the roof overhauled, putting back any slipped or missing slates, and have a check carried out to see if the nails are rusting through and advise us immediately if they are and we will be able to recommend a way forward.

**ANTICIPATED COST:** In the region of £750 to £1,500 initially to make the roof watertight by replacing slipped and missing slates, checking chimney flashings and valley gutters etc. Please obtain quotations.

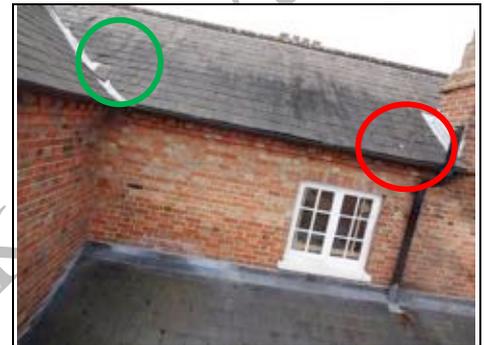
Slate roof to rear with displaced slates (green oval) and lead tingles (red oval)  
Aerial view – 360 photo

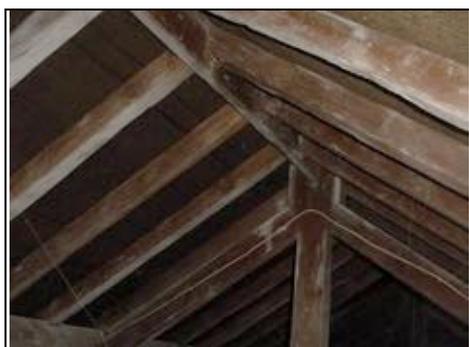
We can see condensation/dampness from within the roof space. This may relate to where wind driven rain is getting through the roof. It may also relate to the amount of condensation in the property from the bathroom below, the kitchenette and general living in the upper floors, particularly as we believe the existing family have younger children and there tends to be a lot more washing going on, which can affect both the timbers, as can be seen in the photo below, and also the ceilings, as again can be seen in the photos below.

Condensation to timbers

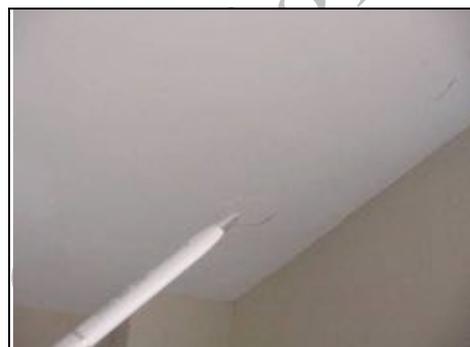
Damp staining from roof above

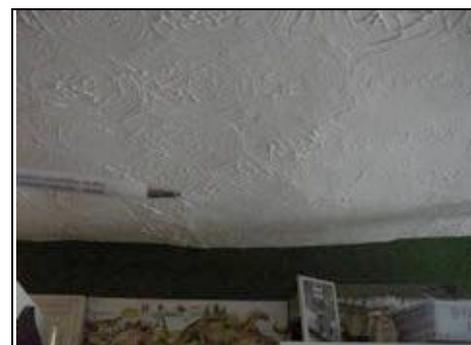
We noted undulations in the ceiling in the rear right bedroom, indicating there may be dampness or problems in this area; we were unable to physically get to this part of the roof.

Undulations in rear right bedroom ceiling

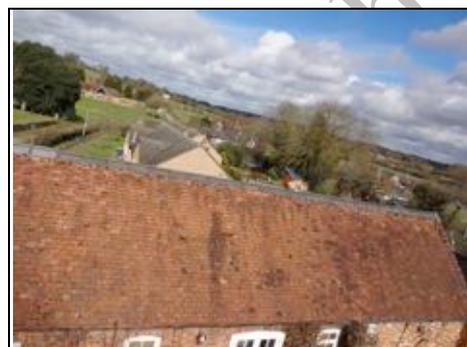
The red clay tile roof to the barn to the left side of the property also needs a general overhaul. The problem is there may be more damage caused than good by repairing anything where there is no specific leak. This is because the tiles look in a delicate condition and we feel that damage may be caused by the slightest bit of weight on the roof. Therefore we would leave this roof until it leaks.

Red clay tile roof  
Aerial view – 360 photo

**ACTION REQUIRED:** We recommend you leave this roof until it actually leaks, however when it does leak there could be fairly major repairs due to damage that could be caused to surrounding tiles when carrying out the work. We suggest that you source some tiles suitable for the work and also have a roofer have a look at the roof and be on call should any problems occur.

**ANTICIPATED COST:** Set aside the sum of £500 to £1,000 for initial works; please obtain quotes.

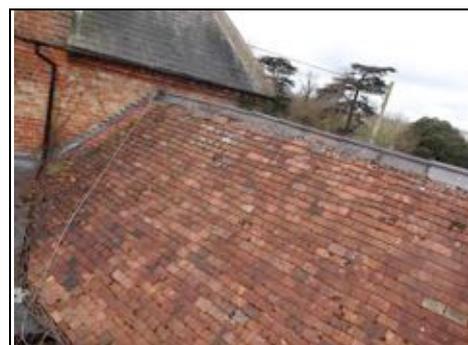
Deterioration to clay tile roof

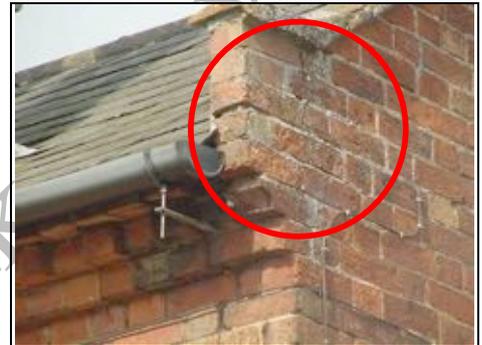
There do look to have been problems in the past, with the one of the left side having cement render repairs which are now cracking and the one parapet to the right side looks to have a hairline crack and spalling brickwork.

Hairline cracking and spalling brickwork to parapet wall to right side

**ACTION REQUIRED:** Close inspection via long ladders of parapet walls, the sooner the better. Make safe, repair and make watertight, as deteriorating parapet walls can allow dampness to get into the property.

**ANTICIPATED COST:** Very difficult to estimate; please obtain quotations once they have been inspected via a long ladder.

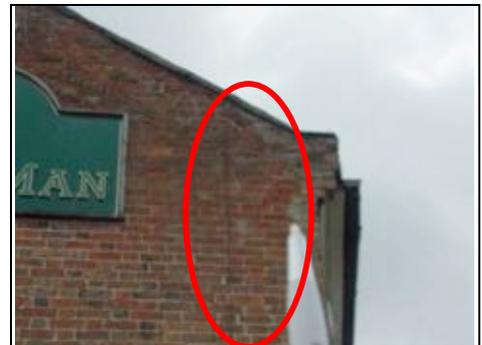
Cracking to parapet wall to left side

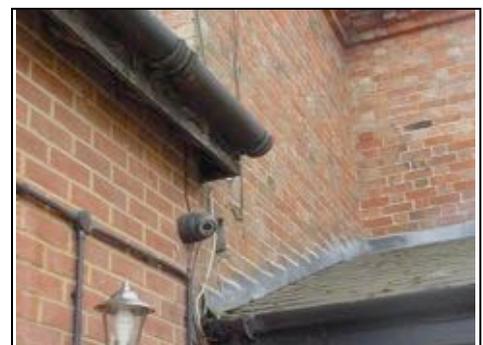
Parapet wall to left side cemented over

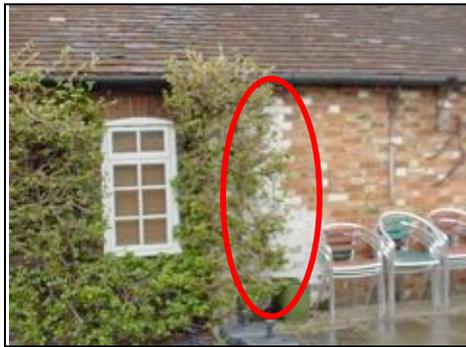
We can see there is some minor movement in the property. There is evident with hairline cracking, both in the toilet extension, the rear of the property and the barn conversion.

Cracking to walls to barn on right side of property

**ACTION REQUIRED:** Ideally we would recommend the existing owners take out an insurance claim, advising that the movement has been noted by a structural surveyor (this should cost them nothing other than time to write the letter). This usually means that the insurance company will carry out a monitoring exercise (the Building Research Establishment recommend monitoring any movement for a minimum of one year) to establish if there is any progressive movement.

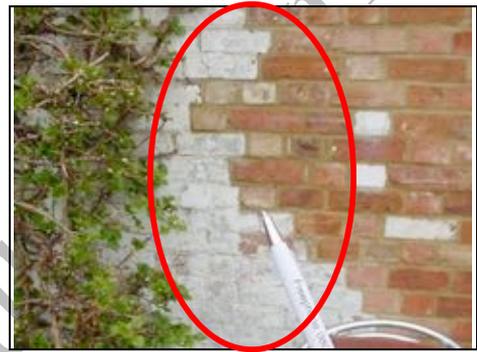
Close up of cracking to barn

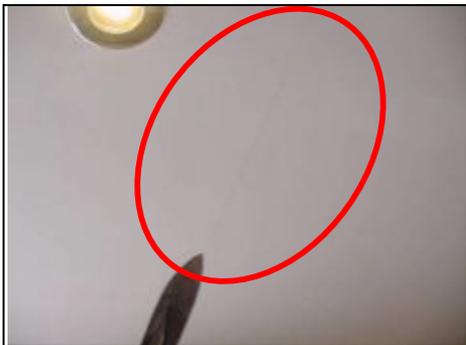
Hairline cracking to ceiling in gents toilets

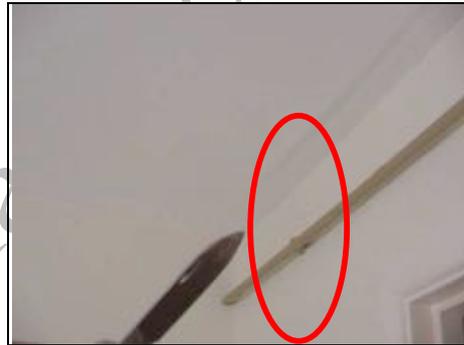
Signs of movement in ceiling to gents toilets

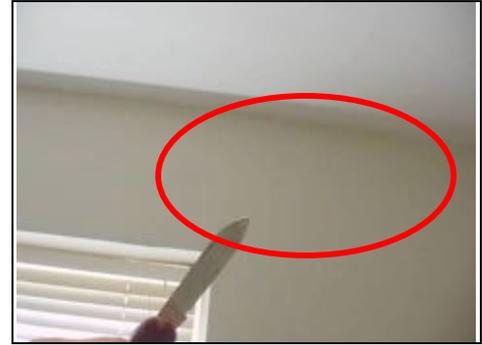
Hairline cracking to walls in gents toilets

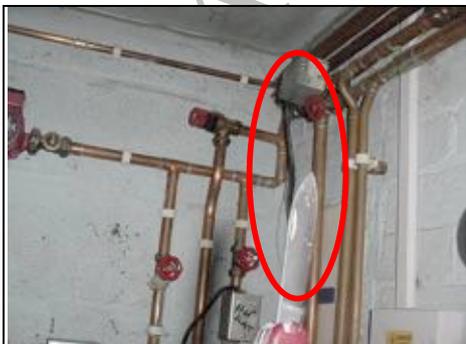
Signs of movement in boiler room where old building meets new building

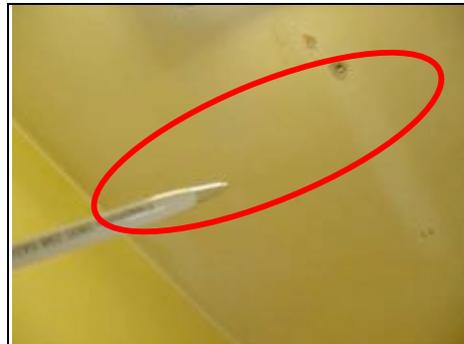
Cracking in ceiling in catering kitchen

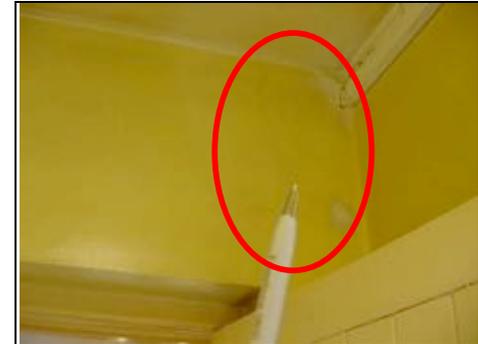
Vertical crack in catering kitchen next to walk in fridge

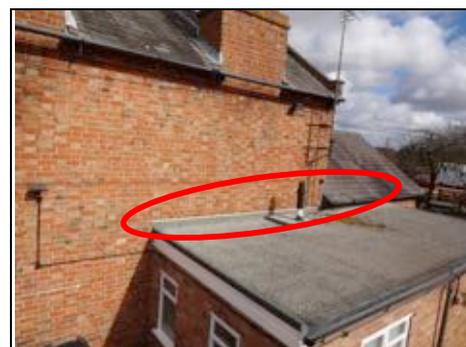
A few looking felt flashing and mortar where toilet extension meets main property toilets

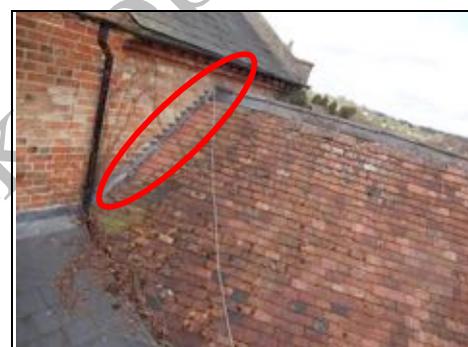
We can also see there is movement in some of the tiles, particularly at the roof joints, which indicates to us there may be some movement in the property and we do feel with movement it is better to be safe than sorry, particularly should be insured for this type of issue.

New tiles to clay tile barn roof  
Aerial view – 360 photo

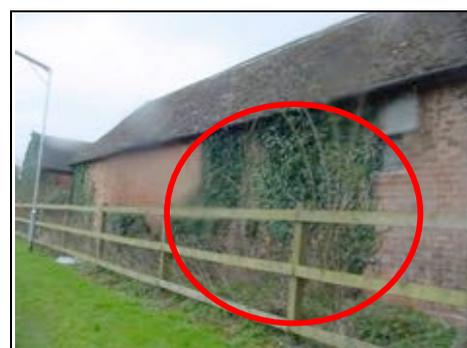
To the left side of the property we can see ivy and vegetation growing. It does look like it has been cut back as we can see ivy at the junction to the rear left side between the main building and the barn over the kitchen. We can also see that ivy has got into the barn roof.

Growth of ivy to left side of property

**ACTION REQUIRED:** We assume the left side is within the boundary of your property. If it is we would recommend that the ivy and vegetation is removed from the wall or cut back. If you do want ivy on the walls we suggest it is on a trellis work. Ideally in most cases ivy is better off not on a wall.

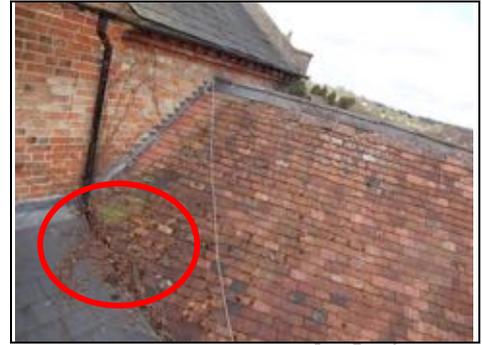
Growth of ivy between rear of property and the barn  
Aerial view – 360 photo

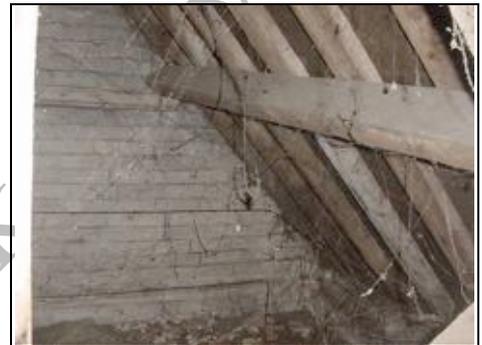
Plant life growing through barn roof

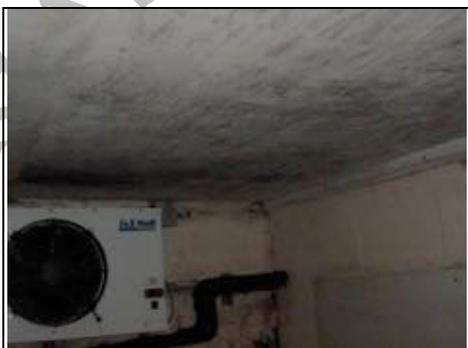
Within the cellar area generally, and specifically in the cold cellar, we believe the moss and black mould there is above what is acceptable from an environmental health point of view. The cellar floor is also damaged.

Dampness and black mould to ceiling in cellar

We recommend you clean, repair, prepare and redecorate the walls. Do remember this is a never ending battle as you are below ground level and therefore rainwater and ground wall will get into the cellar one way or another. However, this is a fairly common cellar problem so most Environmental Health Officers understand the problems and issues.

**ANTICIPATED COST:** Costs for cellar work in the region of £1,500 to £2,500, assuming that the ceiling does not need replacing. Please obtain quotations.

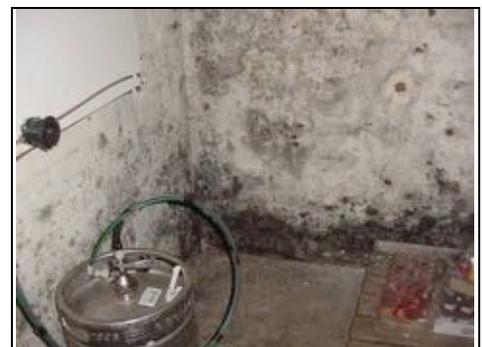
Dampness and black mould in cellar

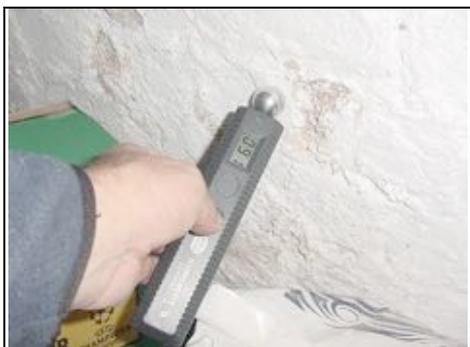
High damp readings in cellar

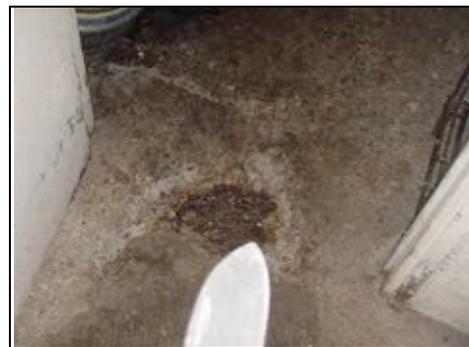
Damage to floor in cellar area

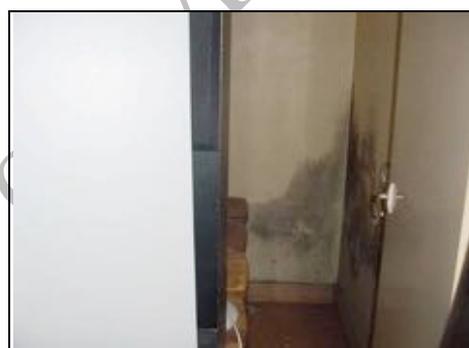
We also noted dampness to the end of the barn area in the area that is presently used as a prep/store area.

Black mould to end of barn in the area presently used as a prep/store area

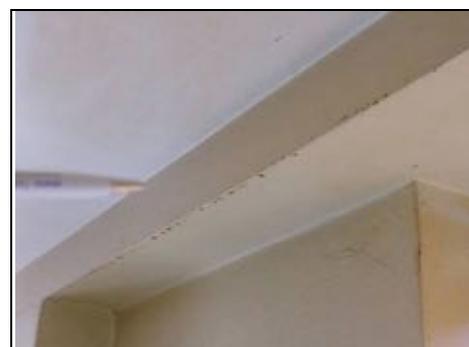
We would also add that the kitchen, particularly the ceilings, has an above average covering of grease but we are aware it is difficult to keep a catering kitchen clean in a busy environment.

Grease dripping off kitchen ceiling

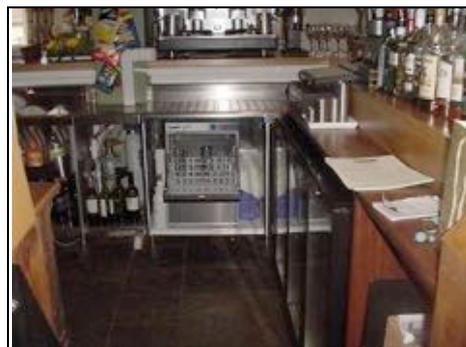
We noted there is a paving slab behind the bar servery area. This should typically be a safety floor.

Stone slabs behind bar servery

**ACTION REQUIRED:** We recommend you check with the Environmental Health whether this is acceptable.

**ANTICIPATED COST:** Costs for safety flooring £1,000 to £2,000, depending whether stone slabs needed.

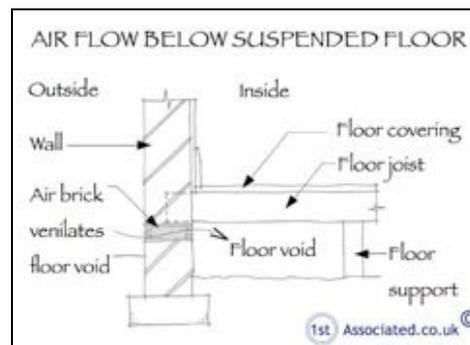
The ground floor feels to be a partly suspended timber floor and this type of floor needs ventilation underneath it to stop it from getting wet rot, dry rot and woodworm. We noted air vents to the front of the property over the cellar area but we did not notice any vents to the rear, they may have been hidden/blocked up by extensions that have been carried out.

Suspended floor

There may be rot under the floor, which is hidden. Without opening up the floor it is very difficult to say what condition it is in, although we would draw your attention to the mould we have mentioned within the cellar area, which will could be contributing to problems, or be a symptom of the problems.

**ACTION REQUIRED:** Ideally remove the ceiling of the cellar to examine the timber floor beneath and carry out any work required. We would add more vents to this floor, particularly bearing in mind the black mould we can see in the cellar area.

**ANTICIPATED COST:** Very difficult to cost without opening up this area. Costs for opening up likely to be around £100 to £250; please obtain quotations.

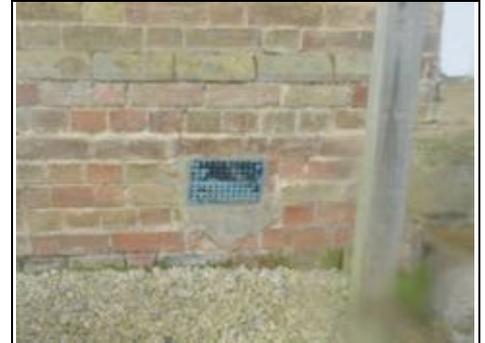
Air brick over cellar

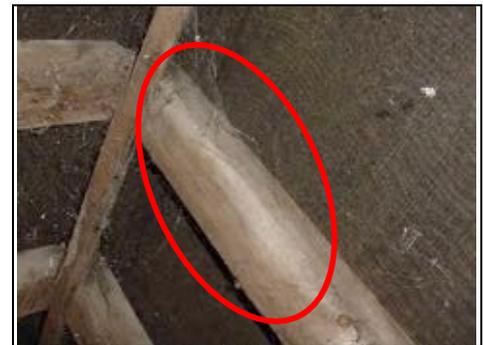
In the barn roof over the top of the kitchen area we found some woodworm. It is very difficult to confirm whether this is historic or active woodworm. We could not see any frass, however having said that we do not normally expect to see that much frass until the spring breeding season.

Signs of woodworm in roof over prep area

**ACTION REQUIRED:** Further investigations needed.

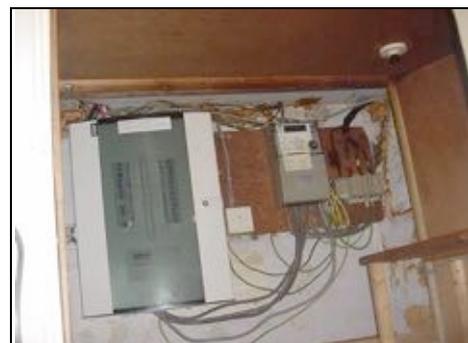
We did note, for example that the electrics in the kitchen are overloaded and extension leads are being used. It is far better and safer if it is hard wired.

Electrics in kitchen

**ANTICIPATED COST:** Few hundred pounds for the test and report but there may be thousands of pounds worth of improvements required. Please obtain quotations ideally before you commit to purchase the lease.

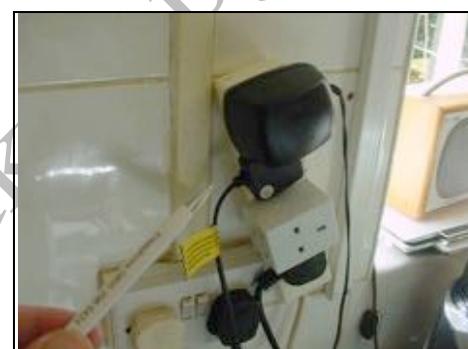
Overloading of electrics
