JOB REFERENCE: XXXX

RESIDENTIAL BUILDING SURVEY

Wisbech
Cambridgeshire.
PE14 XXX

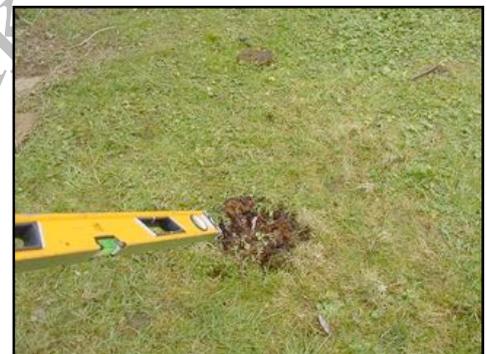
Trees that have been cut down

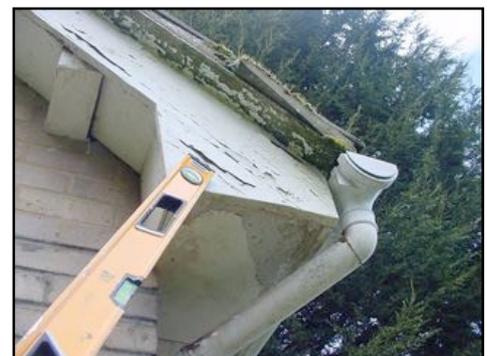
Deterioration to fascias and soffits

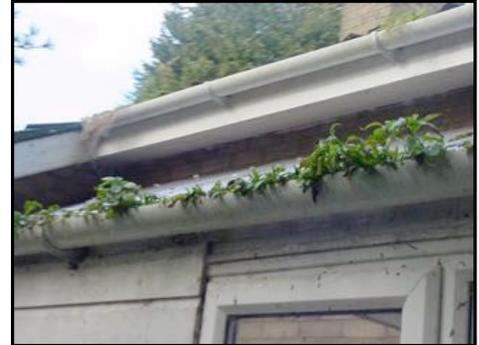
Gutter with vegetation

ACTION REQUIRED: Clear gutters and downpipes and ensure water is draining away from the property correctly.

ANTICIPATED COST: A few hundred pounds; please obtain quotations.

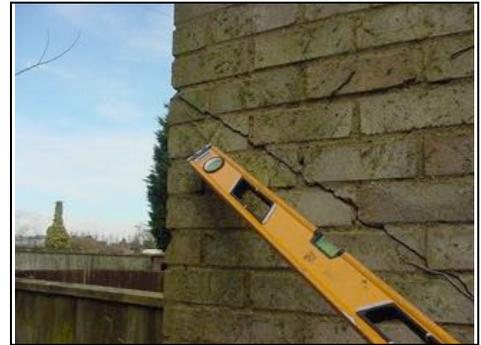
The garage walls have substantial cracks in them and light is visible in some areas. Due to the single skin construction of the garage, this can be problematic.

Cracking to garage wall

ANTICIPATED COST: £750-£1,500; please obtain quotations.

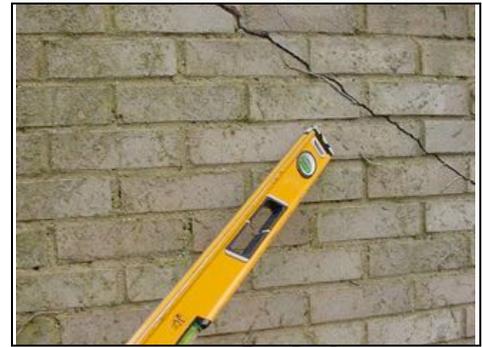
Cracking to garage wall

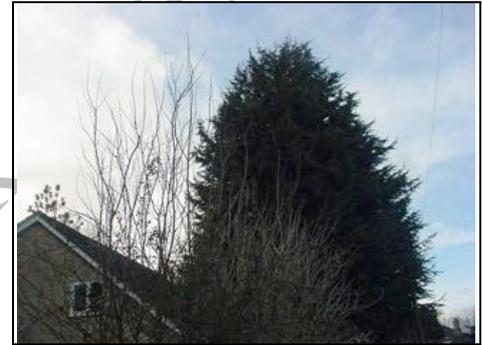
The trees surrounding the property have not been maintained and have overgrown considerably. We would warn against cutting trees down until you have sought professional advice on them. We can see some trees have been cut down to the rear left hand corner and there has also been work in this area and we are advised that the rear left hand corner has been newly re-pointed by the adjacent owner.

Large tree

ACTION REQUIRED: Seek professional advice from an Arboriculturalist / Tree Surgeon.

ANTICIPATED COST: £250-£750; please obtain quotations.

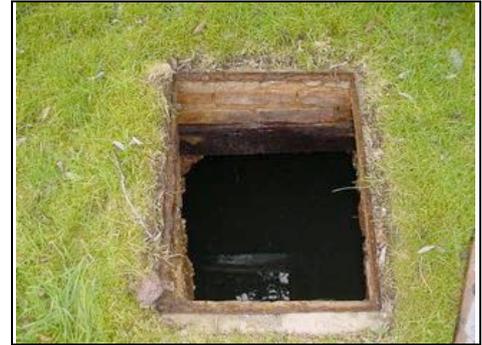
We suspect this to be a septic tank / cesspit. What we could see of it as it was full at the time of our inspection, indicates that it is brick built and these can leak.

Manhole containing septic tank/cesspit

ACTION REQUIRED: Ideally you need to contact the company that drains the septic tank / cesspit as they will normally have an opinion on the condition of it, as they will have seen it when it is empty. Often they will offer a lining service or a worse case scenario would be a GRP tank (Glass Reinforced Plastic).

ANTICIPATED COST: It depends if there is any problems; please obtain quotations.

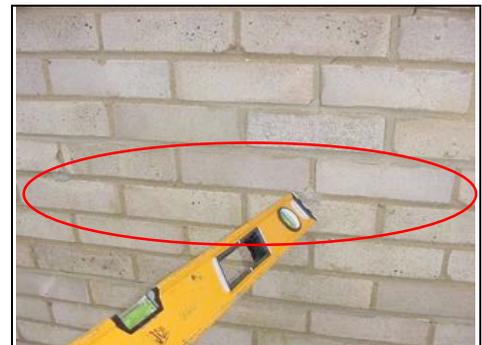
There may have been a previous insurance claim that will affect your insurance premium.

Holes within the property

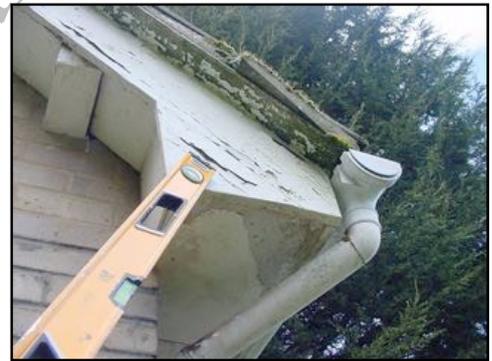
The fascias and soffits and shiplap boarding have suffered from a lack of maintenance over the years, both of which need repair and redecoration.

Fascias and Soffits in need of repair and redecoration

ACTION REQUIRED: We would recommend repair and redecoration.

ANTICIPATED COST: As it is high level work, we would expect costs to be in the region of £1,500-£4,000. We suggest that it may be worthwhile you getting your own tower scaffold; please obtain quotations.

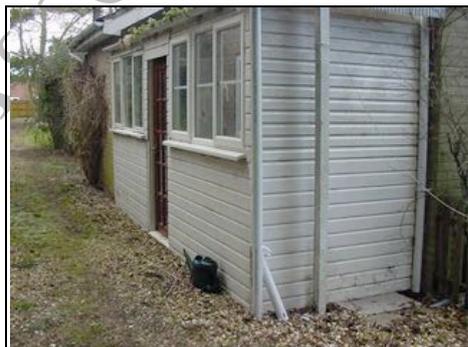
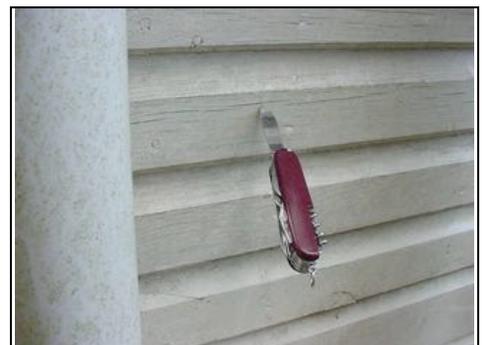
Shiplap Boarding

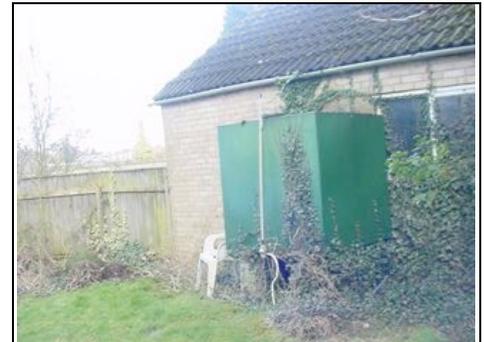
We noted that the oil tank is metal and we find that these are problematic.

Metal Oil Tank

ACTION REQUIRED: We would recommend that they are replaced with a double sealed plastic unit.

ANTICIPATED COST: £2,000 - £3,000; please obtain quotations.

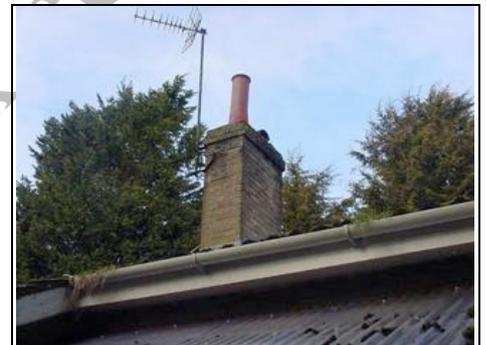
This chimney is brick finished with a lead flashing and two chimney pots. From what we could see from ground level it looked in slightly below average condition considering its age, type and style.

Right Hand Side Chimney

There is some moss to the chimney as we would expect in this sort of location.

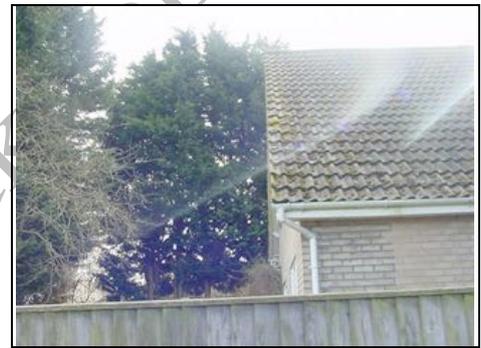
The main roof is pitched and clad with a concrete tile and from ground level this looks in average condition considering the roofs age type and style.

Main roof

Moss

ACTION REQUIRED: When the moss and lichens does build up, then the use of a soft brush is the best way to remove the moss and lichens during the summer months. We would avoid using any chemicals as these can cause deterioration to the surface.

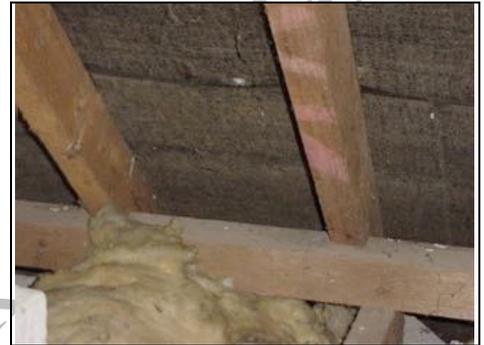
The common rafters on the left hand side of the property we believe have been cut a fraction too deep. Unfortunately we can't see this side of the roof properly due to the trees etc but it has stood the test of time as far as we can see.

Common Rafters

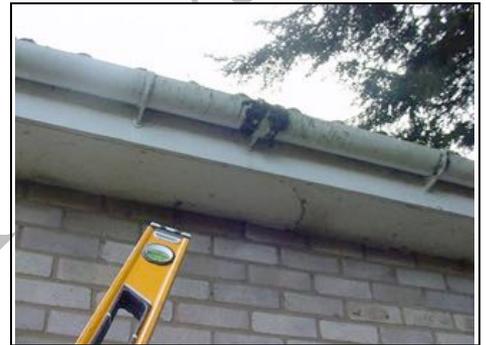
The property has plastic gutters and downpipes. They are in below average condition for their age, type and style. The gutters were full of vegetation at the time of our inspection.

There may be some minor leaks but most people would be happy to live with these providing repairs are carried out within the next six to twelve months.

Leaking Gutter

We also recommend that the gutters and downpipes are cleaned out, the joints are checked and the alignment checked to ensure that the gutters fall towards the downpipes.

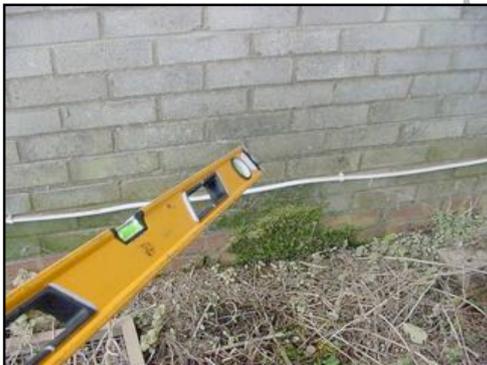
Gutter has leaked on to wall below

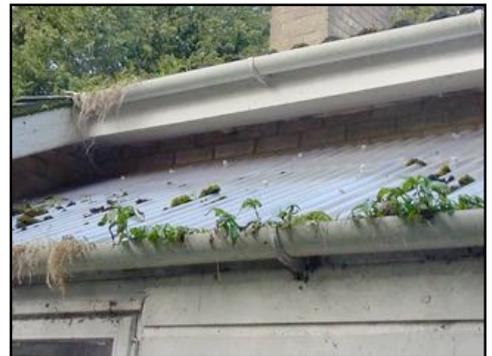
Gutter full of vegetation

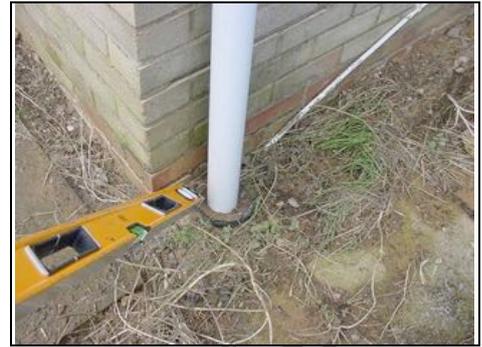
The downpipes feed directly into the ground so if there is a blockage then the drain would have to be opened up. This is a practice we are not particularly keen on; we would much prefer a gulley.

Downpipes feed directly into ground

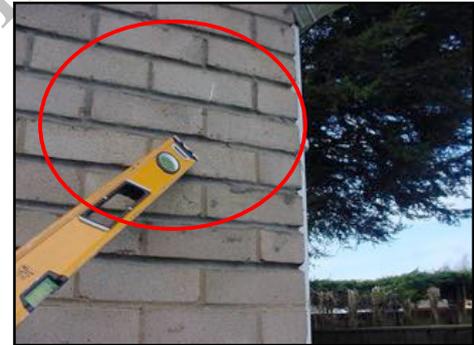
Some repointing to the rear left hand corner has taken place.

Repointing to brickwork

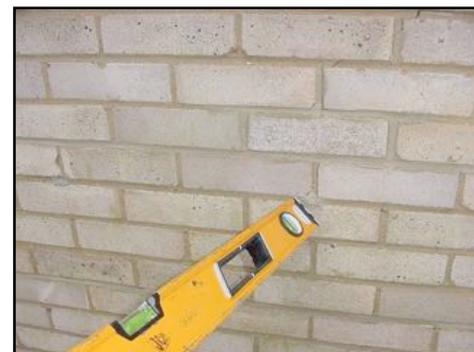
We can see drilled filled holes to the rear of the property which can indicate that repair work and reinforcement has already taken place.

Drilled filled holes to brickwork

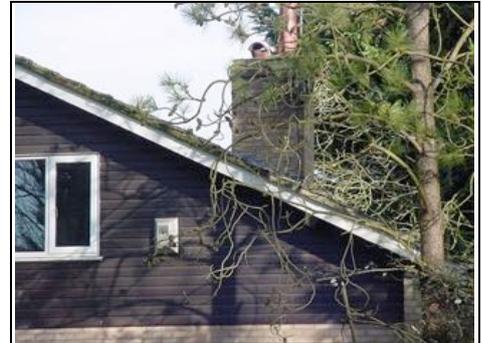
There is black horizontal timber boarding to the front of the property at high level and white horizontal shiplap boarding to the side of the property.

Horizontal timber boarding

ACTION REQUIRED: Both would benefit from redecoration. We would recommend the summer of 2015.

ANTICIPATED COST: £1,500 - £4,000; please obtain quotations.

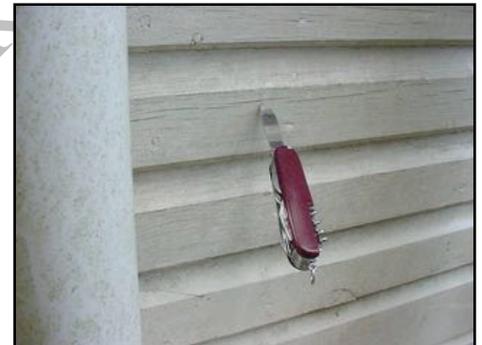
Horizontal shiplap boarding

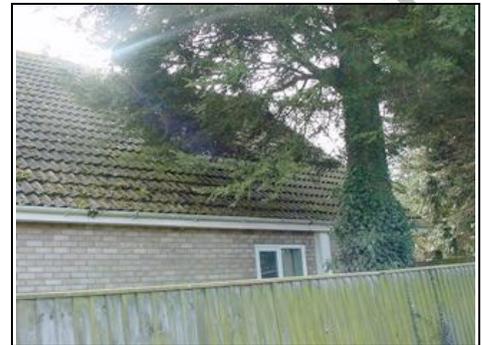
There are lots of trees within what we would term as influencing distance, many of them higher than the house but you do need to speak to your insurance company.

The tree is located next to the property on the left hand side

ACTION REQUIRED: We would recommend you seek expert advice from an arboriculturalist (not a tree surgeon) is asked to view the property and give a ten year plan for maintenance. Please see our comments in the Executive Summary.

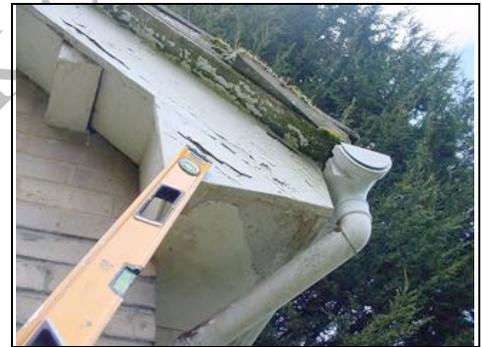
Deterioration to fascias and soffits

ACTION REQUIRED: We recommend redecoration. Make sure gutters and downpipes are watertight (clear of moss etc) before carrying out any work on fascias and soffits.

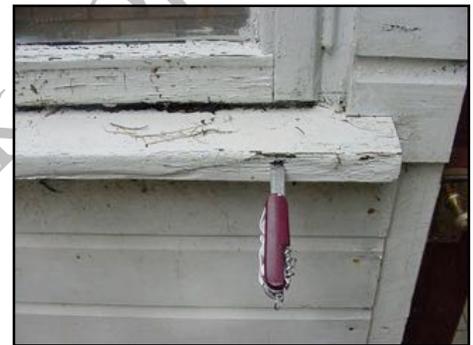
Timber window with rot

ACTION REQUIRED: The timber windows need repair and redecoration and we would expect this to cost a few hundred pounds, however it may be more economic to replace the windows.

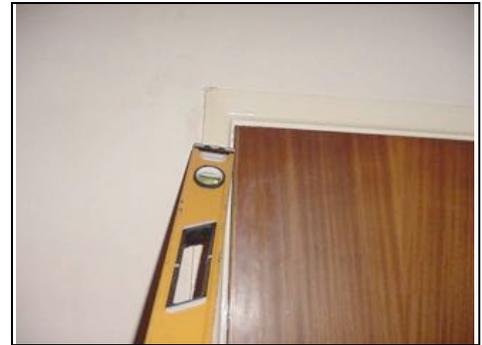
The property has hollow core doors. Many of the doors didn't fit very well, which does indicate that there has been some movement in the property.

Badly fitting doors

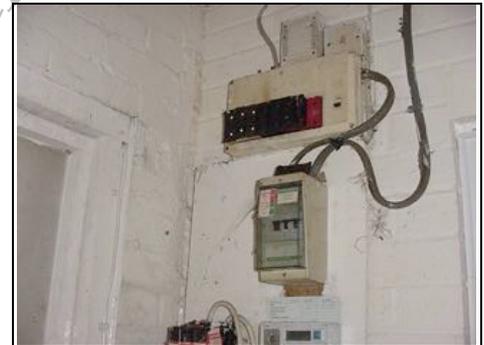
The electric fuses and consumer units were located in the rear entrance area. The fuse board looked dated and contained 1960s wire fuses. Far better are now available and this needs to be up-dated.

Fuse Board

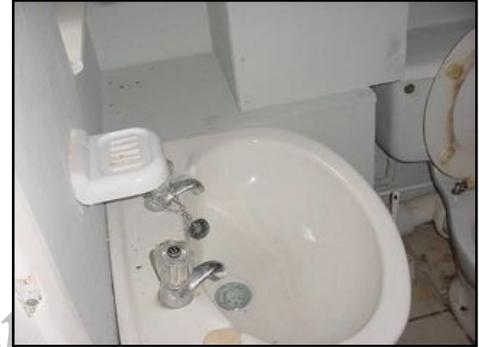
The property has a ground floor cloakroom / shower room consisting of a shower unit, wash hand basin and WC, which looks in below average condition, subject to a lot of day-to-day wear and tear, as one would expect.

Ground floor cloakroom

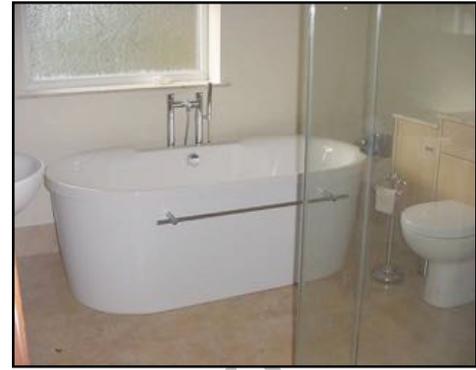
This has been upgraded relatively recently we would say. It is in average condition but there is minor movement to the taps to the bath, however this is a fairly common problem due to the design for this sort of tap system.

First floor bathroom

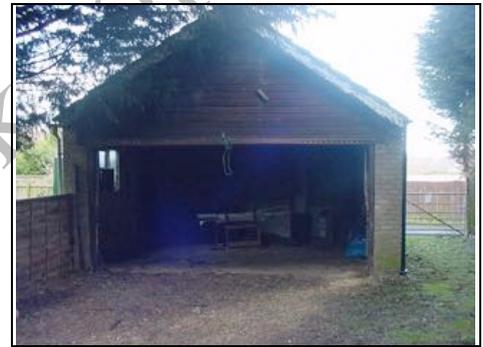
Please see our comments about the cracking and instability of it within the Executive Summary.

Garage
