RESIDENTIAL BUILDING SURVEY

OF
Luton, Beds LU2

1950's
Semi-detached Property

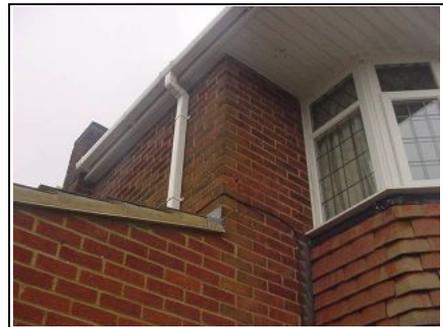
There is a very awkward gutter that has been formed for the garage that sits over your left hand wall. This means that if it leaks it gets damp. However, what is probably far worse is that the water from the garage roof discharges against your neighbour's wall in No 24 Kingsdown Road. We knocked on the door to have a chat with them about any problems they have but unfortunately no-one was in at the time of the inspection.

Awkward guttering

ACTION REQUIRED: You need to speak to your neighbour before you purchase the property and view the inside of the garage to see what problems are being caused. You could minimise the problem by adding a lead flashing to your neighbour's wall but for this you would need their permission.

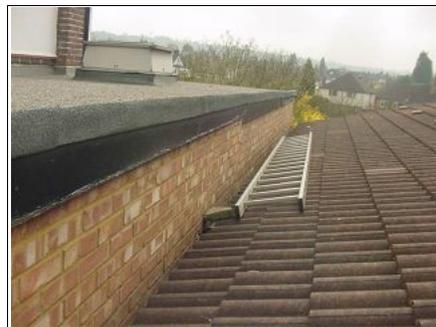
Awkward guttering

ANTICIPATED COST: In the region of £1000-£2000 as this is very awkward work. We would also add that should the gutter leak it will leak onto an "I" beam beneath it so you need to check that this is not rusting from time to time.

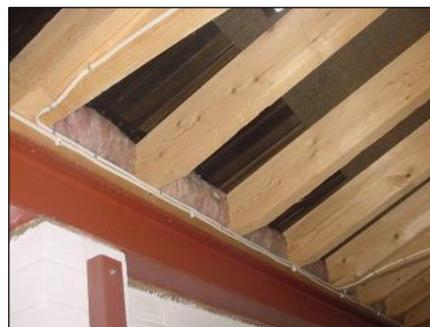
"I" beam sitting under the awkward gutter detail

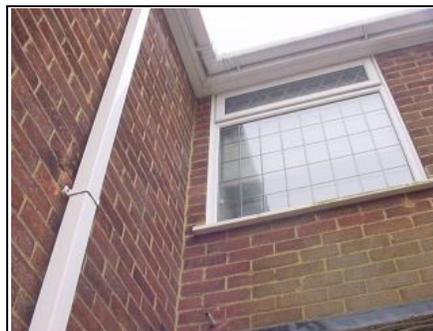
We note that the windows had no trickle vents and that some of your radiators were internal. This means there is a lack of general air movement and airflow within the property which increases the likelihood of condensation. You need to ensure that any moisture/humidity created in the bathroom and kitchen needs to be extracted from the area as quickly as possible.

Plastic double glazed window without trickle vents

ACTION REQUIRED: The best way to do this is to have extract fans that are thermostatically controlled, recommend these are added.

ANTICIPATED COST: In the region of £150 - £300 and always recommend that extract fans are added; quotations required.

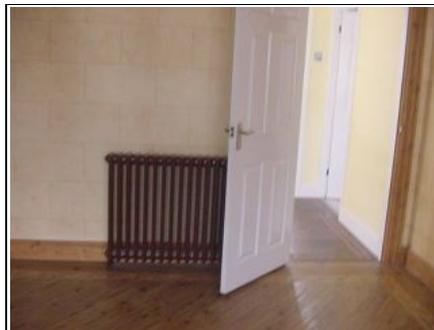
The property has internal radiators. Where internal radiators are used you have a higher than average chance of having condensation as you do not get the same amount of air flow around the property as you do when radiators are positioned underneath the windows. Where the warm air rises it meets the colder air of the window and circulates around the room.

ACTION REQUIRED: Relocate the radiators underneath the windows

ANTICIPATED COST: A few hundred pounds per radiator; quotations required.

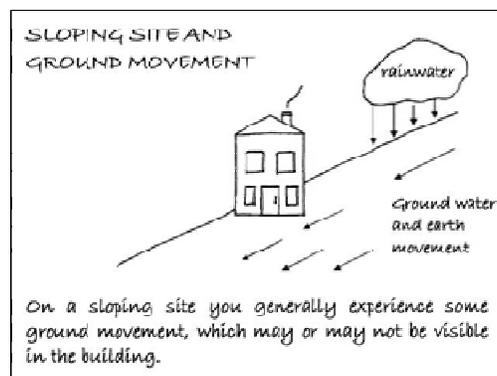
Hard standing to the front

This means that rainwater that lands on the hard standing to the front is directed towards the house and in turn the garage. Due to its position the water discharges towards the house where there are air bricks at low level which effectively act as gutters allowing rain water in underneath the suspended timber floor.

ACTION REQUIRED: You need to protect the air brick and ideally open up the floor to check its condition before you purchase the property. To elaborate further, you have a suspended timber floor which can be affected by dampness getting into it.

ANTICIPATED COST: A few hundred pounds to open up the floor and protect the air bricks. Protection of the air bricks is normally done by putting bricks on edge around them. In a worst case scenario there may already be damage to the timber under the floor; quotations required.

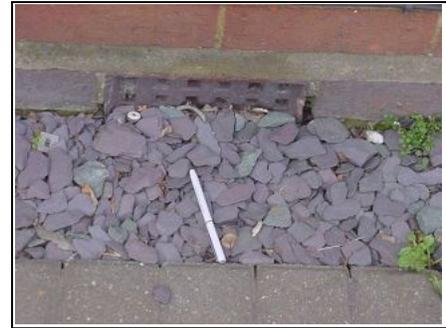
Air bricks acting as gutters

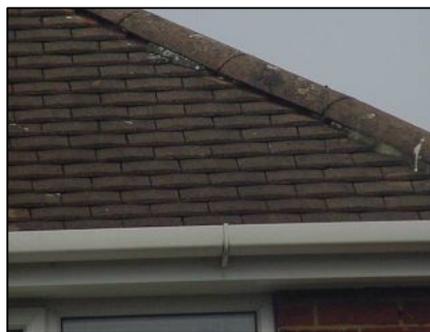
We did notice minor movement in the property and some mortar missing to the ridge of the hipped roof. This often applies to movement in the roof but we can also see some hairline cracking internally. We are slightly concerned that the new decoration internally could be hiding latent defects in the structure.

Mortar missing to ridge of hipped roof

ACTION REQUIRED: We would recommend your solicitor specifically asks the existing owners if there has been any structural movement in the property and if a structural claim has been made with regards to the property.

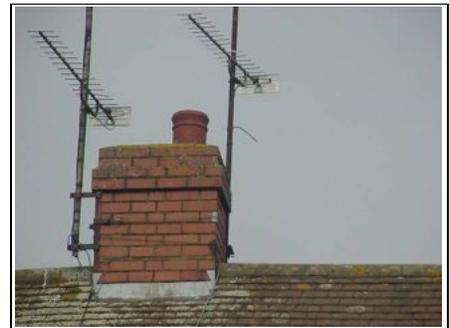
Chimney one

This chimney is built in brick with a lead flashing and one chimney pot. From what we could see the chimney looks weathered and we can also see some moss to the top of it. We were unable to see the very top of the chimney known as the flaunching, we therefore cannot comment upon it. We suspect from the moss we can see that there will be some deterioration.

ACTION REQUIRED: Carry out repointing as soon as possible, check flashing immediately and replace with lead in the long term.

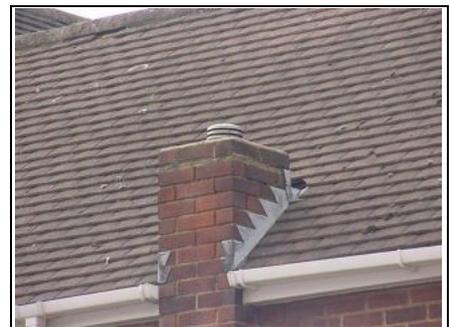
Chimney Two

This chimney is brick finished with a lead flashing and a flue. Brickwork pointing looks slightly weathered.

ACTION REQUIRED: This needs to be

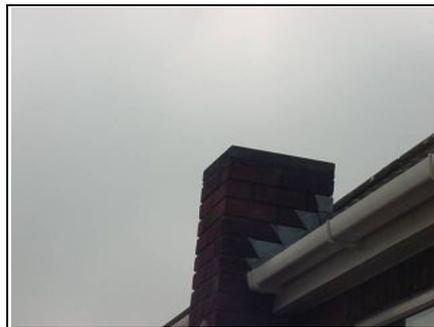
Chimney Three

Again this brick built chimney is slightly weathered and we would recommend it is viewed when the main chimney is viewed. In this case the chimney looks to be capped and we notice there is a vent there for the Worcester boiler in the rear left hand bedroom.

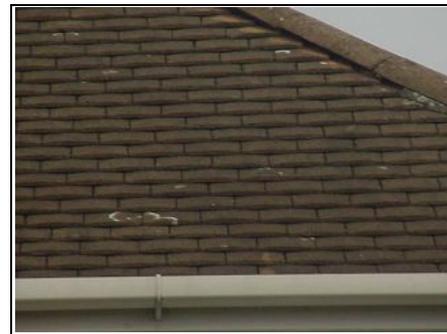
Main roof

The roof is pitched and clad in a small nibbed concrete tile. From what we could see the concrete tiles are lying level and true and look in average condition. We did note that the pointing to the ridge needs renewing and you will need to periodically check these.

It is noted that there were some areas of moss on the roof. This can build up and ultimately block gutters. Ensure the gutters are cleared periodically. Sometimes we find that deterioration occurs to the ridge as in this case and exposed areas such as the perimeter and so you should periodically check these areas.

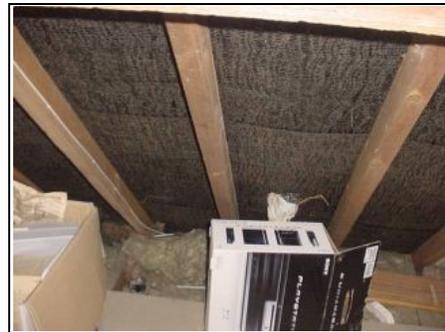
When we inspected the loft space we found a Hessian base Bitumen membrane. This type of membrane has been used since the 1960s. We generally found it to be in average condition, it is damaged in a few more places than we normally find.

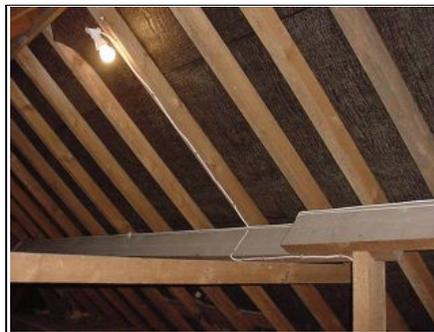
Roof timbers

We found the roof timbers generally in average condition considering their age. There was an unusual stepped purlin detail. We have inspected the roof structure for:

Our examination was limited by the general configuration of the roof, the insulation and stored items. As mentioned what we could see was generally found to be in average condition with exception of the stepped purlin detail. It is feasible that there are problems in the roof that are hidden.

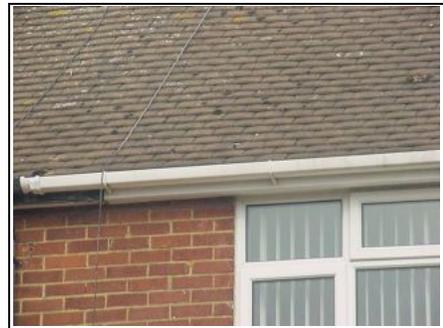
Guttering

The property has profile gutters from ground level and look to be in reasonable condition and be formed of plastic. We would comment that there is moss on the roof which can block the gutters. We also note that you have a different profile gutter to your neighbour. They have a half round gutter and you have a shaped square gutter. This can cause problems but you do need to look to have the correct connector fitted. Although we would add, from our experience, half round pipes work is better than profile pipes or drain pipes such as these.

ACTION REQUIRED: We would always recommend that the gutters and downpipes are cleaned out, the joints are checked and the alignment checked to ensure that the gutters fall towards the downpipes.

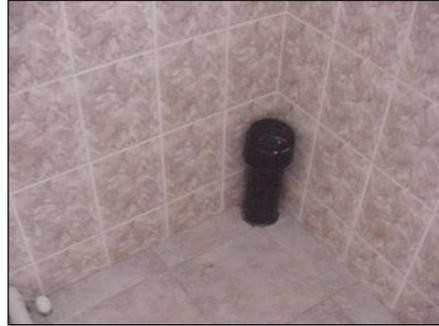
There is an internal soil and vent pipe located in the bathroom. These are known as air inlet valves and are a fairly modern invention. We are not a great lover of internally vented pipes and much prefer them to be vented externally.

Soil and vent pipe located
in bathroom

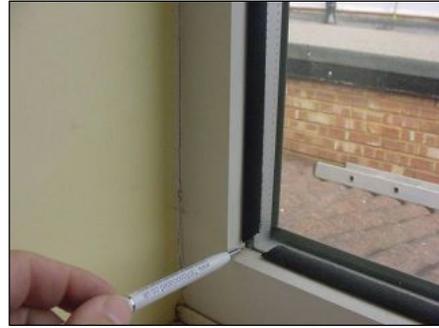
Seal not finishing properly

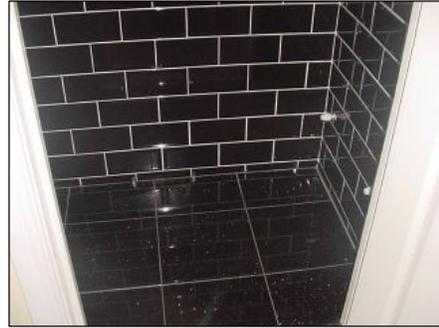
Small shower

We cannot imagine that the small shower under the stairs is not getting condensation. It does of course depend how you use it and for how long. We can see no obvious signs of condensation, however, it depends upon how you utilise the building.

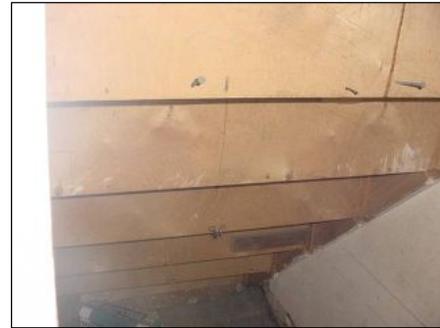
Underside of staircase
(unlined)

Would recommend it is lined.

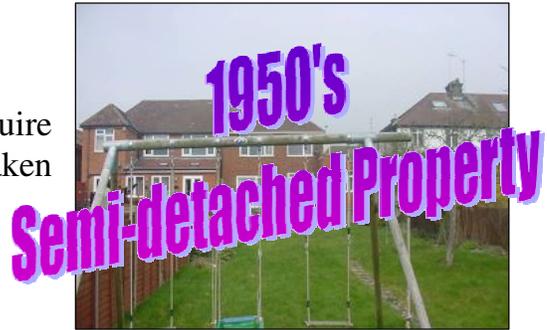
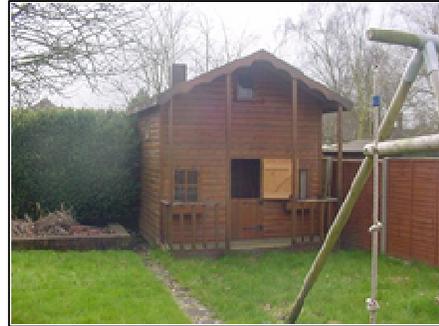
Wendy House – it is likely to require Planning Permission or it needs to be taken down.

Huge Wendy House
