RESIDENTIAL BUILDING SURVEY

XXXX
Ravensden,
Bedfordshire,
MK44 XXX

FOR
Mr X

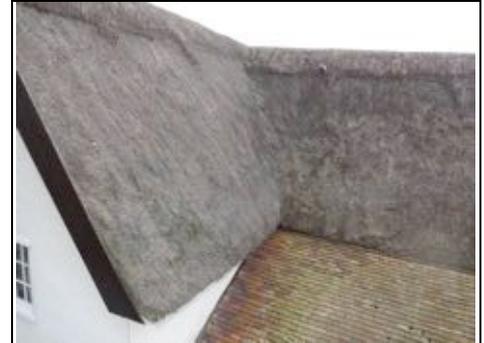
The thatch is nearing the end of its life. We believe that you will have to budget for a replacement thatch. With a listed property it is not just as simple as replacing the thatch, you need to obtain approval and consent. It will more than likely be considered a significant part of this building and as such it may well be closely scrutinised exactly what you are going to do. From what we can see within the roof we feel that unfortunately not only will the thatch need repair/replacement some of the timbers will need repair/replacing as well for example to the left hand side of the property from a limited view what we could see was not in particularly good condition.

Thatch in poor condition

ACTION REQUIRED: From what we have seen within the roof we feel that unfortunately not only will the thatch need replacing but some of the timbers will need replacing as well for example to the left hand side of the property. The owner advised that he had various quotes on the property to replace the thatch from memory ranging from £14,000 - £35,000. We have not seen these quotes and we have estimated our figure below, the quality of these quotes all the companies understanding if the building is listed or not. However, in addition you need to add work to the roof structure and also consultation work you need with the Conservation Officer.

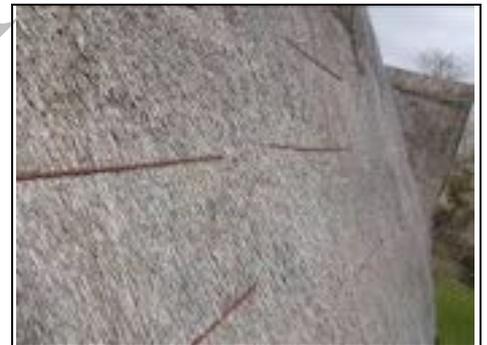
Stitch in time to thatch, rods added to hold thatch in place
~ Aerial View - 360 Photo ~

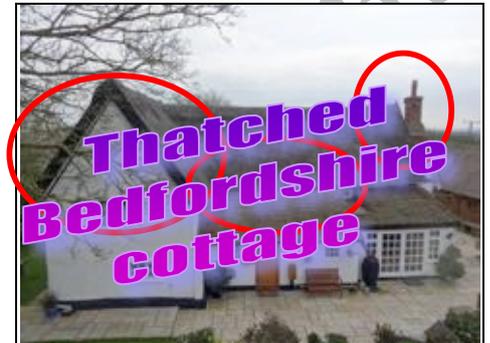
We have divided the roof structure into three areas, the left, middle and right side. We had reasonable access to the middle roof although much of it was covered with insulation, we had no access to the left roof and we could only view it from the middle roof as there was no direct access into it from what we could see. The right roof had a limited view due to both the insulation and lots of stored items although we did move some of them. From what we can see the roof structure has been replaced and repaired over the years.

Plan view of the three roof structures

ACTION REQUIRED: We would recommend that your solicitor specifically asks in writing is there any more information with regard to the metal plates/structural work which effectively are tying/holding the building together. Unfortunately, metal plates add a relative stiffness to what is traditionally a fairly soft building on a timber frame so they can in themselves cause problems if not designed appropriately.

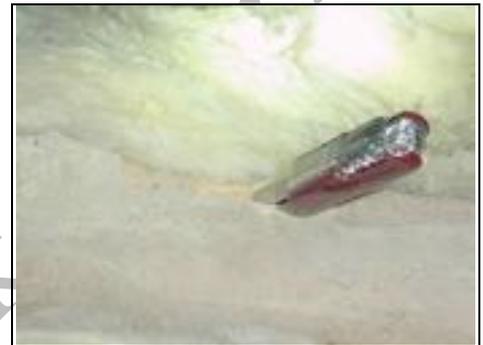
Over the years we have come across lots and lots of woodworm and we normally say any good old property tend to have some woodworm. Having said that most of the woodworm is no longer active and has died off many years ago and in addition to this although there may be holes rarely is it what we term as structurally significant? However, in this instance there does look to be active woodworm in the roof as well as old woodworm in the roof. Unfortunately, that where we tested it with a knife, our knife went directly into the timber and we would then consider that this maybe becoming structurally significant. By this we mean that the timber has been weakened by the woodworm.

Knife going completely into timber common rafter

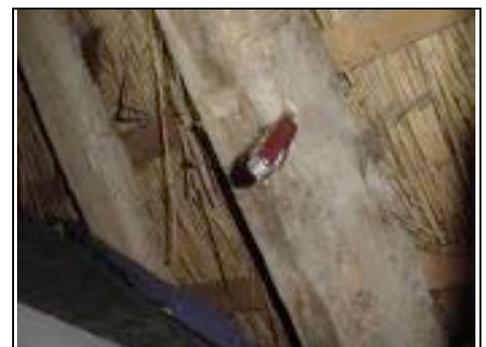
Unfortunately, the environment with insulation being added can improve the woodworm and encourage to breath from what we understand. There is a fair amount of insulation in the roof; all of this will have to be removed to properly view the roof to assess the damage to the timbers. We do feel that some of it is what we would term as a structurally significant in nature although there is of course woodworm in the roof that is not structurally significant. We found woodworm to the centre roof and we believe it also to the left roof.

Woodworm and soft rot

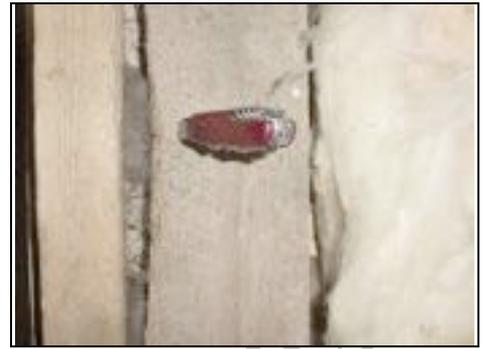
Woodworm

ACTION REQUIRED: If you have immediate plans to re-thatch the property then the whole of the roof structure could be looked at, at that point. If not, a much closer examination of the roof with the insulation removed needs to take place. However, from what we have viewed so far we would expect approximately ten to twenty percent of the roof to have been affected with woodworm to the point where we put a knife into it relatively easily/has potential to be structurally significant.

ANTICIPATED COST: We would recommend setting aside £2,500 - £7,500. The reason why the figure is relatively large is we do think there is a likelihood that there are problems with the roof structure. There is an element of estimation on what we are commenting on as we have not had access to the left side of the roof, we would be able to comment further if direct access to the left side of the roof was formed and if insulation was removed. We do feel we have to warn and advise about the worst case scenario; please obtain quotations.

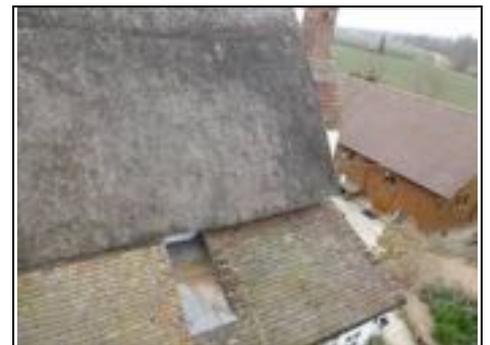
The property has a relatively shallow roof and as such water can sit on it and we noted that the tiles are starting to spall. We would recommend that work is carried out in this area.

We have also found that wind driven rain can get in this style of roof if it is not repaired.

Displaced tiles and in need of repair

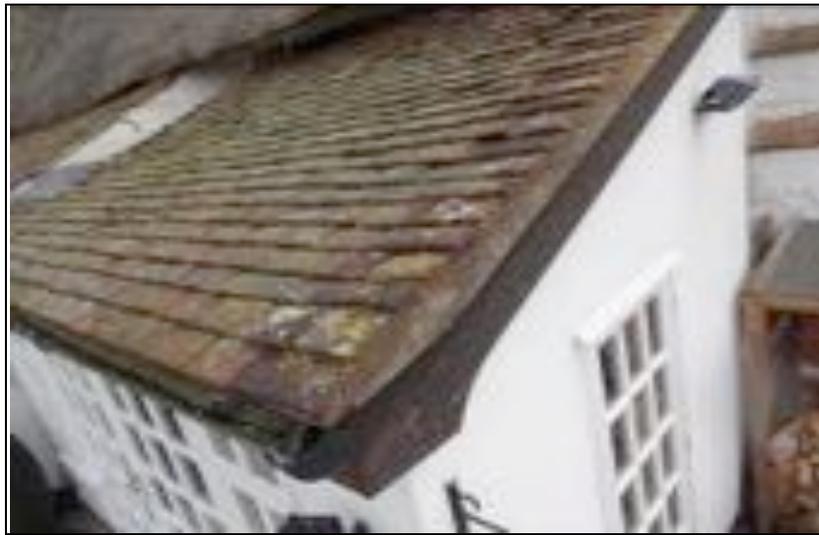
Spalling to tiles
~ Aerial View - 360 Photo ~

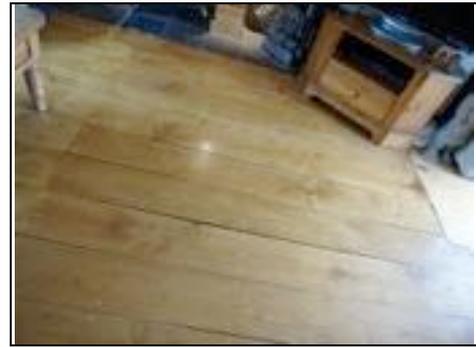
Replacement of original floorboards

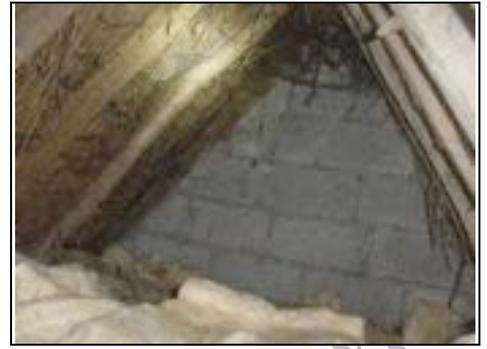
Having said all of that, the areas where we could see the inside of the structure we could see blockwork. Blockwork would have been typically used in the 1960's/1970's so we suspect there has been a lot of replacement work here.

Blockwork

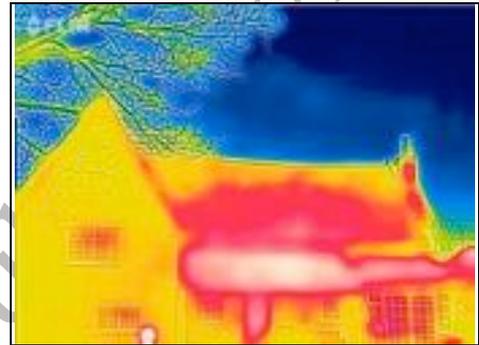
In addition to this we have also thermal imaged the property to see if this gives us any further clues and our evidence shows relatively low heat loss from the wall structure indicating that there is considerable replacement of the walls. Without opening up the walls we cannot confirm this but we do believe the thermal imaging information and the visual information in the roof give a good indication that over fifty percent of the walls have been replaced.

Thermal image showing heat coming out of thatch and tiles but not through what we believed was timber frame building

ACTION REQUIRED: We recommend opening up:

1. The left roof area and allow proper access to re-gain. The owner has specifically asked in writing by your legal adviser when they are aware of any rebuilding of the walls.
2. We recommend areas of render is removed so you can see the existing structure. We would add that unfortunately it is difficult to be conclusive if the usual indicators are not consistent.

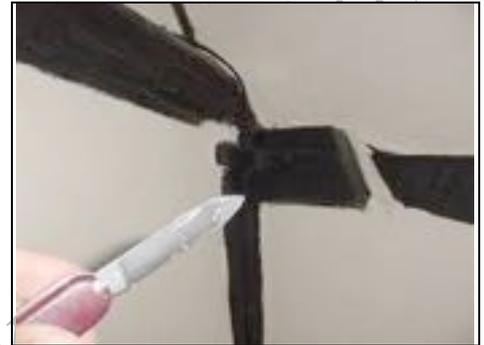
Brace added in middle wall on left side

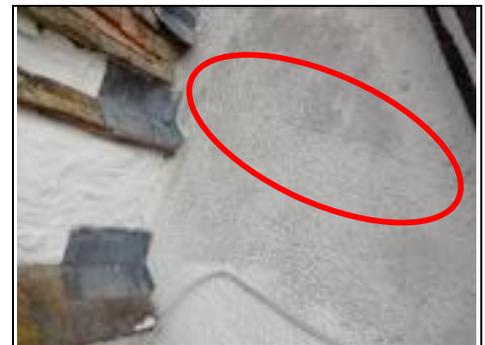
There is hairline cracking visible to some of the internal walls where the wall and ceiling joists meet and there is also hairline cracking to the gable end of the property. You do have to remember that the whole of this property has been repainted in the last few years hiding any usual indications. Again, these cracks are indicating sideways movement left to right.

Hairline cracking to right gable
~ Aerial View - 360 Photo ~

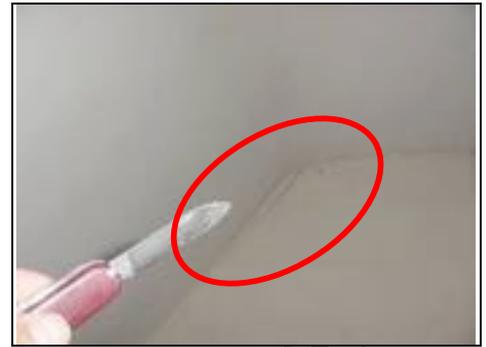
Cracking in far right bedroom

ACTION REQUIRED: Ideally we would recommend the existing owners take out an insurance claim, advising that the cracking has been noted by a structural surveyor (this should cost them nothing other than time to write the letter). This usually means that the insurance company will carry out a monitoring exercise (the Building Research Establishment recommend monitoring any cracks for a minimum of one year) to establish if there is any progressive movement. Your future liability will be limited to the cost of the excess on the insurance providing the insurance company is happy for you to take over the insurance claim.

Monitoring is the only true way of establishing in this particular case of whether it is still moving (which it probably is not due to the amount of wall replacements although it is very difficult to confirm without opening up the walls, etc).

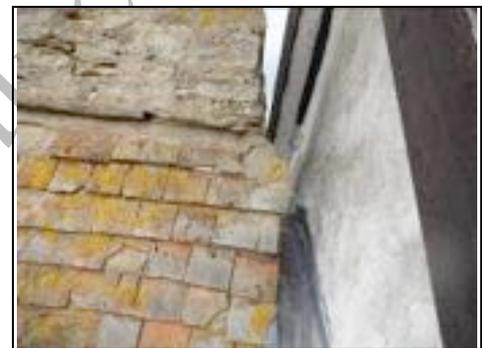
In various areas we found dampness coming in through the stonework for example and we can also see sulphate where there is orange/brownish staining where the soot is being drawn through.

We feel that you will probably have to accept this as a characteristic of this building, given the materials used, the fact that it is on a sloping site and that the house is in the way of that slope, that there will be some dampness.

Damp on gable wall
~ Aerial View - 360 Photo ~

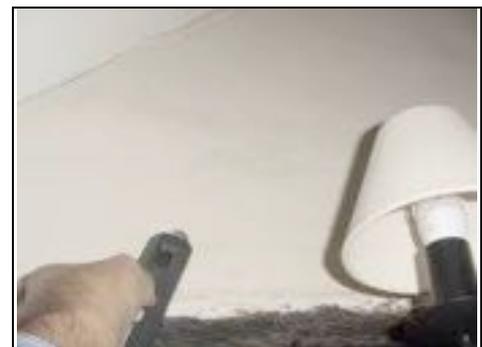
Dampness coming through plaster in right bedroom

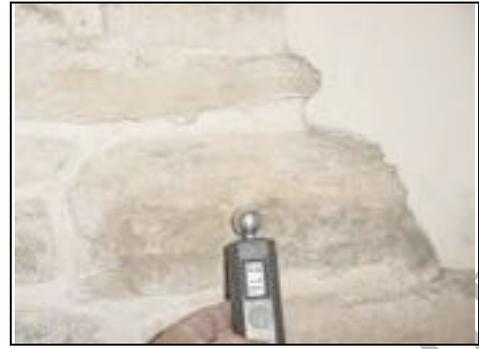
Dampness in stone

ACTION REQUIRED: We would recommend the adding of a French drain around the property. Currently there are paving slabs around the property which unfortunately discharge water against the building.

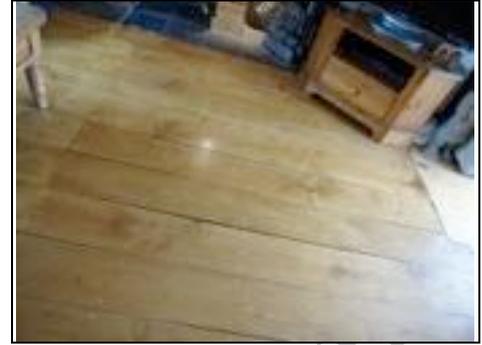
We are advised there is a timber floor in the lounge area which is typically a suspended timber floor. We cannot see anywhere where this has been vented which in a building such as this can lead to wet rot, dry rot deterioration.

We were advised original floorboards were sanded and reshaped

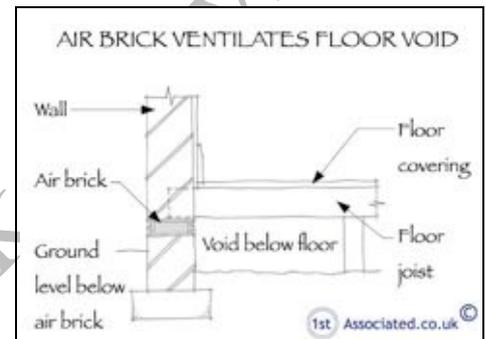
Suspended timber floor

ACTION REQUIRED: Add vents. We would also recommend opening up a section of the floor. The owner advised that the timbers used in this area were the original timbers but in our experience they would not have been that size or that cleanly cut. He did then comment that he had had them sanded, planed and then put back.

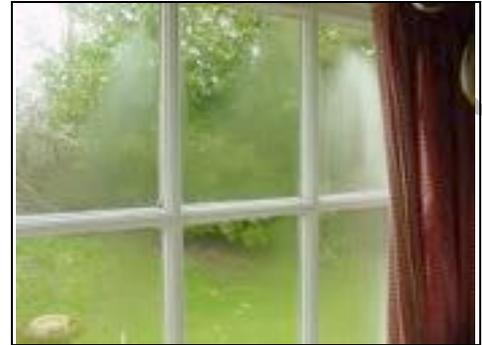
As is often the case with this type of building using an old building in a modern way can create condensation particularly if you do not have suitable extraction. Condensation or any dampness in a timber frame property is not good.

Condensation to windows in kitchen

ACTION REQUIRED: We would recommend large humidity controlled extract fans are added to the kitchen, the bathroom and any areas that are used for drying clothes internally during winter months (we would assume that clothes will be dried externally during the warmer months). By large extract fans we mean 150mm.

ANTICIPATED COST: We would anticipate costs between £250 - £500 per extract fan depending upon the wiring required. We always recommend quotes are obtained before work is agreed/commenced.

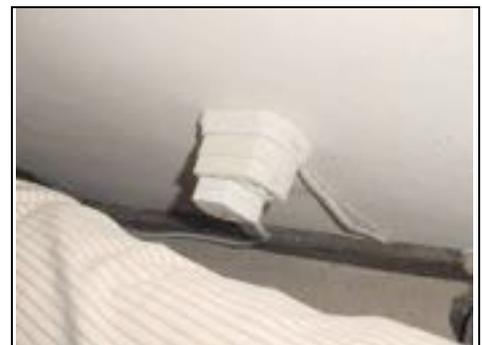
Electrics dated

ACTION REQUIRED: We recommend an Institution of Engineering and Technology (IET) test and report to be carried out by an NICEIC registered and approved electrical contractor or equivalent.

ANTICIPATED COST: £250 - £500 plus any work recommended; please obtain quotations.

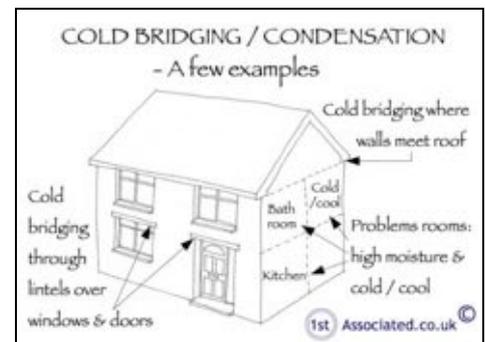
Due to the mixture of materials used we believe there may well be a possibility of cold bridging in the property. Unfortunately, without opening it up it is difficult to confirm. Cold bridging leads to black mould internally unless you control and manage the humidity. In some buildings you do just have to consider this a characteristic of the property.

Cold bridging/thermal bridging

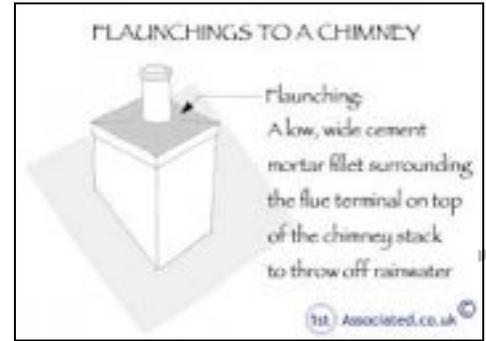
Flaunching

ACTION REQUIRED: The whole of the chimney would benefit from appropriate repair work as we can see there has been inappropriate repair work using cement mortar. We can also see that the lead work detailing could be improved to reduce the amount of water getting into the right gable end. From our experience we don't think this will ever be completely dry but it could be we feel improved. We can also see that the render that adjoins the chimney would benefit from being pre-paired, repaired and redecorated.

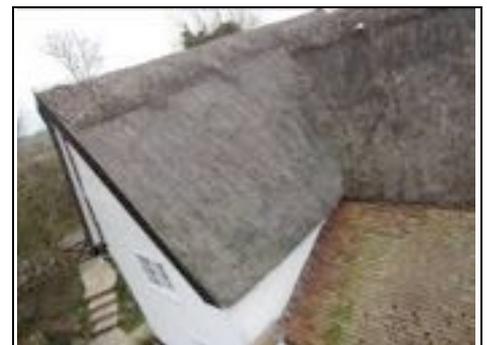
The roof is pitched and thatched with what we believe to be long straw, although it does need samples taking and analysis. From ground level, this looks in below average condition considering the roofs age type and style. We can also see that the roof structure needs work. The owner did advise during our question and answer session that they had carried out some work about five or ten years ago (he could not recall) and he does have quotations for the thatch but do remember with a listed building it is not just about what you want to do; it is also about what the listed building/conservation officer is happy with.

Thatch ridge disintegrating and dampness within thatch
~ Aerial View - 360 Photo ~

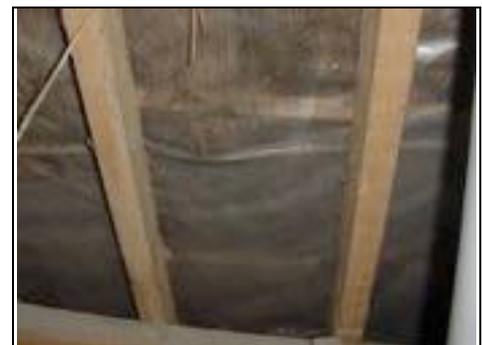
We did not expect to see a protective underlayer under the thatch however we can see some areas where a plastic sheet has been used which we thought was unusual and indicates that part of the thatch has been repaired more recently. We spoke to the owners about this in our question and answers session and they could not recall any specific repairs to the thatch in their time at the property.

This photo shows the common rafters (the ones that form the pitch of the roof) and the dark area between is the underlayer.

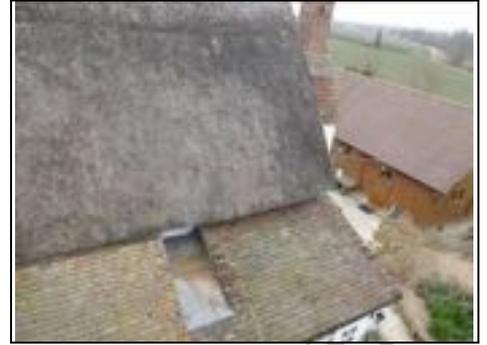
We noted the tiled roofs to the front of the property are relatively shallow and are starting to spall. We would recommend that work is carried out to this area. There is a lead valley to the roof which also needs to be checked when the roof is re-tiled.

Displaced tiles and in need of repair
~ Aerial View - 360 Photo ~

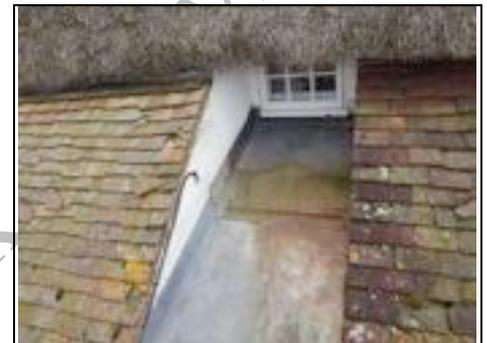
Lead valley to bathroom window
~ Aerial View - 360 Photo ~

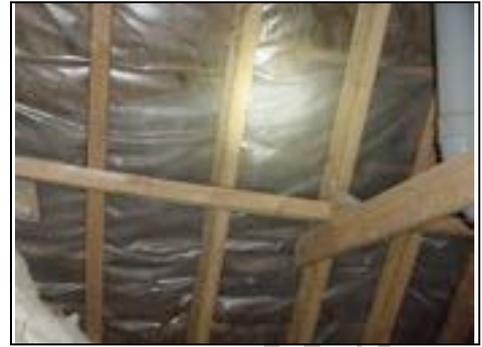
Thin purlins

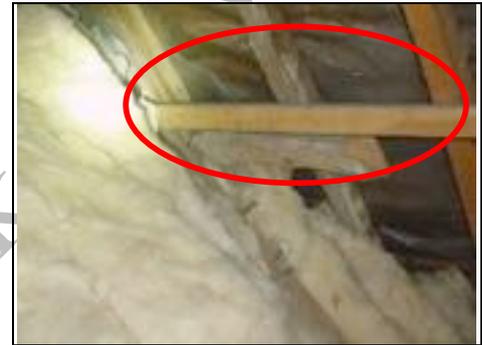
Purlin missing replaced with very thin purlin
Plastic sheeting

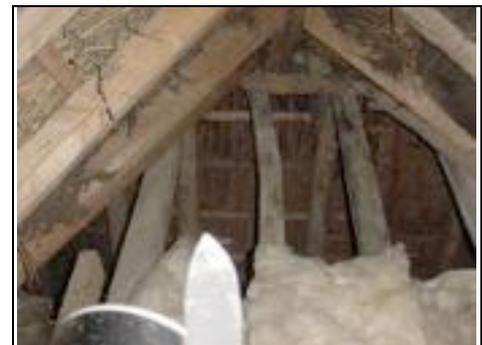
Deterioration/twisting to timbers in left roof

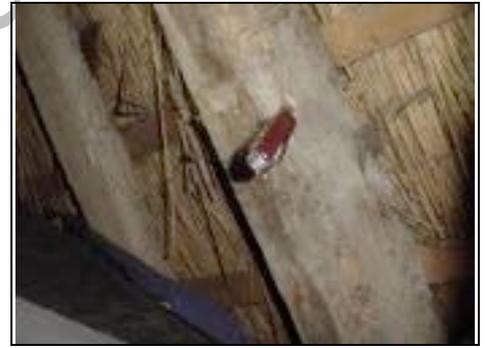
Woodworm and soft rot

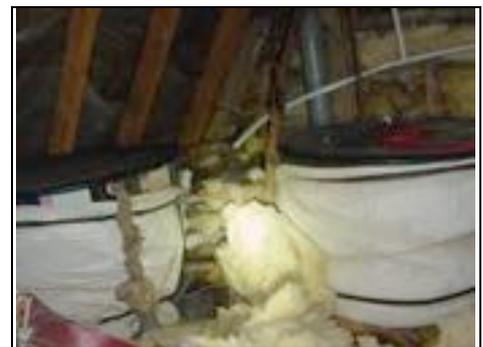
Water tanks in middle roof

We would always recommend that water tanks be drained down and cleared of any debris etc. (we have seen dead birds and other unmentionable things in these tanks). As you are often cleaning your teeth with this water it is best that it is as clean as possible!

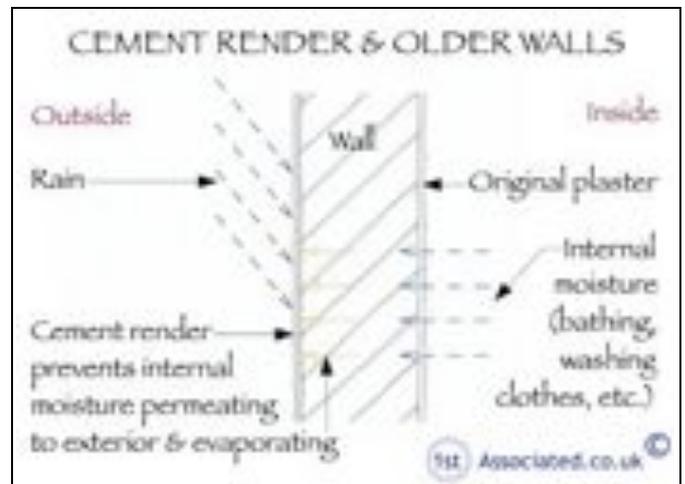
The question that we always ask of these is how much damage the cement render is doing to the timber frame. We do believe in this instance that there is movement in the property and a considerable lean on it so it is well worth carrying out investigations.

Cement render

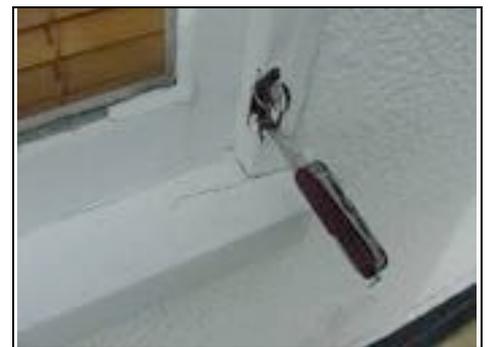
Knife test in rotten window

ANTICIPATED COST: In the region of £750 - £1,000; quotations required.

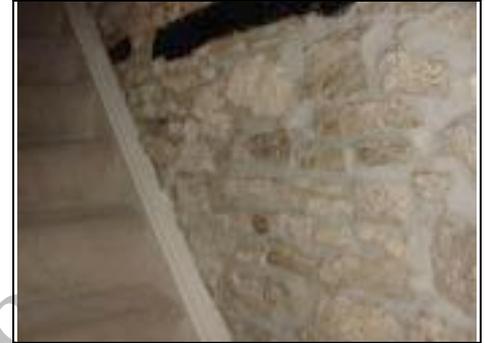
Cement repairs to stonework on side of staircase

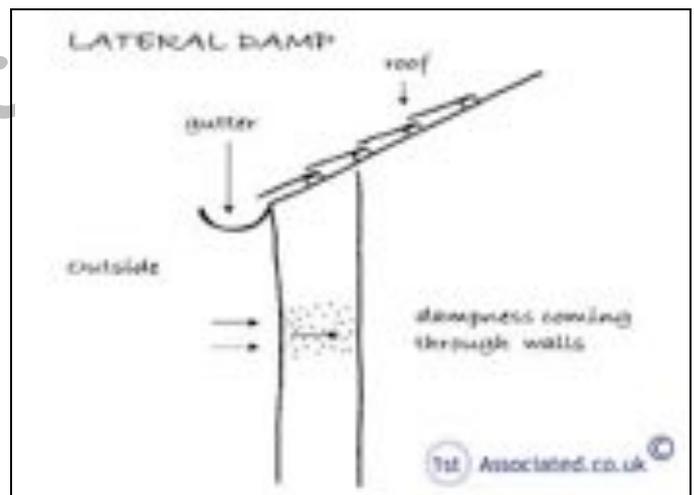
We used a resistance meter on the external walls. We have found significant dampness.

Lateral damp

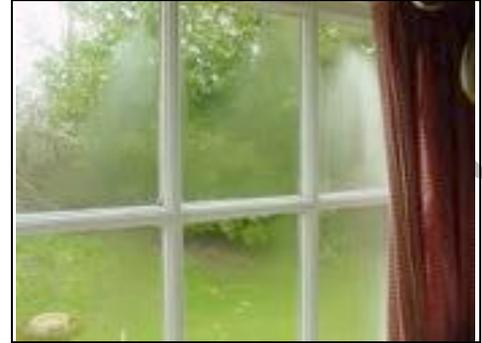
At the time of the inspection there were obvious signs of condensation to the windows in the kitchen and we generally find you do get condensation throughout a property like this even with the characteristic of the property. You do need to consider this will be something you have to live with if you do take this property on.

Condensation to windows in kitchen

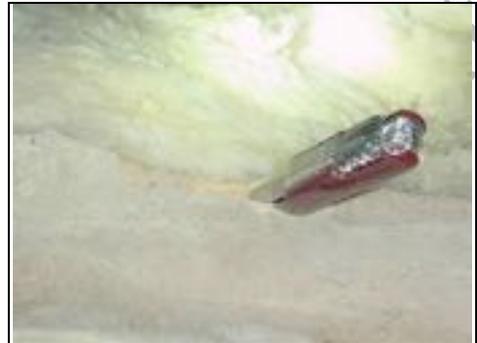
The roof is the main area that we look for woodworm as well as the actual traditional timber structural frame. Within the roof we found visual signs of significant woodworm activity or indeed signs of significant past woodworm activity that has caused what we would term 'structurally significant' damage. In many properties there is an element of woodworm that is not active. Our inspection is usually restricted by insulation covering some of the timbers and general stored items in the roof, as it is restricted throughout the property by general fixtures and fittings.

Woodworm/rot in timber in middle roof where it meets left roof

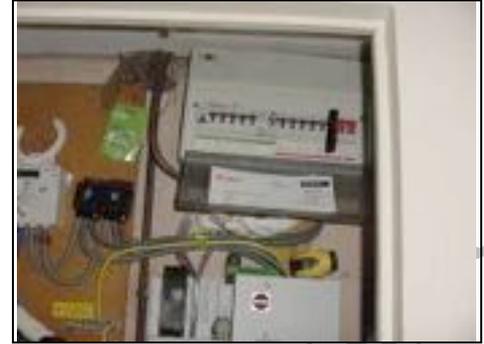
The electric fuses and consumer units were located in a cupboard off the entrance hall. The fuse board looked to be a 1980's - 1990's style. In an older property a defective fuse board can be particularly dangerous.

Fuse Board

ACTION REQUIRED: As the property is changing occupancy an Institution of Engineering and Technology (IET) test and report and any recommendations should be carried out by a NICEIC registered, or equivalent, approved electrical contractor or similarly approved.

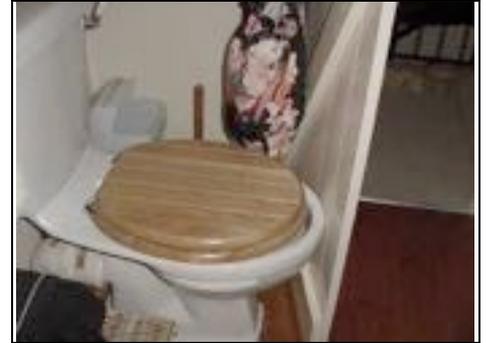
WC very close to door in bathroom

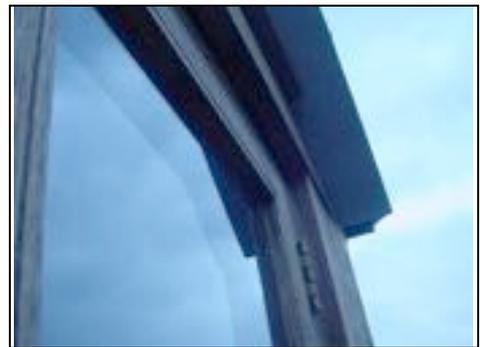
Windows need re-staining
