JOB REFERENCE: XXXX

RESIDENTIAL BUILDING SURVEY

XXXX
Odell
Bedford
Bedfordshire
MK43 XXX

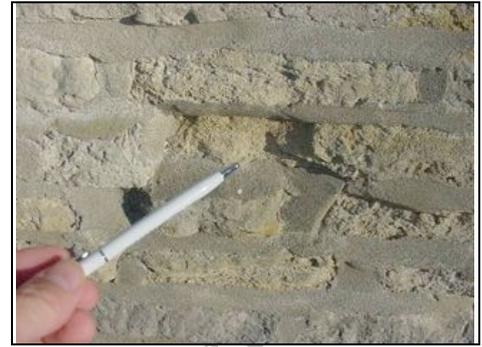
Deterioration

The good news is there is relatively little deterioration in the form of concaved hollowing of the stone that we sometimes find. The not so good news is that the stone is weathered over and above what we would normally expect.

ACTION REQUIRED: We would recommend that you find the oldest stonemason you can and every summer for the foreseeable future employ them to use a soft brush to remove any defective cement mortar and replace it with lime mortar. Then gradually over the years you will improve the situation albeit a slow process.

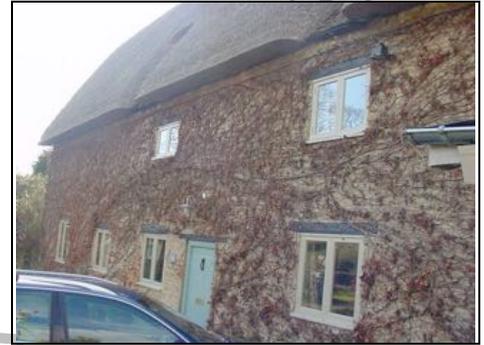
There is ivy and other forms of plant life growing on the building, which unfortunately can cause further deterioration to the stonework. Having said all of that, the stonework, all things considered, does look in average to above average condition.

Plants to stone

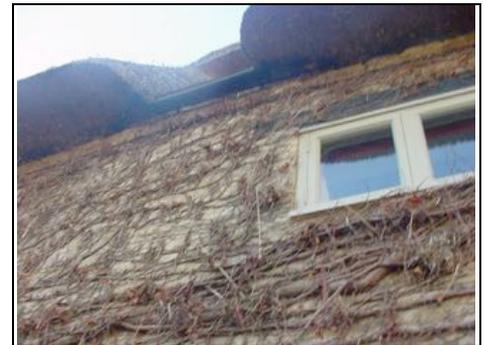
With the building covered in the spring/summer months, leaves, etc tend to hold water against the structure and can cause dampness to get into it. We would normally be able to see signs of this affecting the property inside which we cannot but equally from our experience we cannot see how this property cannot be affected by dampness.

Plant life causing damage

ACTION REQUIRED: Ideally we would recommend that trellis work is inserted between the wall and the ivy, etc to reduce damage.

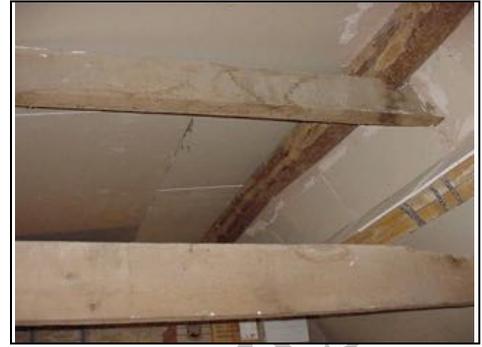
Between the farm house and the barn within the top floor roof area the present owner advised that when they had their survey carried out it deemed that there was not suitable structural support in this area and they have added structural support. From what we could see the timber sizing used would not be what we would have used given the timber characteristics of the rest of the building. Having said that, it seems to have been satisfactory for twenty odd years however our concern is that the new thatch may be hiding movement in the gable ends of the property.

Structural repair

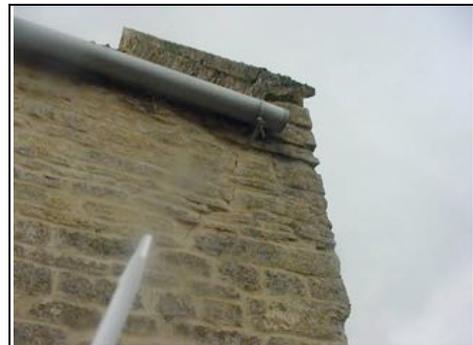
We would not normally mix the dwelling and the barn section but in this particular case we feel that one has an impact on the other. We can see to the far end of the barn that there is cracking to the gable which has been repaired and then re-opened up which indicates to us that the right hand gable is moving and in turn it is possible given the old repairs that we have just mentioned that the right hand gable of the house is also moving.

Cracking

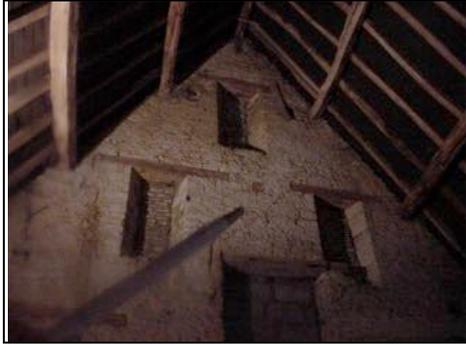
Cracking in gable between house and barn

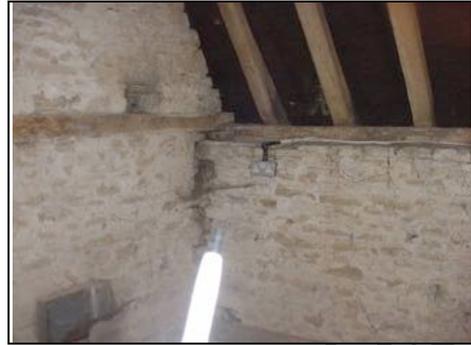
Cracking on rear right hand corner

ACTION REQUIRED: We would recommend the existing owner places an insurance claim, which you then take over. Your legal advisor to check and confirm that this is legally binding. This would then limit your liability to the excess on the insurance and ensure in the possibility that there is movement in this area that you have insurance against this.

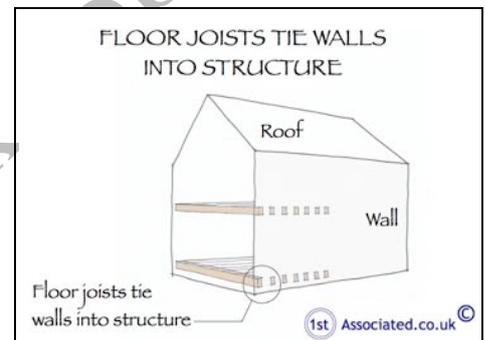
Gable end wall not tied in

ACTION REQUIRED: An insurance claim we believe is essential to purchasing this property. The reason behind this is partly we believe that the gable end is not tied in. There may also be what is often known as a domino effect being caused by the building leaning slightly.

The insurance company would monitor for a year which is typically recommended by the BRE (Building Research Establishment) which may then result in the gable wall being tied in, it may result in buttresses or it may result in foundations being added although we must admit we would resist the latter as often buildings in this era of property were built without foundations and we feel it simply adds extra weight to the property and causes displacement in the structure as a whole. We would be more than happy to help you with any future insurance recommendations giving independent advice – most loss adjusters are working for insurance companies.

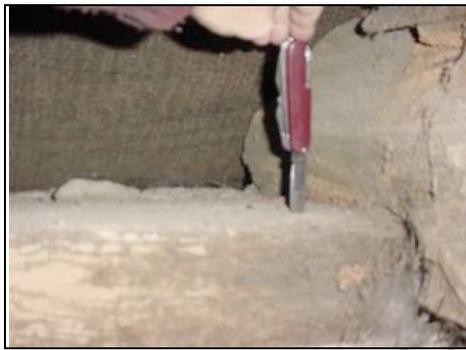
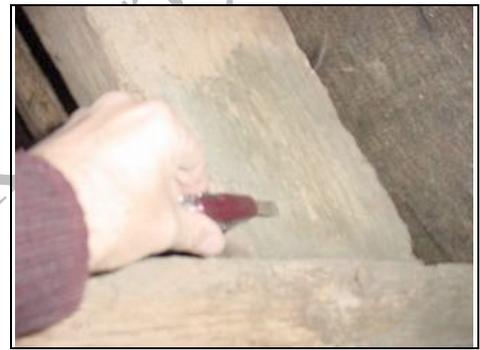
Not surprisingly in an unheated area, the timber is suffering from wet rot. We would add also that this environment is perfect for active woodworm and active woodworm should not be discounted. It really depends what you intend to use the barn for. Please see our comments within the Barn section.

Wet rot

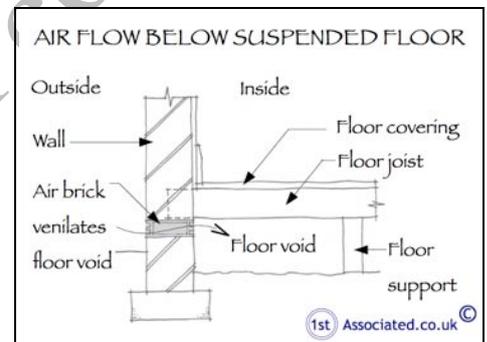
There is a part suspended timber floor to the middle of the property which we suspect there will be wet rot within this area (we have not opened it up as there is no way from what we could see of doing this without damaging the property). We believe it is a suspended timber floor because of the airbricks that we can see outside to the front of the property. Unfortunately we can also see that there are downpipes discharging close to the property as well.

Suspended timber floor

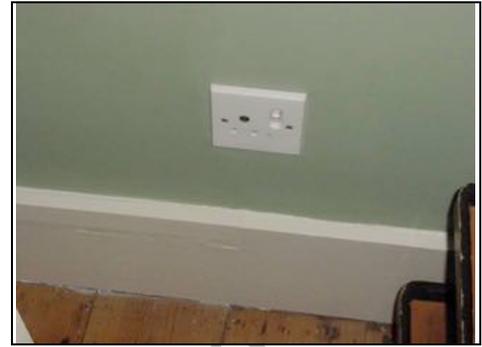
You may or may not have noticed that there are not any ceiling lights to most of the ground floor and the lights come from ground floor level using an older style socket point with a circular pin. We would also draw your attention to the number of socket points.

ACTION REQUIRED: An Institution of Engineering and Technology (IET) test and report and any recommendations to be carried out by an NICEIC registered and approved electrical contractor or equivalent.

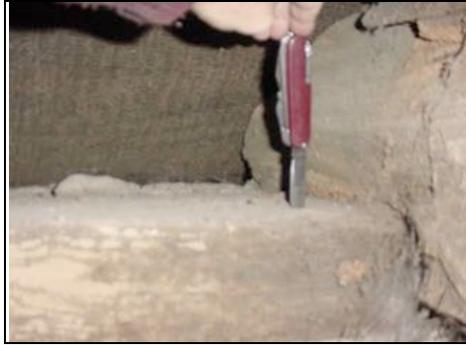
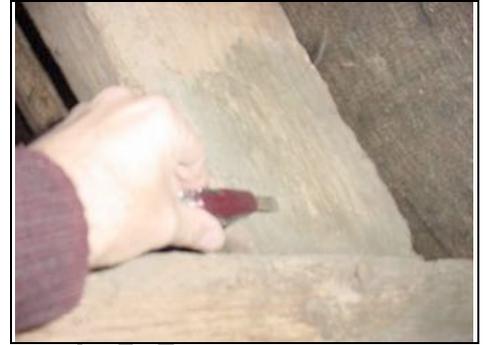
Wet rot was noted to the barn roof structure.

Wet rot

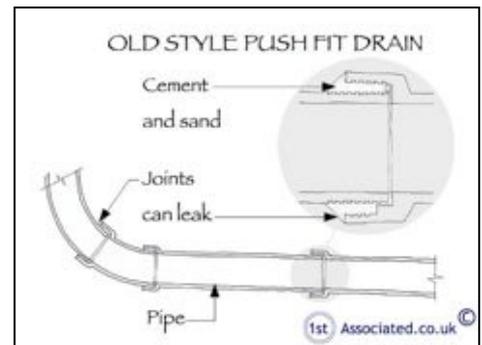
In older properties, such as this, drainage was often push fitted together rather than bonded together which means that they may leak over the years. Whilst we ran the tap for 5 minutes in the bathroom without any build up or blockages the only way to be 100% certain of the condition of the drains is to have a closed circuit TV camera report.

Push fit drain

The only true way to find out the condition of the drains is to have a closed circuit TV camera report to establish the condition of the drains. In this age of property there have often been leaks over the years.

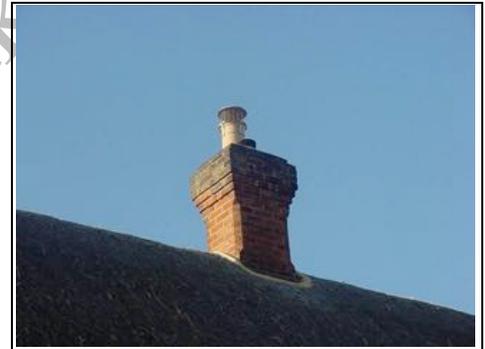
This chimney is brick finished with a cement flashing and one chimney pot/flue. From what we could see from ground level it looked in average condition considering its age, type and style.

There is some minor moss on the tops of all the chimneys indicating that the pointing may be starting to go.

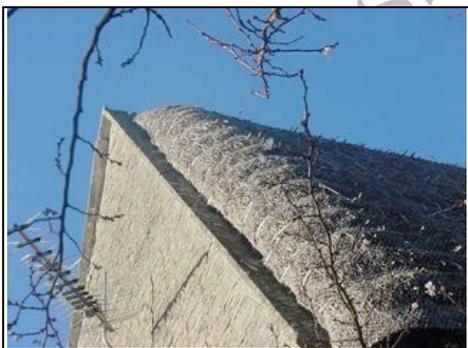
Where the properties meet and to the right hand side of the barn there are exposed parapet walls. The parapet is in a susceptible position and is exposed to the elements. There looks to have been repairs to the very tops of the parapet walls and they form part of the gable ends. Please see our comments with regards to the gable ends. In all cases where the parapet walls meet the roofs there are cement fillets. From ground level we cannot advise whether these have an element of lime but they do look as if they have been carried out in cement, in which case they will in due course tend to crack as they cannot cope with the movement in older properties and leaks will occur.

Left hand gable

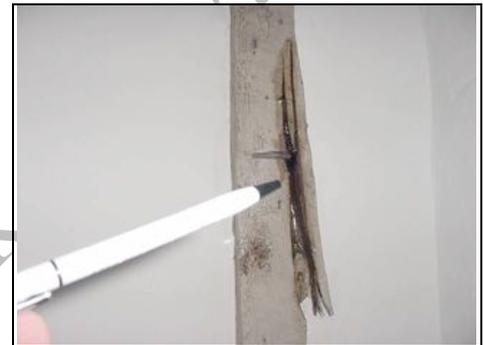
Damage to common rafter

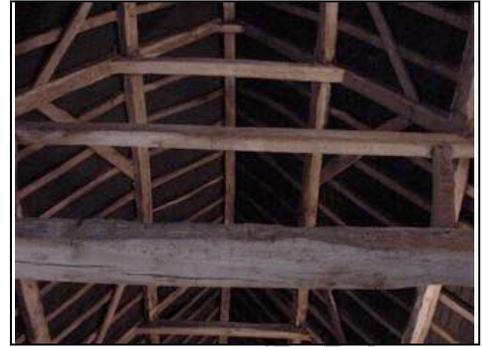
We believe there may be some active woodworm in the barn. The barn roof structure was viewed from ground level; it would need access from scaffolding or a lifting device for a close inspection. It was only closely inspected from a platform to the right hand side where we could see there was woodworm evidence and also soft rot to the timber.

Queen post roof structure in barn

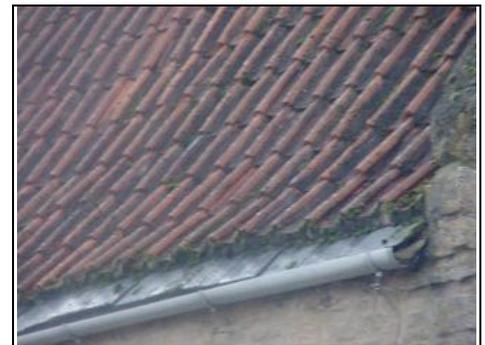
The guttering is plastic and would benefit from being given extra support. We can see an end cap missing and also various dips in it, which we feel may lead to water discharging down the property.

End cap missing to guttering on barn

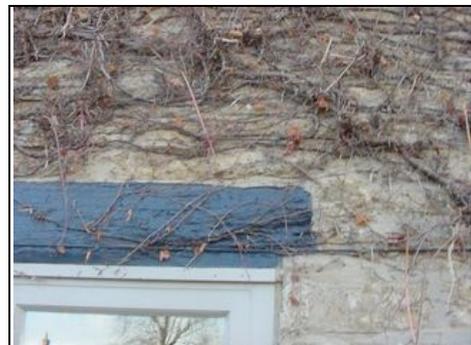
Timber lintels with poor end bearing

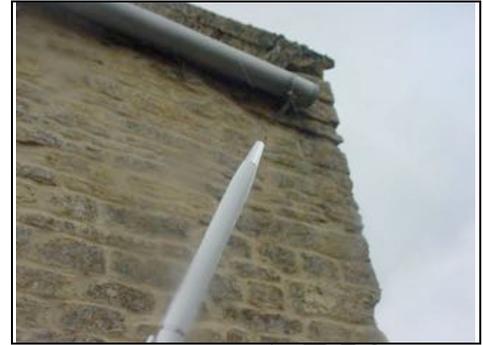
Cracking to far right of barn

ACTION REQUIRED: Please see our comments in the Executive Summary.

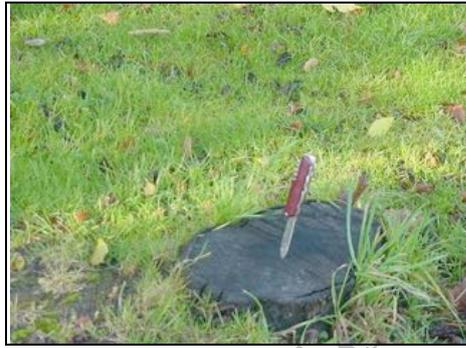
Tree damaged from scaffolding for thatching which duly died and was cut back

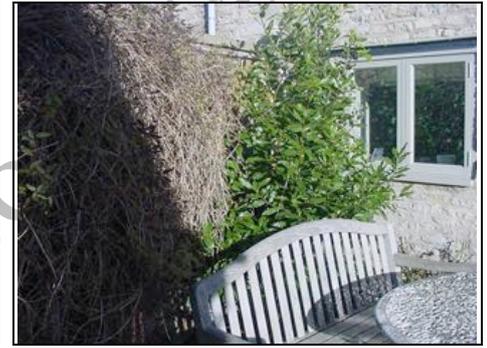
Plants growing on walls

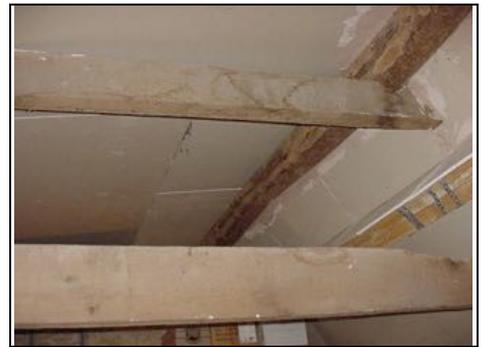
Within the roof we could see the common rafters. Some of these timbers were darker indicating to us that there may be some dampness getting in but in this case the timbers may still be drying out from when the thatch was added. There was no area where we could physically see the thatch. If you wish, and obtain permission in writing, we would be more than happy to employ a builder on your behalf to remove the plasterboard in the end right hand room. We do think this would be particularly useful as there are areas of water staining to the timbers.

Water staining to timbers

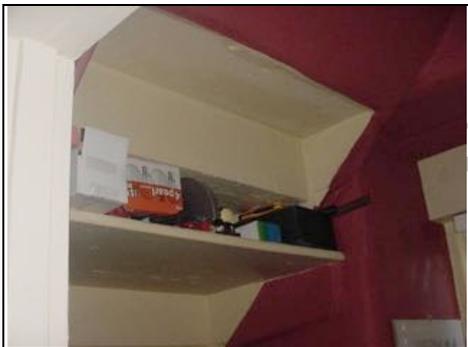
We noted that the underside of the staircase was exposed. It is more normal today to have a half hour fire barrier to stop fire spreading from the ground floor to the first floor in a worse case scenario. You may wish to take a view on whether you add this.

Staircase not lined

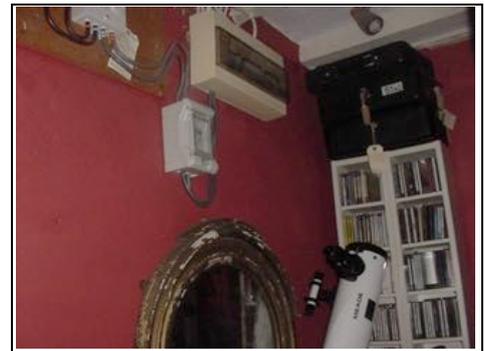
The electric fuses and consumer units were located under the stairs on the ground floor. The fuse board looked 1980's/1990's and better are now available. In an older property, particularly where it is thatched, a defective fuse board can be particularly dangerous.

Fuse Board

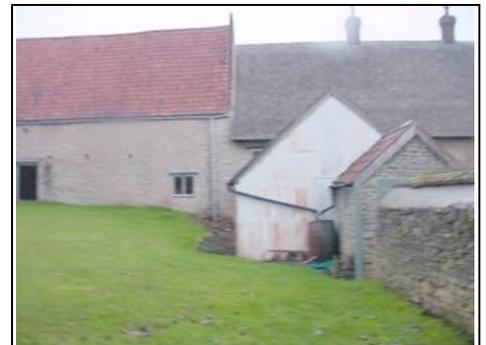
We have been unable to determine the ultimate means of rain/surface water disposal. The drains are likely to be discharging into the ground and is likely to cause dampness into the kitchen area.

Downpipe discharging into ground

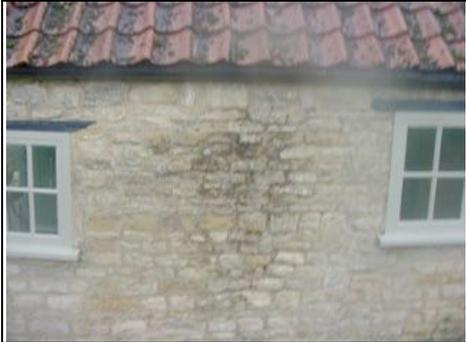
The guttering to the outbuilding looks to be leaking and the stonework beneath is weathered.

Gutter leaking onto wall

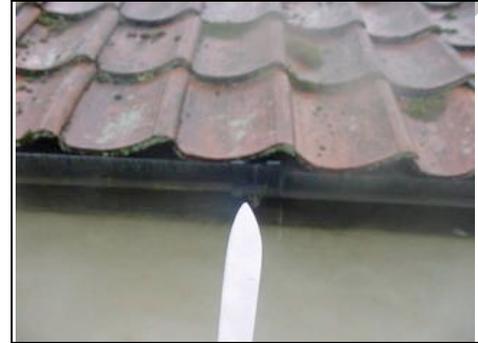
Gutter leaking on outbuilding
