RESIDENTIAL BUILDING SURVEY

XXX
HARPENDEN
Hertfordshire
AL5 XXX

Prepared by:
XXXX
INDEPENDENT CHARTERED SURVEYORS

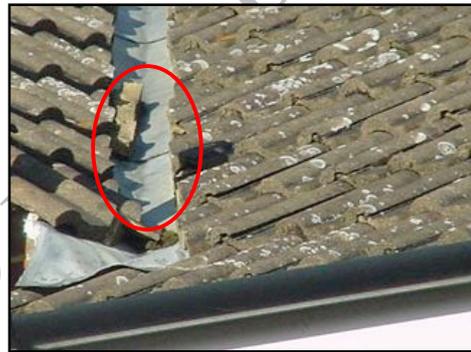
Valley gutter

Close up of valley gutter where concrete fillets have come out

ACTION REQUIRED: Repairs are needed to stop water getting into the roof structure. We would take the opportunity to check all the valley gutters.

ANTICIPATED COST: The most expensive part will be actually getting access to the valley gutters. Expect costs in the region of £750 to £1,500. You do need to ensure that the builders have good access as this will mean they will carry out a good job. It may well be worth insisting that they use a tower scaffold to access the area rather than ladders and crawler boards.

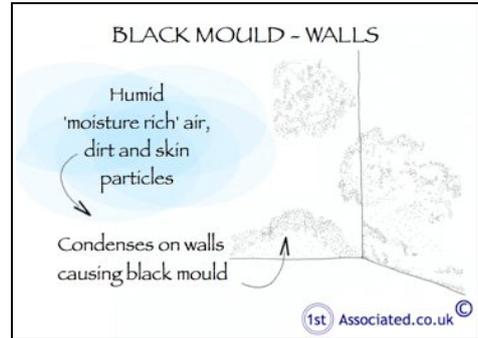
There is potential for black mould and condensation due to lack of air within the property and extract ventilation. When we went around the property we were surprised to see some areas, which seems to be being affected by condensation and black mould. This normally occurs due to lack of air circulation and extraction of humid air within a property.

Black mould

We would always start by adding large humidity controlled extract fans to the kitchen and bathroom areas and see if this improves things. It could be just the way the existing family is living in the property, i.e. drying washing on radiators without ventilating the house, or heating the house without airing it by occasionally opening windows.

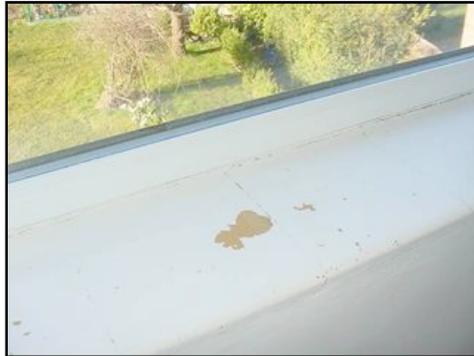
Paint is coming off which is a sign of condensation

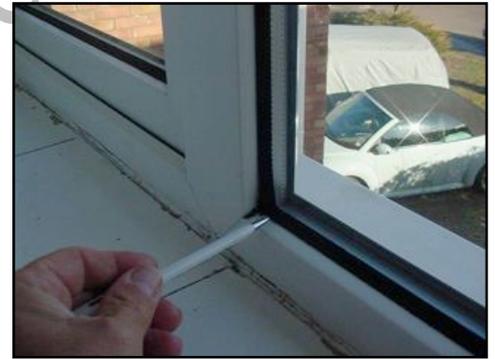
Black mould on window sill

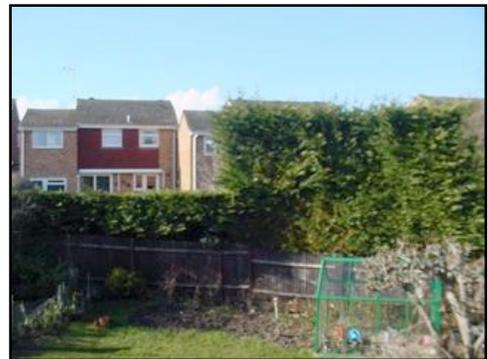
There are overgrown conifers in the rear garden. Ironically at one time conifers seemed to be the answer to everything for a quick growing tree, but are now said to be one of the biggest reasons for neighbourhood disputes.

Over grown conifers

ACTION REQUIRED: Have a chat with the neighbours you share the conifer fence with prior to committing to purchase the property to see if they are happy and amenable for them being maintained and reduced in size occasionally.

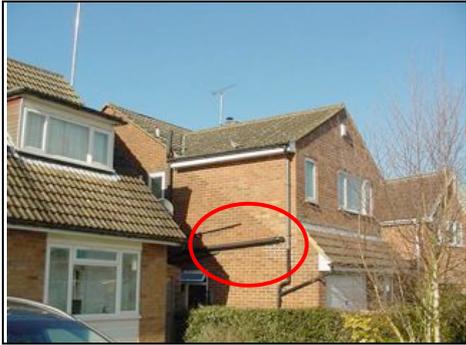
An awkward high level drainage run has been incorporated in with the extension to form the en-suite bathroom and there also looks to have been alterations to the original bathroom drainage. Only time and usage will tell as to whether this works satisfactorily. We noted a rodding eye to one end of the high level drainage which will help should it become blocked.

View of left side of property with awkward horizontal drainage run

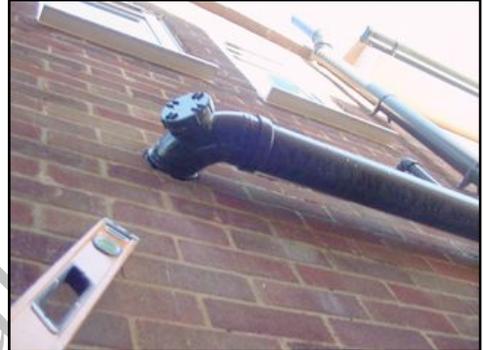
Awkward soil and vent pipe with rodding eye

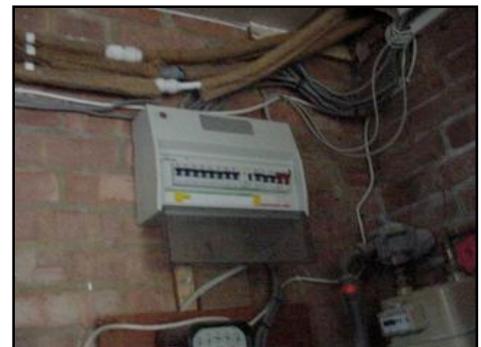
Fuse board

The electrics look slightly dated; probably original, though it may have been updated when there were alterations. There are better fuseboards

ACTION REQUIRED: If you have young children or elderly people in the house we recommend changing the fuseboard as soon as possible.

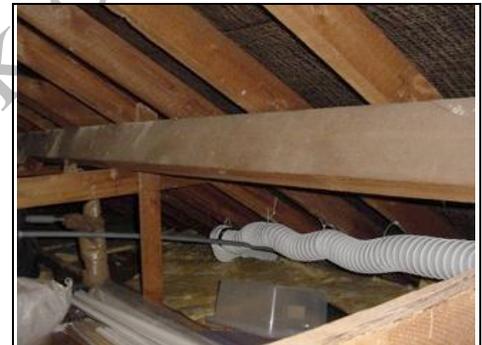
There are some awkward details that have come about due to the extension, one of these is the extraction which has resulted in this Elephant's trunk vent in the roof, which we are not certain is working that successfully.

Elephant's trunk vent system

ACTION REQUIRED: We would look at extracting directly outside the property with large humidity controlled extract fans going through the walls. This would avoid any problems of the Elephant's trunk extraction leaking condensation into the roof and causing mould and deterioration.

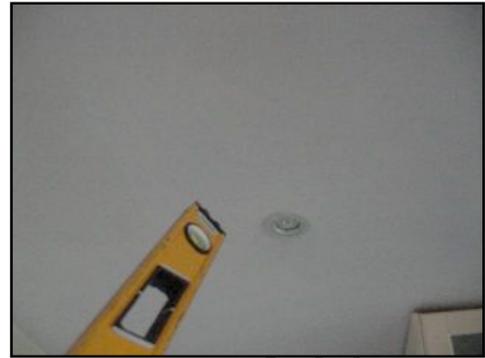
Old style ceiling lights

ACTION REQUIRED: Replace with modern ceiling lights.

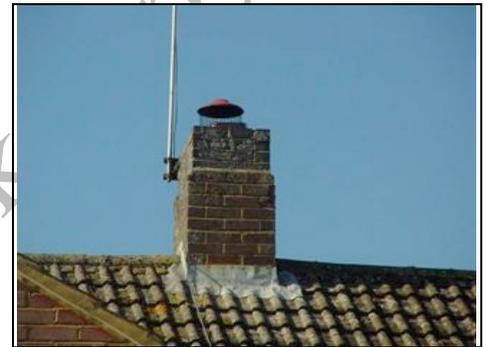
Central Chimney

This chimney is brick finished with a lead flashing and one cow. From what we could see from ground level it looked in average condition considering its age, type and style.

There is an aerial attached to the chimney which we do not recommend as it can cut into the brickwork rather like a cheese wire cutting into cheese. Given the height of the aerial (and next door's aerial) we wonder whether there is a problem with getting a reception in this area.

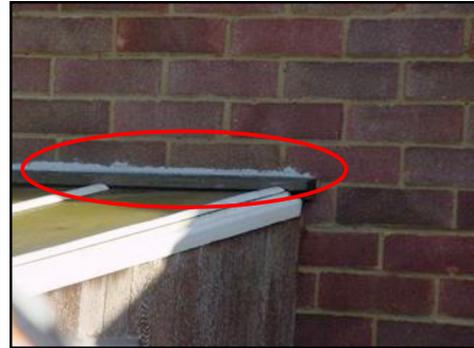
Poor flashing

Assuming we are accepting this is a below average quality rear lean-to it is the join where it meets the roof that is probably the problem area as this is likely to leak when it rains.

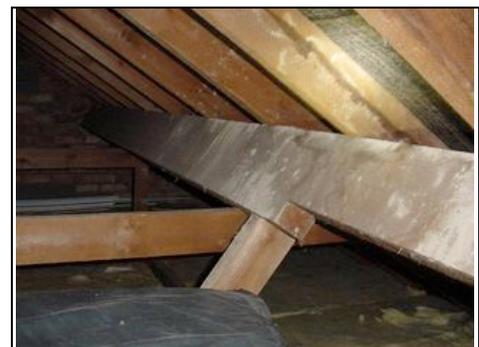
For some reason the purlin has been cut

What we could see was generally found to be in average condition for its age, type and style. It is, however, feasible that there are problems in the roof that are hidden. We did note that the purlin has been cut.

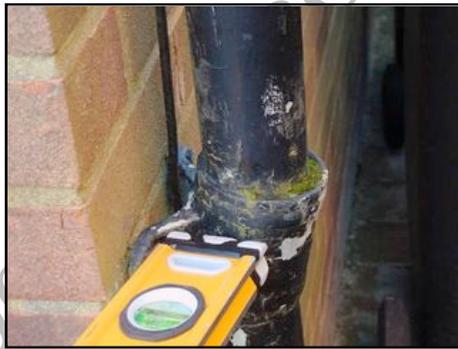
Leaking downpipe

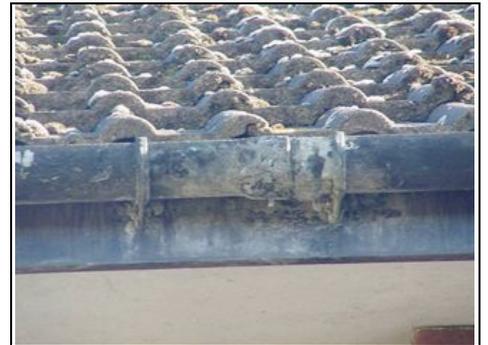
Leaking gutter

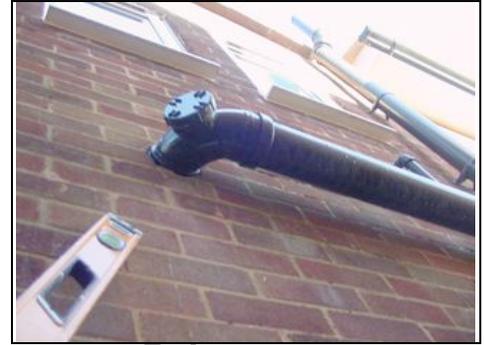
Soil and vent pipe – awkward configuration

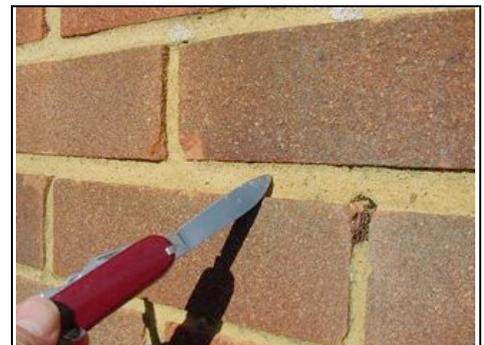
Weathering to pointing

ACTION REQUIRED: We would suggest you inspect the pointing in the summer of 2015 and ad hoc repointing is worth carrying out when you carry out the repair work to the roof verge.

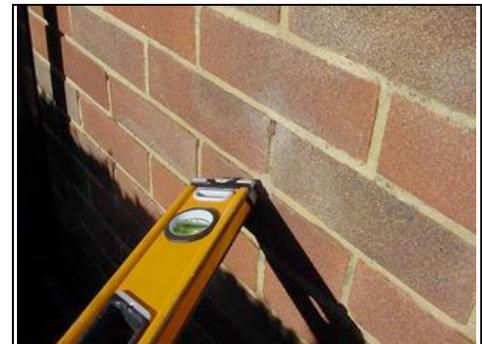
Weathering to pointing

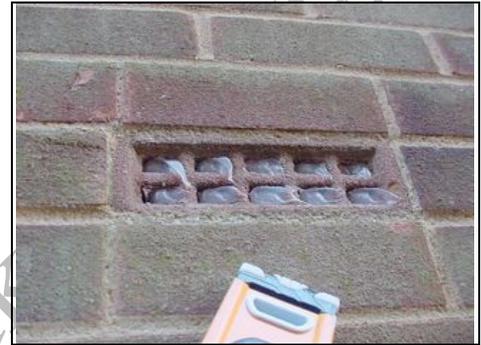
Blocked high level airbrick

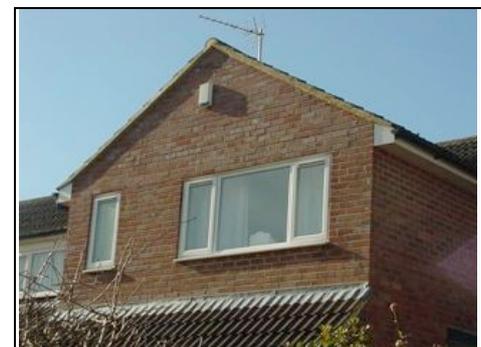
Windows without trickle vents

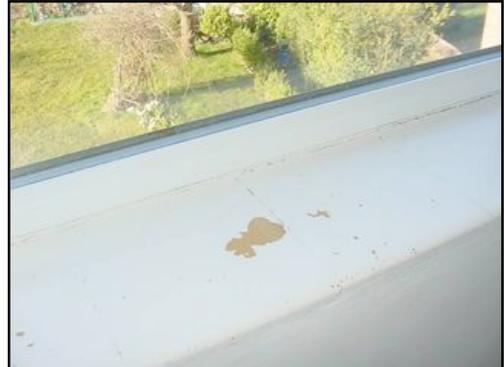
At the time of the inspection there were signs of condensation in the property, for example the paint coming off to the window sill, which is often a sign of water ponding on the window sills.

Paint is coming off which is a sign of condensation

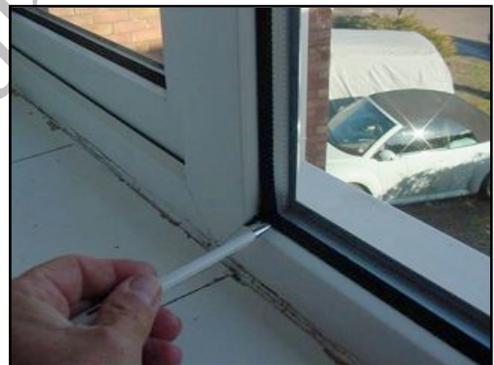
Minor black mould was found to the windows. There seems to be a problem in the property with condensation, which is

Black mould on window sill

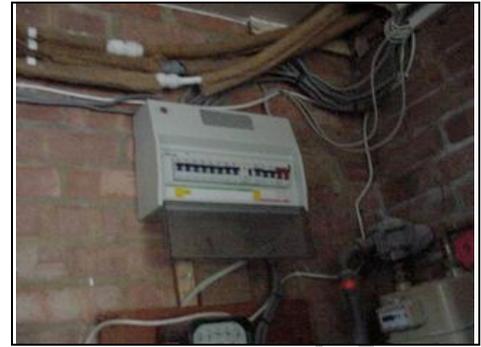
Fuse Board

The electric fuses and consumer units were located in the garage. The fuse board looked to be from the 1980's/1990's and we believe better are now available and we would be surprised that it was not changed when the extension was carried out.

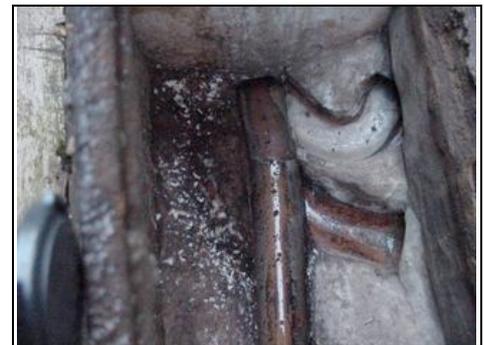
Left hand drain

It looks like there have been alterations to this drain.
