# RESIDENTIAL BUILDING SURVEY

Biggleswade  
Bedfordshire  
SG18 XXX

**Two storey  
mid terraced  
modern property**

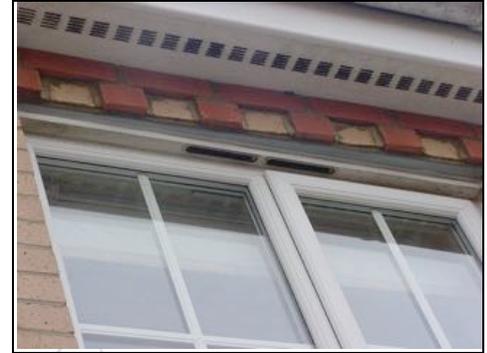
The property has been built at an angle which we mean is that we can see this by looking at the lintels which show the property is not square which is unusual for this to be this pronounced.

Property not square – twist in lintel

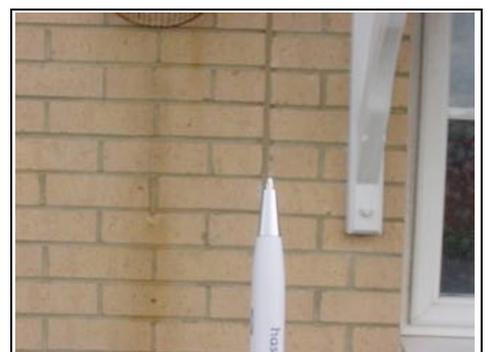
Mastic joint between two buildings

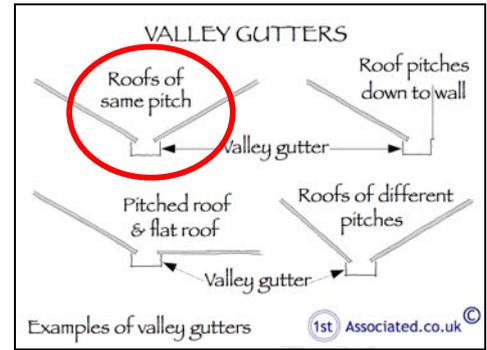
The property has a valley gutter which we noted the cement mortar has come away which in turn means you will get leaks into the roof.

Valley gutter to pitched roof

**ACTION REQUIRED:** Check all valley gutters and verge details and remove the cement mortar and replace.

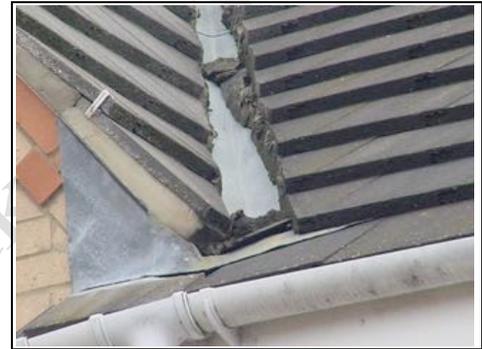
Cement mortar has come away

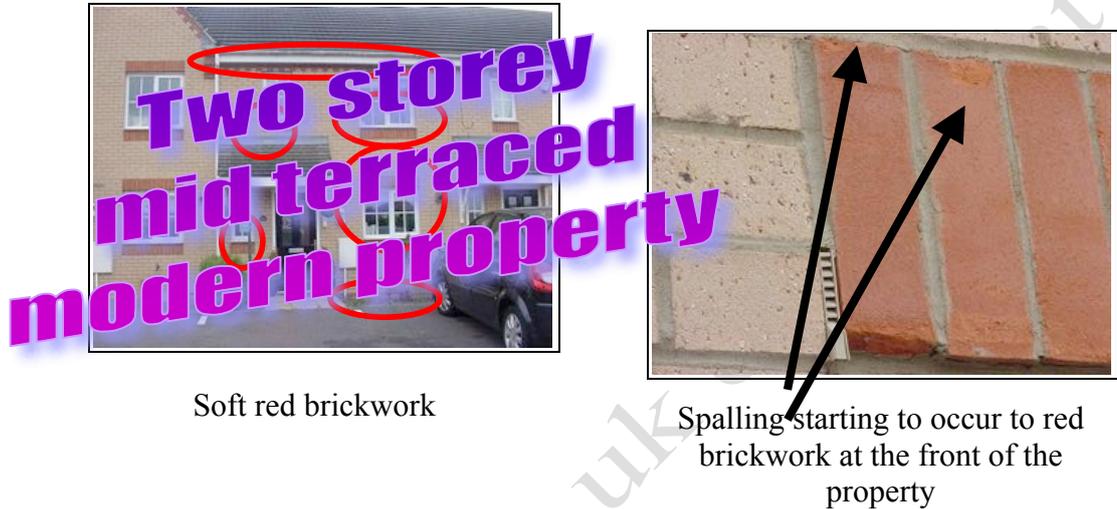
We noticed soft red brickwork has been used to highlight areas of the property and are a feature of the property have started to spall.

For example: to the soldier course of bricks over the windows.

Whilst the spalling is minor this really should not be occurring on such a modern property.

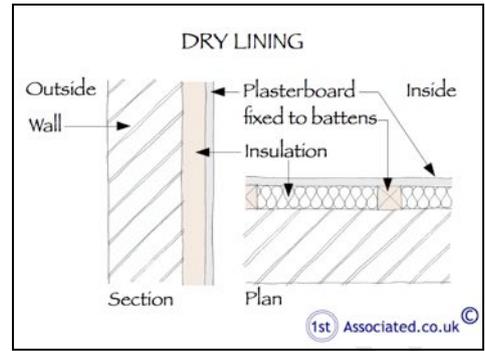
The walls have been dry lined

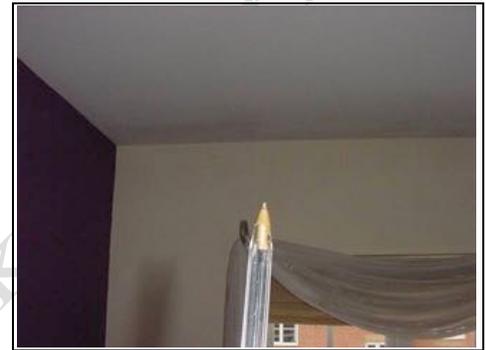
The cracking is relatively straight which tends to mean that it is a plasterboard crack (the property is lined with a gypsum plaster) and is what is known as dry lined or false wall construction please see our sketch. This type of hairline cracking is relatively common in this type of modern property particularly where there are problems with humidity/condensation.

Cracking in master bedroom

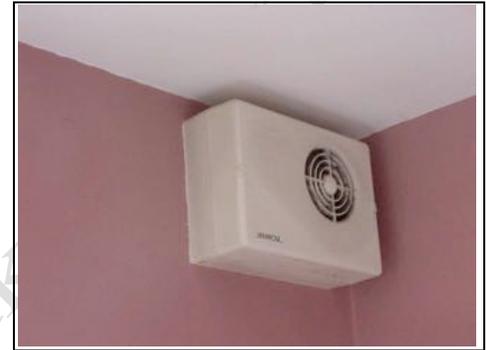
Extract in kitchen never used

Interestingly when we spoke to the present owner they advised that they have never used the extract fan in the kitchen and did not know where the switch was located. We could not get the extract fan to work and recommend you replace this extract fan.

**ACTION REQUIRED:** Again, we would recommend replacement of the fan with a large humidity controlled extract fan.

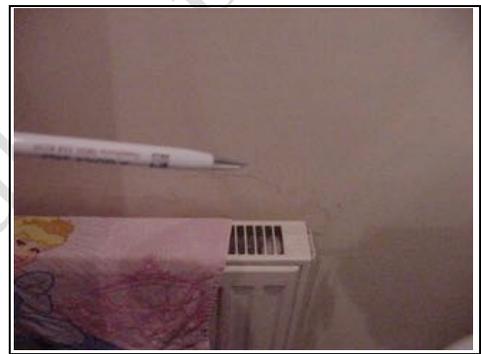
Quite unusually we noticed some staining around the radiators which may relate to drying of clothes internally.

Staining around radiator

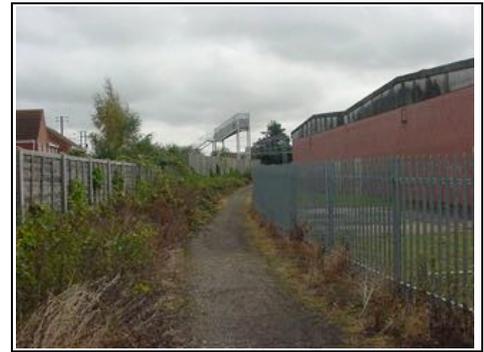
The property is located quite near to industrial buildings and train line. Throughout the time we were carrying out our survey we could hear a beeping noise which sounded like a truck reversing which may relate to an industrial premises. In the end the noise was carrying on for so long we did not believe it was a truck reversing but a noise made by one of the industrial buildings.

Nearby industrial buildings with bridge in the background over train line

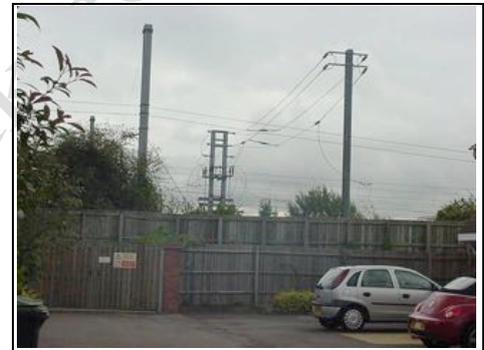
We also noted that the railway line is fairly close by and that you will probably be able to here noise from the railway whilst in the garden although we did not experience this on the day of our survey.

Railway line at the end of the road

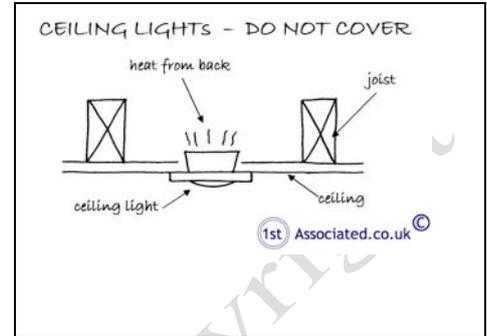
Ceiling lights must not be covered

**ACTION REQUIRED:** Check when putting stored items into the roof that you do not cover the lights.

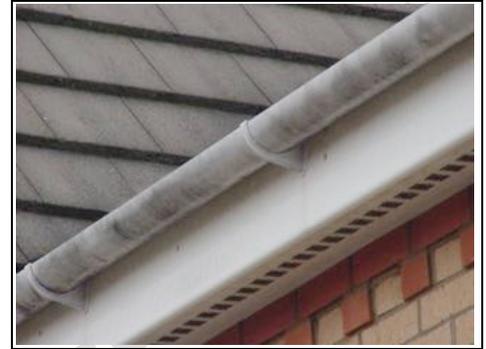
Moss covered gutters

**ACTION REQUIRED:** Clear guttering of any blockages and moss. We would recommend you stand outside the property next time it rains heavily and see how well the drains cope with the rainwater particularly looking at the guttering and the joints. We would also recommend that the gutters and downpipes are cleaned out, the joints are checked and the alignment checked to ensure that the gutters fall towards the downpipes.

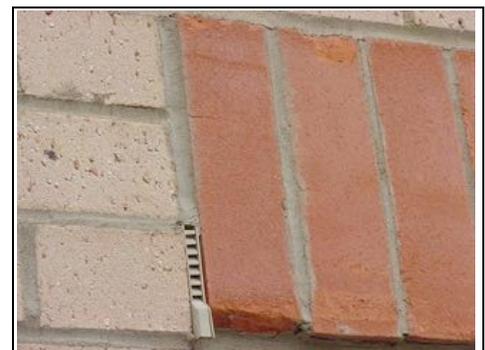
Spalling to red brickwork

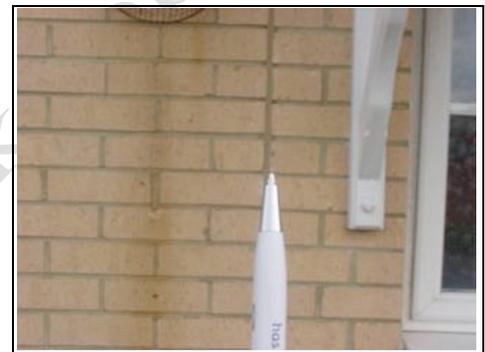
We noted mastic joints between properties. An expansion joint is good practice in modern properties as they have very little room to move.

Mastic between properties

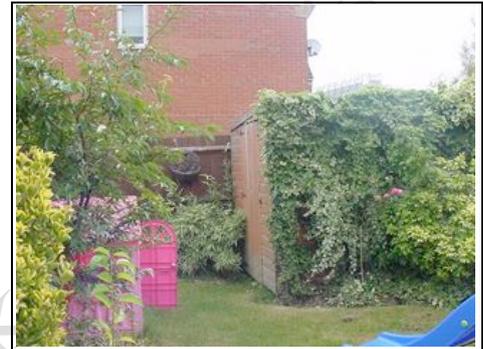
Shed covered with ivy

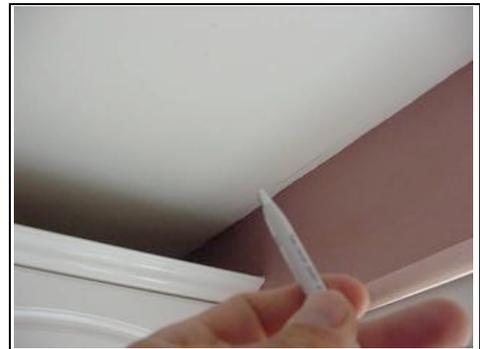
There is some hairline cracking occurring within the property. This is quite a common occurrence in this era of property particularly where there is an element of humidity and by differential movement in the structure. Unfortunately plasterboard cannot cope with very much movement. They tend to be very straight cracks.

Hairline cracking to ceiling

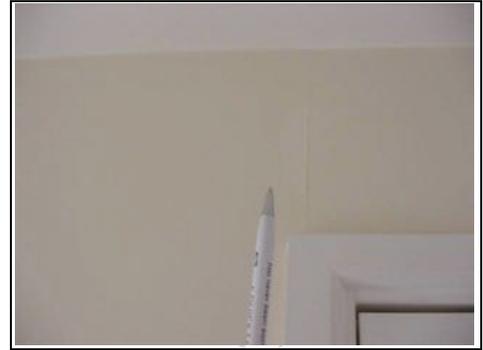
Hairline cracking

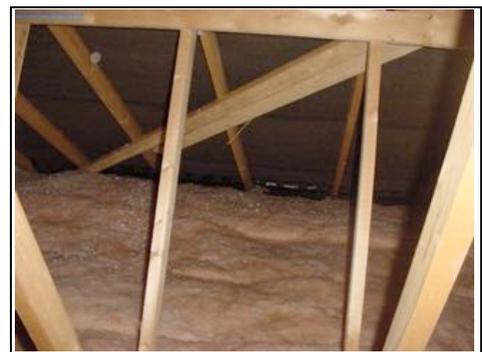
- 1.0) as we did not have full view of the roof space due to the mass of insulation and stored items.

Mass of insulation

**ACTION REQUIRED:** The only way to be 100 per cent certain is to have the roof cleared and checked.
