JOB REFERENCE: XXXX

# RESIDENTIAL BUILDING SURVEY

XXX Peterborough,  
Cambridgeshire,  
PE7 XXX

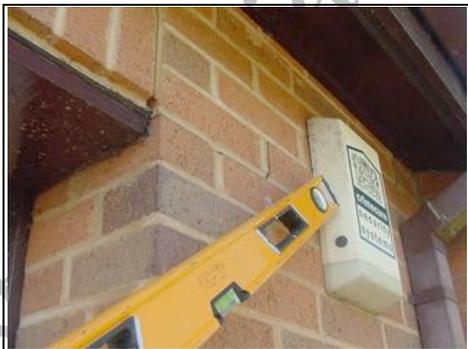
##### **1.1.1) Front right hand corner**

As you are aware there are cracks to the front right hand corner of the property (we also found various other cracks in the property) which has resulted in the mortgage companies Valuer requiring an Engineers report in relation to this issue. We have not had a copy of the valuation report but this was our understanding from what the estate agent advised us.

Step crack to right hand side

**ACTION REQUIRED:** We would recommend that you do not purchase this property based upon the potential of progressive movement considering your risk criteria.

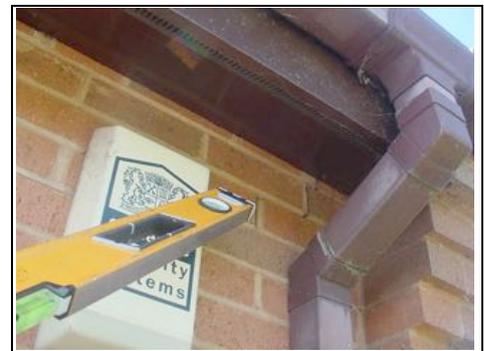
Step crack to right hand side

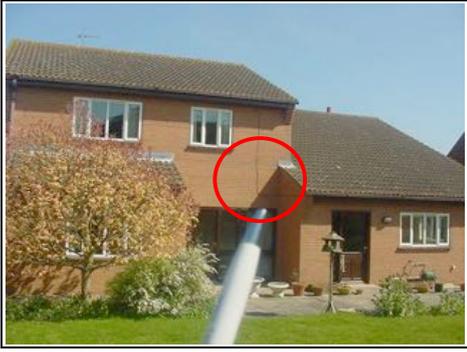
### 1.1.2) Rear middle

Area where cracking is at rear of the property

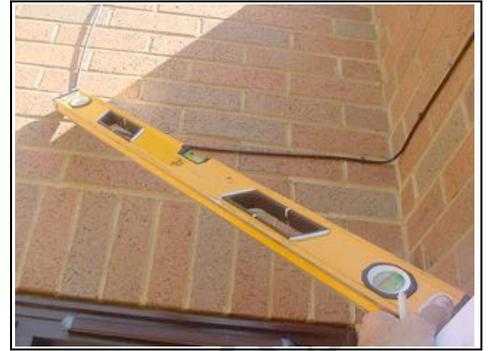
Step crack to rear of property

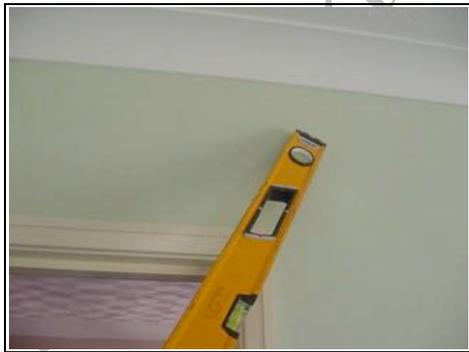
##### Reception room- front left

Crack in reception room above the door

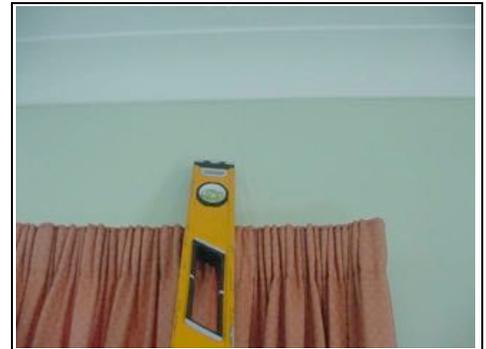
Cracks above window in reception room

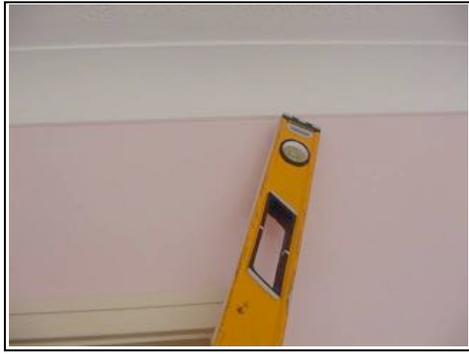
Second reception room – front left

Crack in second reception room  
above the door

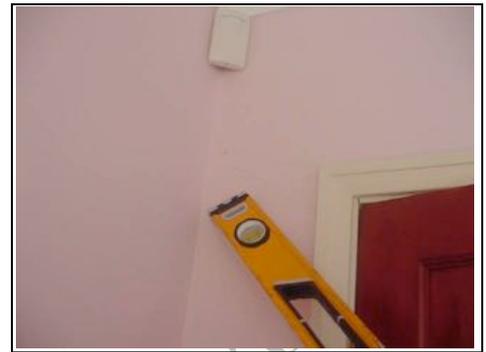
Crack in second reception room  
near the door

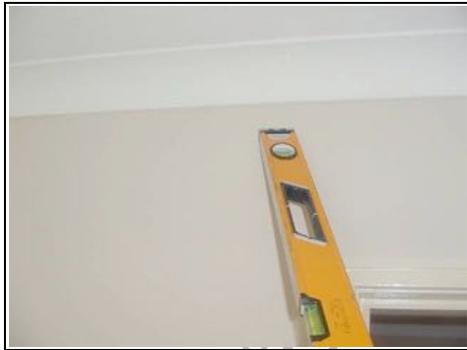
Kitchen

Crack above door in kitchen

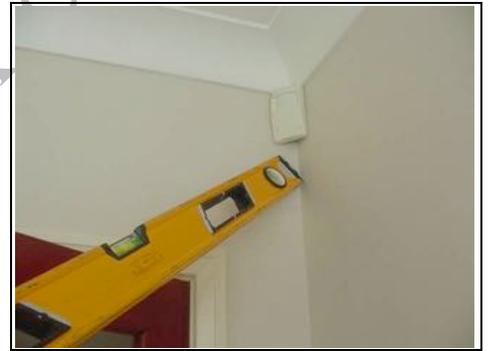
Crack in corner near door  
in kitchen

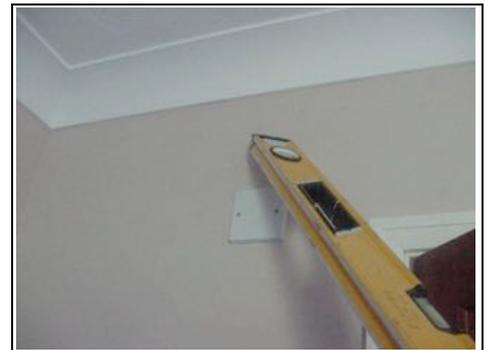
Bedroom - rear right

Crack above door in bedroom –  
rear right

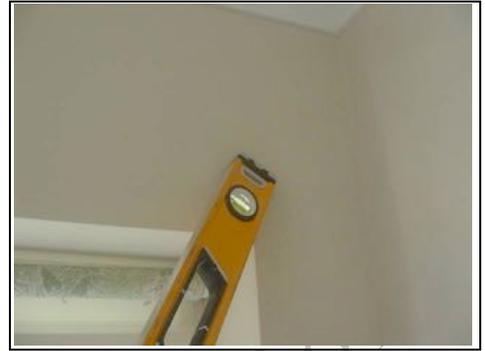
Cloakroom – left middle

Crack to window in cloakroom

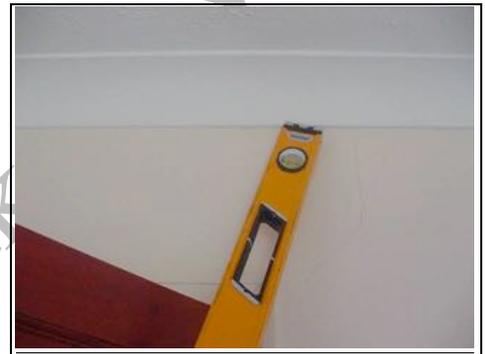
Bedroom – rear left

Crack above door in bedroom – rear left

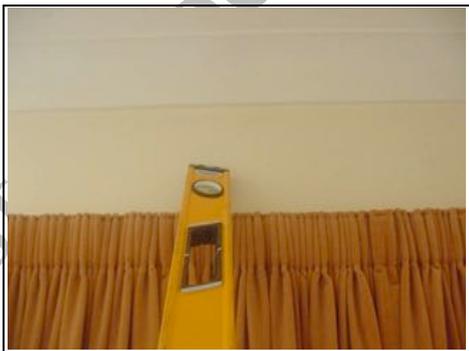
Sun room

Vertical crack

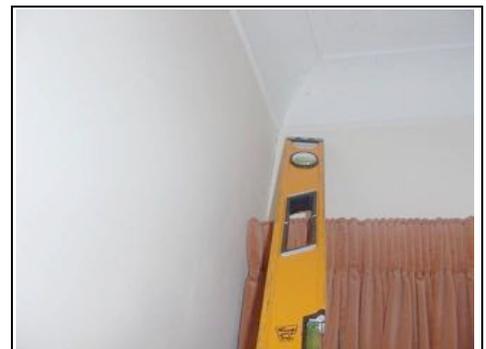
Crack in corner of sunroom

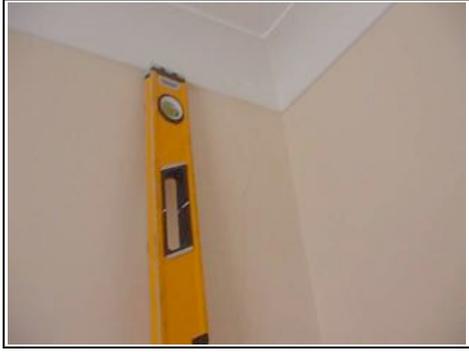
Bedroom - rear right

Vertical crack bedroom –rear  
right

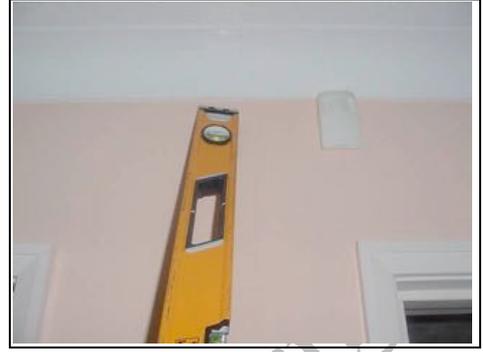
Vertical crack bedroom –rear  
right

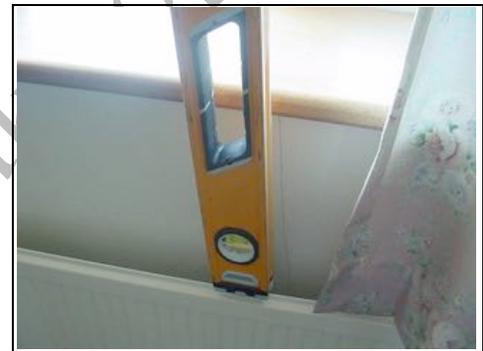
Bedroom – rear left

Vertical crack above radiator  
bedroom –rear left

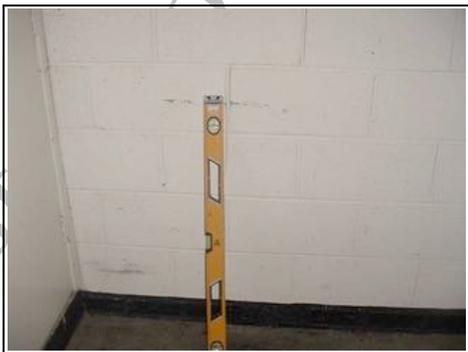
Crack in garage

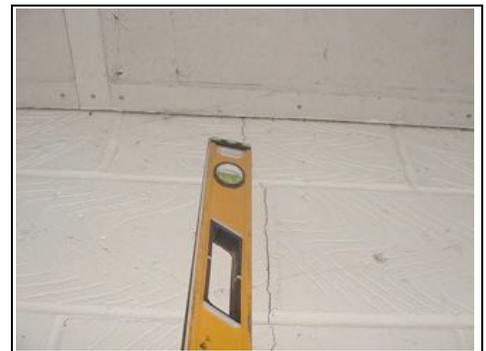
Cracking right hand wall

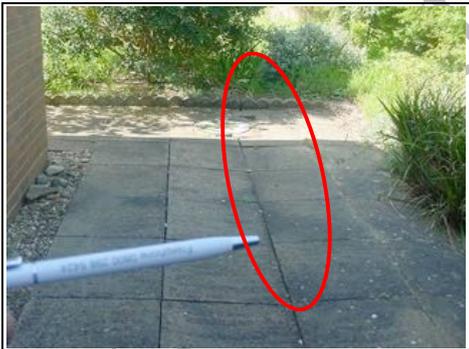
Drains can be a problem when they leak causing damage and deterioration to foundations. We noted a dip in the ground where the drainage run is likely to be, on the right hand side of the property. This could be from poor back filling but we would then ask why this is not occurring to all the drains? This then leads us to believe there could be a problem in this area.

Dip in ground - drains right hand side following the drainage run

A way of checking this is to have a closed circuit TV camera test and report of the drains.

**ACTION REQUIRED:** Your Legal Advisor to check and confirm if the drains have been replaced. We would also recommend that a closed circuit TV camera report of the drains is carried out.

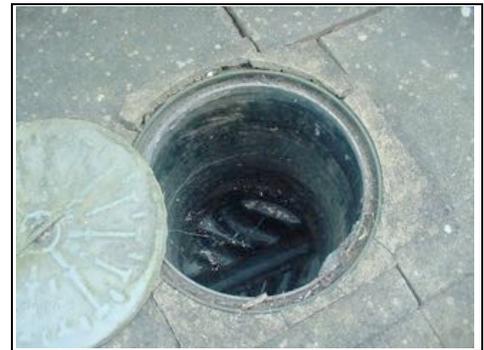
Manhole near dip in the ground

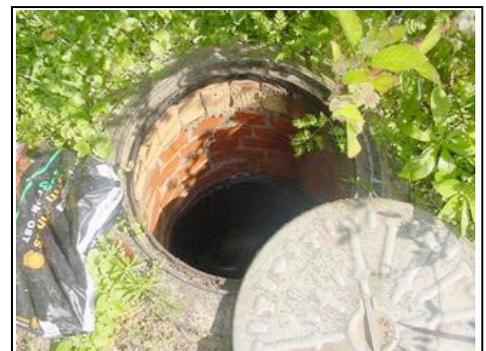
Brick manhole- front right

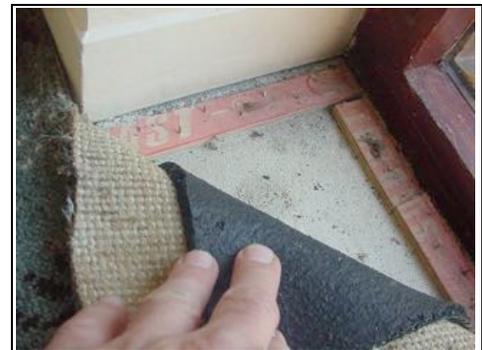
Hollow floor in sunroom

This means that something has caused the hollow areas. It could be the dropping away of the building on this side which is effectively leaving a cantilevered floor slab.

It could be, as mentioned, leaking drains, poor foundations or poor ground conditions such as the ground having a clay content.

**ANTICIPATED COST:** We have been involved in this type of work ourselves and you could literally be signing a blank cheque as you are pumping into a void in the ground without knowing the size of it. Before this work is carried out we would recommend trial holes and further investigations take place. This is a worst case scenario but nevertheless it has to be considered bearing in mind your wish for this to be a long term home. Costs will be £5,000 to £25,000; please obtain quotations.

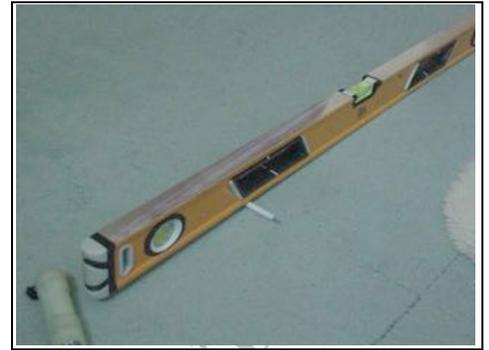
We can see also see a dip in the bathroom floor and we feel that the deflection is an effect of other things that are going on at the property. Whilst the deflection can be reduced, by the adding of herringbone strutting or similar to brace the property, again we are not dealing with the cause of the problem but just the effects.

Dip in bathroom floor

**ACTION REQUIRED:** Adding of herringbone strutting to the joists, checking the joist ends and the joists in general to ensure they are not cracked or defective. This will make a stronger first floor level but as mentioned it is only dealing with the effect rather than the cause.

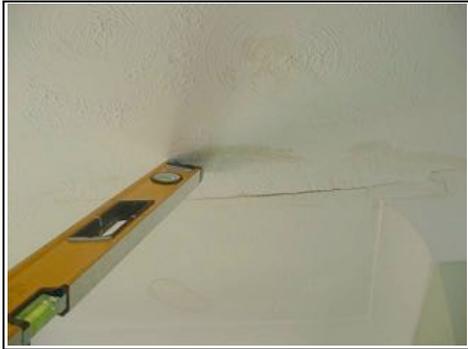
Staining and crack in reception room, from leak in chimney

We believe this staining relates to the chimneys and the detailing to the rear. It is possible this has been aggravated by minor movement to the building but we often find in this era of property that it is down to poor workmanship. In particular we often find that flashings around chimneys are poorly carried out.

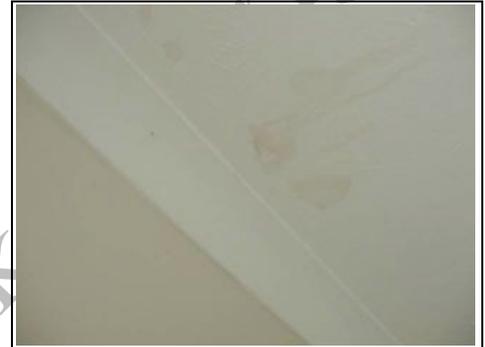
Staining from leak in utility room

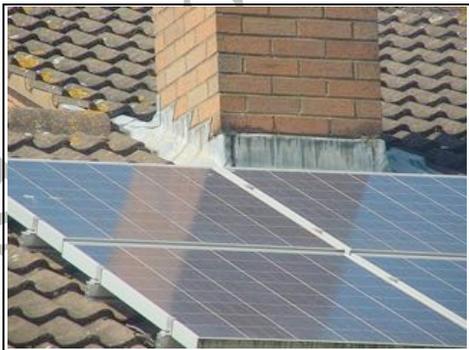
Left chimney - lead flashing and pointing needs checking

**ACTION REQUIRED:** You need to carry out repairs to the chimneys if needed and check the solar panel fixings. We would also draw to your attention that you need to check and confirm who owns the solar panels.

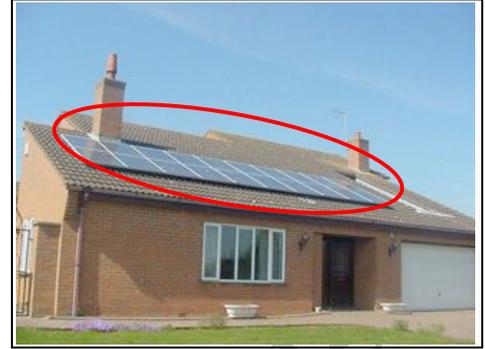
There is a chance the dampness coming into the front reception room could have been caused by the installation of the solar panel system. We have come across an instance where damage by the solar panel company has caused leaks in the property.

Solar panels

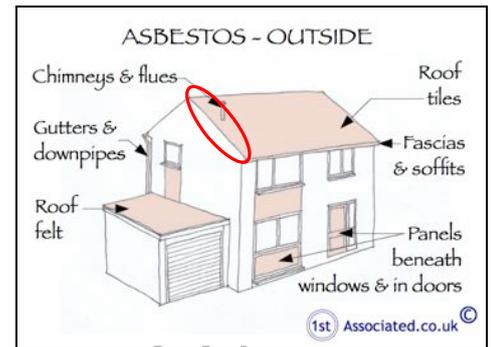
Asbestos was noted to the perimeter of the roof and is fairly common in this age of property.

Asbestos to roof verge

**ACTION REQUIRED:** Our insurance company require us to advise we are not asbestos specialists. We recommend you have an asbestos survey carried out by a specialist asbestos company.

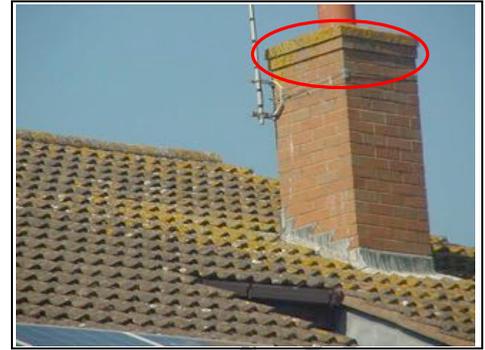
This chimney is also brick built with a lead flashing and one chimney pot. From what we could see from ground level it looked in slightly below average condition considering its age, type and style because of the dampness getting in.

Again we cannot see the flashing or the back of the flashing and moss is visible on top of the chimney indicating dampness is possibly getting in.

Right chimney

**ACTION REQUIRED:** Periodically inspect the chimney.

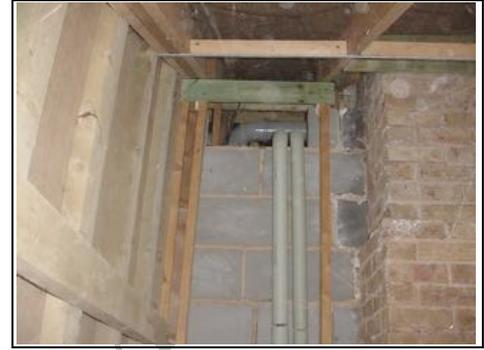
Right hand chimney area-  
dampness coming in

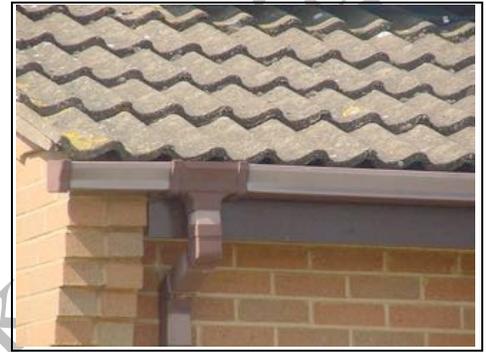
The property has older style plastic gutters and downpipes. Plastic is susceptible to expansion and contraction during weather variations. This can lead to displacement of joints and subsequent leaking. Long term exposure to sunlight will also lead to brittleness.

Old style plastic guttering affected by sunlight

There may be some minor leaks but most people would be happy to live with these providing repairs are carried out within the next six to twelve months.

**ACTION REQUIRED:** We would always recommend you stand outside the property next time it rains heavily and see how well the drains cope with the rainwater particularly looking at the guttering and the joints as some of the guttering looks to be out of alignment.

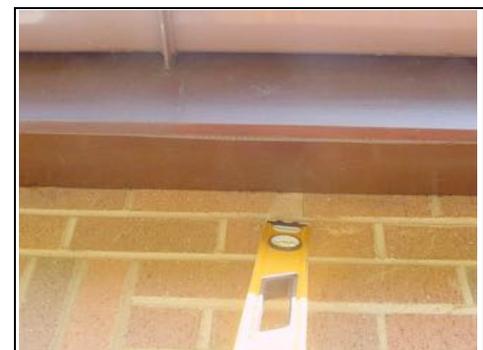
Slightly wide joint in pointing in some areas

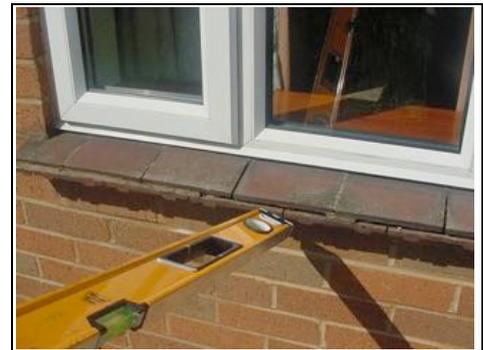
Window sills need work

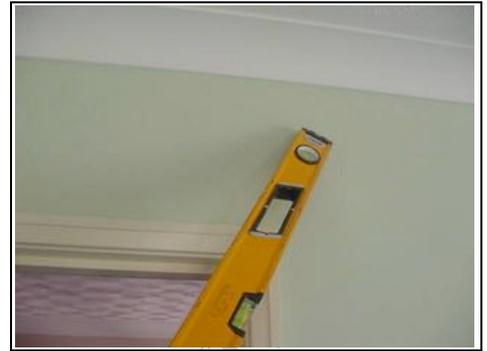
Crack in reception room

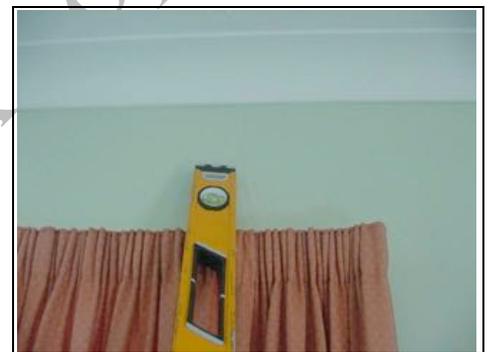
Crack above window in reception room
