RESIDENTIAL BUILDING SURVEY

xxxxxxx,
London,
W10 xxxx

INTRODUCTION
REPORT FORMAT
SYNOPSIS

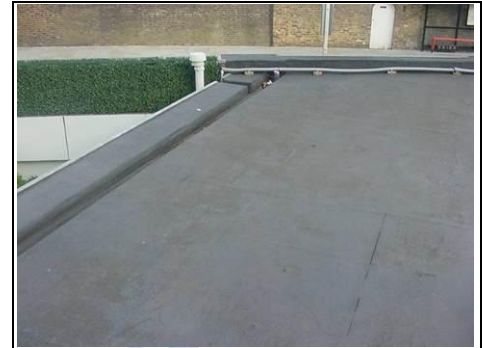
Our experience of black mono-ply roofs is that they tend to absorb the heat considerably and in our experience do not weather well. We have come across a few cases now where blistering occurs.

Black mono-ply roof

ACTION REQUIRED: We are unhappy to recommend this type of roof. Whilst there were no visible signs internally of it leaking we do feel it's only a matter of time.

ANTICIPATED COST: To replace the roof will be £5,000 - £10,000 (five thousand to ten thousand pounds) dependent upon how you replace it. An alternative may be to put shingle over the top of it to protect it from the sun and the frost. However we do not know how strong the roof structure is; please obtain quotations.

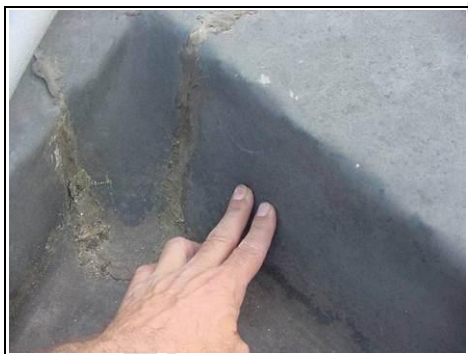
We would add that some of the detailing, we feel, is poor, for example, the up-stand does not seem to be bedded properly. We could also see lines visible on the mono-ply where it joins, possibly something has been sitting on the roof.

Checking the detailing

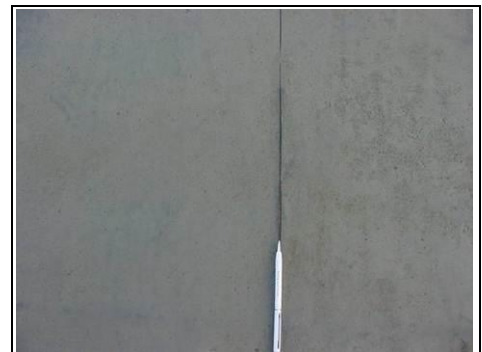
Lines on mono-ply roof

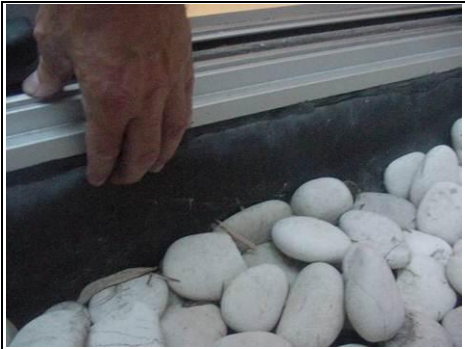
We also noted that mono-ply had been used for the rear light well. Again we would much prefer to see more traditional materials used such as lead

Mono-ply used on rear light well

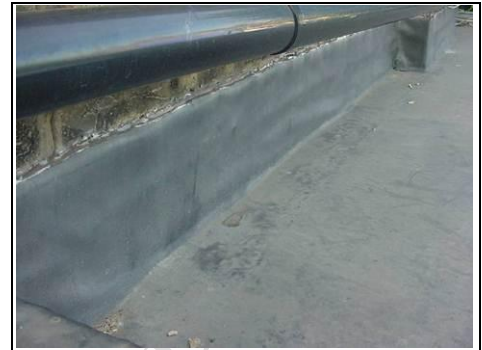
Flashing on the roof where it meets the building next door. We would prefer this to be lead.

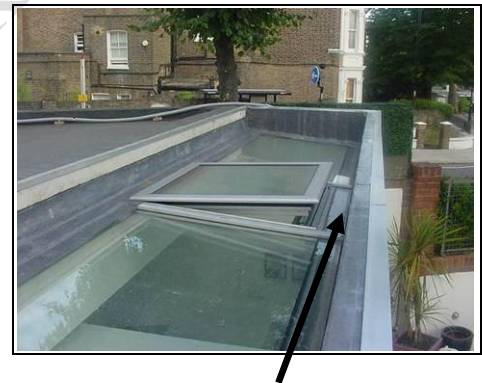
For example, where the windows are above the kitchen, there is a very small box gutter which, from what we can see, will become blocked.

Roof windows above the kitchen with small box gutter

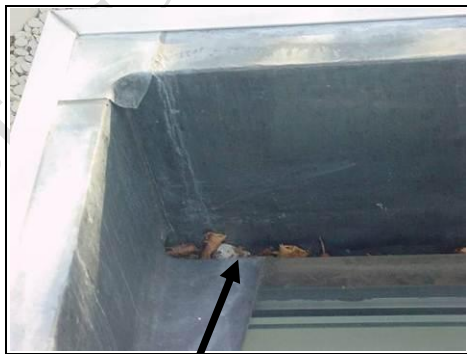
Close up of small box gutter

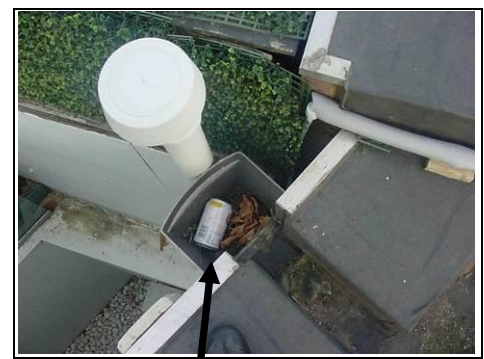
We also removed tin cans from the hopper head and we were not keen on the detail and would prefer to see larger hopper heads.

Cans and leaves in hopper head

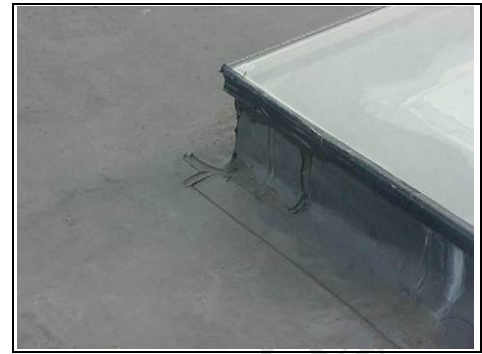
We think that some of the roof windows will leak. In our opinion they are poorly detailed as the edges of the windows have a tape around them rather than a proper frame. We do appreciate that the water does have to run off the glass but we feel this tape may come away over the years and allow dampness in and in turn break the double glazed seal.

Detail to the roof window

ACTION REQUIRED: We believe you need specialist advice with regard to the roof lights. We would personally prefer a domed roof light. Please see our article on roof lights in the appendices.

ANTICIPATED COST: We would expect costs in the region of £250-£500 (two hundred and fifty to five hundred pounds) for a domed roof window; please obtain quotations.

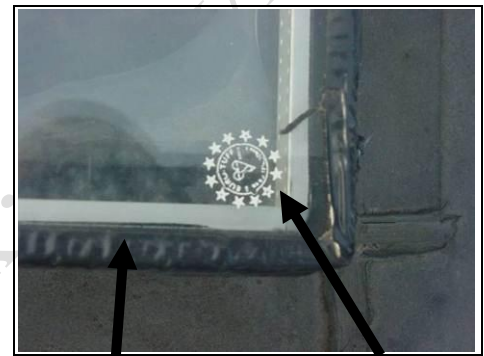
Tape around the edge of the glass instead of a frame.

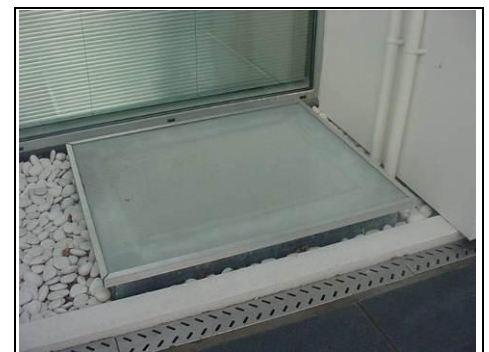
This window has a trim- why do the main roof windows not have a trim like this?

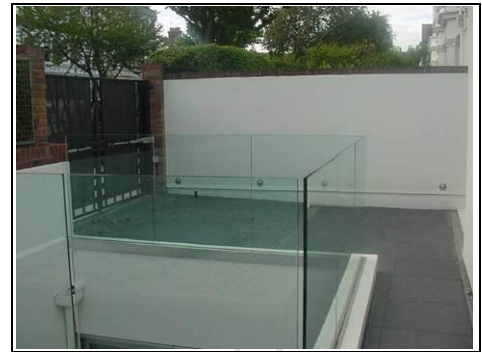
Front light well/patio - top

The light wells/patios to the front and rear below ground level are in danger, we feel, of allowing dampness through. We could see some blistering and we were getting higher readings to the walls then we would like. This does indicate that dampness could come through.

ACTION REQUIRED: This is very difficult to resolve. To some extent you may just end up painting it every year or so to keep it looking good. You could add weep holes, which to some extent would direct the rain water; this is difficult to do properly as an afterthought. The complete solution would be to take down the wall and rebuild it; however this would depend on how bad it gets. You may have to live with it not looking that great and then make a decision on what to do.

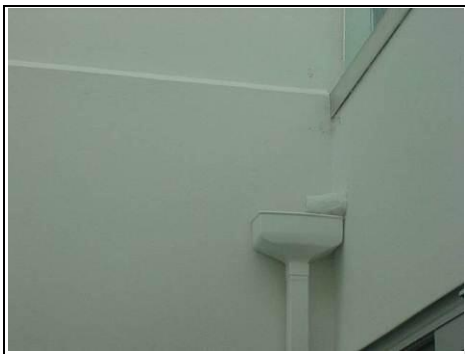
We would prefer to see weep holes for the water to come through rather than fighting against it.

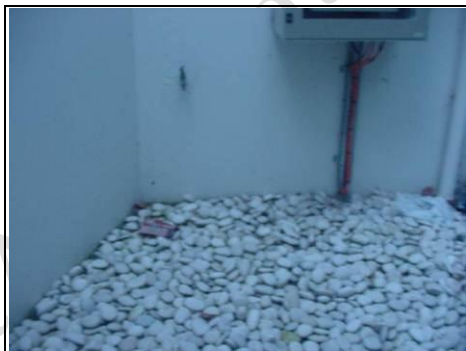
Bottom of the rear light well where we were getting high readings

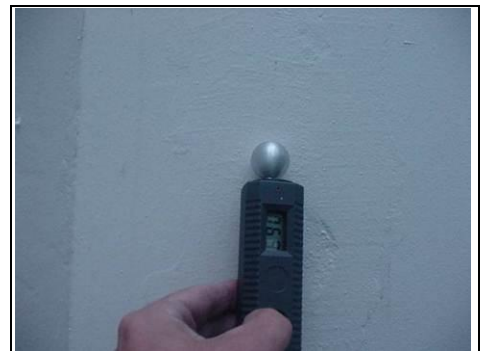
Testing with the damp meter – reading of 69

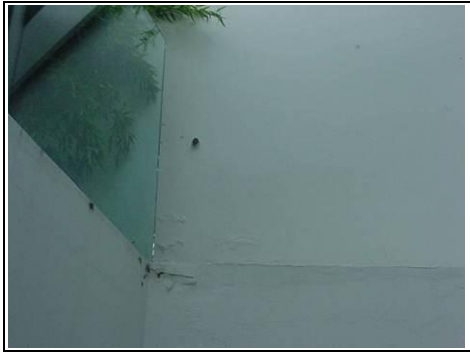
Blistering to rear light well
right hand side

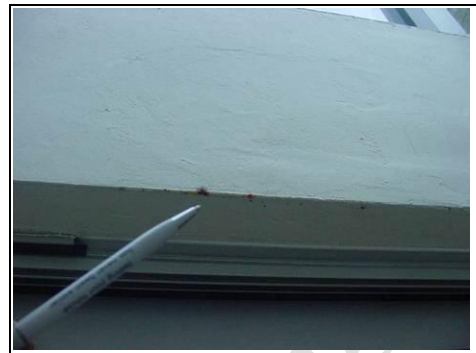
Rusting on the corner bead.

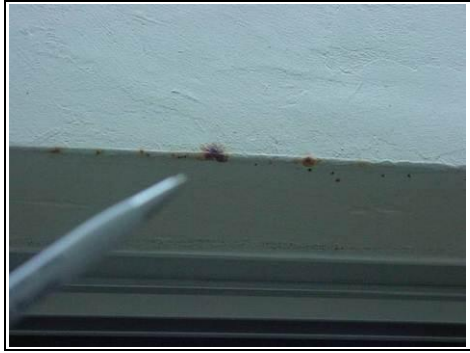
Whilst we have already mentioned the rusting we just want to draw your attention to it. We were surprised to see, that in a property that has only been refurbished in March of this year some four or five months ago, rusting visible on some of the metal work. This metal work is to the rear light well and does indicate to us that there may be a problem with dampness in this area.

Rusting to corner beads

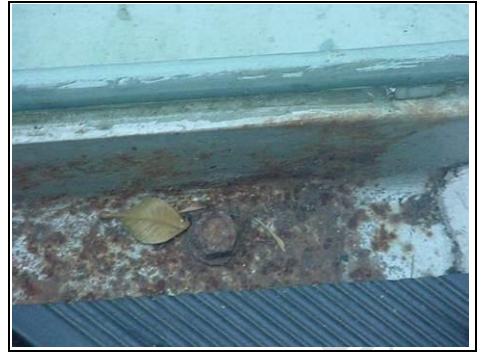
There was also some rusting around the rear light well at the base of the glass.

Rust to the base of the rear light well

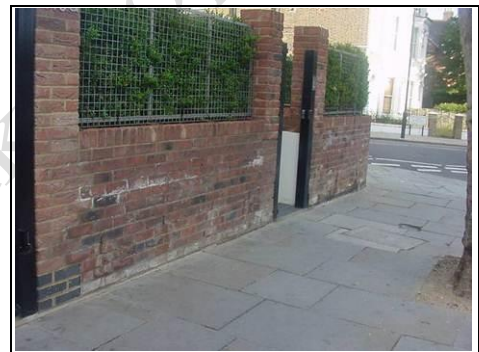
We can see that the wall design has been thought through i.e. having a soil bed at high level. It also has weep holes to allow the water to drain out but unfortunately efflorescence is visible and also staining around the weep hole. This will be an on-going maintenance issue.

Front wall has problems with water coming out of it

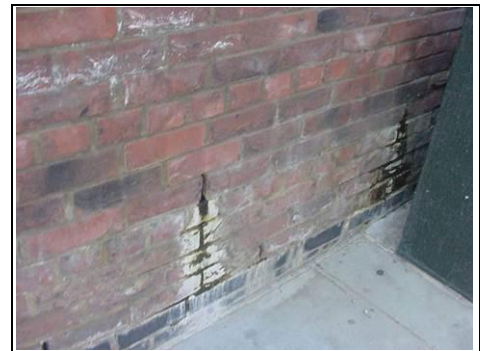
Weep holes that have not been cleaned up

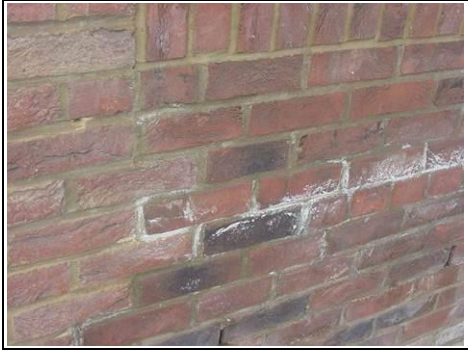
Efflorescence on wall

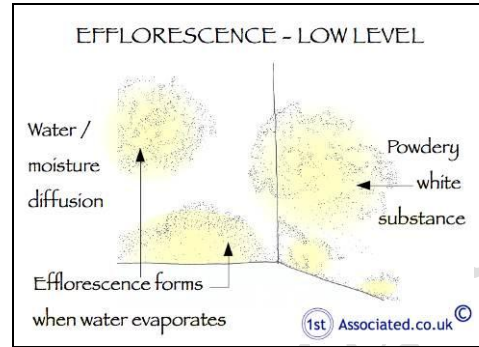
Efflorescence

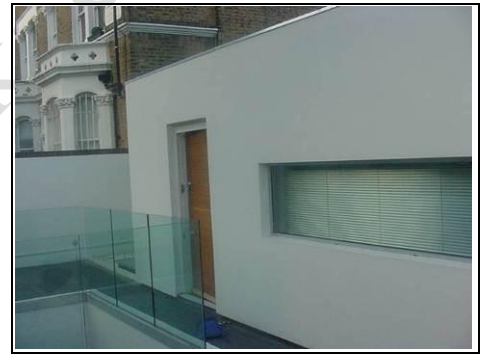
We were advised by the owner that this property was completely re-furbished in March 2012. We can already see some defects coming through. We feel there are a fair amount of alterations and amendments that need to be made to this property to make it work. There is also a lot of white painting to be done to keep it in a pristine condition. We would say that you are looking at this property in its best condition (we would almost use the term ‘painted to sell’) in sunny summer London weather! It will look far worse in a year or so in the middle of the winter.

Property will require a lot of maintenance

ACTION REQUIRED: You need to have a budget to allow regular maintenance of this property. This will be for both on-going maintenance such as clearing the roof and also planned maintenance in the form of re-decorating.

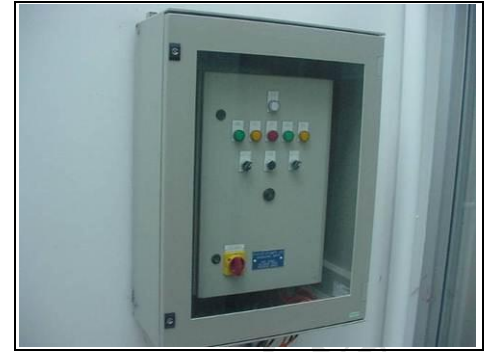
The property has a pump drainage system. You need to be aware that this can be noisy as it sits outside the rear master bedroom.

Waste water pump control box

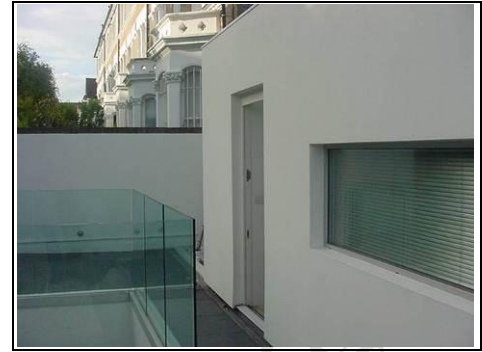
The flush render on the exterior of the property is not the best way to render a property although we appreciate it is part of the modernist style.

No drip detail above the window

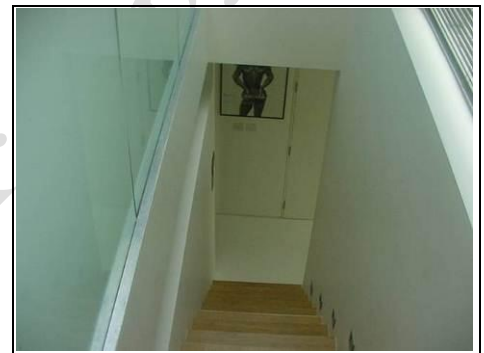
There is no handrail and although this may look good design wise the practicality of not having a handrail on wooden stairs may not be as good?

No hand rail on stairs

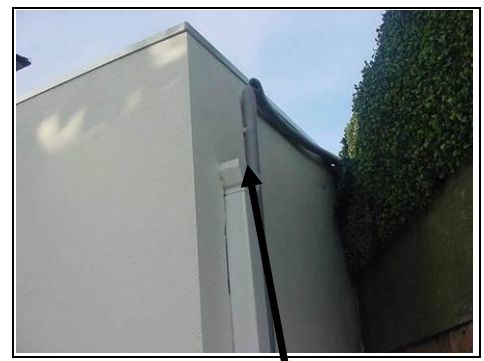
Whilst we have spoken about the small box gutter that goes with this we feel that with the amount of rain we get, this could over flow and we would look to replace it with a larger hopper head.

Small hopper head front right hand corner

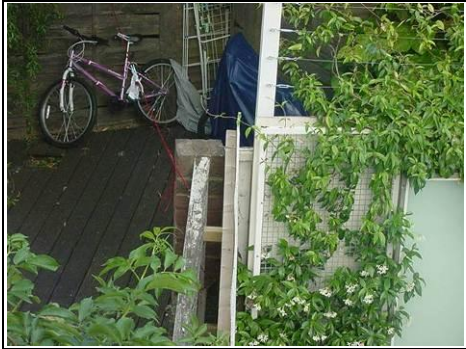
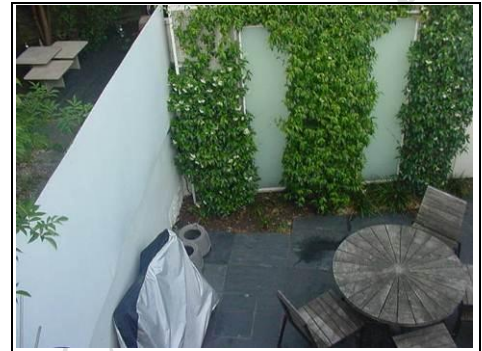
We believe that there will be noise transfer from the neighbour to the rear left hand side as there is only a thin board between you. This could be relatively easily sorted out.

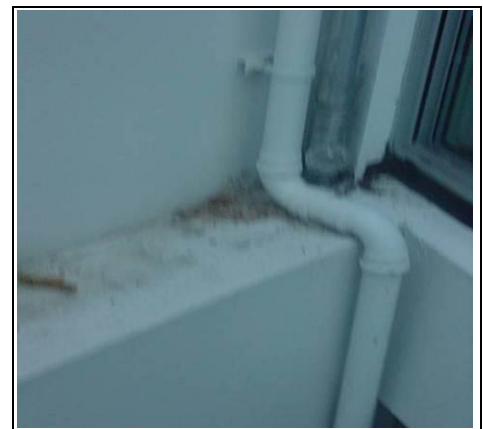
There really should not be ledges on a white property such as this where water can sit.

Ledge on white wall
