RESIDENTIAL BUILDING SURVEY

XXXX St Albans, Hertfordshire. AL3 XXX

INDEPENDENT CHARTERED SURVEYORS

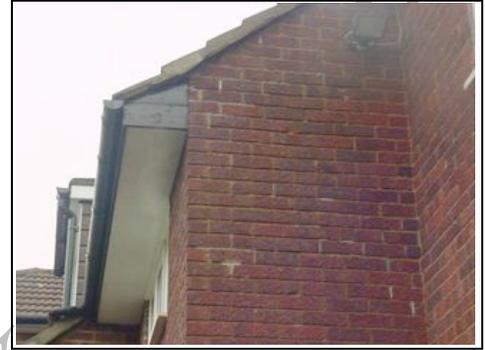
Asbestos was commonly used in this age of property. We believe that the soffits are asbestos and there may also be other elements of asbestos in the property.

ACTION REQUIRED: Use a specialist company to carry out an inspection identifying the type and condition of the asbestos – we are not asbestos surveyors.

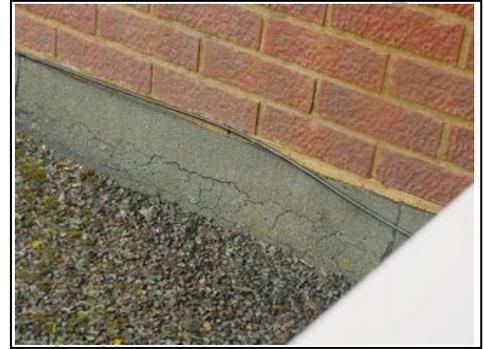
The roof over the entrance porch we could see had moss sitting on it indicating that it is flat rather than having a fall of approximately twelve degrees. Water sitting on a roof will reduce its life span. We anticipate that the flat roof over the porch roof will have five more years of life particularly the flashing detail that is in felt which you can see is starting to crack; this may even go sooner.

Flat roof to front of property showing signs of deterioration

ACTION REQUIRED: Budget to replace within the next five years. We recommend using a high performance felt and you must ensure there are 'falls' on these roofs. A good way to do this is to add an insulation cut to fall and then finish with a high performance felt.

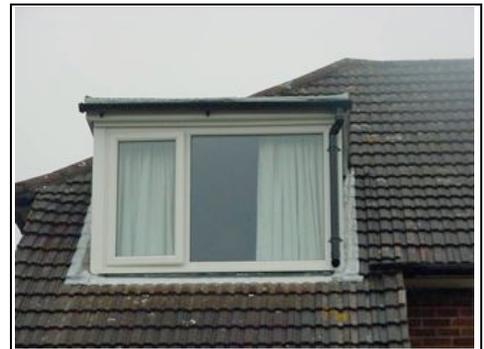
We can only assume that the dormer roof is of a similar age and will also require re-felting in five years (we have checked it inside the property using our electronic damp meter to the walls where they meet the roof and found no dampness in these areas).

Dormer roof with flat roof above

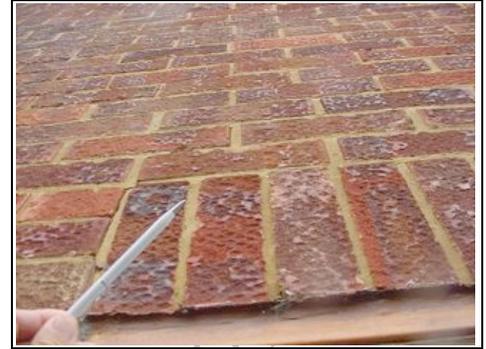
3) Cracks over the Rear Sliding Doors

You have cracks over the rear sliding doors, we believe these have been caused when the new 'sliding doors' were fitted.

ACTION REQUIRED: None, however you should monitor this from time to time to check it is not opening up. Unfortunately the side to the left of the window (all directions given as you face the property) also has additional weight where the lintel is over the dining room area.

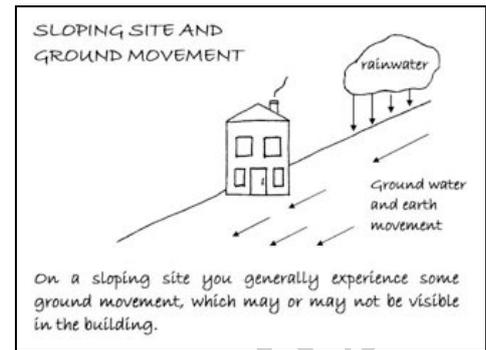
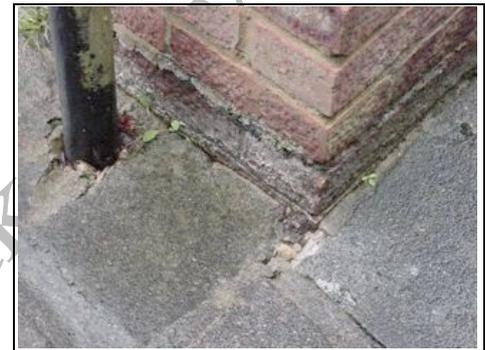
We noted that the damp proof course to the rear of the property was slightly low on the rear left hand side (it should have two courses of brickwork between the ground level and the damp proof course and it only had one). This was causing some spalling to the brickwork.

Damp proof course is slightly low to the rear right hand corner of the property.

ACTION REQUIRED: We recommend that you have a look the next time there is a heavy downpour of rain just to see how the rainwater passes from the rear of the property to the front to see if there is any obvious signs where it can/is causing damage and deterioration and then take appropriate action.

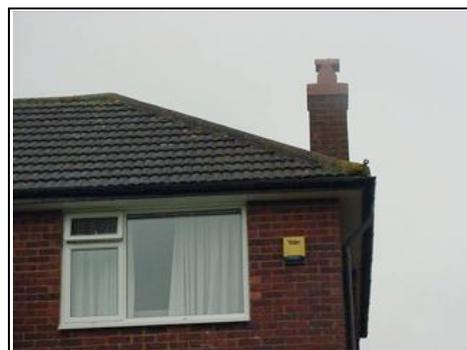
This chimney is brick finished with one chimney pot with lead flashings. It is tall and thin. From what we could see the chimney looks in average condition; although some repairs have taken place to the brickwork in the form of a cement mortar patch; this may have been to repair where an area has been removed or similar.

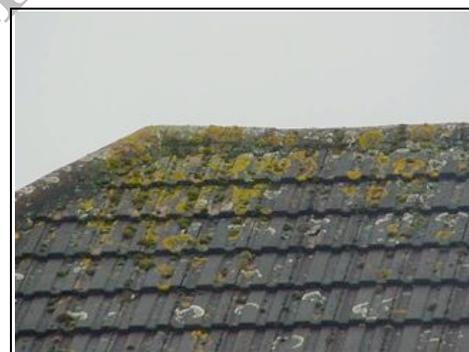
We could see moss on the concrete tiles; this can cause problems with damage to the tile surfaces and/or block gutters.

ACTION REQUIRED: Once moss has built up we would recommend that it is cleared.

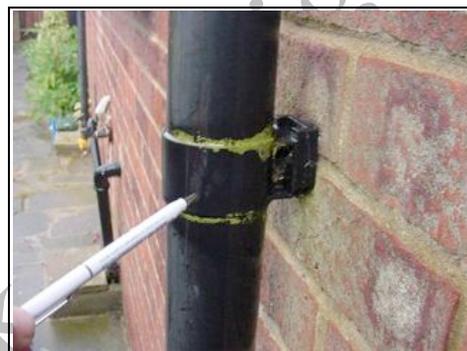
The adjoining photo shows a downpipe with green moss coming out of the joints which indicates that it may have been blocked; it is a back up which is notoriously difficult to clean. This needs to be checked when it next rains.

ACTION REQUIRED: We would always recommend that the gutters and downpipes are cleaned out, the joints are checked and the alignment checked to ensure that the gutters fall towards the downpipes.

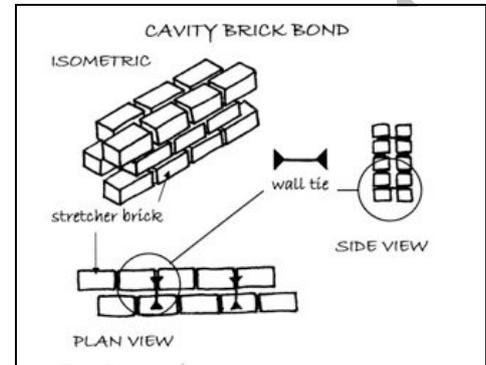
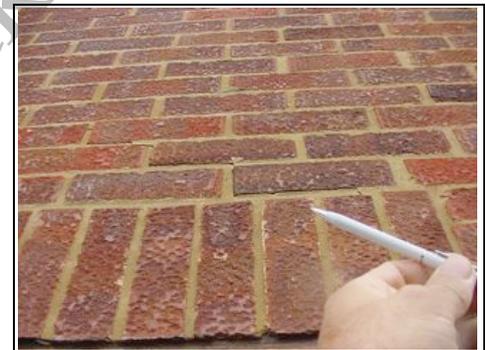
The brickwork needs some repointing with a suitable mortar, which will reduce the likelihood of any dampness getting into the structure. We generally found the brickwork and pointing in average condition considering the properties age and type.

ACTION REQUIRED: Repoint in a like for like mortar

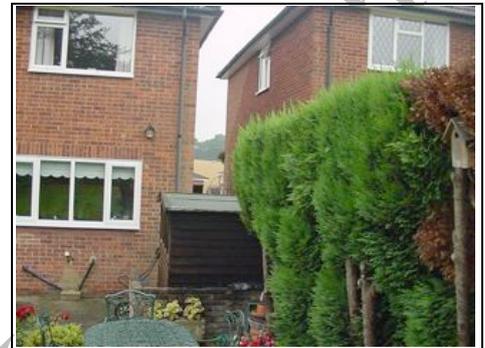
You have a few conifers surrounding the property it should be remembered that trees in general need regular maintenance. The conifers can grow very quickly.

ACTION REQUIRED: Ensure trees are regularly maintained. Please see our comments in the Executive Summary.

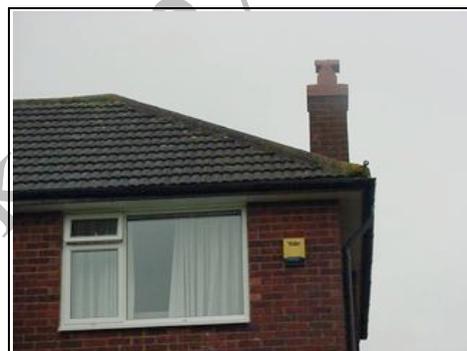
The property has painted timber fascia boards and probably asbestos soffits; these are in average condition, (which means there is likely to be some rot) although much of the fascia is hidden by the guttering.

ACTION REQUIRED: Please see our comments on asbestos in the Executive Summary and the Other Matters Section of this Report.

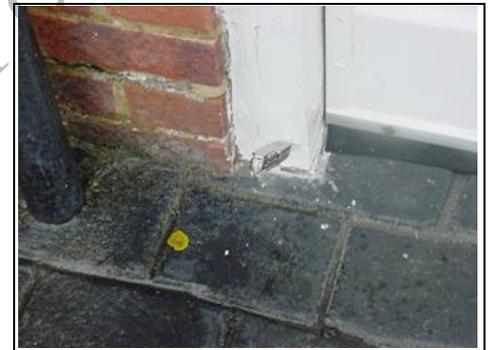
We can see to the base of the garage door that new timbers have been cut and spliced in. The new timber is not in particularly good condition and we would imagine you would have to do this again within the next five years.

Base of garage door has been previously replaced.

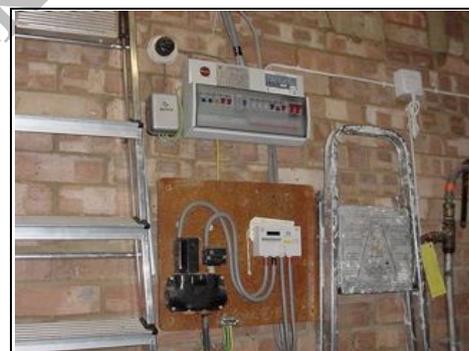
The electric fuses and consumer units were located in the garage. We would date the fuse board as being from the 1980/1990s (although the owner was adamant it was newer).

ACTION REQUIRED: As the property is changing occupancy an IEE report should be carried out by a NICEIC registered and approved electrical contractor.
