# RESIDENTIAL BUILDING SURVEY

**XXX**

**Roxton**

**Bedfordshire**

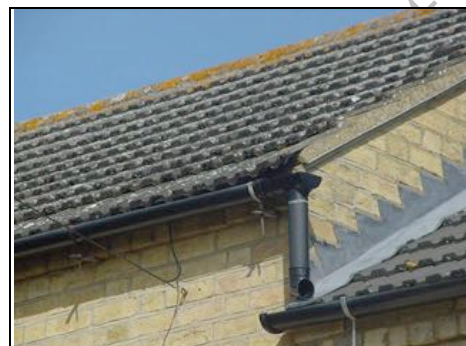
The original roof covering would have been slate. This has been replaced with a heavier concrete tile. Modern Building Regulations require a traditional structural support is provided where this takes place. We can't see any obvious additional support that has been added and equally we cannot see any significant movement in the timbers.

Main roof

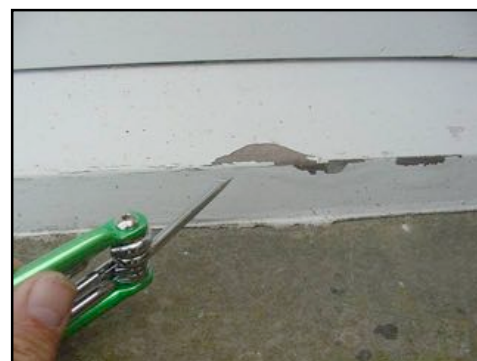
We noticed that some of the paint was flaking on the timber windows and bare timber was visible. We also noticed some areas had been filled in.

Flaking paint to timber windows

**ACTION REQUIRED:** Ideally repair, prepare, and redecorate in the summer of XXXX. We certainly wouldn't leave it longer than the summer of XXXX.

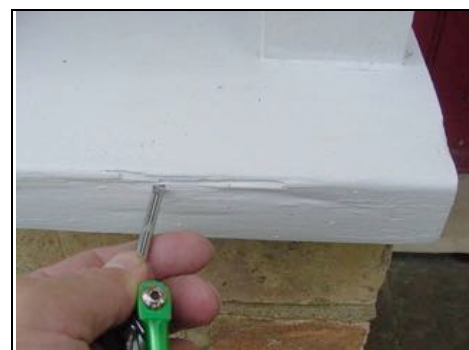
Deterioration to windows

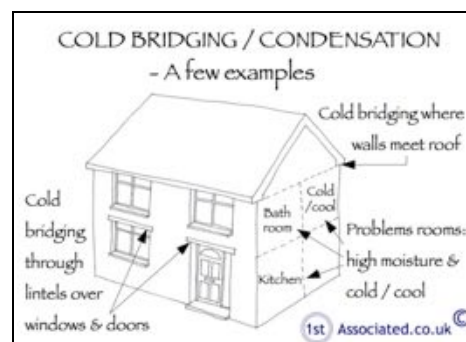
Cold bridging/thermal bridging

**ACTION REQUIRED:** Improve the extraction to areas of high humidity with the installation of good large humidity controlled extract fans to the bathroom (we appreciate it has already got one but better are available) and the kitchen.

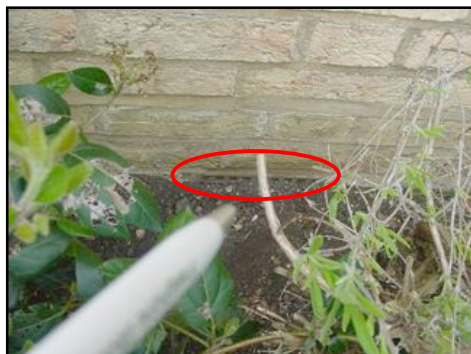
The difficulty comes with the rear airbricks where you need to have a 'cup of tea' meeting with both your neighbours (ideally before you commit to the purchase of the property) and advise them that there are high ground levels causing minor dampness into your property and probably causing dampness into the timber floor and that the ground needs to be lowered. This is probably possible in some areas, however there is also a garage to part of the property.

Hidden airbrick

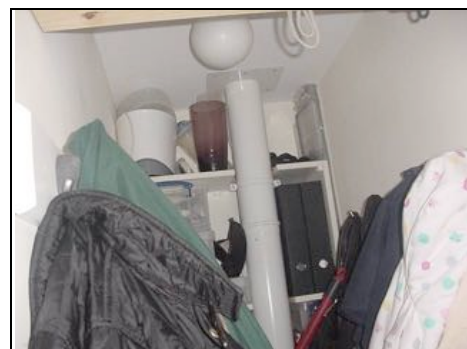
We are advised the boiler is relatively new, we could not see it due to the amount of stored items in the cupboard. We were pleased to see a plastic oil tank, typically these are double lined. We would recommend that the system be tested and overhauled before exchange of contracts and that a regular maintenance contract be placed with an approved heating engineer.

Stored items in boiler cupboard

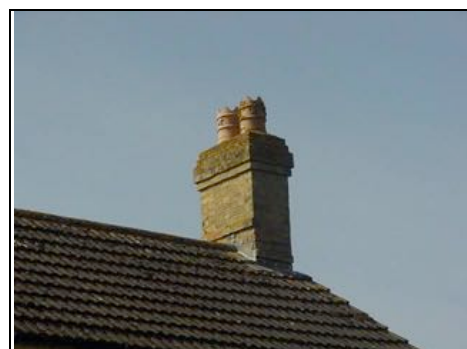
This chimney is brick finished with a lead flashing and two decorative chimney pots. From what we could see from ground level it looked in average condition considering its age, type and style. There is some moss at the top and there is a slight lean to the chimney.

Right hand chimney

**ACTION REQUIRED:** As per the left chimney.

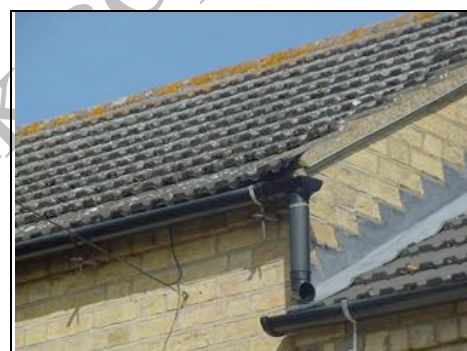
A heavier concrete tile has replaced the original slate (we did find some old slate tiles underneath the insulation in the right hand roof) and therefore there should be additional roof support which there isn't in this case.

Main Roof

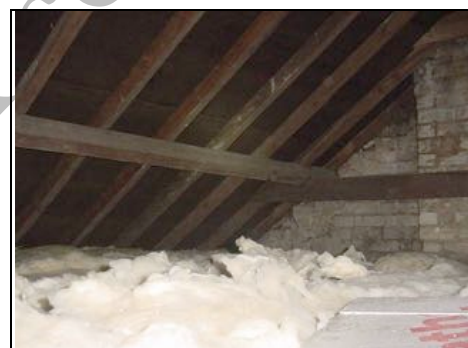
When we inspected the loft space we found a Hessian base Bitumen membrane to the right hand side. This type of membrane has been used since the 1960s. We generally found it to be in average condition, with damage in some areas which is what we typically find.

This photo shows the common rafters (the ones that form the pitch of the roof) and the dark area between is the underlayer

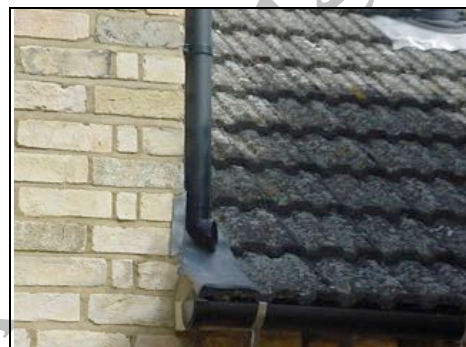
All the water from the main roof is surcharging onto the smaller roof to the rear of the property. We believe that the guttering may have trouble coping and may overflow.

Surcharging gutters and downpipes

**ACTION REQUIRED:** We would recommend you stand outside the property next time it rains heavily particularly to the rear of the property (obviously gaining permission from the neighbours first) and see how well the drains cope with the rainwater particularly looking at the guttering and the joints.

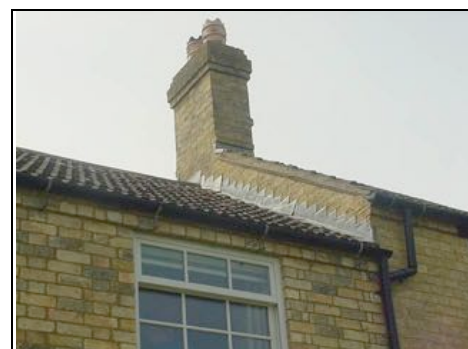
Overloading of gutters and downpipes

We also recommend that the gutters and downpipes are cleaned out, the joints are checked and the alignment checked to ensure that the gutters fall towards the downpipes.

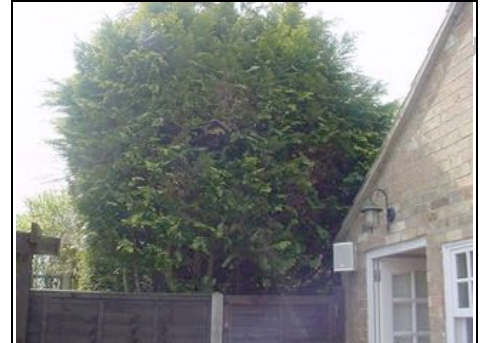
The tree is located in next doors garden but is right next to your property

**ACTION REQUIRED:** Please see our comments in the Executive Summary.

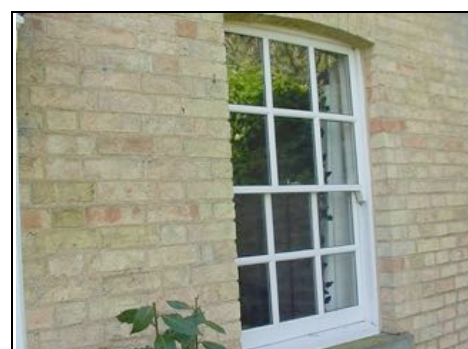
The property has modern double glazed timber sliding sash windows. The modern version of these sliding sash windows does not tend to have the problems of the older version unless it has been put in badly. These look in reasonable condition although there are some areas of soft rot.

Modern sliding sash window with double glazing

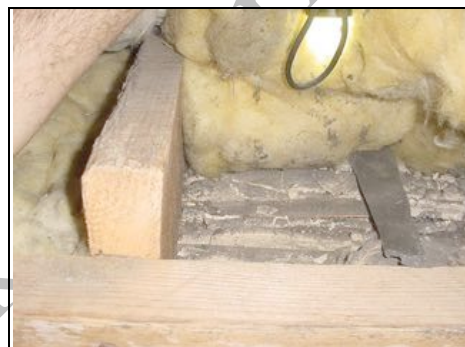
In the older part of the property on the right hand side there was originally lath and plaster ceilings; when we lifted the insulation in the roof space we could see the lath and plaster. It is not in very good condition and had loosened the grip on the lath.

Lath and plaster

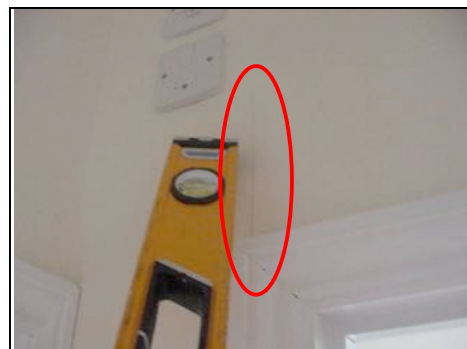
We can see a vertical crack between the new and old that looks to have been filled and painted over. This is effectively the focal point of any movement.

Hairline cracking

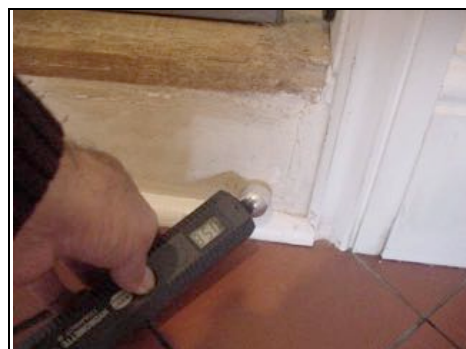
Testing for rising damp at the step in the construction between the kitchen and the main building.

**ACTION REQUIRED:** Please see the Executive Summary.

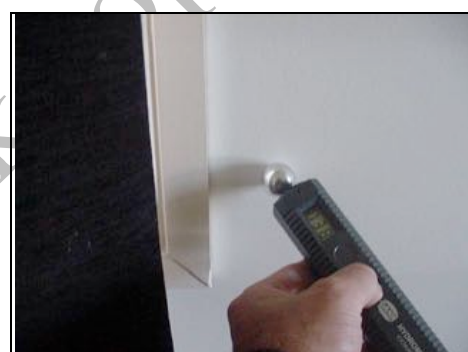
We used a resistance meter on the external walls. We found it to be in line with what we would expect for this age, type and style of property.

Testing for lateral dampness

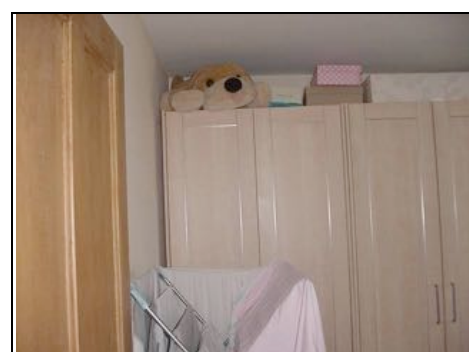
Condensation depends upon how you utilise the building. If you do your washing and then dry it in a room without opening a window you will, of course, get condensation. Common sense is needed and a balance between heating, cooling and ventilation of properties and opening windows to air the property regularly.

Washing drying in the right hand bedroom

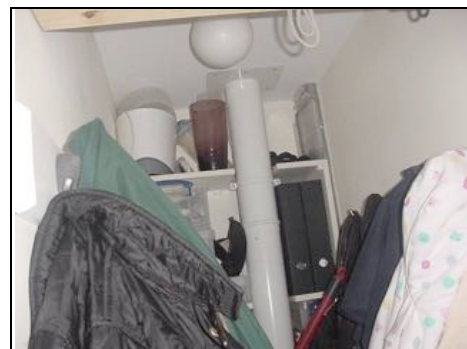
The wall mounted Worcester Bosch boiler was located in the ground floor cupboard. Unfortunately we could not see it due to all the stored items. We are advised the boiler was installed in 2007/2008.

Stored items in boiler cupboard

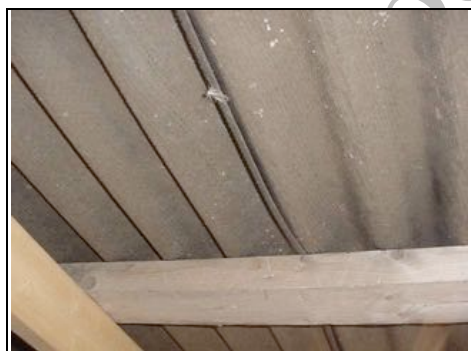
There is a substantial garage/workshop area. We were shown that it has electricity and an outside water supply. The current owner has put a lean-to type structure around it; we discussed the roofing of this with them and they said they had found problems with the corrugated roof that they had used and that it sagged and seemed to need a lot of support.

Roof to lean-to
