## RESIDENTIAL BUILDING SURVEY

Ravensden,  
Bedfordshire  
MK44 XXX

INDEPENDENT CHARTERED SURVEYORS

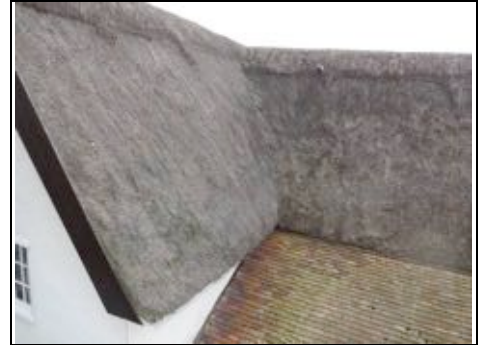
The thatch is nearing the end of its life. We believe that you will have to budget for a replacement thatch. With a listed property it is not just as simple as replacing the thatch, you need to obtain approval and consent. It will more than likely be considered a significant part of this building and as such it may well be closely scrutinised exactly what you are going to do. From what we can see within the roof we feel that unfortunately not only will the thatch need repair/replacement some of the timbers will need repair/replacing as well for example to the left hand side of the property from a limited view what we could see was not in particularly good condition.

Thatch in poor condition

**ACTION REQUIRED:** From what we have seen within the roof we feel that unfortunately not only will the thatch need replacing but some of the timbers will need replacing as well for example to the left hand side of the property. The owner advised that he had various quotes on the property to replace the thatch from memory ranging from £14,000 - £35,000. We have not seen these quotes and we have estimated our figure below, the quality of these quotes all the companies understanding if the building is listed or not. However, in addition you need to add work to the roof structure and also consultation work you need with the Conservation Officer.

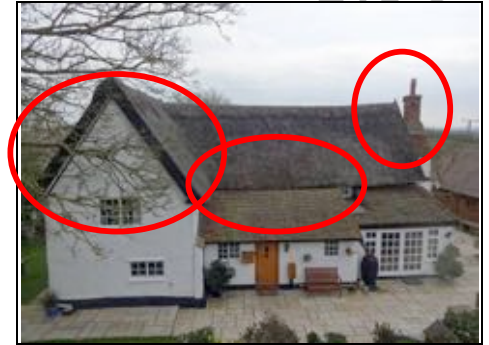
We have divided the roof structure into three areas, the left, middle and right side. We had reasonable access to the middle roof although much of it was covered with insulation, we had no access to the left roof and we could only view it from the middle roof as there was no direct access into it from what we could see. The right roof had a limited view due to both the insulation and lots of stored items although we did move some of them. From what we can see the roof structure has been replaced and repaired over the years.

Plan view of the three roof structures

**ACTION REQUIRED:** We would recommend that your solicitor specifically asks in writing is there any more information with regard to the metal plates/structural work which effectively are tying/holding the building together. Unfortunately, metal plates add a relative stiffness to what is traditionally a fairly soft building on a timber frame so they can in themselves cause problems if not designed appropriately.

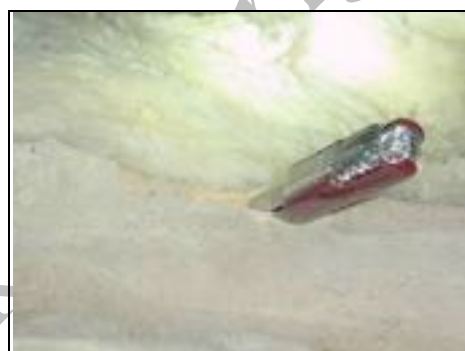
Over the years we have come across lots and lots of woodworm and we normally say any good old property tend to have some woodworm. Having said that most of the woodworm is no longer active and has died off many years ago and in addition to this although there may be holes rarely is it what we term as structurally significant? However, in this instance there does look to be active woodworm in the roof as well as old woodworm in the roof. Unfortunately, that where we tested it with a knife, our knife went directly into the timber and we would then consider that this maybe becoming structurally significant. By this we mean that the timber has been weakened by the woodworm.

Knife going completely into timber common rafter

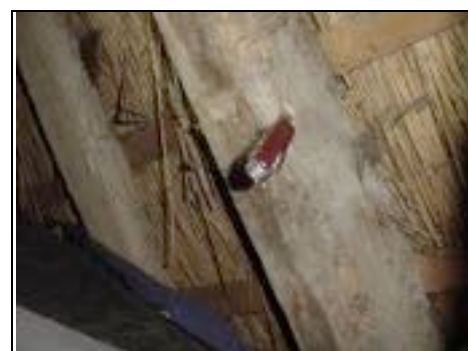
Unfortunately, the environment with insulation being added can improve the woodworm and encourage to breath from what we understand. There is a fair amount of insulation in the roof; all of this will have to be removed to properly view the roof to assess the damage to the timbers. We do feel that some of it is what we would term as a structurally significant in nature although there is of course woodworm in the roof that is not structurally significant. We found woodworm to the centre roof and we believe it also to the left roof.

Woodworm and soft rot

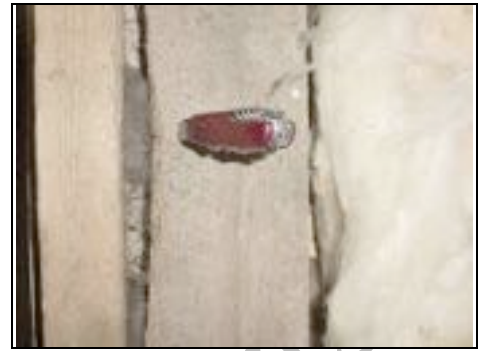
Woodworm

**ACTION REQUIRED:** If you have immediate plans to re-thatch the property then the whole of the roof structure could be looked at, at that point. If not, a much closer examination of the roof with the insulation removed needs to take place. However, from what we have viewed so far we would expect approximately ten to twenty percent of the roof to have been affected with woodworm to the point where we put a knife into it relatively easily/has potential to be structurally significant.

**ANTICIPATED COST:** We would recommend setting aside £2,500 - £7,500. The reason why the figure is relatively large is we do think there is a likelihood that there are problems with the roof structure. There is an element of estimation on what we are commenting on as we have not had access to the left side of the roof, we would be able to comment further if direct access to the left side of the roof was formed and if insulation was removed. We do feel we have to warn and advise about the worst case scenario; please obtain quotations.

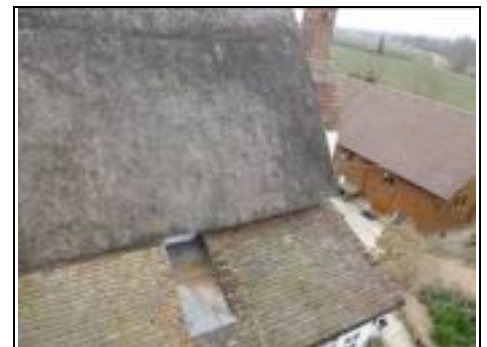
The property has a relatively shallow roof and as such water can sit on it and we noted that the tiles are starting to spall. We would recommend that work is carried out in this area.

We have also found that wind driven rain can get in this style of roof if it is not repaired.

Displaced tiles and in need of repair

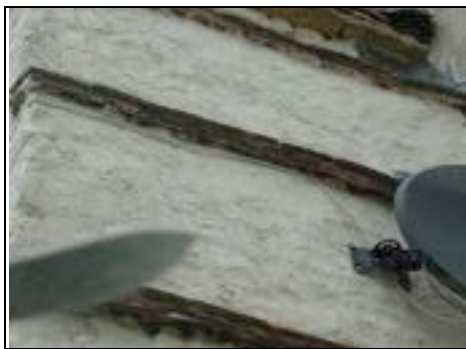
Over the years there have been many alterations, some of which we can see that the builders at the time did not understand the implications of what they were doing using modern materials on older buildings such as the cements that have been used as well as being against the legal requirements of a Listed building. We can also see some relatively recent work to the stone chimney with cement which again is not appropriate and will harm the building (see comments on lime every time within the Walls Section of this report).

Cement repairs on stone chimney

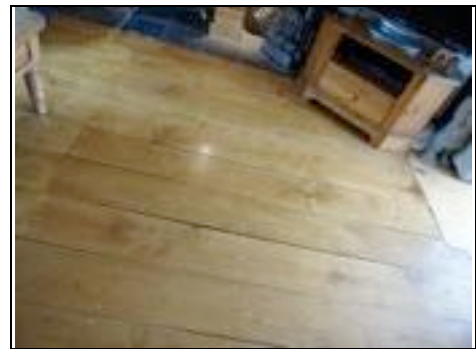
Replacement of original floorboards

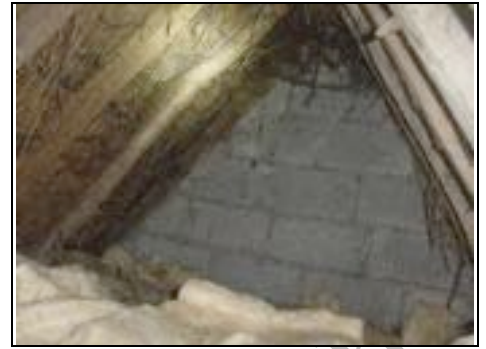
Having said all of that, the areas where we could see the inside of the structure we could see blockwork. Blockwork would have been typically used in the 1960's/1970's so we suspect there has been a lot of replacement work here.

Blockwork

The only way we can really understand and analyse this building in this particular case is to open it up.

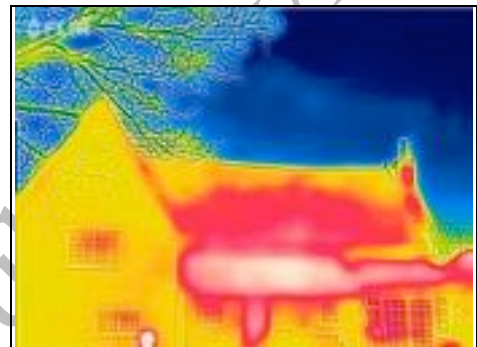
In addition to this we have also thermal imaged the property to see if this gives us any further clues and our evidence shows relatively low heat loss from the wall structure indicating that there is considerable replacement of the walls. Without opening up the walls we cannot confirm this but we do believe the thermal imaging information and the visual information in the roof give a good indication that over fifty percent of the walls have been replaced.

Thermal image showing heat coming out of thatch and tiles but not through what we believed was timber frame building

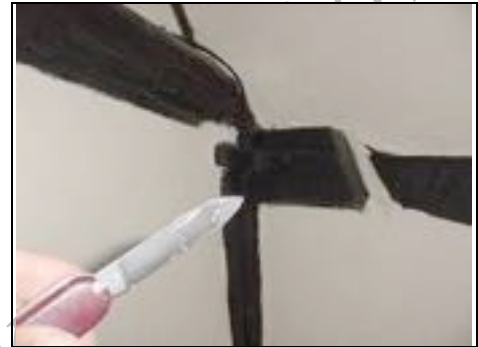
Brace added in middle wall on left side

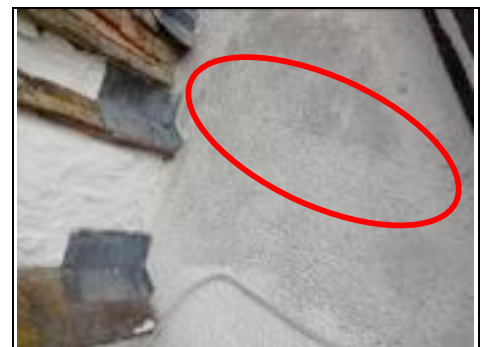
There is hairline cracking visible to some of the internal walls where the wall and ceiling joists meet and there is also hairline cracking to the gable end of the property. You do have to remember that the whole of this property has been repainted in the last few years hiding any usual indications. Again, these cracks are indicating sideways movement left to right.

Hairline cracking to right gable  
~ Aerial View - 360 Photo ~

**ACTION REQUIRED:** Ideally we would recommend the existing owners take out an insurance claim, advising that the cracking has been noted by a structural surveyor (this should cost them nothing other than time to write the letter). This usually means that the insurance company will carry out a monitoring exercise (the Building Research Establishment recommend monitoring any cracks for a minimum of one year) to establish if there is any progressive movement. Your future liability will be limited to the cost of the excess on the insurance providing the insurance company is happy for you to take over the insurance claim.

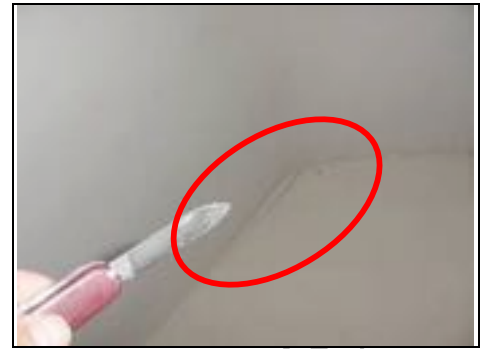
Cracking in far right bedroom

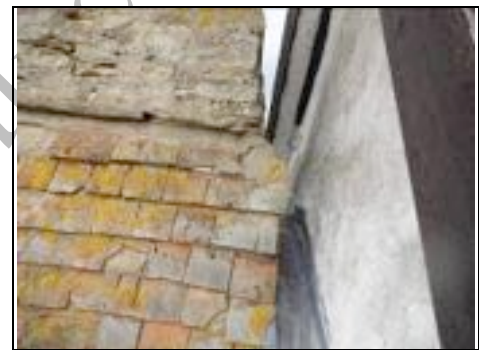
In various areas we found dampness coming in through the stonework for example and we can also see sulphate where there is orange/brownish staining where the soot is being drawn through.

Damp on gable wall  
~ Aerial View - 360 Photo ~

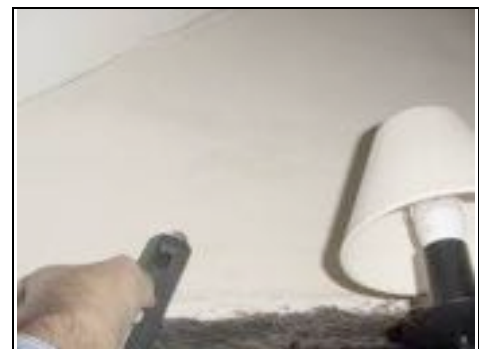
Dampness coming through plaster in right bedroom

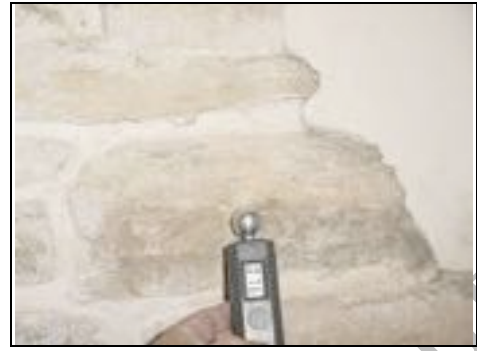
Dampness in stone

**ACTION REQUIRED:** We would recommend the adding of a French drain around the property. Currently there are paving slabs around the property, which unfortunately discharge water against the building.

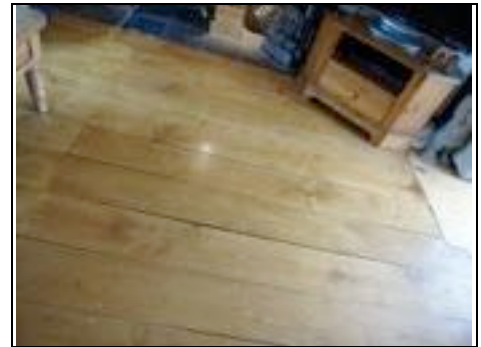
We are advised there is a timber floor in the lounge area, which is typically a suspended timber floor. We cannot see anywhere where this has been vented which in a building such as this can lead to wet rot, dry rot deterioration.

We were advised original floorboards were sanded and reshaped

**ACTION REQUIRED:** Add vents. We would also recommend opening up a section of the floor. The owner advised that the timbers used in this area were the original timbers but in our experience they would not have been that size or that cleanly cut. He did then comment that he had had them sanded, planed and then put back.

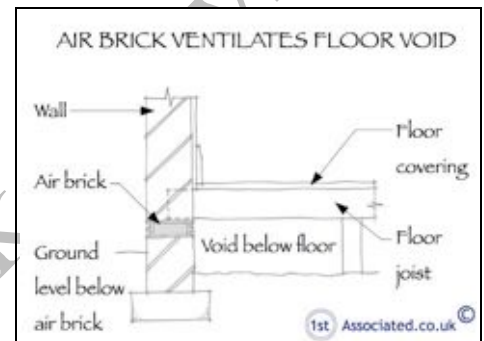
Suspended timber floor

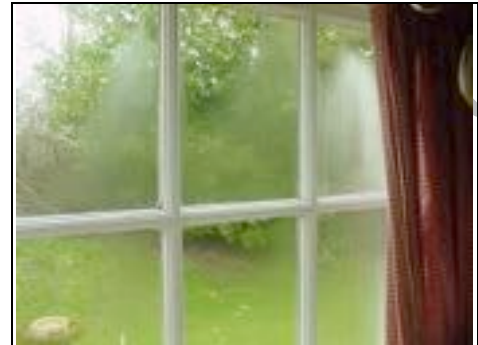
As is often the case with this type of building using an old building in a modern way can create condensation particularly if you do not have suitable extraction. Condensation or any dampness in a timber frame property is not good.

Condensation to windows in kitchen

**ACTION REQUIRED:** We would recommend large humidity controlled extract fans are added to the kitchen, the bathroom and any areas that are used for drying clothes internally during winter months (we would assume that clothes will be dried externally during the warmer months). By large extract fans we mean 150mm.

**ANTICIPATED COST:** We would anticipate costs between £250 - £500 per extract fan depending upon the wiring required. We always recommend quotes are obtained before work is agreed/commenced.

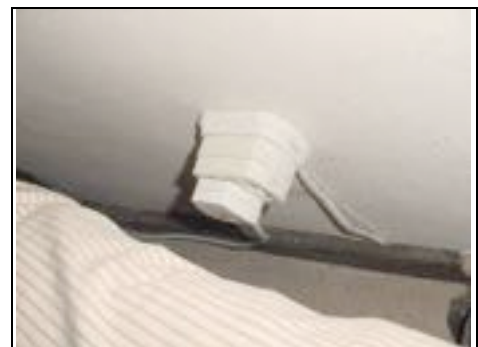
Electrics dated

**ACTION REQUIRED:** We recommend an Institution of Engineering and Technology (IET) test and report to be carried out by an NICEIC registered and approved electrical contractor or equivalent.

**ANTICIPATED COST:** £250 - £500 plus any work recommended; please obtain quotations.

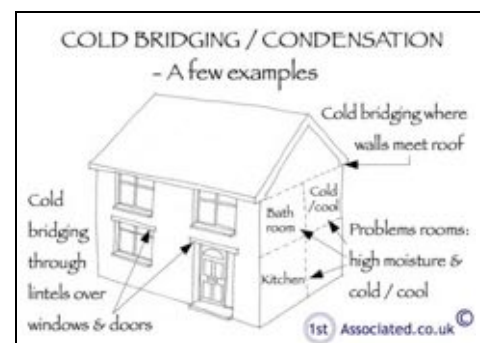
Due to the mixture of materials used we believe there may well be a possibility of cold bridging in the property. Unfortunately, without opening it up it is difficult to confirm. Cold bridging leads to black mould internally unless you control and manage the humidity. In some buildings you do just have to consider this a characteristic of the property.

Cold bridging/thermal bridging

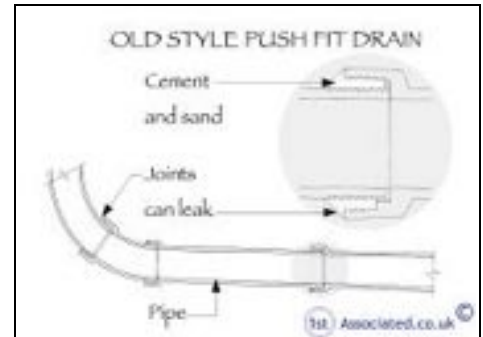
In older properties, such as this, drainage was often push fitted together rather than bonded together which means that they may leak over the years. Whilst we ran the tap for 15 minutes without any build up or blockages the only way to be 100% certain of the condition of the drains is to have a closed circuit TV camera report.

Push fit drain

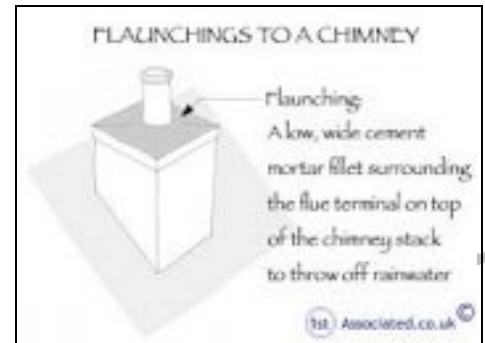
Flaunching

**ACTION REQUIRED:** The whole of the chimney would benefit from appropriate repair work as we can see there has been inappropriate repair work using cement mortar. We can also see that the lead work detailing could be improved to reduce the amount of water getting into the right gable end. From our experience we don't think this will ever be completely dry but it could be we feel improved. We can also see that the render that adjoins the chimney would benefit from being pre-paired, repaired and redecorated.

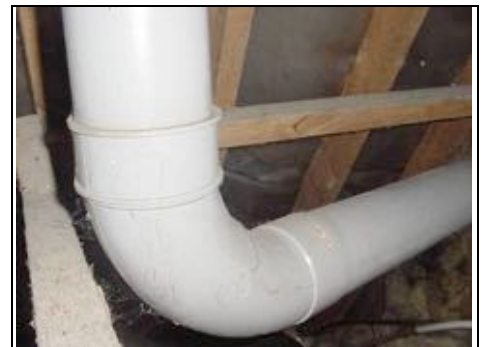
Plastic pipe within roof

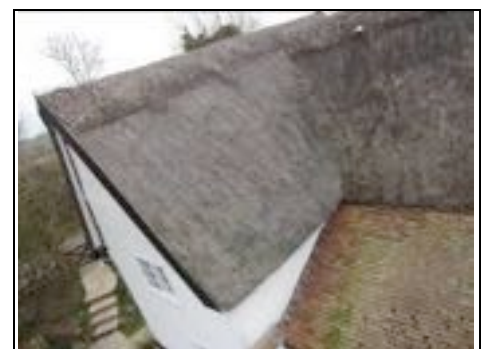
The roof is pitched and thatched with what we believe to be long straw, although it does need samples taking and analysis. From ground level, this looks in below average condition considering the roofs age type and style. We can also see that the roof structure needs work. The owner did advise during our question and answer session that they had carried out some work about five or ten years ago (he could not recall) and he does have quotations for the thatch but do remember with a listed building it is not just about what you want to do; it is also about what the listed building/conservation officer is happy with.

Thatch ridge disintegrating and dampness within thatch  
~ Aerial View - 360 Photo ~

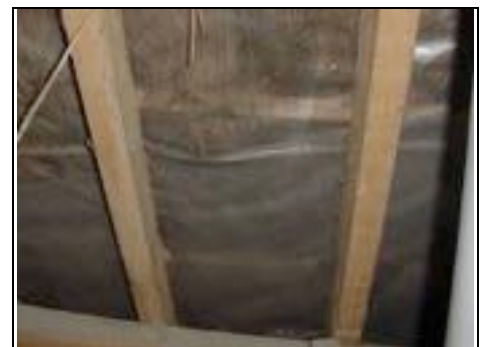
We did not expect to see a protective underlayer under the thatch however we can see some areas where a plastic sheet has been used which we thought was unusual and indicates that part of the thatch has been repaired more recently. We spoke to the owners about this in our question and answers session and they could not recall any specific repairs to the thatch in their time at the property.

This photo shows the common rafters (the ones that form the pitch of the roof) and the dark area between is the underlayer.

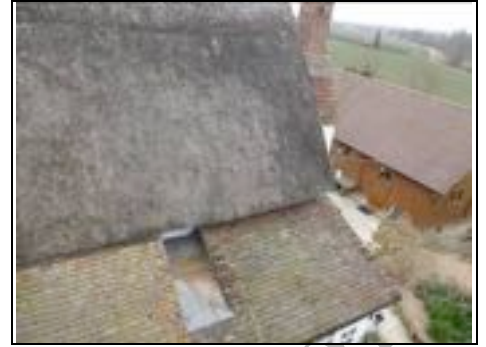
We noted the tiled roofs to the front of the property are relatively shallow and are starting to spall. We would recommend that work is carried out to this area. There is a lead valley to the roof which also needs to be checked when the roof is re-tiled.

Displaced tiles and in need of repair  
~ Aerial View - 360 Photo ~

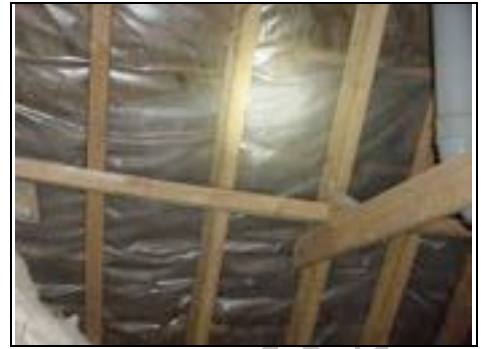
Thin purlins

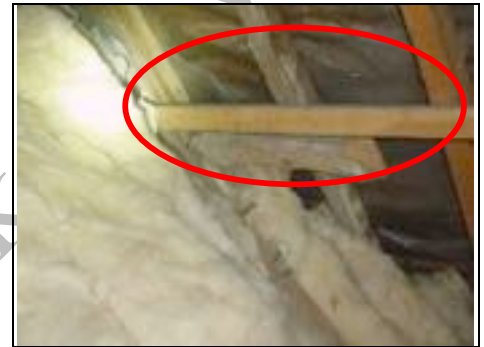
Purlin missing replaced with very thin purlin  
Plastic sheeting

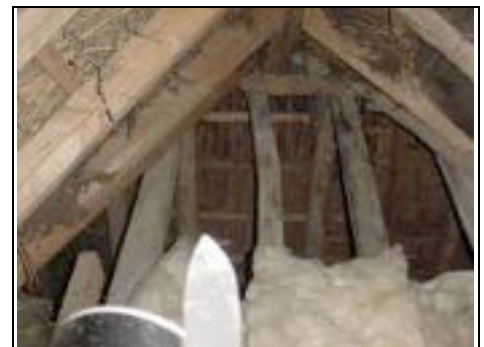
Deterioration/twisting to timbers in left roof

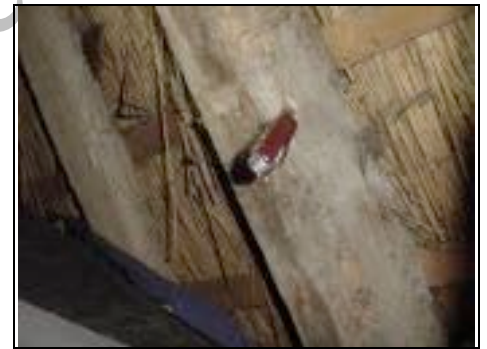
Woodworm and soft rot

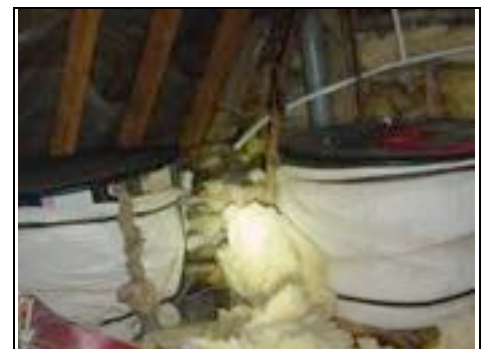
Water tanks in middle roof

We would always recommend that water tanks be drained down and cleared of any debris etc. (we have seen dead birds and other unmentionable things in these tanks). As you are often cleaning your teeth with this water it is best that it is as clean as possible!

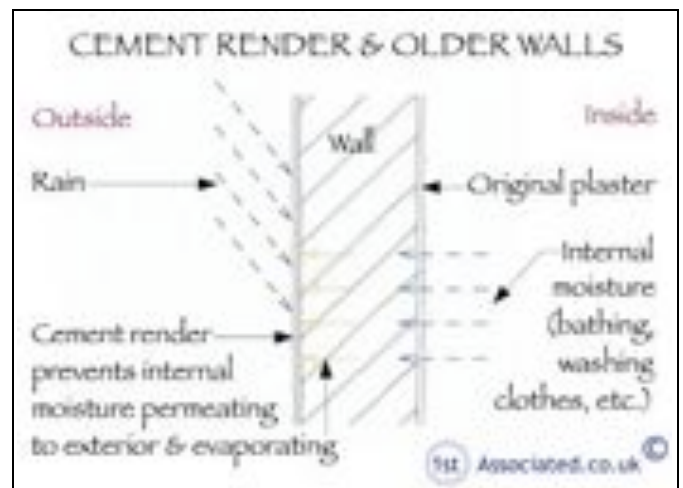
The question that we always ask of these is how much damage the cement render is doing to the timber frame. We do believe in this instance that there is movement in the property and a considerable lean on it so it is well worth carrying out investigations.

Cement render

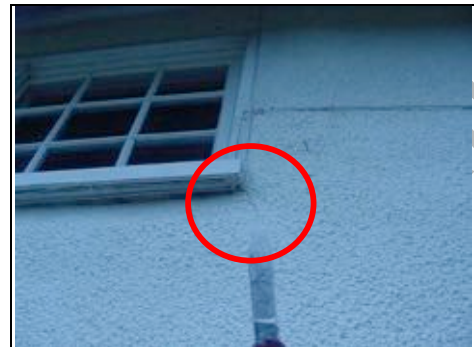
Cracking

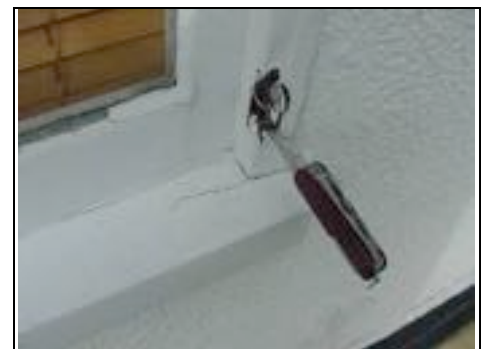
Knife test in rotten window

**ACTION REQUIRED:** General repairs and easing and adjusting of the windows and doors.

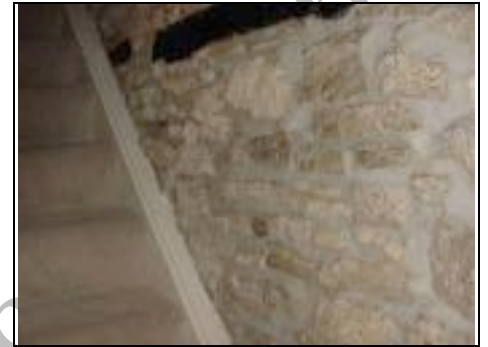
Cement repairs to stonework on side of staircase

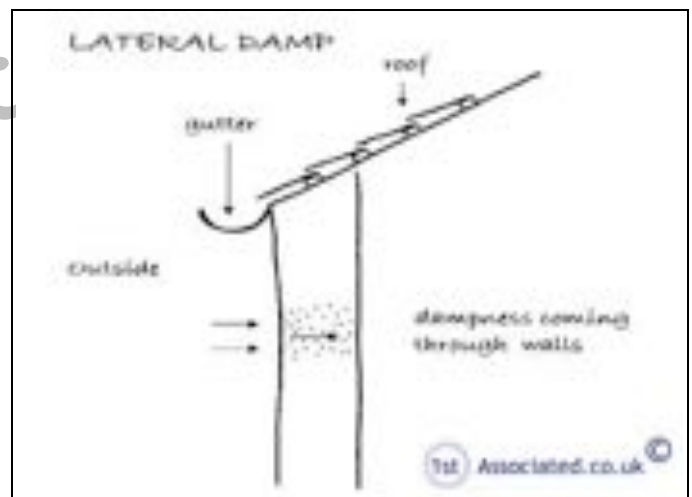
We used a resistance meter on the external walls. We have found significant dampness.

Lateral damp

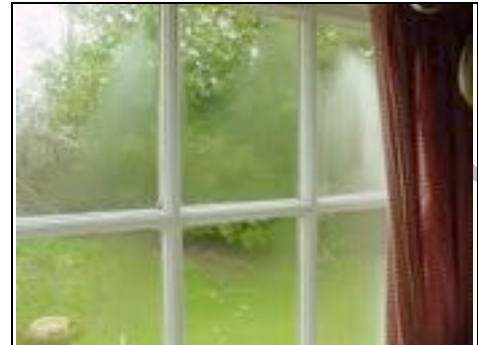
At the time of the inspection there were obvious signs of condensation to the windows in the kitchen and we generally find you do get condensation throughout a property like this even with the characteristic of the property. You do need to consider this will be something you have to live with if you do take this property on.

Condensation to windows in kitchen

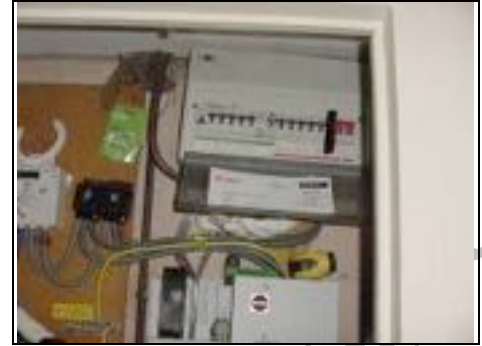
The electric fuses and consumer units were located in a cupboard off the entrance hall. The fuse board looked to be a 1980's - 1990's style. In an older property a defective fuse board can be particularly dangerous.

Fuse Board

**ACTION REQUIRED:** As the property is changing occupancy an Institution of Engineering and Technology (IET) test and report and any recommendations should be carried out by a NICEIC registered, or equivalent, approved electrical contractor or similarly approved.

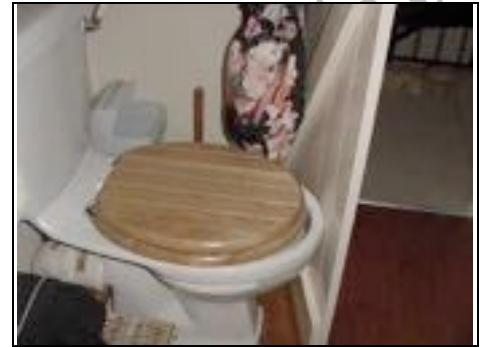
WC very close to door in bathroom

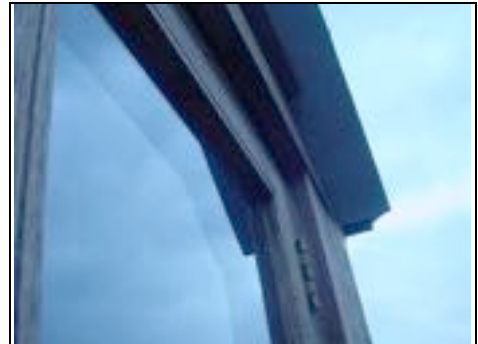
Windows need re-staining
