SCHEDULE OF CONDITION

**XXXX Industrial Estate
XXXX
Oakley
Bedfordshire
MK43 XXX**

**FOR
Mr X**

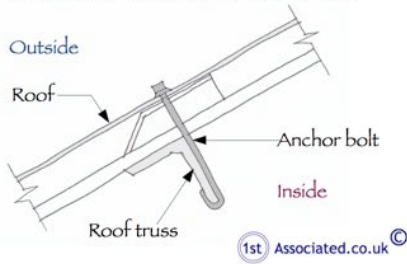
<p>Rusting anchor bolts</p>	<p>Anchor bolts rusting and protective plastic caps missing, also some mis-drilled holes</p>

<p>Replace all rusting anchor bolts, replace all missing plastic caps, repair any mis-drilled holes</p>

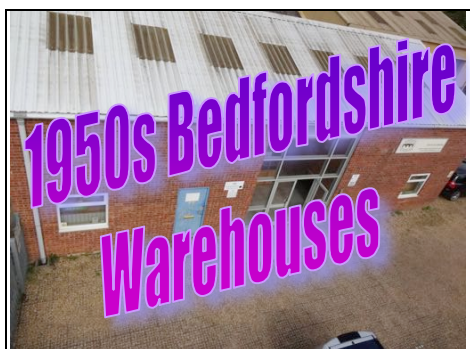
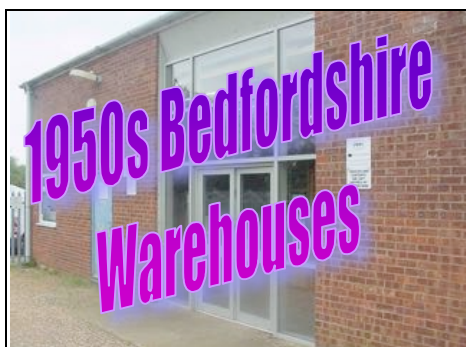
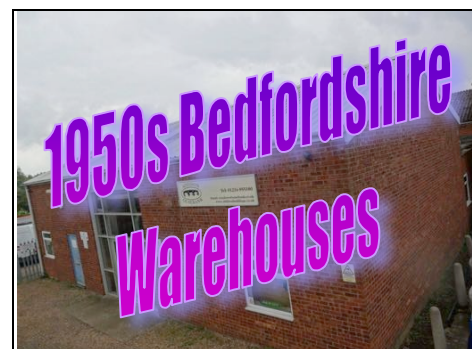
DESCRIPTION	CONDITION	ACTION REQUIRED
Roofs: Profile metal sheets		See Roof Section
Gutters and Downpipes: Plastic We viewed the gutters from ground level	Weathered

<p>General efflorescence visible to brickwork indicating there is dampness getting into the brickwork</p> <p>Vegetation growth</p>

Ensure all gutters are watertight and falling towards the downpipe and clear. Repair downpipes and secure as necessary, ensure downpipes are clean and clear.

<p>Repair bricks</p> <p>Resolve dampness</p> <p>Investigate drainage around the building</p>

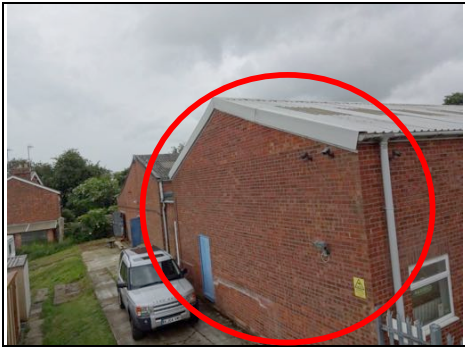
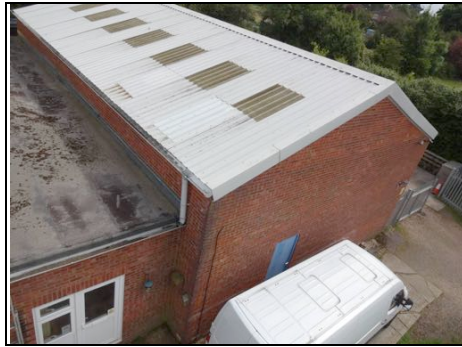
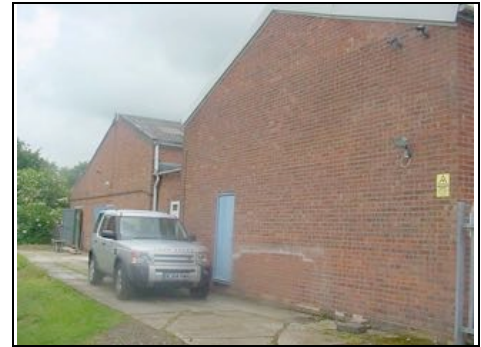
DESCRIPTION	CONDITION	ACTION REQUIRED
Roofs: Profile metal sheets		See Roof Section
Walls Structure: Metal portal frame		See Front Elevation.
Wall Finish: Stretcher bond brickwork	Damage and spalling to base of brickwork

<p>Surcharging/overflowing to roof and gutters allowing discharge of water down the rear corner of the building</p>

<p>Dampness and vegetation visible at low level</p>	<p>Alter gutter/roof to resolve problems.</p> <p>Clean</p>
<p>External Detailing:</p> <p>Bargeboard: Metal</p> <p>Doors: Blue door</p>	<p>Appears to be allowing water to discharge down the wall causing deterioration.</p>

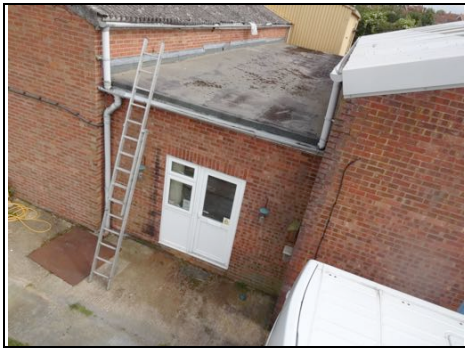
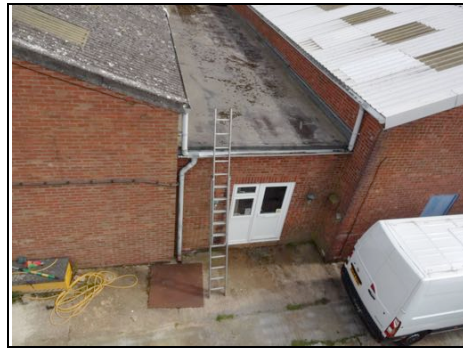
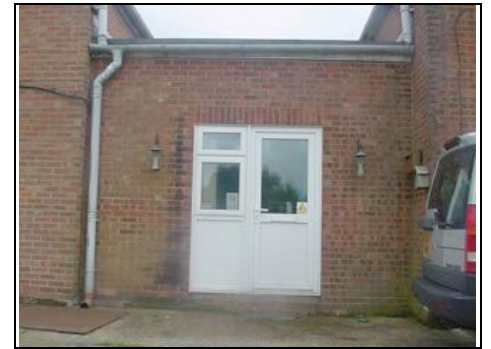
DESCRIPTION	CONDITION	ACTION REQUIRED
Roofs: Flat roof covered in felt		See Roof Section
Gutters and Downpipes: Plastic	Discharging onto ground so may cause dampness into corner of building	Form gully
Wall Finish: Stretcher bond brickwork	Old fixing points   Pattern staining

<p>Moss to base</p>

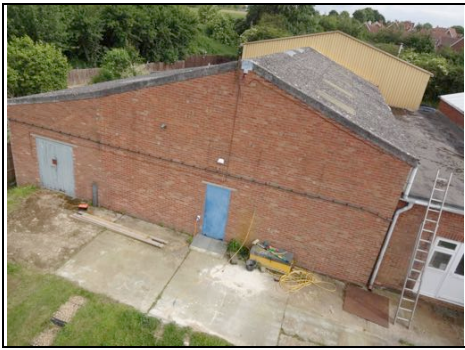
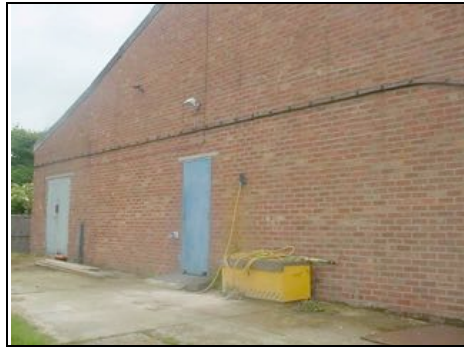
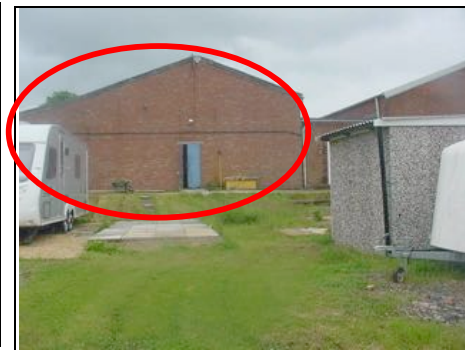
DESCRIPTION	CONDITION	ACTION REQUIRED
Roofs: Asbestos		See Roof Section
Walls Structure: 'I' beam profile		
Wall Finish: Stretcher bond brickwork	Old fixing points, marked and vegetation growth to base

<p>Deteriorating with rot to the base</p>  	<p>We are advised that the timber doors will be replaced – your legal advisor to confirm.</p>
<p>Double blue door with concrete lintels</p>

<p>Deterioration to double doors</p>

Make good
External Detailing: Fascias: Asbestos		Remove

<p>We are advised that the timber doors will be replaced – your legal advisor to confirm.</p>
<p>Signage: Old signage on brickwork</p>		
<p>Other: Security cameras at high level</p>

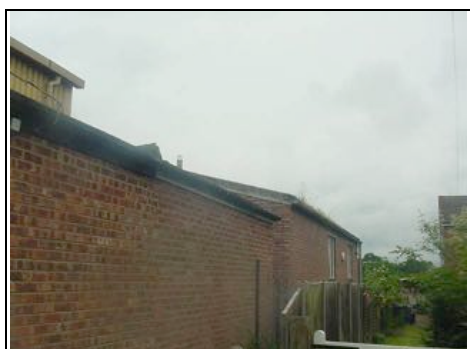
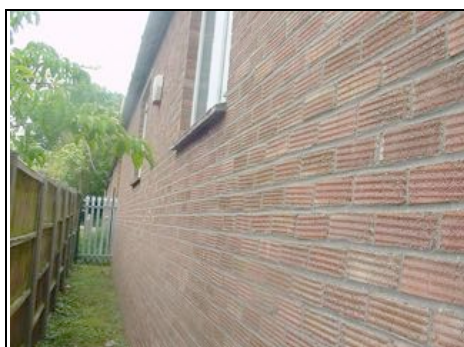
DESCRIPTION	CONDITION	ACTION REQUIRED
Roofs: Asbestos		See Roof Section
Gutters and Downpipes: Asbestos We viewed the gutters from ground level.	Grass growing

Overflow and surcharging of the gutter

<p>Deterioration to asbestos downpipe</p>

<p>Downpipe breaking up</p>

Remove and replace. We believe this is part of the owners upgrade works. We would also recommend downpipes discharge into a soakaway rather than to the base of the property. Ensure all gutters are watertight and falling towards the downpipe and clear. Repair downpipes and secure as necessary, ensure downpipes are clean and clear.

<p>Remove all asbestos</p>
<p>Walls Structure:</p> <p>'I' beam profile</p>		
<p>Wall Finish:</p> <p>Stretcher bond brickwork</p>	<p>Average</p>	
<p>External Detailing:</p> <p>Windows:</p> <p>Two metal crittal windows with Georgian wire polished plate glass</p>

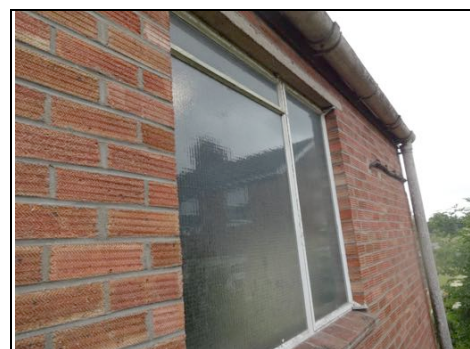
<p>Flaking paint</p> <p>Cracked glass in both windows.</p>

<p>Replace broken glass</p> <p>Repair, prepare and redecorate.</p> <p>And/or Replace</p>

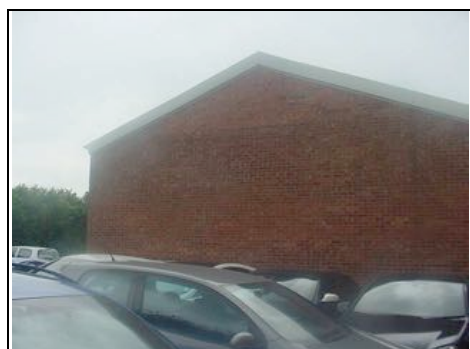
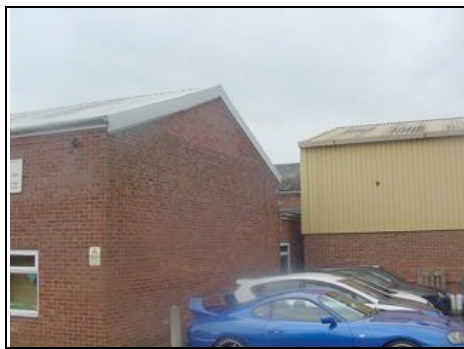
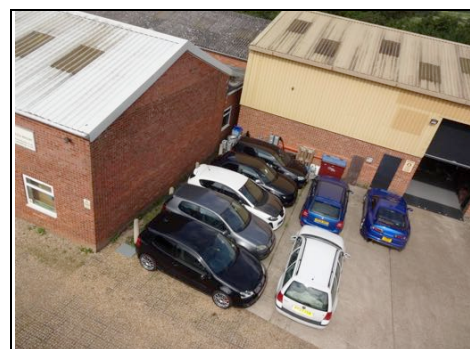
DESCRIPTION	CONDITION	ACTION REQUIRED
Roofs: Profile metal sheets		See Roof Section
Walls Structure: Metal portal frame		See Front Elevation.
Wall Finish: Stretcher bond brickwork	Efflorescence and lichens

Efflorescence

Investigations to be carried out to stop dampness on gable end

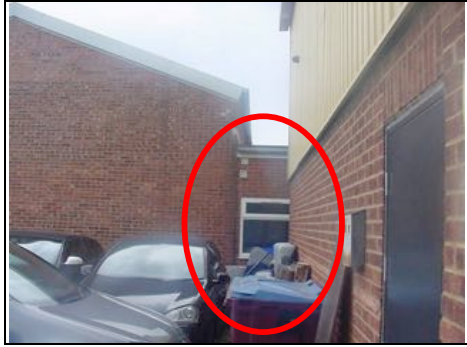
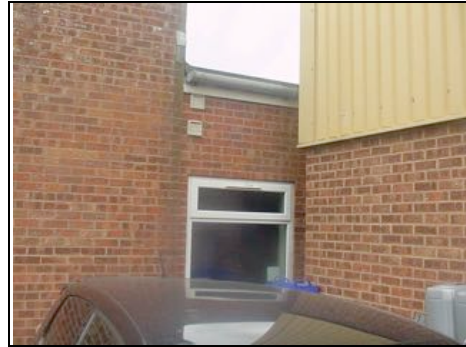
DESCRIPTION	CONDITION	ACTION REQUIRED
Roofs: Flat felt roof		See Roof Section
Gutters and Downpipes: Plastic We viewed the gutters from ground level.	<p>Gutter on rear right flat roof</p>   <p>Plastic going into asbestos</p>   <p>Weathered and deterioration</p>  	<p>Ensure all gutters are watertight and falling towards the downpipe and clear.</p> <p>Repair downpipes and secure as necessary, ensure downpipes are clean and clear.</p>

Wall Finish: Stretcher bond brickwork		
External Detailing: Fascias: Timber	Weathered	Repair, prepare and redecorate.
Windows: Plastic window with trickle vents	Trims missing to sill base	Replace trims

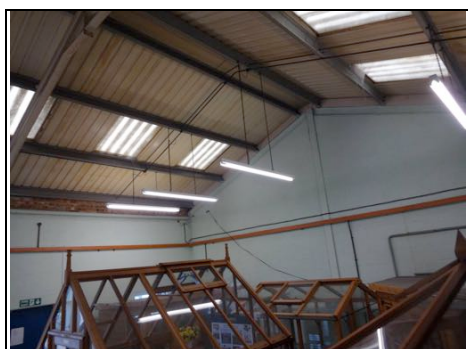
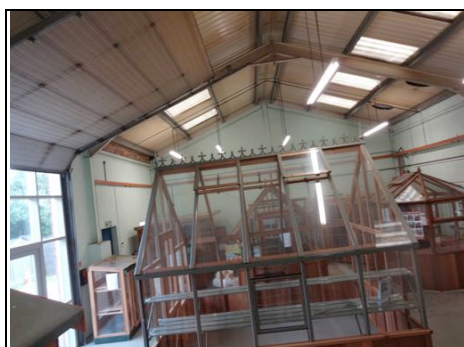
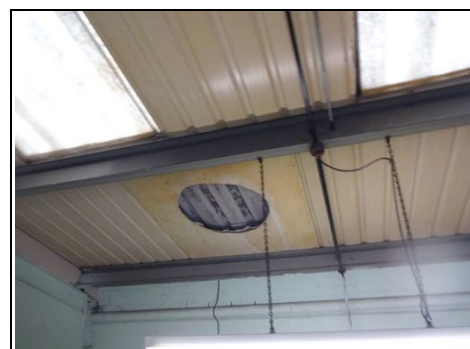
DESCRIPTION	CONDITION	ACTION REQUIRED
Roof: Profile metal sheet roof Metal purlins Wind brace	Some leaks. Two circular openings on rear

Rust staining Cobwebs Rust staining Dirty and marked

Make roof watertight, general clean and redecorate. Repair, prepare and redecorate Clean
Roof windows: GRP roof windows	Damaged trim	Repair and make watertight and make good

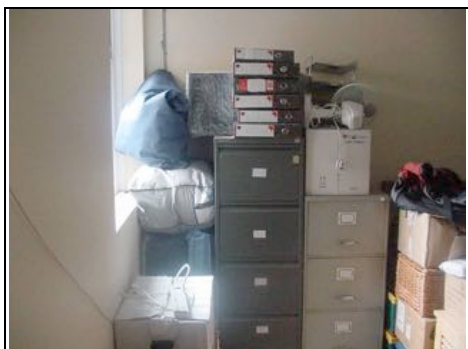
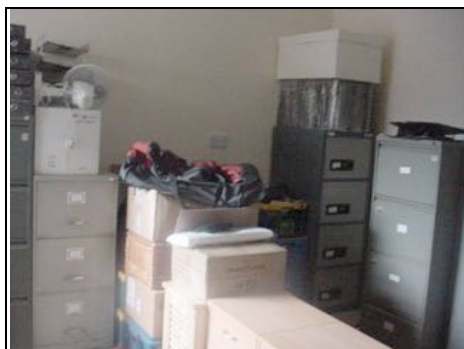
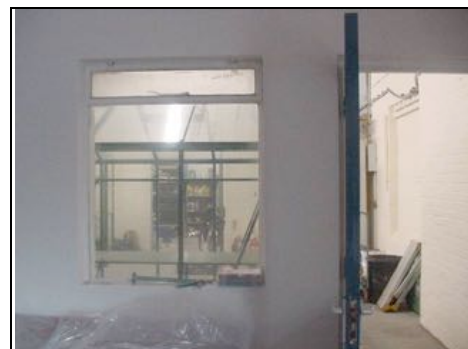
DESCRIPTION	CONDITION	ACTION REQUIRED
Ceilings: Painted plaster	Dated	Repair, prepare and redecorate
Walls: Painted (solid) Walls hidden by filing cabinets and storage units	Marked Hairline crack adjacent to door

Repair, prepare and redecorate
Floors: Concrete	Average	Clean
Detailing: Windows: External plastic window with trickle vent and top opening window	Average	Clean

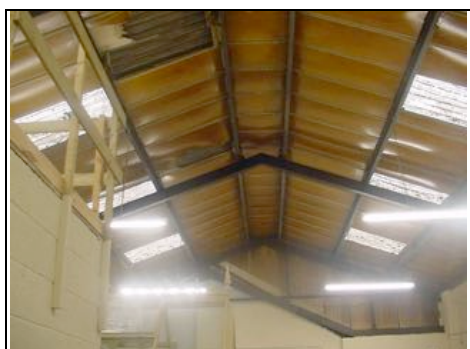
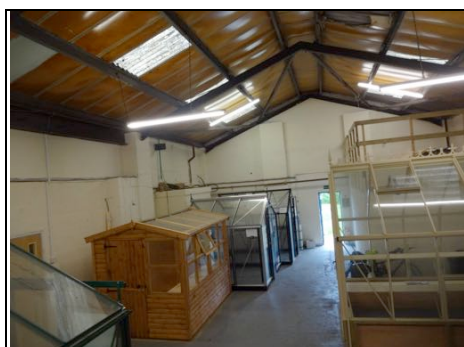
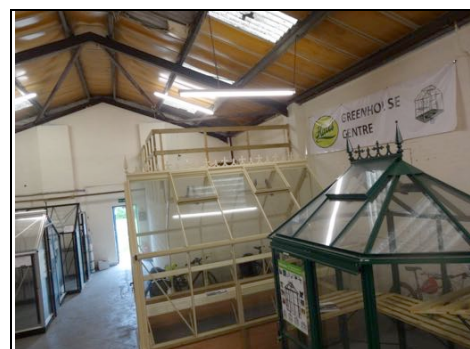
DESCRIPTION	CONDITION	ACTION REQUIRED
<p>Roof:</p> <p>Underclad asbestos roof</p>	<p>Three major areas of water damage where asbestos can be seen</p> <p>Damaged</p>

<p>Fascia board coming away</p>

<p>We have been advised this roof is being replaced; confirm specification and agree quality standard.</p>

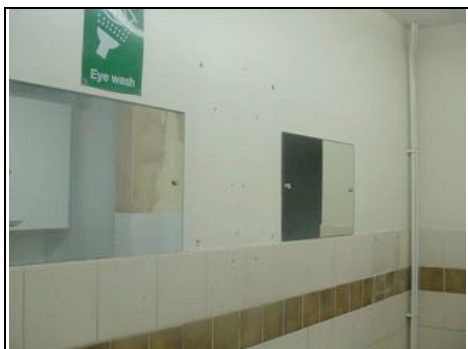
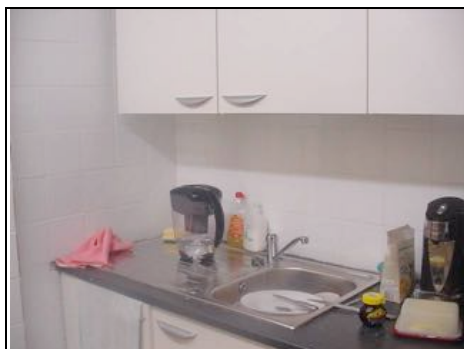
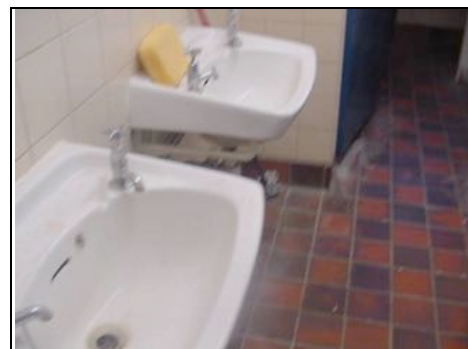
DESCRIPTION	CONDITION	ACTION REQUIRED
Ceiling: Plaster	Parts of plaster unpainted

Rust staining to ceiling indicating that flat roof above may be leaking

<p>Floors:</p> <p>Quarry tiles</p>	<p>Unfinished, some quarry tiles missing in two main areas</p>

Repair, prepare and redecorate.
Walls: Old tiles and modern white tiling Plaster painted and unpainted	Some tiles missing Unfinished/damaged by water	Clean Repair, prepare and redecorate.

<p>Replace missing tiles Deep clean</p>
<p>Detailing:</p> <p>Doors:</p> <p>Painted</p>	<p>Poorly fitted</p>

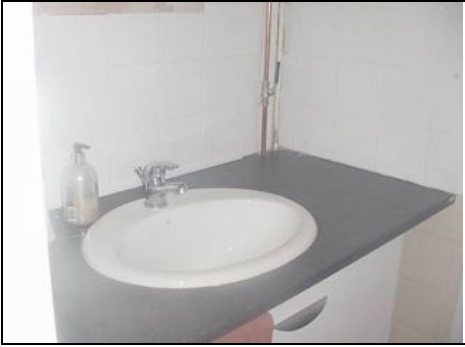
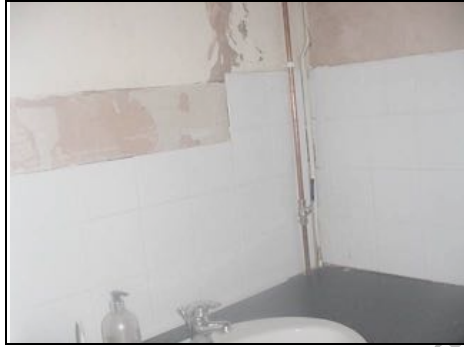
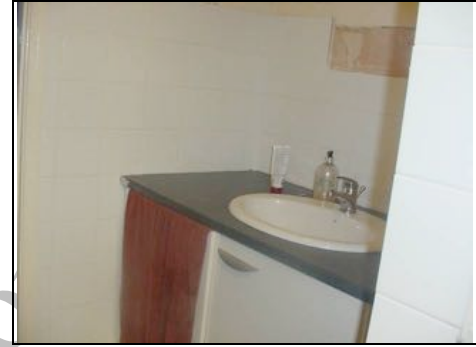
DESCRIPTION	CONDITION	ACTION REQUIRED
Ceiling: Plaster	Unfinished  	Repair, prepare and redecorate.
Walls: Tiled	Unfinished  	Add tiles

Floors: Tiled	Unfinished

Make good and deep clean.
Sanitary Ware: Vanity unit and wash hand basin	Average	Deep clean
Detailing: Doors: Timber	Unfinished	Repair, prepare and redecorate Or Replace door
Services: Mixture of copper and plastic  		See Services Section.

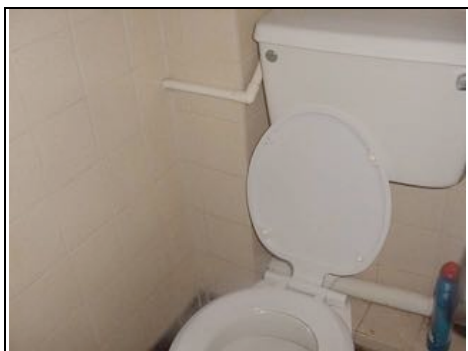
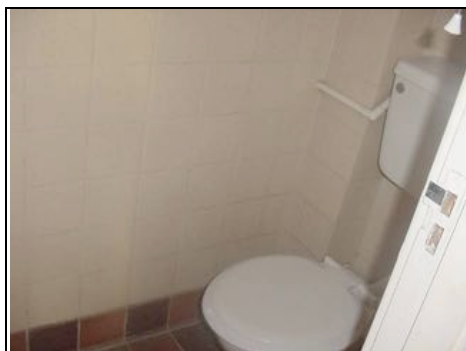
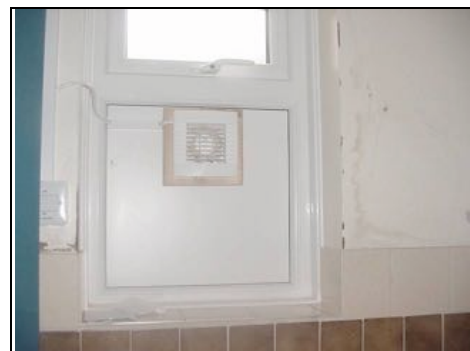
DESCRIPTION	CONDITION	ACTION REQUIRED
Ceiling: Plaster	Average	Repair, prepare and redecorate.
Walls: Tiled to approx. 1.5m	Dampness	Resolve dampness Deep clean
Floors: Quarry tiles	Dated	Deep clean.
Sanitary Ware: WC with low level cistern	Dated	Deep clean
Detailing: Windows: Blocked up window with extract fan and frosted glazing above	Average	Repair, prepare and redecorate

<p>Doors:</p> <p>Door with borrowed light</p>	<p>Badly fitted.</p> <p>Glazing missing to borrowed light.</p>

<p>Re-fit. Repair, prepare and redecorate.</p> <p>Replace glazing</p> <p>Or</p> <p>Replace door</p>
<p>Services:</p>		<p>See Services Section.</p>

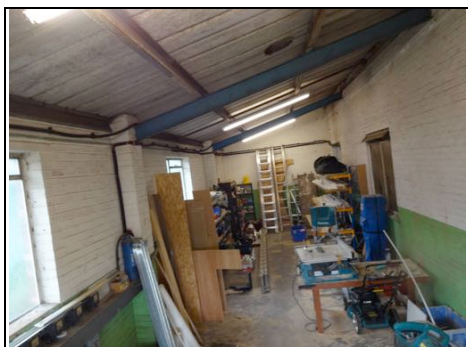
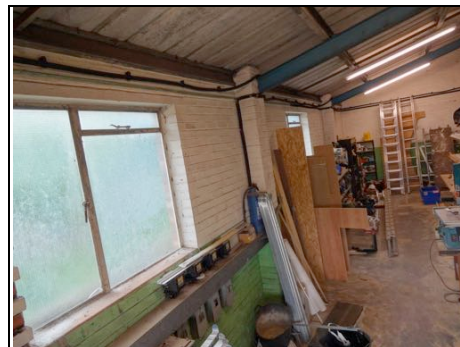
DESCRIPTION	CONDITION	ACTION REQUIRED
Roof: Underside of asbestos 'I' beams forming common rafters/pitch of roof	Opening cut in asbestos roof Dampness

Rusting

Walls: Painted brickwork Unpainted blockwork	Dated Dated	Repair, prepare and redecorate Repair, prepare and redecorate
Detailing: Windows: Metal internal window External windows	Broken glass Cracked	Replace broken glass Repair, prepare and redecorate Replace broken glass Repair, prepare and redecorate
Floors: Concrete	Old fixing points	Make good
Services: Electrics in glazed storage area Electrics in workshop area		See Services Section Electric test and report required

Resolve dampness.
