COMMERCIAL BUILDING SURVEY

Luton

FOR

Mr X

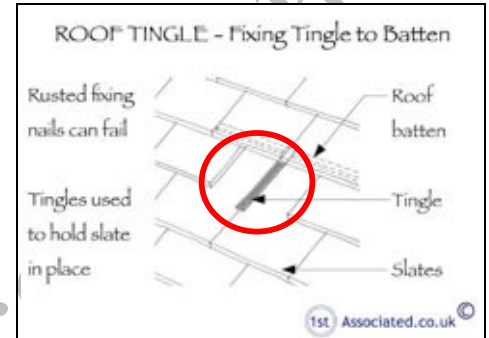
To the roof there are a number of areas of slates that have been repaired with lead tingles.

We would generally comment where there are a dozen plus lead tingles, as there are in this instance, we would normally be recommending to re-roof. However, bearing in mind you are looking to do alterations and improvements to the property you may wish to wait on this work.

Slate tingles

ACTION REQUIRED: We would recommend you monitor the roofs and be aware if they do leak they are likely to need replacing rather than repairing. The work is likely to require scaffolding, which could be quite costly.

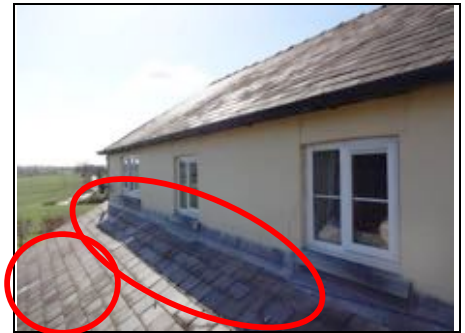
Slates repaired with lead tingles to the rear roof
Ariel view – 360 photo

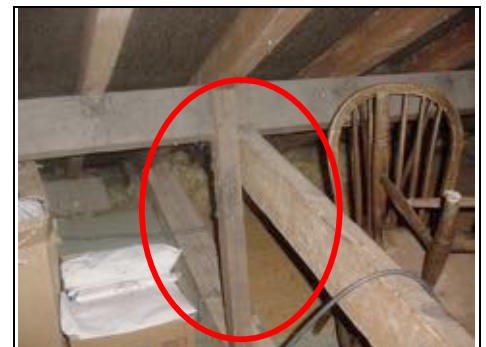
Within the roof space accessed from the first floor lounge we can see what is known as an A Frame cut timber roof. When we inspected this it did look like some extra timbers have been added to help stabilise it. It is difficult to be certain but we do feel it is best to be safe than sorry.

Additional timbers added

ACTION REQUIRED: Your legal advisor to specifically ask if there have been any structural alterations to the roof and the property as a whole.

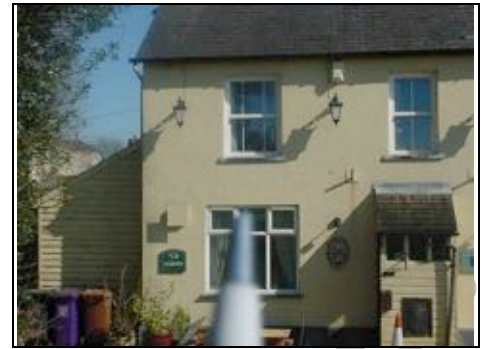
Cracks to front left window

ACTION REQUIRED: We would suggest to be on the safe side that the existing owners take out an insurance claim, advising that the cracking has been noted by a structural surveyor (this should cost them nothing other than time to write the letter). This usually means that the insurance company will carry out a monitoring exercise (the Building Research Establishment recommend monitoring any cracks for a minimum of one year) to establish if there is any progressive movement. Your future liability will be limited to the cost of the excess on the insurance providing the insurance company is happy for you to take over the insurance claim.

Your solicitor needs to ensure this is a legally watertight process and ensure your liability is limited to paying the excess on the insurance only.

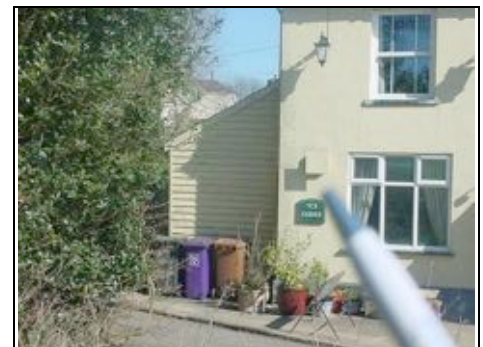
Cracks to the front left wall

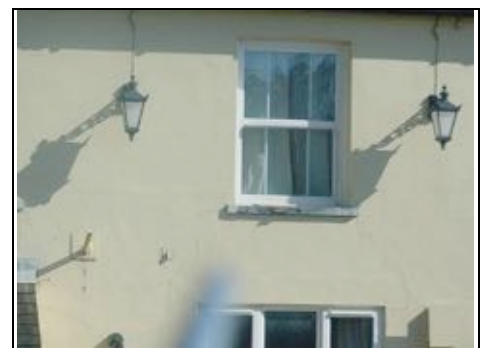
Cracks to the front right first floor window

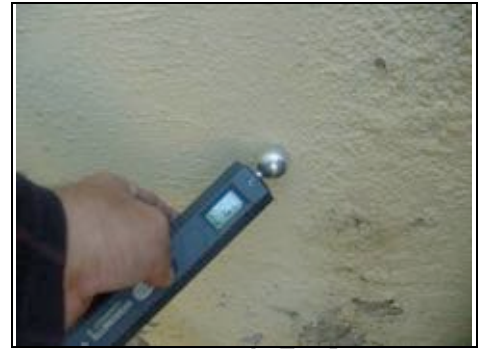
The property sits on a sloping site and as such water is travelling from the top to the bottom of the sloping site and the property is in the way and this has resulted in dampness getting in to the property particularly to the rear. The front of the property is higher so the drainage area is not affected however we do think that the dampness hidden beneath the floor level.

Dampness to the rear left corner

We can see there has been a long term problem here and that a half round gully has been formed to the left side and to the rear of the property. It can be affective but it does not seem to be working well in this particular case so we would recommend the adding of a French drain or an equivalent.

ACTION REQUIRED: We would recommend adding a French drain to minimise dampness.

ANTICIPATED COST: £5,000 - £10,000 as it is fairly long French drain and will need to be quite deep to get a suitable fall on it. We recommend a perforated pipe is used at the base and this discharges into the waste pipe. Please obtain quotations.

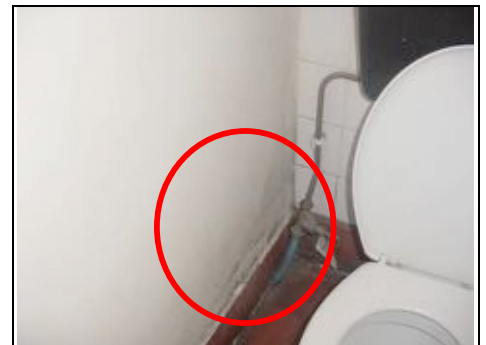
Dampness to the downstairs WC

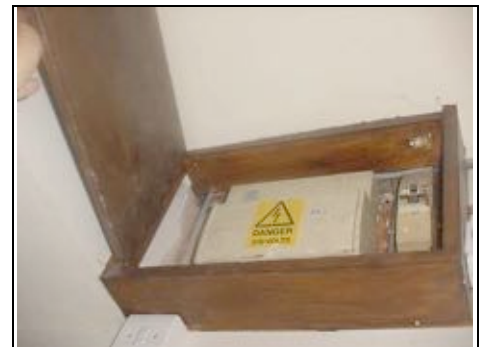
Electrics in the bar

ACTION REQUIRED: Your solicitor to ask in writing for sight of the electric test to confirm it is for the whole of the property.

If it isn't we recommend an Institution of Engineering and Technology (IET) test and report to be carried out by an NICEIC registered and approved electrical contractor or equivalent. We assume you need to alter the electrics to suit the proposed use of the children's nursery.

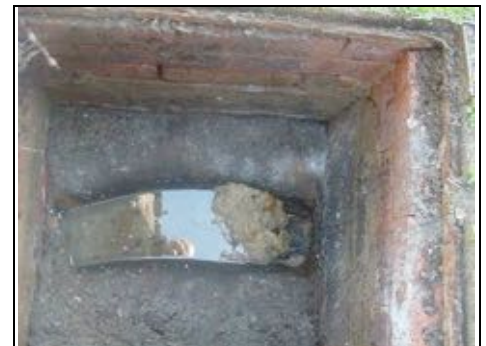
Blocked drain to the right of the property

ACTION REQUIRED: Your legal advisor needs to check and confirm you have permission to do this. We would also recommend a closed circuit TV camera report of the drains.

ANTICIPATED COST: A few hundred pounds for CCTV report; obtain quotes.

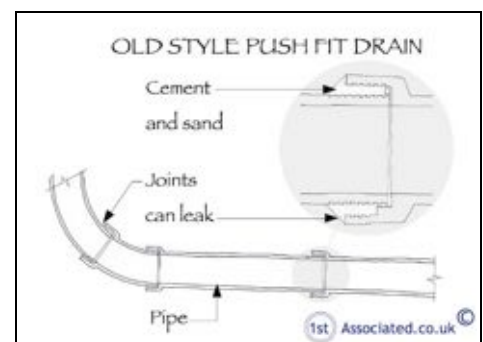
Push fit drains

In older properties, such as this, drainage was often push fitted together rather than bonded together.

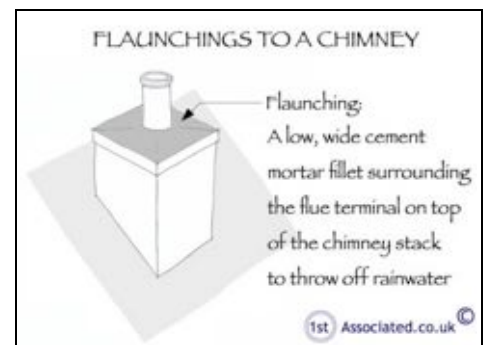
Unfortunately, we were unable to see the flaunching, we therefore cannot comment upon them.

Flaunching

ACTION REQUIRED: Periodically inspect the chimney.

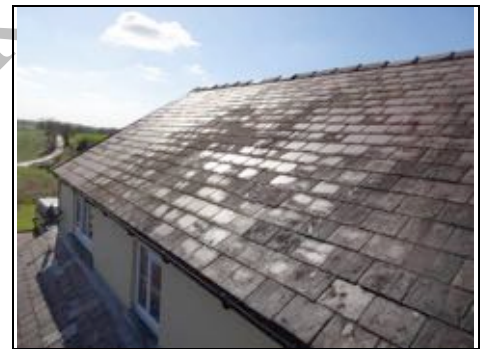
The main roof is pitched and clad with slate. From ground level, this looks in below average condition considering the roofs age type and style.

Main rear roof

Carry out periodic inspections and maintenance of the roof, as required.

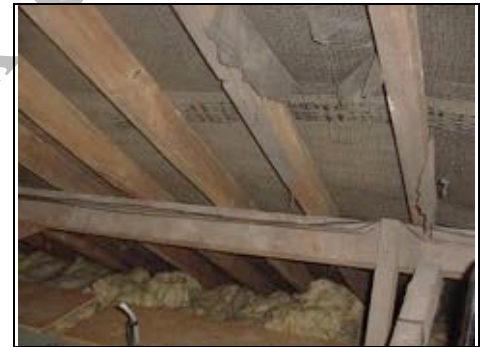
When we inspected the loft space we found a Hessian based Bitumen membrane. This type of membrane has been used since the 1960s. We generally found it to be in average condition, it is damaged in a few more places than we normally find.

Hessian based felt

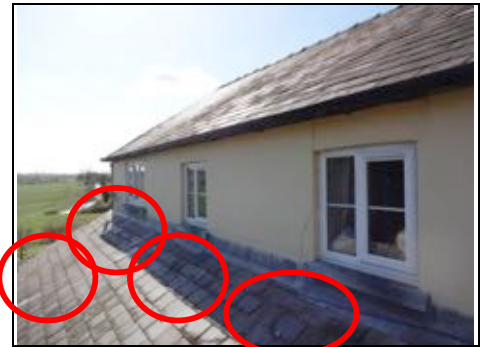
As with the main roof this slate roof has been repaired with lead tingles.

Rear pitched roof
Ariel view – 360 photo

ACTION REQUIRED: Please see our comments in the Executive Summary.

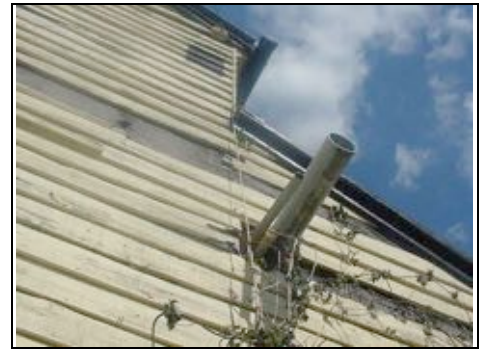
Pipes coming out of the Right side gable end

ACTION REQUIRED: We would recommend your legal advisor checks and confirms what these pipes relate to with the owner of the property, as our other thought is that the shower room and toilet above the first floor are not plumbed in.

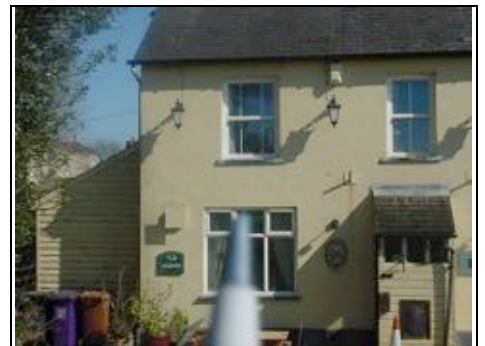
We did note cracking in the structure, please see our comments in the Executive Summary about movement.

Cracking to the front left of the property

We would remind you that any hairline cracks that appear need to be sealed as soon as possible to stop dampness and water getting in.

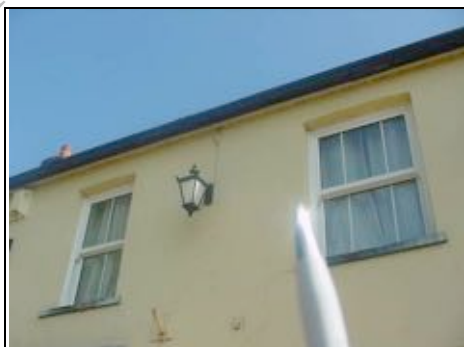
Cracking to the front top right of the property

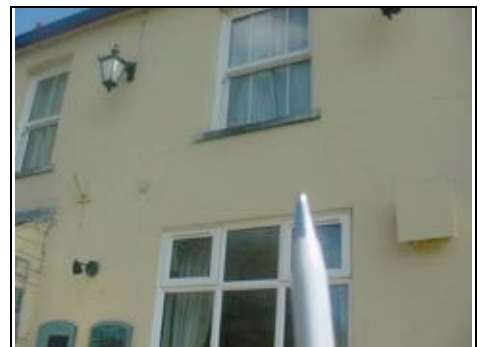
Cracking to the front right of the property

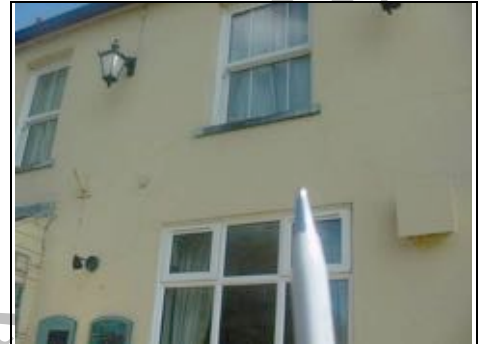
In this case we found no drip detail to the windows.

No drip detail

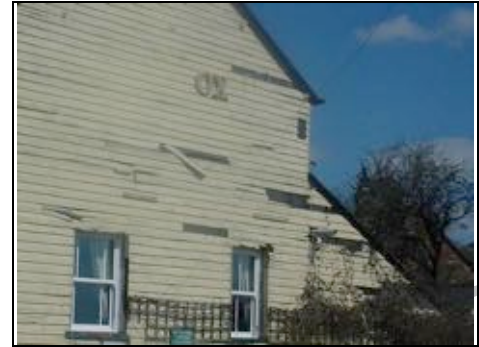
This cladding has obviously seen better days and has a lot of wet rot in it but we are aware you are intending to extend on this right side so you have the opportunity to add external installation.

Boarding coming off right side wall

ACTION REQUIRED: We would recommend external redecoration if you're not going to develop immediately. This will in part protect the property as long as the cracks have been correctly sealed first.

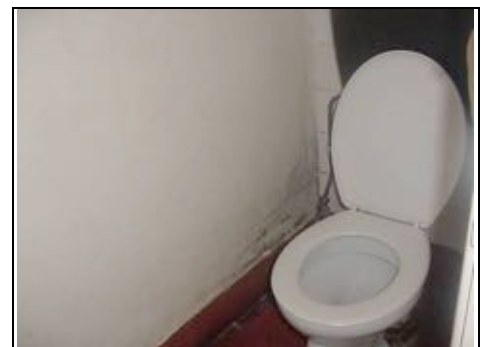
A visual inspection and tests with a moisture meter have been taken to the perimeter walls. In this particular case we have found rising damp to the rear of the property.

Rising damp in the ladies toilet

ACTION REQUIRED: Please see the Executive Summary.
