SCHEDULE OF CONDITION

**Eversholt
Bedfordshire
MK17 XXX**

We have been instructed to inspect and prepare a Schedule of Condition for XXXX, Eversholt, Bedfordshire MK17 XXX.

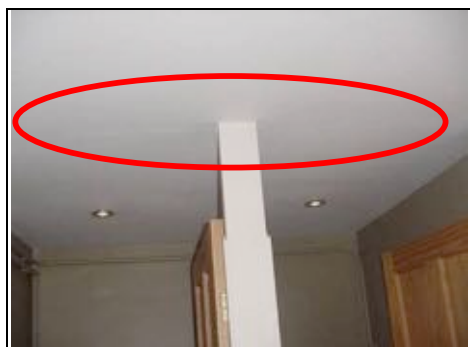
Hairline cracking

DESCRIPTION	CONDITION	ACTION REQUIRED
Ceiling: Painted modern plaster – double sheet of plasterboard	Hairline cracking	Repair, prepare and redecorate
Walls: Painted modern plaster	Dated and marked	Repair, prepare and redecorate.
Floors: Safety style flooring	Ingrained dirt	Clean or replace
Detailing: Windows: Three timber casement windows	Dated	Repair, prepare and redecorate
Doors: Pine WC doors Door to inner lobby removed	Dated	Repair, prepare and redecorate

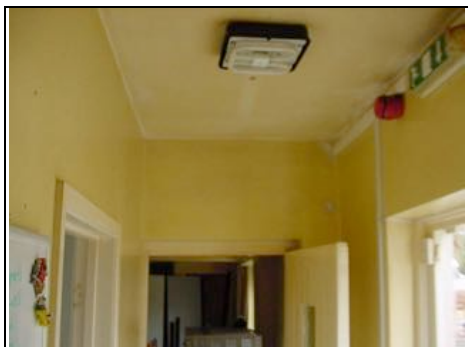
Corridor ceiling

Grease stained Screw fixings Hairline cracking

Deep clean, repair, prepare and redecorate
Walls: Painted	Dated Hairline cracking, particularly over the stable door area Horizontal cracking.

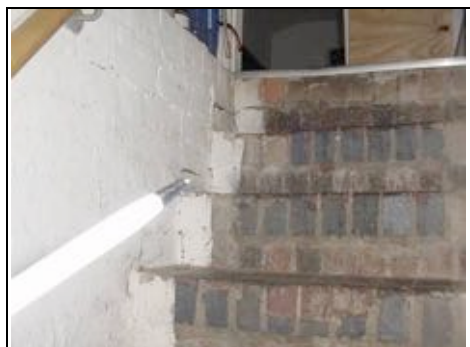
Crack in steps

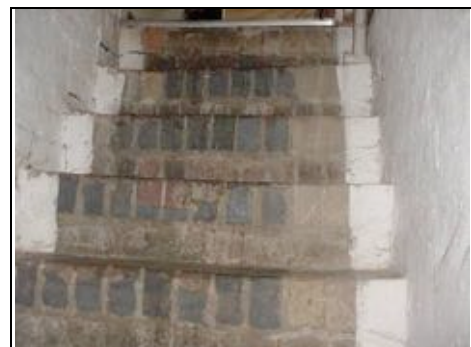
Worn brick steps

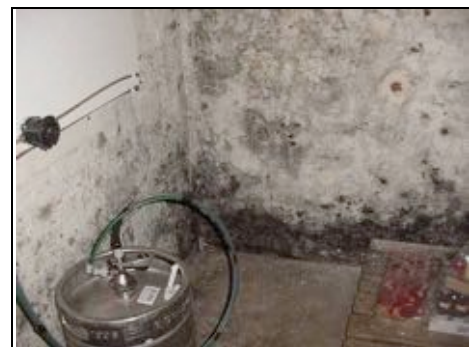
Black mould

DESCRIPTION	CONDITION	ACTION REQUIRED
Ceiling: Painted plywood	Black mould	Resolve dampness, repair, prepare and redecorate
Walls: Painted brickwork Painted blockwork	Black mould Dampness

Resolve dampness, repair, prepare and redecorate.
Floors: Concrete	Ingrained dirt and worn Water sitting on floor

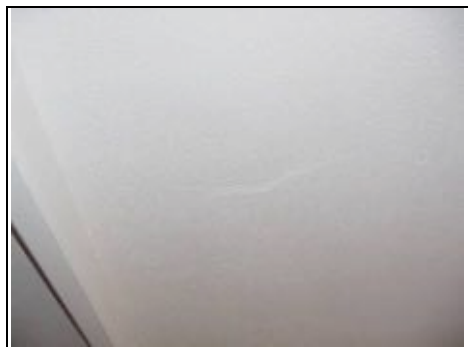
Older style texture paint on ceiling

DESCRIPTION	CONDITION	ACTION REQUIRED
Ceiling: Older style textured paint Two painted beams	May have asbestos content Undulations to ceiling Condensation likely.	Asbestos report Repair, prepare and redecorate Add large good quality humidity controlled extract fan.
Walls: Painted	Considerable movement around door frame

Landlord to place an insurance claim to monitor movement for at least a year as recommended by the BRE; please see our other comments. Repair, prepare and redecorate.
Floors: Wood look vinyl	Worn	Clean or replace

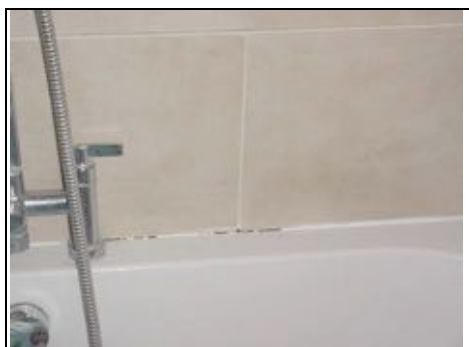
Black mould around bath

Repair, prepare and redecorate. Add large good quality humidity controlled extract fan
Walls: Tiled	Some mould where mastic meets bath	Clean and re-mastic
Floors: Wood look vinyl	Average	Clean or replace.
Detailing: Windows: Timber casement	Dated	Repair, prepare and redecorate

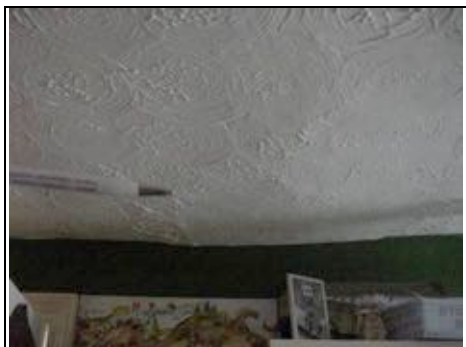
Undulations in ceiling

DESCRIPTION	CONDITION	ACTION REQUIRED
Ceiling: Textured paint	Undulating generally, dip to left side	Investigate leak/deterioration to roof structure. Repair, prepare and redecorate.
Walls: Painted modern plaster Woodchip paper Chimney breast to right side Dividing curtain down centre of room at time of inspection.	Average	Repair, prepare and redecorate. Add vent
Floors: Carpet	Average	Clean or replace
Detailing: Windows: Two timber casement windows	Black mould	Repair, prepare and redecorate

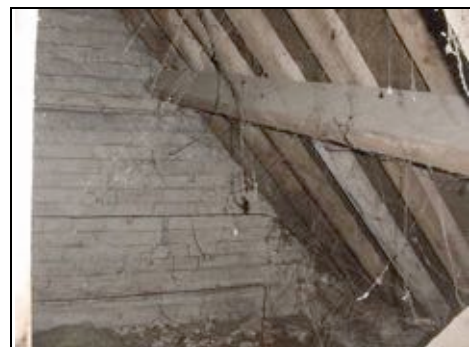
Plant life growing in roof

DESCRIPTION	CONDITION	ACTION REQUIRED
Roof Access: Accessed via double flap from Prep Area No light or ladder Boarded		
Roof Structure: Kingpost roof	Some timbers have been replaced	
Roof Timbers: Common rafters	Back to back timber repairs Woodworm visible.
