PROPERTY REPORT AND NEGOTIATION DOCUMENT

XXXX
Dunstable
Bedfordshire
LU6 XXX

INTRODUCTION

We have been instructed to inspect and prepare a Property Report and Schedule of Condition for:

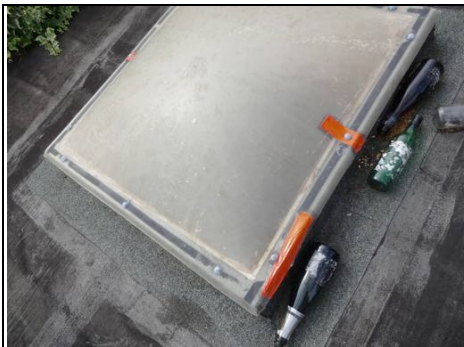
The rear large flat roof has six roof windows that have been repaired in what we would term as DIY quality.

Large flat roof, roof window repairs
Aerial view – 360 photo

ACTION REQUIRED: Ideally re-roof all of these roofs ensuring that there is a good fall on the roof. We would recommend adding insulation with a good quality high performance elastomeric type felt.

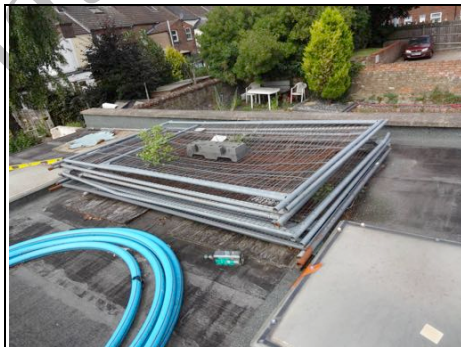
Large flat roof, lots of stored items
Aerial view – 360 photo

We would also recommend cutting back the bushes and the ivy that is currently on the roof and in the short term clear the roof of all the stored items such as the pallets, metal fence panels and piping.

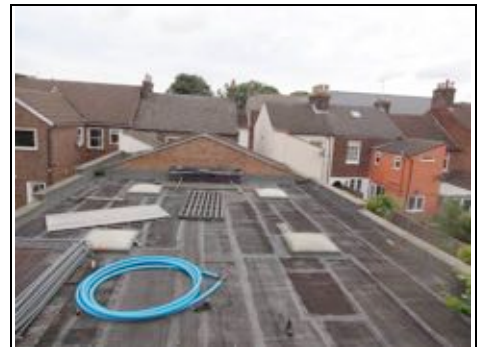
There is a large flat roof (no.7) to the rear and two small flat roofs, one to the front (no.4) and one to the rear left corner (no.8) that are not in particularly good condition.

Large flat roof (no.7) with six roof windows, full of stored items
Aerial view – 360 photo

We are also concerned that the flat roof is unvented. Given the training rooms below which generate higher than typical humidity, albeit they have a comfort cooling system installed, we much prefer to have cross-vented flat roofs and indeed is usually part of Building Regulations requirements.

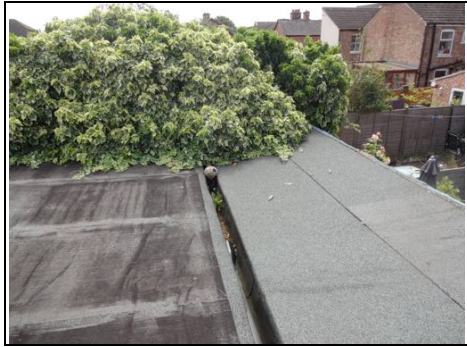
The rear left roof (no.8) is adjoining to the large flat roof. It has a box gutter where it joins the rear left flat roof. There is vegetation growing on the roof in this area, which needs removing and also the poor detail to the box gutter needs improving.

Also the roof looks to have been patch repaired again and again with liquid bitumen.

Rear left roof (no.8) and box gutter
(with the ball at the end)
Aerial view – 360 photo

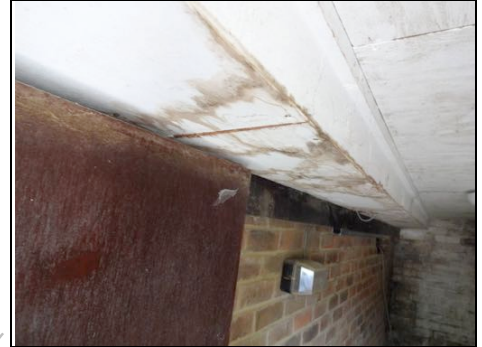
Box gutter leaking
Aerial view – 360 photo

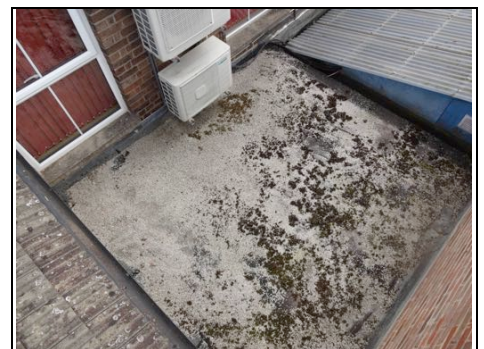
The front flat roof (no.4) has moss sitting on it which indicates it is a flat flat roof and we wonder how water discharges off this roof. The moss indicates that water sits on the roof and does not discharge.

Front flat roof (no.4), view from
high level
Aerial view – 360 photo

ACTION REQUIRED: We would recommend a water test on the front flat roof and would also recommend excluding it from the lease.

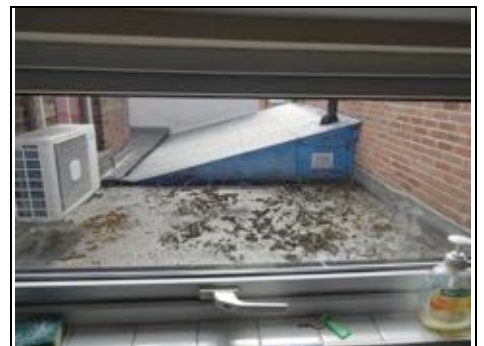
Small hidden flat roof (no.4),
covered with moss
Aerial view – 360 photo

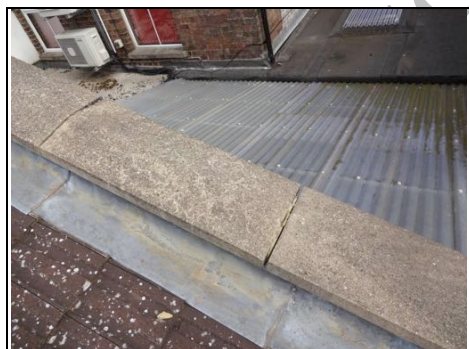
There are also a considerable number of parapet walls and box gutters around flat roofs and roofs in general which need attention. We can see a mastic has been used to carry out DIY quality repairs and that weathering is also present to a lot of the joints.

Weathering to coping stone joint
Aerial view – 360 photo

ACTION REQUIRED: Exclude from the lease, however basic repairs do need to be carried out to make sure these areas are safe and water tight.

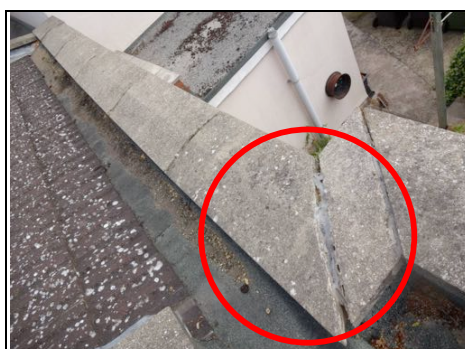
DIY repairs - mastic in the joints to
the coping stone
Aerial view – 360 photo

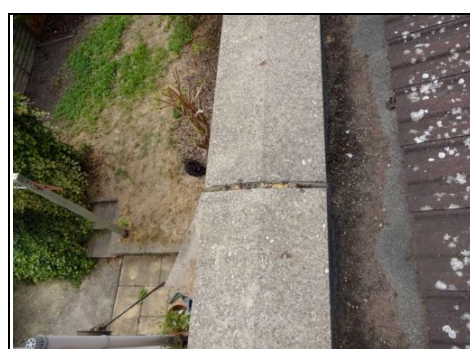
Weathering to coping stone joint
Aerial view – 360 photo

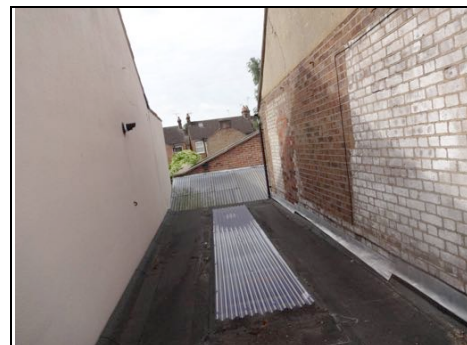
There is a basic flat roof over the garage area with a basic roof light with a plastic corrugated cover over it. We can see the flashings to this have been repaired with flashband, which we consider a temporary repair material.

Garage roof
Aerial view – 360 photo

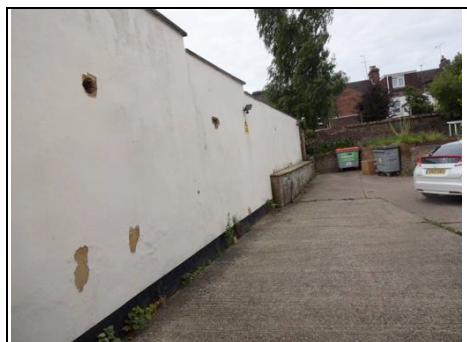
Rising dampness was noted and recorded with damp metres in the property, especially around the internal toilets. Dampness is also noted to the right side wall, approximately a meter in height with plants growing to the base of the property.

Dampness to right wall
Aerial view – 360 photo

ACTION REQUIRED: We recommend you resolve dampness in the walls. Note this is likely to have had temperamental affect over the years to any embedded timbers close to walls where there has not been suitable ventilation such as in the basement.

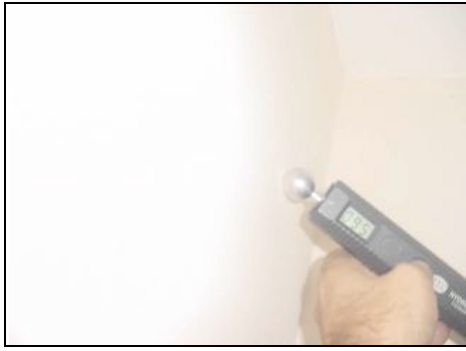
Dampness to wall

Dampness is getting into the structure due to deteriorating render and poor edge detail to the roof.

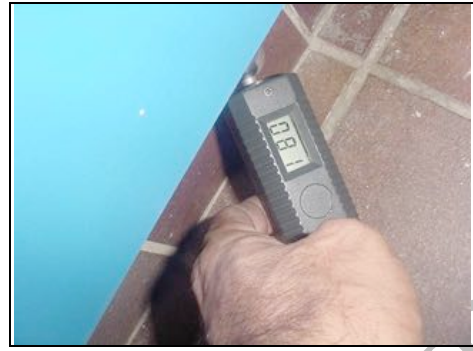
Dampness in toilet area

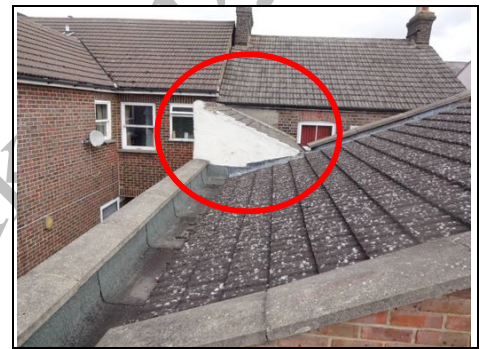
Rendered wall

We would recommend excluding all damp areas and the basement from the lease terms.

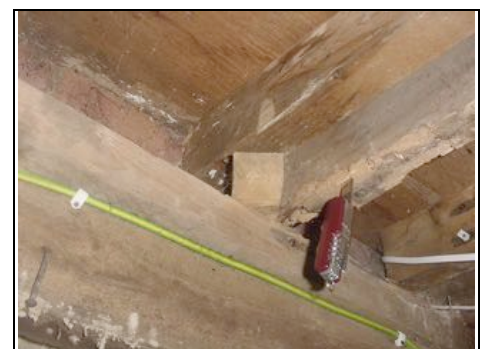
We would recommend you exclude the basement from the lease as it is not an area that is being used and it is damp. We could also see that there has been previous repairs within the basement for example to rotting joist ends which have been bedded into the wall.

Back to backing of timber
Knife test into rotten old timber of
floor joist

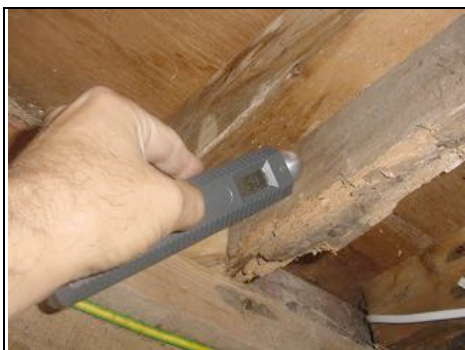
High damp metre readings on timber joists

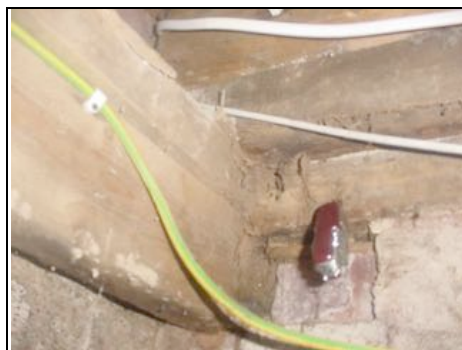
Knife into rotting timber

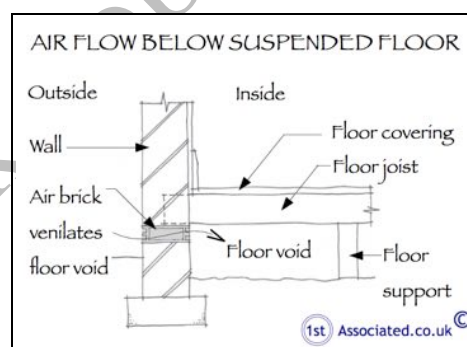
With this age of property it is likely there were/are suspended timber floors in the property. Our concern is that these are being encased by the new construction which may then mean they are susceptible to wet rot, dry rot and woodworm.

Suspended timber floor

ACTION REQUIRED: Any suspended timber floors should be vented/or alternatively excluded from the Lease.

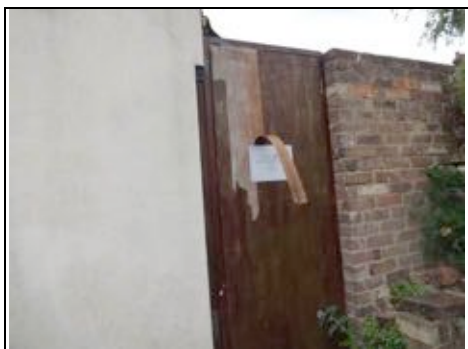
Rear fire exit door
Aerial view – 360 photo

ACTION REQUIRED: We recommend this fire exit is reviewed and the fire requirements of the property as a whole, particularly in an environment where there is a lot of people to show very clear appropriate signage and it is also to restrict the spread of the fire.

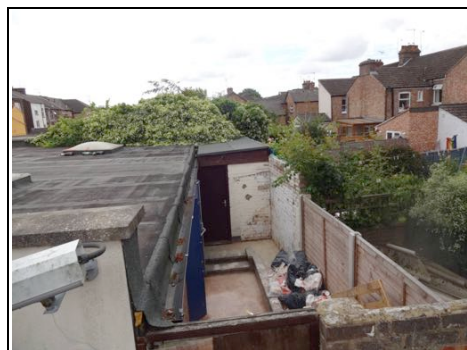
There is a small outside yard to the rear, which we assume is part of fire exit facilities, which did not look to be usable at the time of our inspection.

Rear courtyard
Aerial view – 360 photo
