## SCHEDULE OF CONDITION

**XXXX**  
**Dunstable,**  
**Bedfordshire**  
**LU6 XXX**

We have been instructed to inspect and prepare a Schedule of Condition for  
XXXX, Dunstable, Bedfordshire LU6 XXX

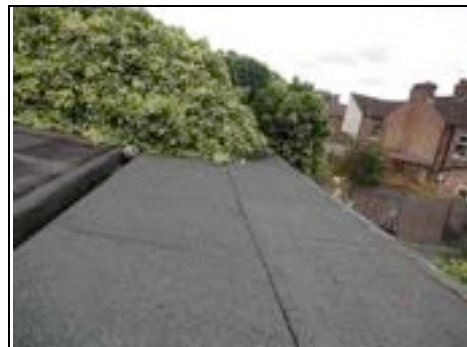
Main Flat Roof no:7

<p>Soft areas Repaired many times with bitumen mastic</p> <p>Vegetation growing to rear left corner.</p>

<p>Stored items on roof: timber panels, fencing panels and tools.</p>   <p>Mineral felt around all six roof windows with DIY quality repairs.</p>    	<p>We recommend this roof is excluded from Lease or joint high-level inspection with the landlord's surveyor to be carried out prior to signing of the lease or legal completion of the lease from high-level cherry picker or equivalent.</p> <p>We recommend these roof windows are excluded from Lease or joint high-level inspection with the landlord's surveyor to be carried out prior to signing of the lease or legal completion of the lease from high-level cherry picker or equivalent or replace.</p>

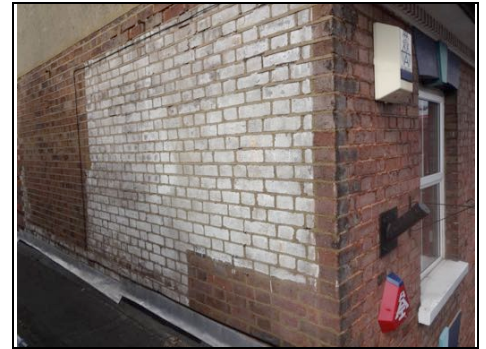
Left side close up view

Cracking to render at left side, daylight visible when in the roof

Deterioration to render Flemish bond brickwork below Old signage Bricked up window	Diagonal cracking to rear.

Single brick wall requires major repair

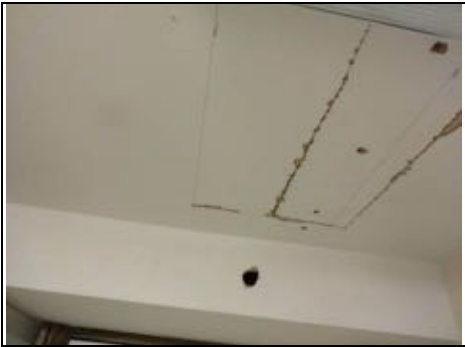
Damaged and dated ceiling

DESCRIPTION	CONDITION	ACTION REQUIRED
<b>Ceiling:</b> Painted modern plaster	Damaged and dated	Repair, prepare and redecorate
<b>Walls:</b> Painted modern plaster	Marked	Repair, prepare and redecorate.
<b>Floors:</b> Quarry tiles	Damp found	Resolve dampness Deep clean.
<b>Sanitary Ware:</b> One WC	Dirty	Deep clean
One wash hand basin into a vanity unit	Dirty	Deep clean
<b>Detailing:</b> <b>Doors:</b> Formica		Repair and clean or replace
<b>Services</b>		See Services Section.

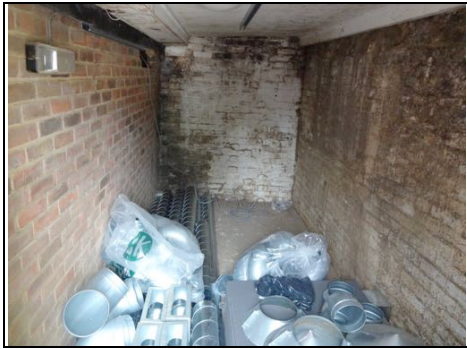
Debris

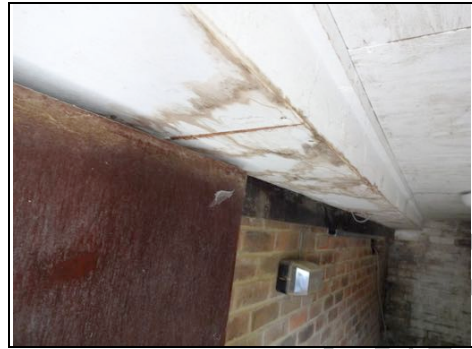
Staining to the ceiling

DESCRIPTION	CONDITION	ACTION REQUIRED
<b>Ceiling:</b>  Painted plywood	Staining visible from roof leaks.	Resolve roof leak, making watertight. Repair, prepare and redecorate.
<b>Walls:</b>  Painted	Staining visible	Resolve roof leak, making watertight. Repair, prepare and redecorate.
<b>Floors:</b>  Concrete	Stored items	
<b>External Detailing:</b>  <b>Doors:</b>  Entrance door to left	Dilapidated	Repair, prepare and redecorate or replace.
<b>Services:</b> Lighting Heating, ventilation and air conditioning pipework		See services section

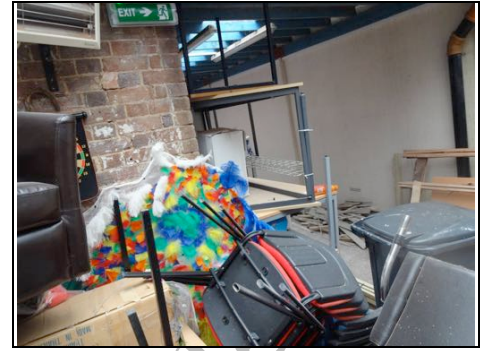
Debris and stored items

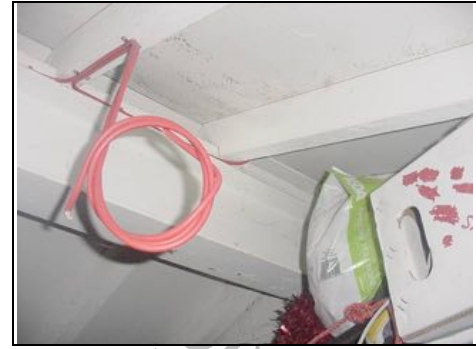
Close up of ceiling

DESCRIPTION	CONDITION	ACTION REQUIRED
<b>Ceilings:</b>  Painted Cathedral ceiling	Dark areas/staining	Resolve dampness. Make watertight. Repair, prepare and redecorate
<b>Walls:</b>  Unfinished wood decking Steels visible	Unfinished	Assumed will be finished Recommend re-visit
<b>Floors:</b>  Timber	Unfinished	Assumed will be finished Recommend re-visit
<b>Detailing:</b>  <b>Doors:</b>  Painted	Dated	Clean.
<b>Services:</b>		See Services Section

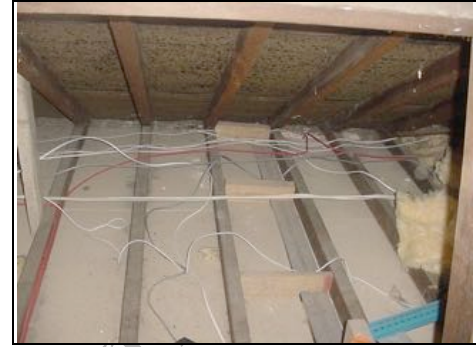
Constraint added likely to be roof spread

No insulation

DESCRIPTION	CONDITION	ACTION REQUIRED
<b>Roof Access:</b>  Loft hatch within open plan office	Some floor boarding  No insulation	We recommend adding lights and ladder
<b>Roof Structure:</b> Cut timber roof with extra timbers added to form collars and braces
