RESIDENTIAL BUILDING SURVEY

Ravensden,
Bedfordshire
MK44 XXX

INDEPENDENT CHARTERED SURVEYORS

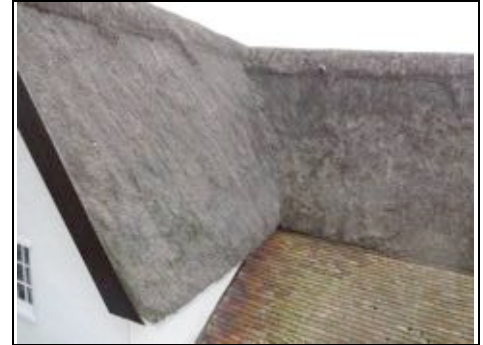
The thatch is nearing the end of its life. We believe that you will have to budget for a replacement thatch. With a listed property it is not just as simple as replacing the thatch, you need to obtain approval and consent. It will more than likely be considered a significant part of this building and as such it may well be closely scrutinised exactly what you are going to do. From what we can see within the roof we feel that unfortunately not only will the thatch need repair/replacement some of the timbers will need repair/replacing as well for example to the left hand side of the property from a limited view what we could see was not in particularly good condition.

Thatch in poor condition

ACTION REQUIRED: From what we have seen within the roof we feel that unfortunately not only will the thatch need replacing but some of the timbers will need replacing as well for example to the left hand side of the property. The owner advised that he had various quotes on the property to replace the thatch from memory ranging from £14,000 - £35,000. We have not seen these quotes and we have estimated our figure below, the quality of these quotes all the companies understanding if the building is listed or not. However, in addition you need to add work to the roof structure and also consultation work you need with the Conservation Officer.

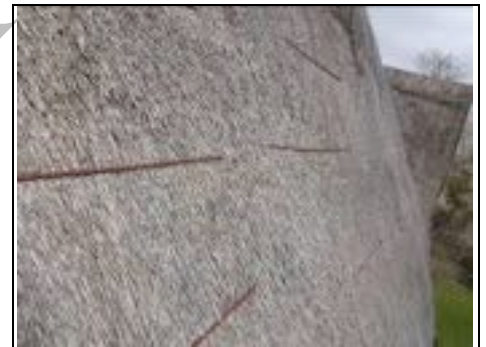
Stitch in time to thatch, rods added to hold thatch in place
~ Aerial View - 360 Photo ~

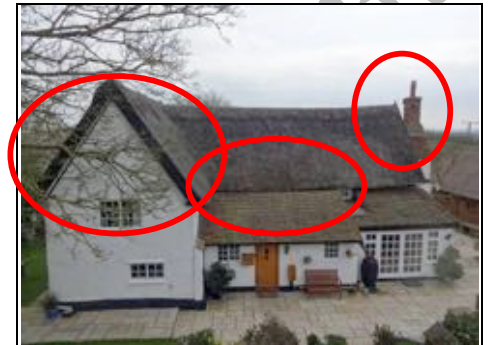
We have divided the roof structure into three areas, the left, middle and right side. We had reasonable access to the middle roof although much of it was covered with insulation, we had no access to the left roof and we could only view it from the middle roof as there was no direct access into it from what we could see. The right roof had a limited view due to both the insulation and lots of stored items although we did move some of them. From what we can see the roof structure has been replaced and repaired over the years.

Plan view of the three roof structures

ACTION REQUIRED: We would recommend that your solicitor specifically asks in writing is there any more information with regard to the metal plates/structural work which effectively are tying/holding the building together. Unfortunately, metal plates add a relative stiffness to what is traditionally a fairly soft building on a timber frame so they can in themselves cause problems if not designed appropriately.

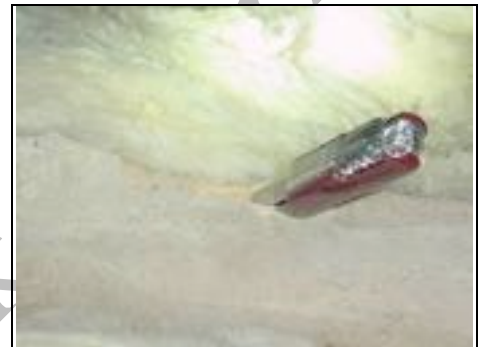
Over the years we have come across lots and lots of woodworm and we normally say any good old property tend to have some woodworm. Having said that most of the woodworm is no longer active and has died off many years ago and in addition to this although there may be holes rarely is it what we term as structurally significant? However, in this instance there does look to be active woodworm in the roof as well as old woodworm in the roof. Unfortunately, that where we tested it with a knife, our knife went directly into the timber and we would then consider that this maybe becoming structurally significant. By this we mean that the timber has been weakened by the woodworm.

Knife going completely into timber common rafter

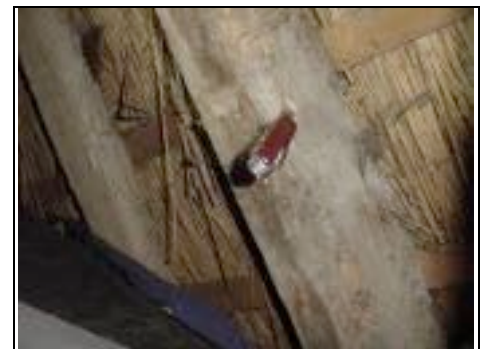
Unfortunately, the environment with insulation being added can improve the woodworm and encourage to breath from what we understand. There is a fair amount of insulation in the roof; all of this will have to be removed to properly view the roof to assess the damage to the timbers. We do feel that some of it is what we would term as a structurally significant in nature although there is of course woodworm in the roof that is not structurally significant. We found woodworm to the centre roof and we believe it also to the left roof.

Woodworm and soft rot

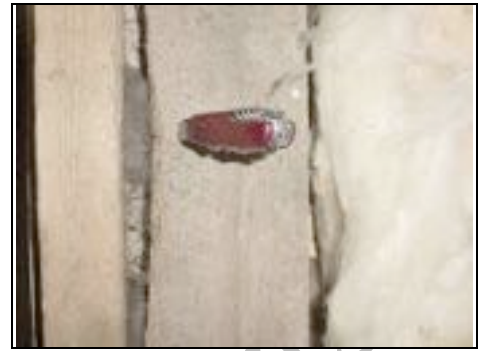
Woodworm

ACTION REQUIRED: If you have immediate plans to re-thatch the property then the whole of the roof structure could be looked at, at that point. If not, a much closer examination of the roof with the insulation removed needs to take place. However, from what we have viewed so far we would expect approximately ten to twenty percent of the roof to have been affected with woodworm to the point where we put a knife into it relatively easily/has potential to be structurally significant.

ANTICIPATED COST: We would recommend setting aside £2,500 - £7,500. The reason why the figure is relatively large is we do think there is a likelihood that there are problems with the roof structure. There is an element of estimation on what we are commenting on as we have not had access to the left side of the roof, we would be able to comment further if direct access to the left side of the roof was formed and if insulation was removed. We do feel we have to warn and advise about the worst case scenario; please obtain quotations.

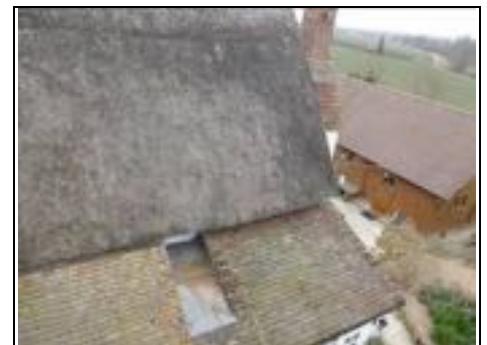
The property has a relatively shallow roof and as such water can sit on it and we noted that the tiles are starting to spall. We would recommend that work is carried out in this area.

We have also found that wind driven rain can get in this style of roof if it is not repaired.

Displaced tiles and in need of repair

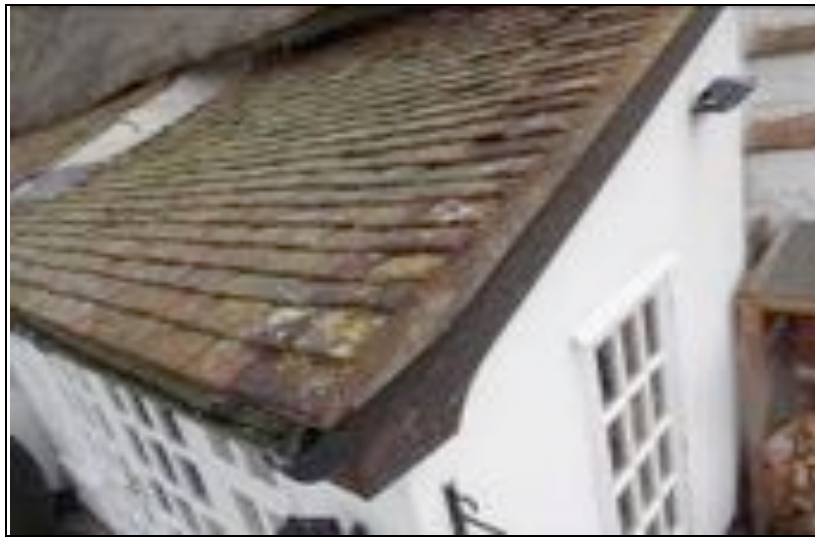
Spalling to tiles
~ Aerial View - 360 Photo ~

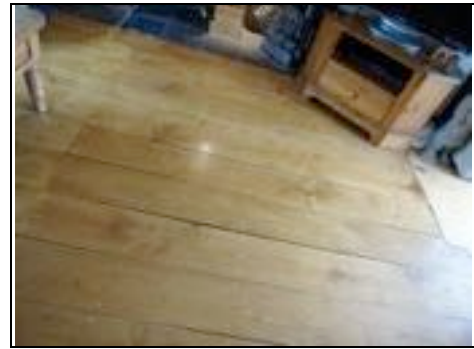
Replacement of original floorboards

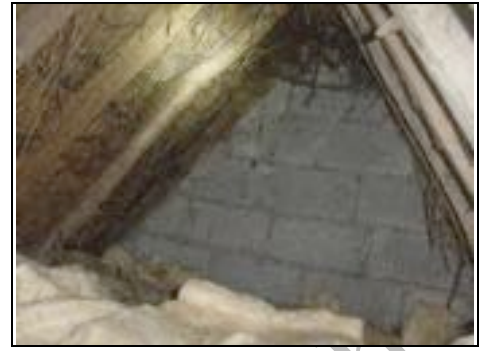
Having said all of that, the areas where we could see the inside of the structure we could see blockwork. Blockwork would have been typically used in the 1960's/1970's so we suspect there has been a lot of replacement work here.

Blockwork

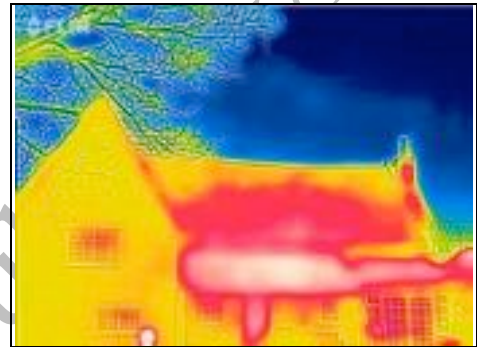
In addition to this we have also thermal imaged the property to see if this gives us any further clues and our evidence shows relatively low heat loss from the wall structure indicating that there is considerable replacement of the walls. Without opening up the walls we cannot confirm this but we do believe the thermal imaging information and the visual information in the roof give a good indication that over fifty percent of the walls have been replaced.

Thermal image showing heat coming out of thatch and tiles but not through what we believed was timber frame building

ACTION REQUIRED: We recommend opening up:

1. The left roof area and allow proper access to re-gain. The owner has specifically asked in writing by your legal adviser when they are aware of any rebuilding of the walls.
2. We recommend areas of render is removed so you can see the existing structure. We would add that unfortunately it is difficult to be conclusive if the usual indicators are not consistent.

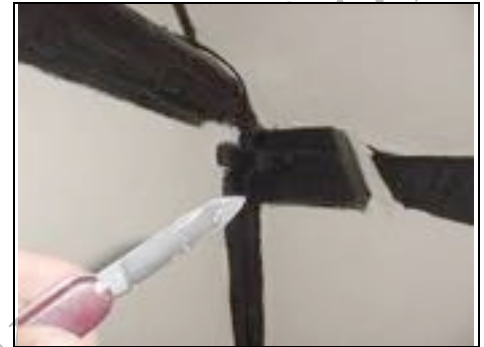
Brace added in middle wall on left side

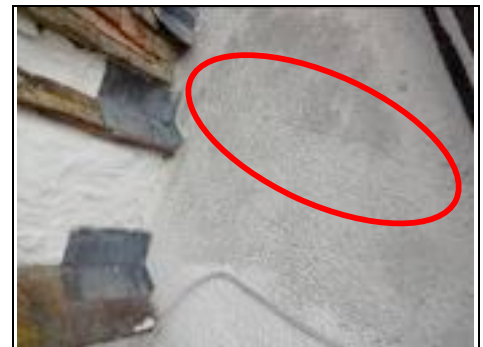
There is hairline cracking visible to some of the internal walls where the wall and ceiling joists meet and there is also hairline cracking to the gable end of the property. You do have to remember that the whole of this property has been repainted in the last few years hiding any usual indications. Again, these cracks are indicating sideways movement left to right.

Hairline cracking to right gable
~ Aerial View - 360 Photo ~

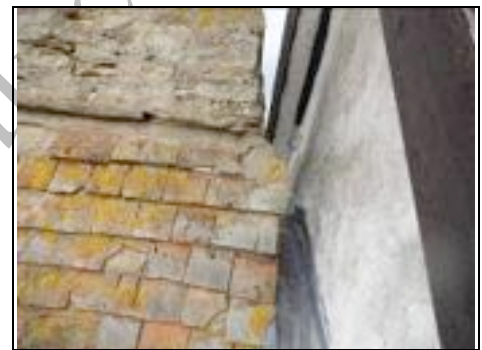
In various areas we found dampness coming in through the stonework for example and we can also see sulphate where there is orange/brownish staining where the soot is being drawn through.

We feel that you will probably have to accept this as a characteristic of this building, given the materials used, the fact that it is on a sloping site and that the house is in the way of that slope, that there will be some dampness.

Damp on gable wall
~ Aerial View - 360 Photo ~

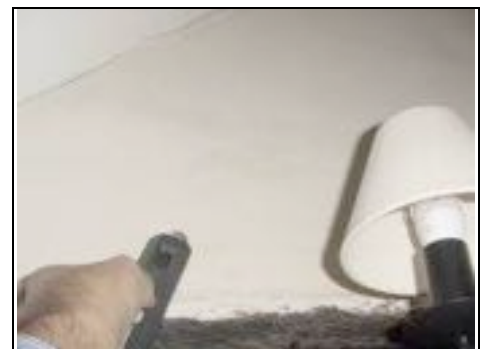
Dampness coming through plaster in right bedroom

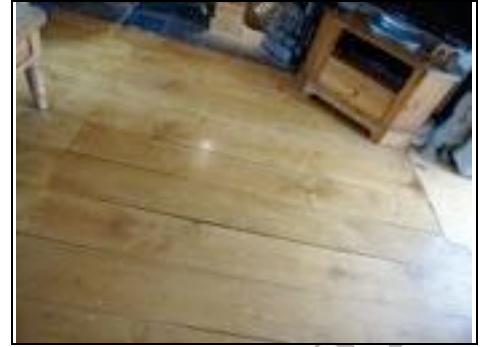
We are advised there is a timber floor in the lounge area, which is typically a suspended timber floor. We cannot see anywhere where this has been vented which in a building such as this can lead to wet rot, dry rot deterioration.

We were advised original floorboards were sanded and reshaped

ACTION REQUIRED: Add vents. We would also recommend opening up a section of the floor. The owner advised that the timbers used in this area were the original timbers but in our experience they would not have been that size or that cleanly cut. He did then comment that he had had them sanded, planed and then put back.

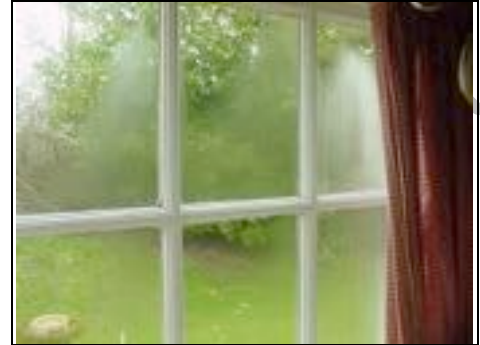
As is often the case with this type of building using an old building in a modern way can create condensation particularly if you do not have suitable extraction. Condensation or any dampness in a timber frame property is not good.

Condensation to windows in kitchen

ACTION REQUIRED: We would recommend large humidity controlled extract fans are added to the kitchen, the bathroom and any areas that are used for drying clothes internally during winter months (we would assume that clothes will be dried externally during the warmer months). By large extract fans we mean 150mm.

ANTICIPATED COST: We would anticipate costs between £250 - £500 per extract fan depending upon the wiring required. We always recommend quotes are obtained before work is agreed/commenced.

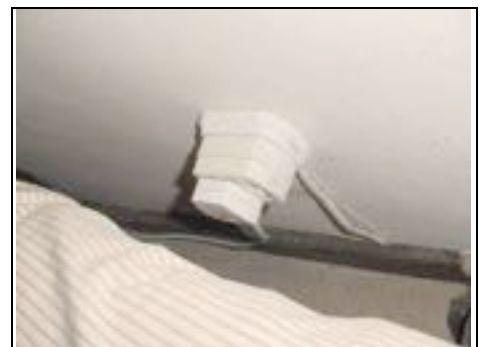
Electrics dated

ACTION REQUIRED: We recommend an Institution of Engineering and Technology (IET) test and report to be carried out by an NICEIC registered and approved electrical contractor or equivalent.

ANTICIPATED COST: £250 - £500 plus any work recommended; please obtain quotations.

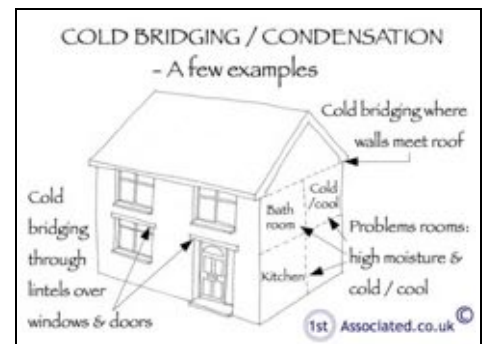
Due to the mixture of materials used we believe there may well be a possibility of cold bridging in the property. Unfortunately, without opening it up it is difficult to confirm. Cold bridging leads to black mould internally unless you control and manage the humidity. In some buildings you do just have to consider this a characteristic of the property.

Cold bridging is caused by a colder element in the structure allowing coldness to pass through the structure much quicker when warm moist air is present in the property, often caused by things like having a shower or a bath, cooking or washing, particularly if you are drying washing on the radiators. This is also caused by the general climate, which results in condensation on the element.

Cold bridging/thermal bridging

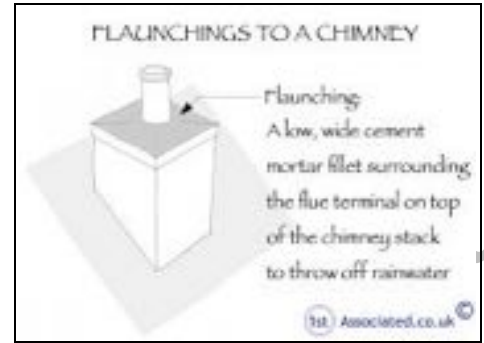
Flaunching

ACTION REQUIRED: The whole of the chimney would benefit from appropriate repair work as we can see there has been inappropriate repair work using cement mortar. We can also see that the lead work detailing could be improved to reduce the amount of water getting into the right gable end. From our experience we don't think this will ever be completely dry but it could be we feel improved. We can also see that the render that adjoins the chimney would benefit from being pre-paired, repaired and redecorated.

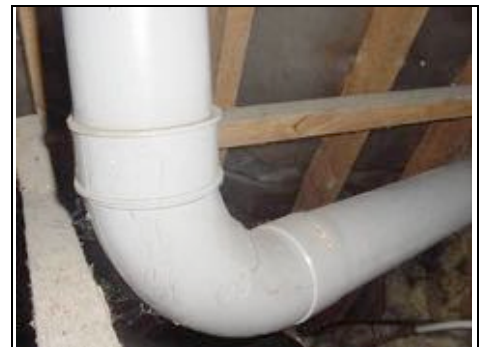
Plastic pipe within roof

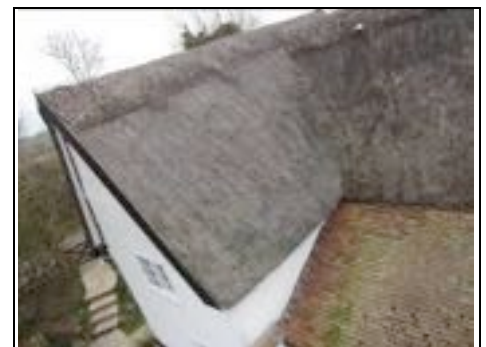
The roof is pitched and thatched with what we believe to be long straw, although it does need samples taking and analysis. From ground level, this looks in below average condition considering the roofs age type and style. We can also see that the roof structure needs work. The owner did advise during our question and answer session that they had carried out some work about five or ten years ago (he could not recall) and he does have quotations for the thatch but do remember with a listed building it is not just about what you want to do; it is also about what the listed building/conservation officer is happy with.

Thatch ridge disintegrating and dampness within thatch
~ Aerial View - 360 Photo ~

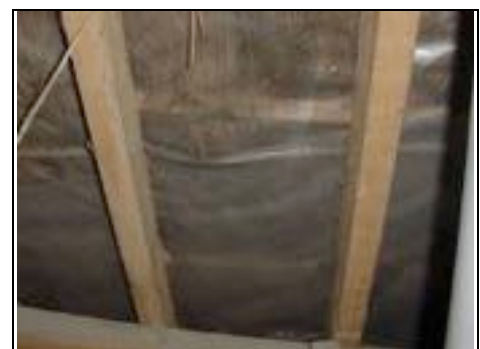
We did not expect to see a protective underlayer under the thatch however we can see some areas where a plastic sheet has been used which we thought was unusual and indicates that part of the thatch has been repaired more recently. We spoke to the owners about this in our question and answers session and they could not recall any specific repairs to the thatch in their time at the property.

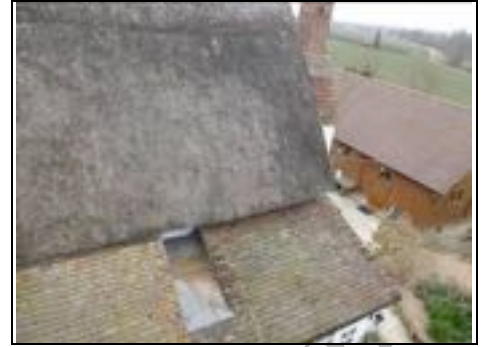
We noted the tiled roofs to the front of the property are relatively shallow and are starting to spall. We would recommend that work is carried out to this area. There is a lead valley to the roof which also needs to be checked when the roof is re-tiled.

Displaced tiles and in need of repair
~ Aerial View - 360 Photo ~

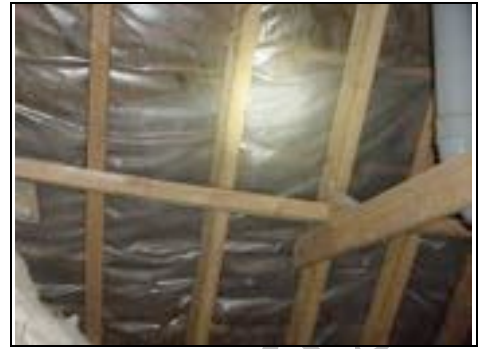
Thin purlins

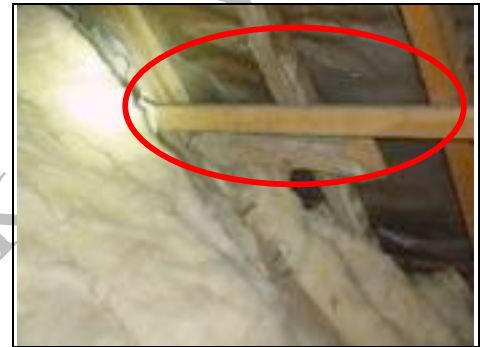
Purlin missing replaced with very thin purlin
Plastic sheeting

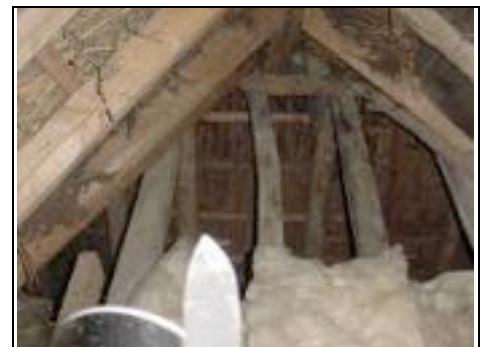
Deterioration/twisting to timbers in left roof

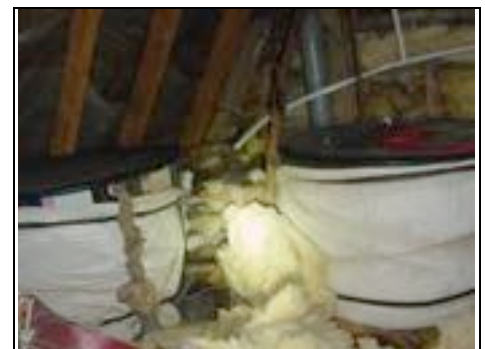
Water tanks in middle roof

We would always recommend that water tanks be drained down and cleared of any debris etc. (we have seen dead birds and other unmentionable things in these tanks). As you are often cleaning your teeth with this water it is best that it is as clean as possible!

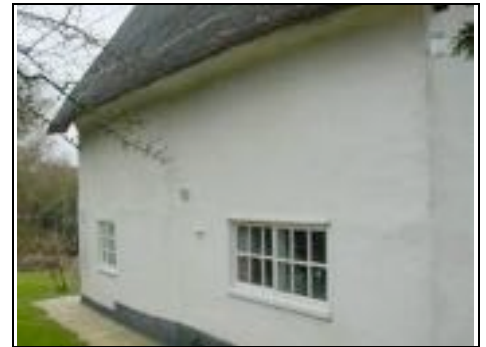
We are always wary when we see rendered properties as the render can hide a lot particularly in this case where we believe alterations have taken place.

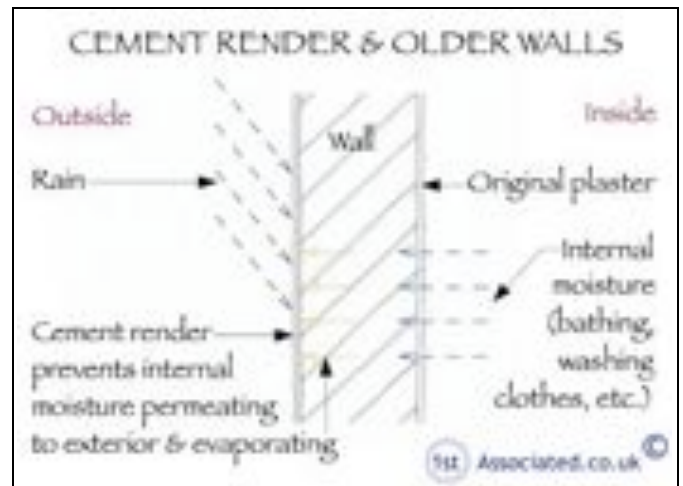
The question that we always ask of these is how much damage the cement render is doing to the timber frame. We do believe in this instance that there is movement in the property and a considerable lean on it so it is well worth carrying out investigations.

Cement render

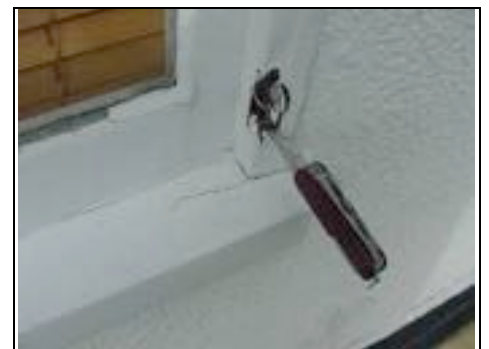
Knife test in rotten window

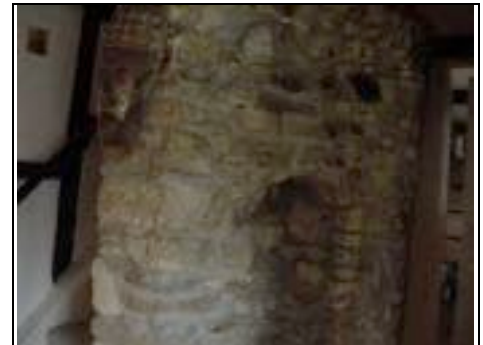
There also looks to be a central chimney built in stonework and one found within the roof. With further investigate it may well be what is known as a smoke hood which is one of the earlier chimneys which would be another historic element in the building.

Old chimney?

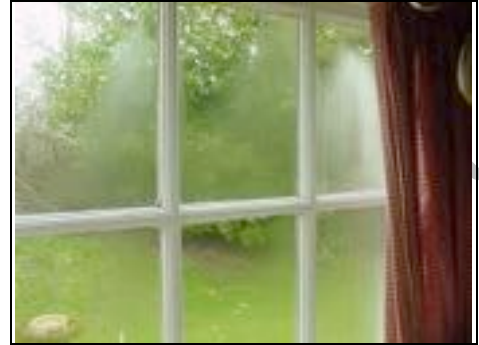
At the time of the inspection there were obvious signs of condensation to the windows in the kitchen and we generally find you do get condensation throughout a property like this even with the characteristic of the property. You do need to consider this will be something you have to live with if you do take this property on.

Condensation to windows in kitchen

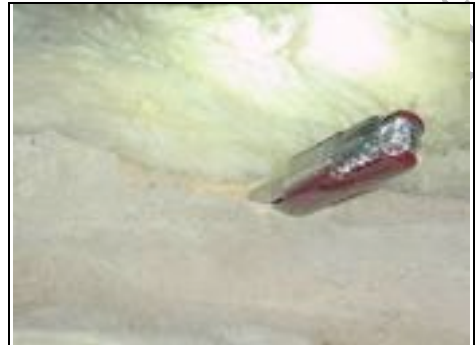
The roof is the main area that we look for woodworm as well as the actual traditional timber structural frame. Within the roof we found visual signs of significant woodworm activity or indeed signs of significant past woodworm activity that has caused what we would term 'structurally significant' damage. In many properties there is an element of woodworm that is not active. Our inspection is usually restricted by insulation covering some of the timbers and general stored items in the roof, as it is restricted throughout the property by general fixtures and fittings.

Woodworm/rot in timber in middle roof where it meets left roof

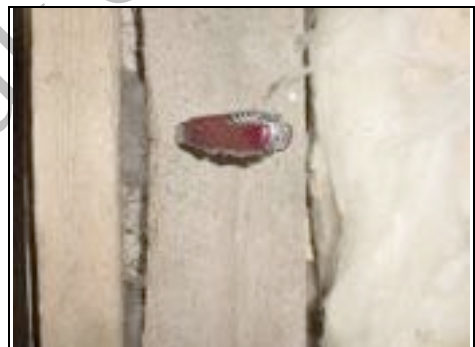
Woodworm

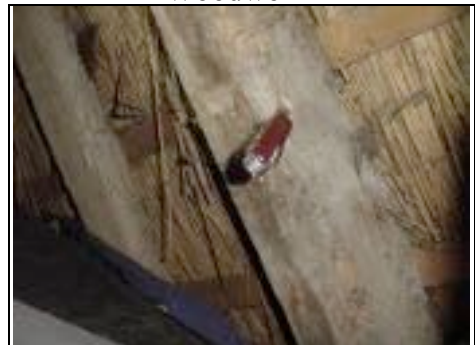
Woodworm and soft rot

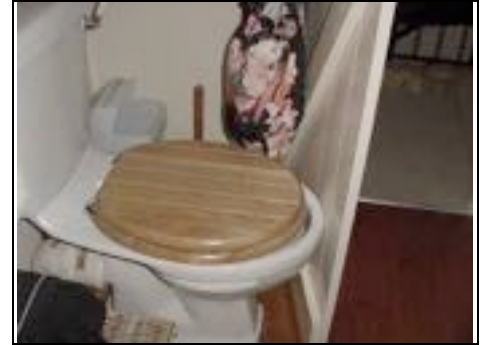
WC very close to door in bathroom

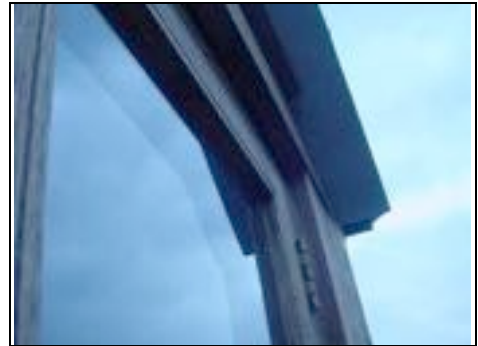
Windows need re-staining
