RESIDENTIAL BUILDING SURVEY

**Newbury
Berkshire
RG14**

Mr H

INDEPENDENT CHARTERED SURVEYORS

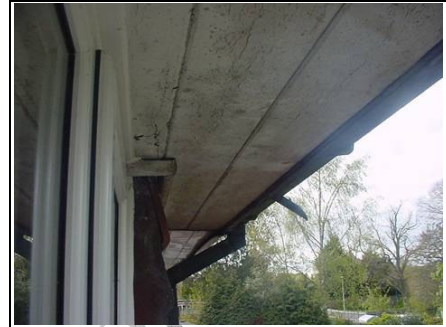
The timber fascias and soffits are in a poor decorative condition and would benefit from redecoration. We normally take guidance from the adjoining roofs however we noted the vents on the next door roofs indicate that they have been re-roofed, however it is very difficult to see any major difference in the roofs.

Close up of soffits

ACTION REQUIRED: This would also be the ideal opportunity to replace them with a vented fascia and soffit like your next door neighbour has which will then allow the roof to be better vented. Alternatively, you can re-paint the fascias and soffits. We recommend that action is taken in the summer of 2012. This will also give the opportunity of clearing the gutters and checking the joints, etc.

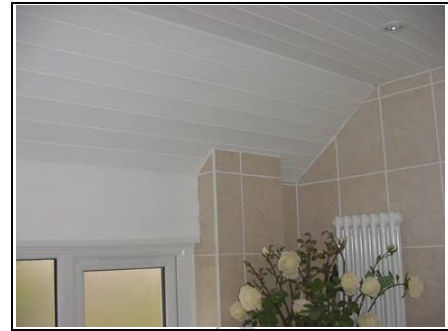
Properties such as these suffer from cold bridging, which results in condensation and is a characteristic of this era of property. Whilst we note the relatively new windows have trickle vents, which means there will be air movement in the property, we would still recommend adding better extract fans to the bathroom and kitchen which have humidity controlled thermostats that switch themselves on and off as humidity level is reached. This will help reduce cold bridging.

Cold bridging point where ceiling follows line of roof

ACTION REQUIRED: Add new humidity control extract fans in the summer of 2012. Whether you see condensation or not very much depends on how you utilise the property.

ANTICIPATED COST: A few hundred pounds; please obtain quotations.

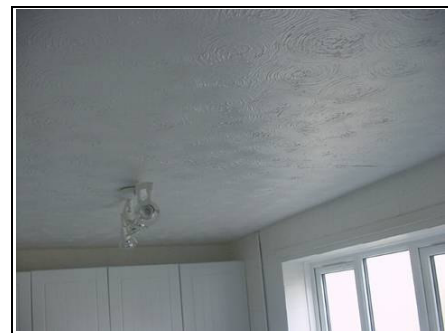
We noted the ceilings have textured paint, commonly known by the trade name of Artex. Whilst this is not a problem it is fairly dated and was normally used when the ceilings were in poor condition. You may or may not like this finish.

Artex ceiling

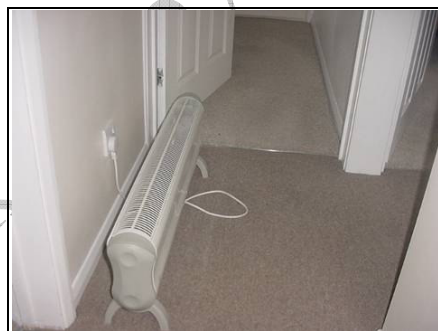
This property has a solid fuel controlled heating system from what we understand. We also noted additional background heat in the form of electric radiators.

Additional heater

ACTION REQUIRED: We recommend you have a discussion with the existing owners to check you are happy with this form of heating as, from our experience, many people find it inconvenient; it is very much a personal choice.

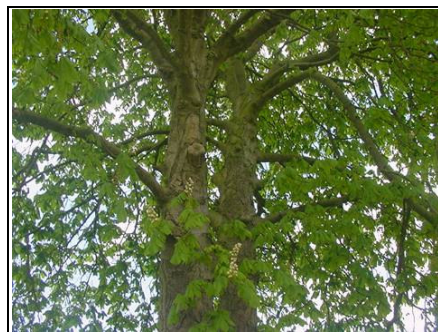
Mature tree in rear garden 14

ACTION REQUIRED: We recommend an arboriculturist (not a

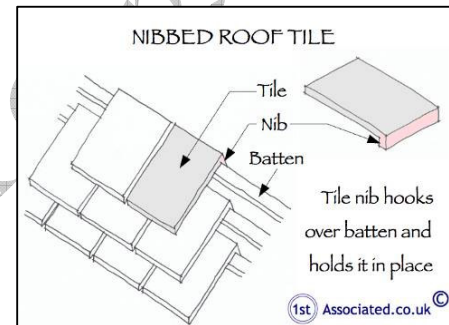
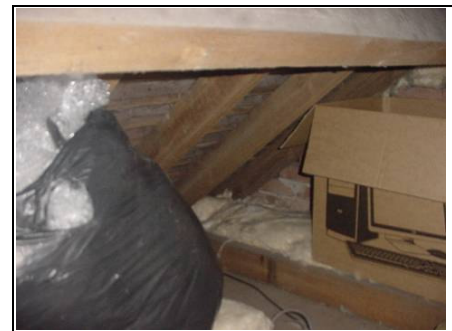
You can see the back of the nibbed tiles in the adjacent photo. The white pattern staining is where wind driven rain has got in.

Back of the nibbed tiles

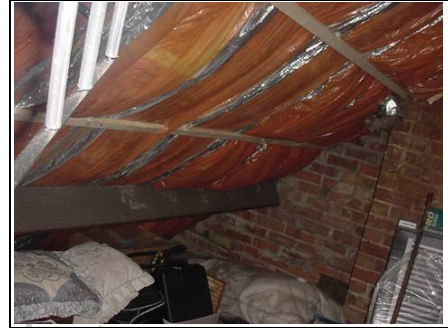
Insulation battened in place

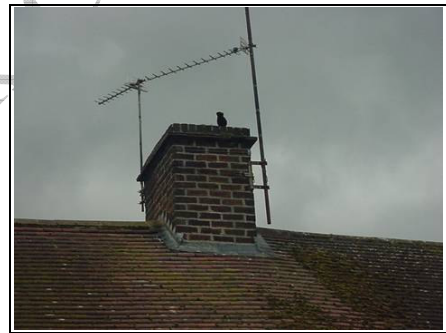
This chimney is brick finished with a lead flashing and no chimney pots that we could see. From what we could see from ground level it looked in average condition considering its age, type and style, though we would say there are aials on the chimney which can cause damage particularly where they use a wire to fix them on in brackets, which could act like a cheese wire cutting into the brickwork.

Chimney

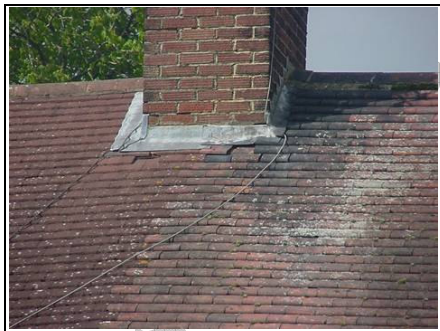
The main roof is pitched and clad with a clay nibbed tile (possibly concrete), viewed from ground level, this looks in average condition considering the roof's age type and style. However, when we went in to the roof we noticed that it did not have a protective underlayer. We noticed a slight undulation in the roof. We noted a few missing and displaced tiles, as we would expect with this age of property.

Undulation in the roof

ACTION REQUIRED: We would recommend a roofer spends a day on your roof repositioning the tiles and making sure it is watertight for the winter (we would also get them to quote at the same time). You need to then carry out periodic inspections with this type of roof, and mend the roof as soon as any problems are noted. Please see our comments in the Executive Summary.

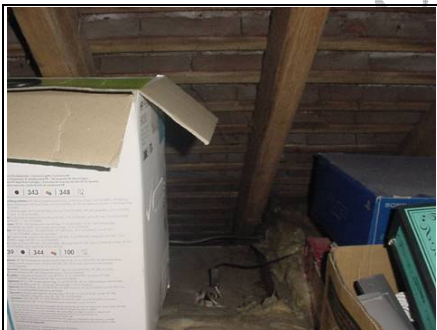
We noted there is no protective underlayer. This means that wind driven rain can get underneath the tiles and indeed we can see that this is happening from the staining within the roof. We are always in a Catch 22 with regard to this type of roof as although it is letting in some rain water it is not letting in that much due to the protective foil and insulation membranes that have been put in place.

We could see the backs of tiles in some areas

ACTION REQUIRED: we would recommend in this case that you consider what we call a stitch in time measure. This is to use a solid insulation board (which you can stand on) with a board over the top and fix this within the roof, thereby forming a storage surface and also an extra layer of protection within the building.

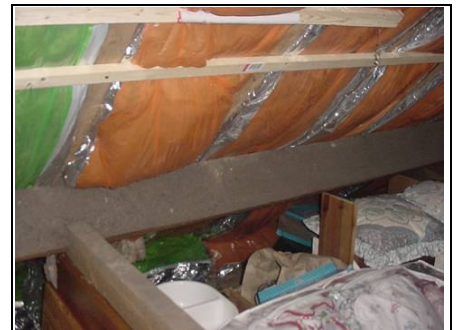
Bagged insulation that has been put on and securely battened at a later date

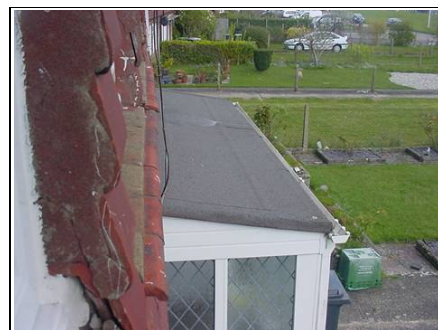
This is a shallow pitched porch roof covered with a mineral felt and looks in average condition as viewed from the front window.

Front porch roof

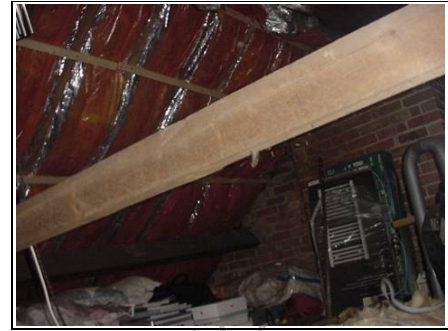
Our examination was limited by the general configuration of the roof, the mass of insulation and stored items. What we could see was generally found to be in average condition for its age, type and style. Our only comment would be that we believe a timber has been added to add extra bracing. It is, however, feasible that there are problems in the roof that are hidden.

View of roof and extra timber

ACTION REQUIRED: The only way to be 100 per cent certain is to have the roof cleared and checked.

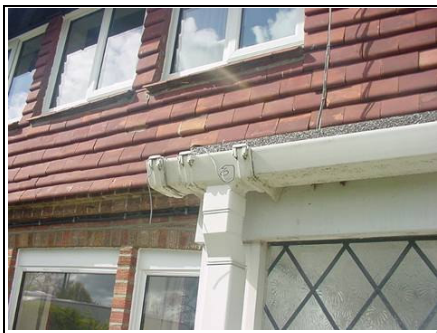
The property has plastic gutters and downpipes, which are profile in some cases, and in are in average condition for their age, type and style. There may be some minor leaks, such as the hopper head to the rear looked to be overflowing, but most people would be happy to live with these providing repairs are carried out within the next six to twelve months.

Gutter and downpipe

ACTION REQUIRED: We would always recommend you stand outside the property next time it rains heavily and see how well the drains cope with the rainwater particularly looking at the guttering and the joints. We would also recommend that the gutters and downpipes are cleaned out, the joints are checked and the alignment checked to ensure that the gutters fall towards the downpipes.

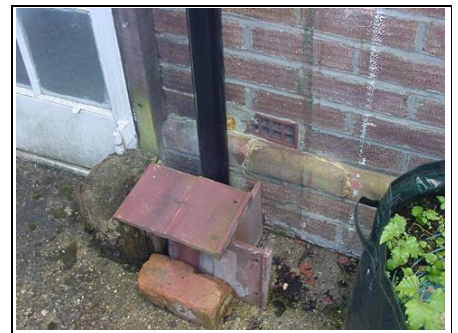
A better surround needed
around gully

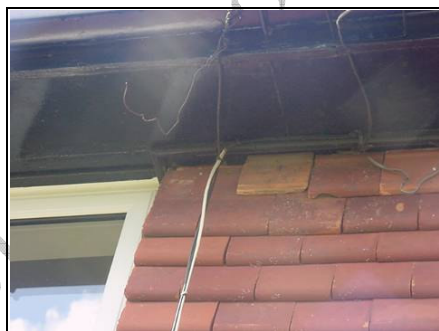
There is vertical tiling to the top half of the property in we believe a nibbed clay tile. There are a few tiles missing and displaced, as is often the case. The vertical tiles are feature of the look of this property.

Missing tile at top will allow birds in

ACTION REQUIRED: Ask the roofer when they are looking at the main roof to also put any displaced vertical tiles back in place. We recommend you get a store of these sort of tiles for when the wind blows strongly.

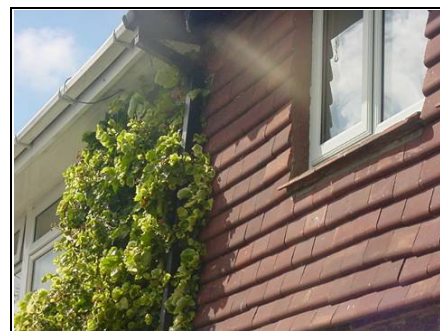
Next door's ivy

We would also recommend next door's ivy is cut back.

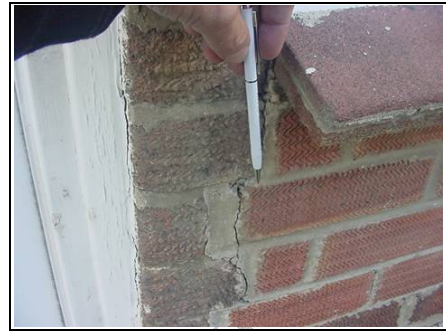
We would remind you that any hairline cracks that appear need to be sealed as soon as possible to stop dampness and water getting in and causing blisters and hollow areas.

Pen indicating minor hairline cracking where some work has been carried out around the rear kitchen window

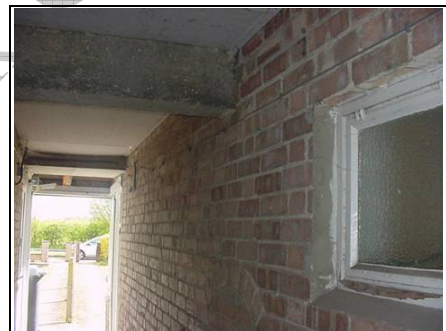
These may cause cold bridging.

Concrete lintel

ACTION REQUIRED: Please see our comments in the Executive Summary and article in the Appendices.

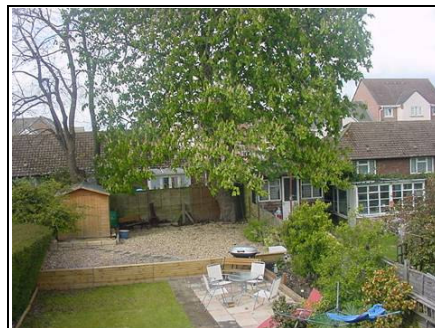
There is a large tree in your garden. Please check with the insurers as to whether they consider it within influencing distance of the property. Please see our further comments on this

Mature tree in rear garden

ACTION REQUIRED: You need to have a discussion with the insurance company before committing to purchase this property and also we recommend you obtain advice from an arboriculturalist (not a tree surgeon) in the summer of 2012. Please see our comments in the Executive Summary.

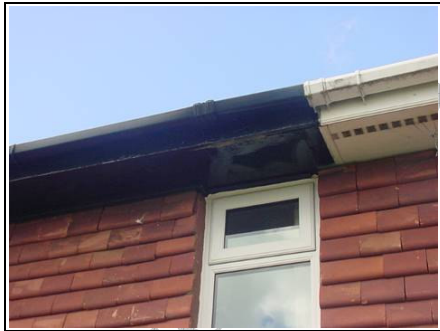
The fascias and soffits are painted timber and we would comment they are in below average condition for their age, type and style. More interestingly, we would comment that your adjoining neighbours have vented fascias and soffits indicating that they have been re-roofed and have a protective underlayer.

We can see some detonation to the fascias and soffits

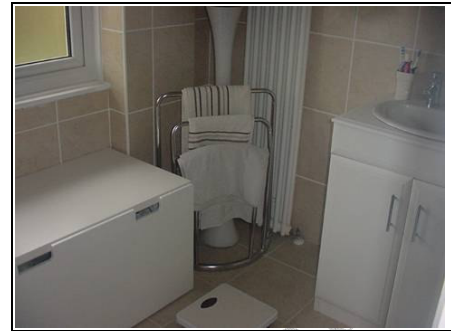
The bathroom has a tiled floor. With a wooden floor you will always get some deflection, however minor. This deflection in the floor will ultimately mean that the tiles will need re-grouting.

Tiling on bathroom floor

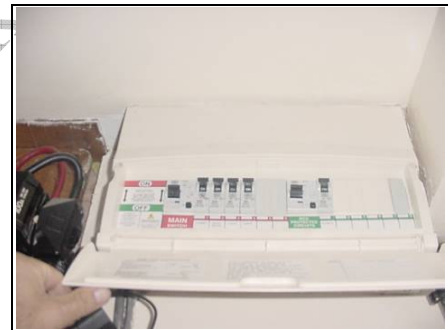
The electric fuses and consumer units were located in the entrance hallway and are from the 1970's / 1980's. The fuse board looked dated and far better are now available.

Fuse board

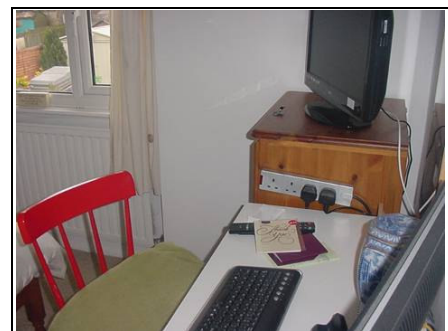
There appears to be a general lack of socket points.

Here you can see an extension lead has been used

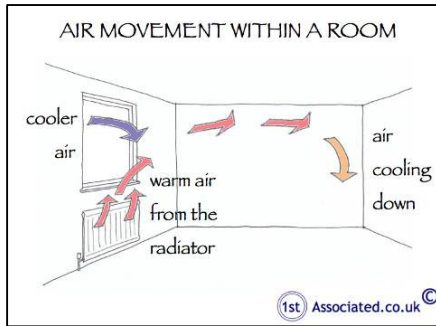
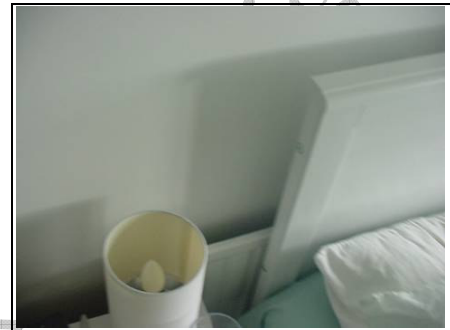
We noted an internal radiator. We would move this underneath the windows as this gives a better circulation of air and reduce the chance of condensation.

Internal radiator

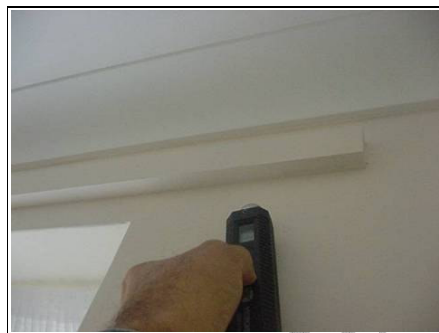
Dampness and condensation around
the concrete window lintel
