RESIDENTIAL BUILDING SURVEY

XXX
XXX
Clophill,
Bedfordshire
MK45 XXX

FOR
Mr X

INDEPENDENT CHARTERED SURVEYORS

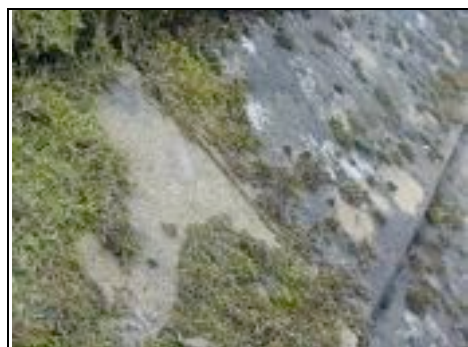
Concrete tiles have come away

ACTION REQUIRED: The protective underlayer, the battens and the concrete tiles need replacing as soon as possible to make the property watertight and also the concrete tiles surface is starting to deteriorate where moss has been sitting on them for some time.

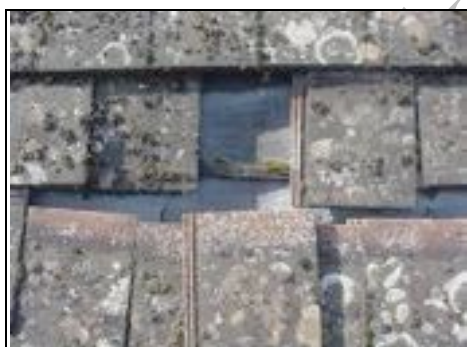
Moss to roof and marks where surface has deteriorated of tile

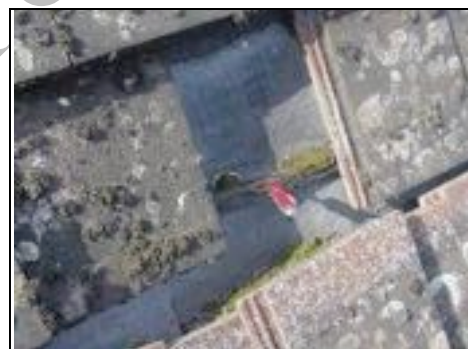
Roof tile missing

Batten rotten

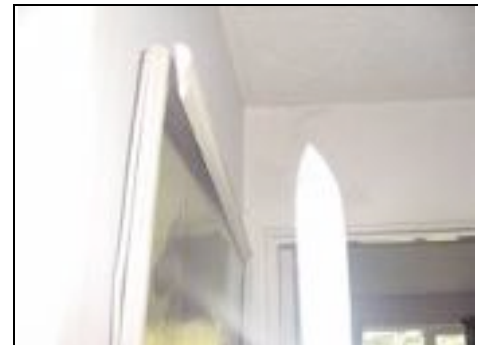
Flat roofs
Timber cladding rotting and coming away on dormer

Leak from flat roof above bathroom

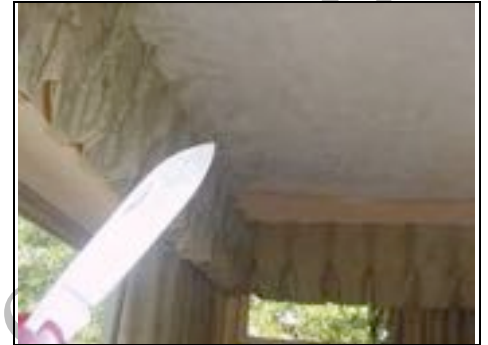
Flat roof to lounge extension

Dampness visible to lounge extension flat roof

ACTION REQUIRED: Ultimately we recommend re-roofing with an insulated roof that is cut to falls towards the gutters. The mineral felt that is present looks relatively new, we think the leaks that can be seen inside may be either old leaks or what is known as cold bridging which we explain more about later on.

ANTICIPATED COST: For new roofs with insulation known as warm roofs (please see sketch) £1,000 - £2,000 per roof plus scaffolding if required; quotations required.

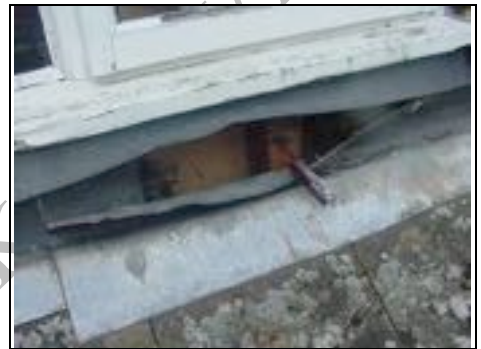
Area we opened up
Lead come away

Timber frame

ACTION REQUIRED: Consider adding insulation to the property but be aware that it can cause interstitial condensation. This is very important in a property where there is a large element of timber construction.

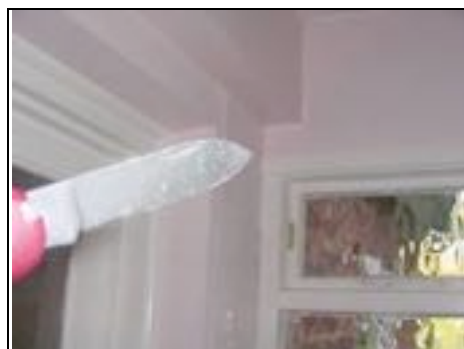
There is differential movement between the original structure and the areas that look to have been added on to the front porch and to the rear. These are single storey areas with flat roofs.

Crack to front entrance area

Differential movement

ACTION REQUIRED: Ideally we would recommend the existing owners take out an insurance claim, advising that the cracking has been noted by a structural surveyor (this should cost them nothing other than time to write the letter). This usually means that the insurance company will carry out a monitoring exercise (the Building Research Establishment recommend monitoring any cracks for a minimum of one year) to establish if there is any progressive movement. Your future liability will be limited to the cost of the excess on the insurance providing the insurance company is happy for you to take over the insurance claim.

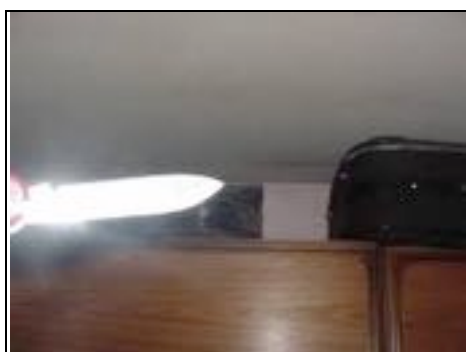
Hidden crack in left bedroom

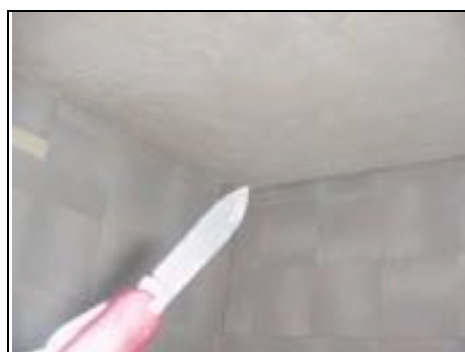
Hairline cracks in bathroom

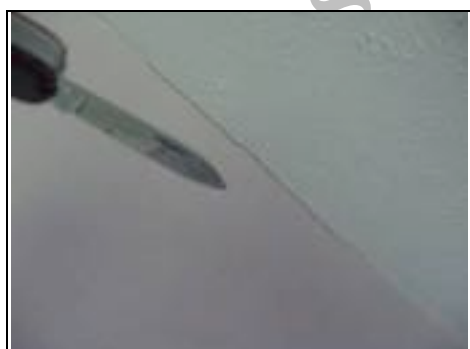
Hairline cracking right bedroom

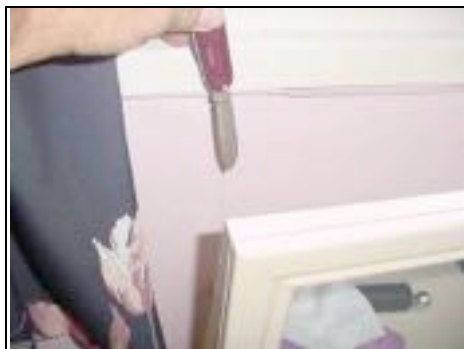
Hairline cracking right bedroom

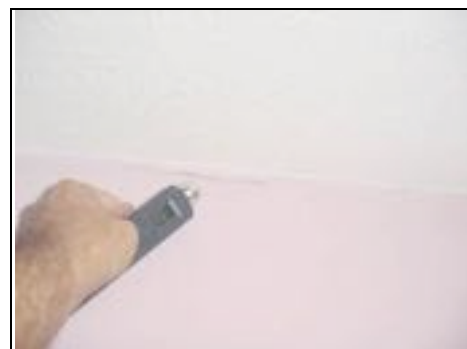
Cracking to high level in right bedroom

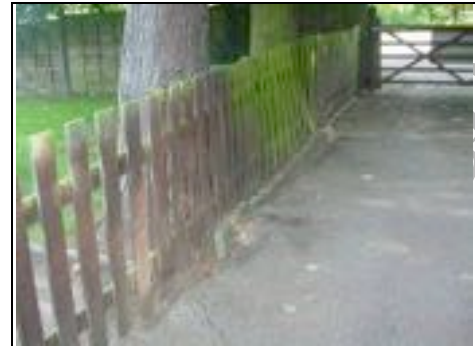
Trees causing damage to tarmac

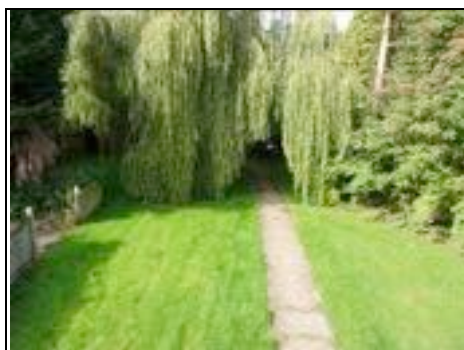
Willow tree to rear

Weeping willows in particular are renowned for having a very long root ball and we could also see that to some nearby trees roots had come to the surface. We have been advised in the past this is where they are hunting out water.

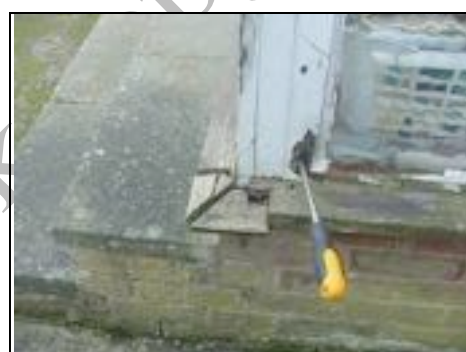
The external timber generally needs repair such as the shiplap boarding to the dormers and the timber to the windows and doors, some of which has wet rot.

External joinery deteriorating

ACTION REQUIRED: A lot of the timber is probably saveable although whether it is worth saving we would question and it may be more economical to replace in some areas.

ANTICIPATED COST: Re-securing the shiplap boarding, replacement, repair and redecoration and replacement of windows and doors, etc we would expect to cost in the region of £2,000 - £5,000; please obtain quotations.

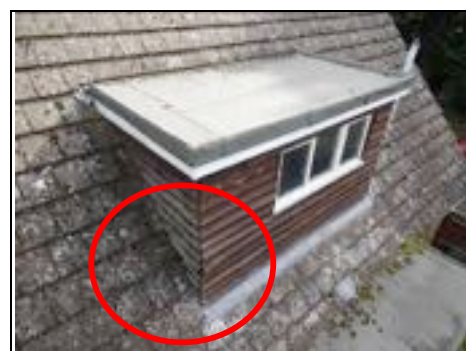
Deteriorating shiplap boarding to dormer

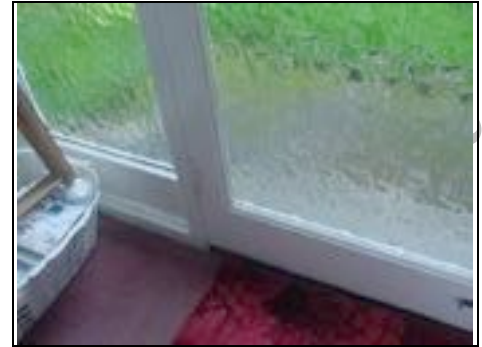
There is older style glass in many of the windows and doors. We cannot see a British standard safety kite mark and we believe that this glass is not safety glass therefore it can shatter. The plastic sheets have cracked and ideally should be replaced with a safety glass.

Not safety glass

ACTION REQUIRED: Replace glass with safety glass.

ANTICIPATED COST: Set aside the sum of £75 to £200 per door depending upon the quality of door you want; please obtain quotations.

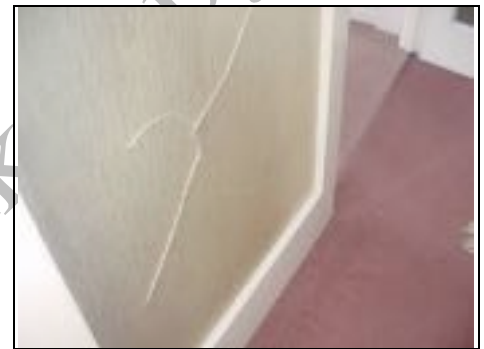
Broken plastic in door

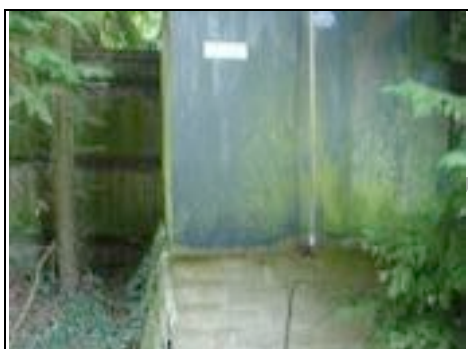
There is a metal oil tank without a bund wall which can cause problems if there is an oil leak. We can see rusting starting to occur to the metal container. You need to periodically check this particularly to the base.

Oil tank rusting

ACTION REQUIRED: We recommend you budget for a replacement oil tank; the sooner the better.

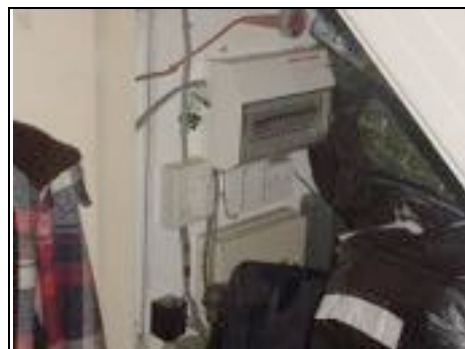
Fuse board under stairs

We saw some areas where the electrics were dated. We are advised by the owner the electric system was tested on 19th August 2014 by Jordan Services (01438 355583). We suggest that you ring them as they would be the ideal people to give a quote on re-wiring.

ACTION REQUIRED: We recommend an Institution of Engineering and Technology (IET) test and report to be carried out by an NICEIC registered and approved electrical contractor or equivalent.

We would also recommend the number of socket points are improved as we seem to be using more and more electricity.

ANTICIPATED COST: £250 - £500 plus any work recommended; please obtain quotations.

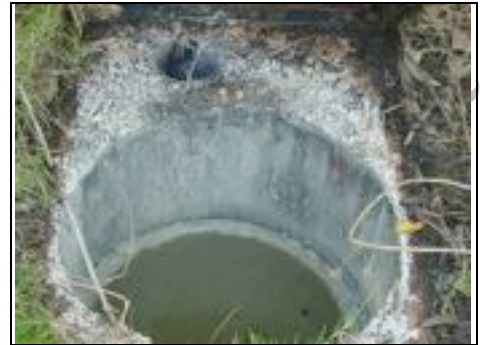
Septic tank full

We would recommend that you ring them.

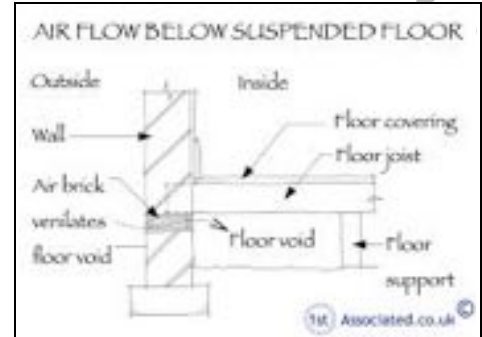
Suspended timber floor

There is more deflection to the ground floor than we would expect. In this particular case it could be due to dampness getting into the suspended timber floor, either the supporting timbers or the ends of the joists, or it could given the conditions also be woodworm or even there is an outside chance of wet rot. It is very difficult to tell from the surface that we could see (from the kitchen).

ACTION REQUIRED: We recommend that you have a section opened up by a carpenter and photographed and then we would be more than happy to comment.

We would not recommend buying the property unless this happens. We say this knowing that you are looking to agree a carpenter to visit the property and the owners agreed this. We would be happy to duly comment on it.

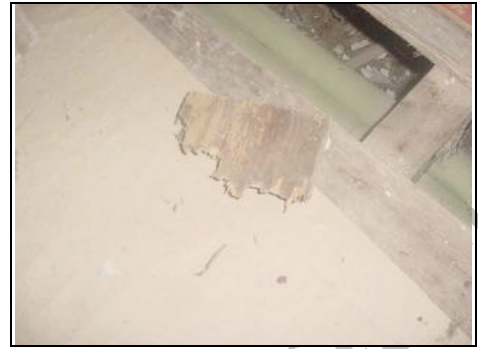
Loose piece of timber with
woodworm found under floor

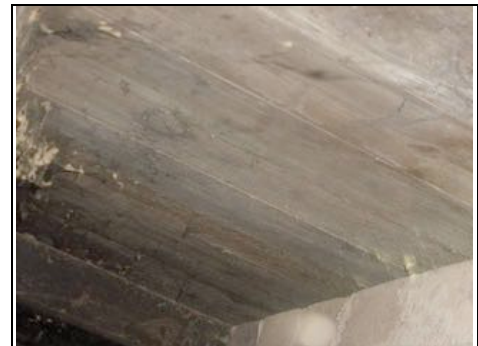
Underside of floorboards all
looking in reasonable condition

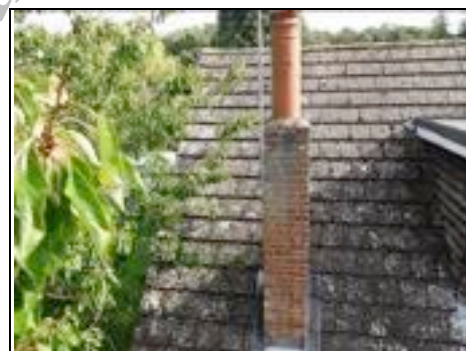
Rear right chimney

This is a slender brick finished chimney with a lead flashing and one chimney pot. From what we could see from ground level it looked in slightly below average condition considering its age, type and style as it is weathered. To the top of the chimney is some spalling and efflorescence. It is relatively straight as you can see in the photo. A close up inspection may reveal further problems.

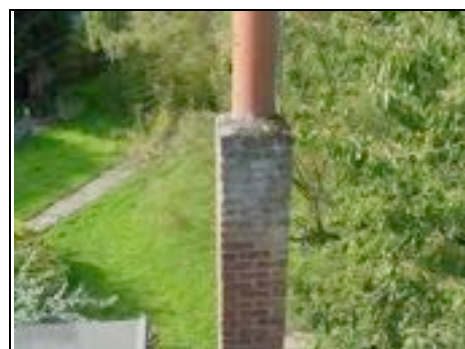
Chimney

We noted an aerial attached to the chimney which we are not keen on as it cuts into the brickwork rather like a cheese wire cutting into cheese.

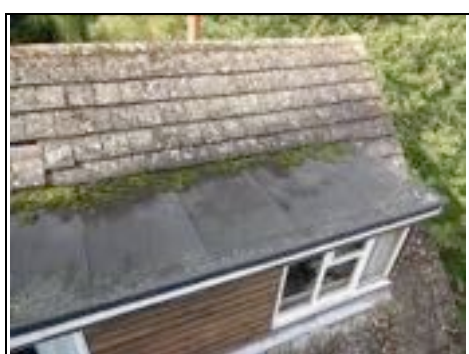
The dormer window roof is covered in mineral felt and the cheeks of the dormer are clad in shiplap boarding. Generally we could comment for their age, type and style they are in poor condition.

Front dormer window
Moss sitting against pitched roof

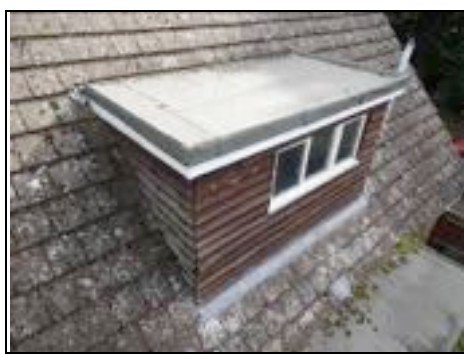
Rear dormer window leaks visible
internally

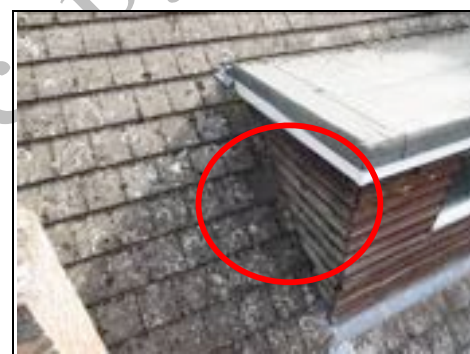
Shiplap boarding coming away to
rear dormer

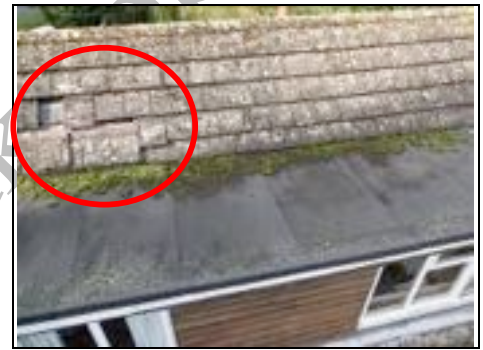
Concrete tiles have come away

ACTION REQUIRED: Please see our comments in the Executive Summary.

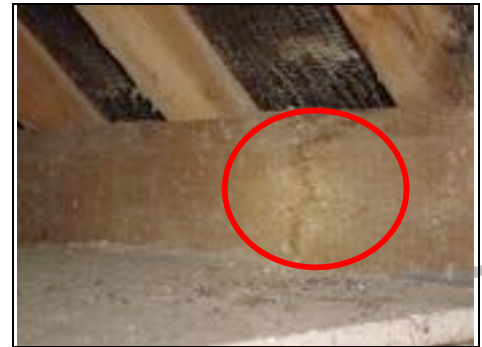
Staining coming through where pitched roof meets the flat roof

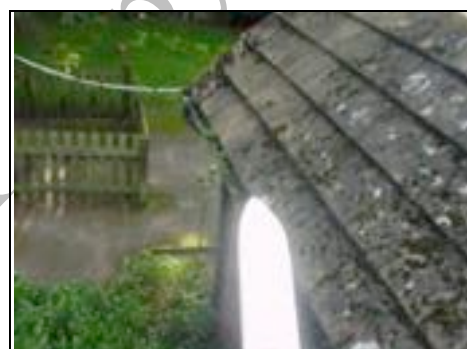
There are some minor leaks but most people would be happy to live with these providing repairs are carried out within the next six to twelve months.

Gutters full of vegetation

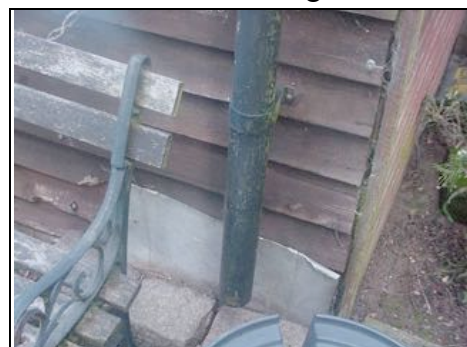
Downpipe from left roof discharges onto ground

We would recommend you stand outside the property next time it rains heavily and see how well the drains cope with the rainwater particularly looking at the guttering and the joints.

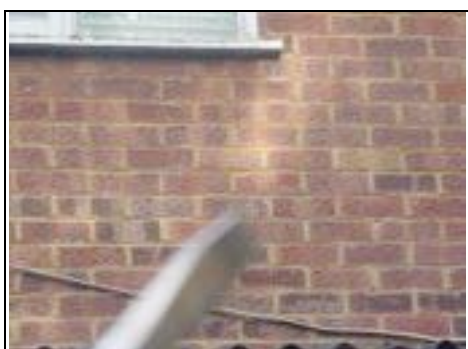
The property has been repointed which makes it very difficult to identify movement in the structure. We identified a small crack through the brickwork on the left hand gable which is unusual. A typical pattern for brickwork cracking is around windows and doors and holes in the structure. It could have been an area of cracking that has been covered up.

Crack in brickwork

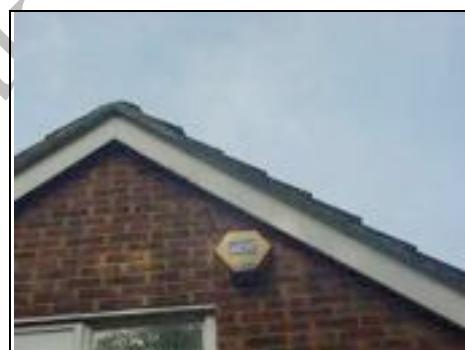
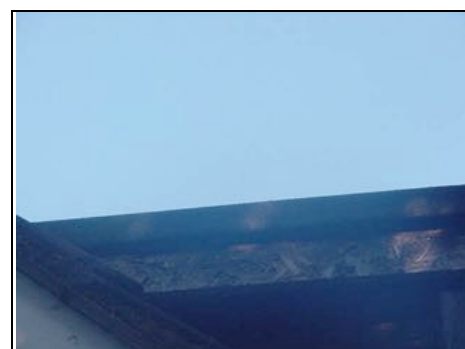
Bargeboard to gable end

Fascia and soffit at high level replaced with sterling board

ACTION REQUIRED: Some of the fascias and soffits will need replacing and some will need repairing and redecorating. Make sure gutters and downpipes are watertight before carrying out any work on fascias and soffits.

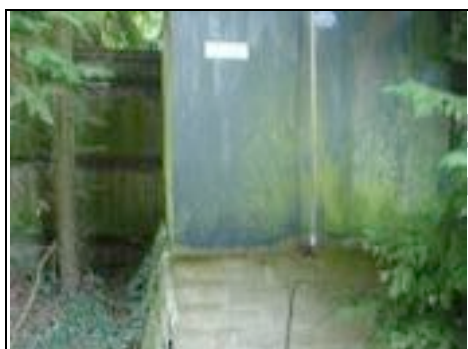
Oil tank

The oil tank looks in below average condition with some rust occurring. It really is not possible for us to establish if the oil tank is leaking from a one-off inspection, although there were no obvious visible signs or smells.

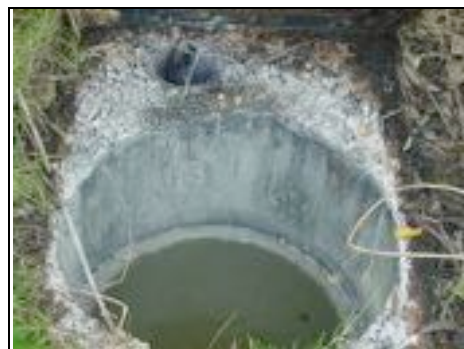
Septic tank full

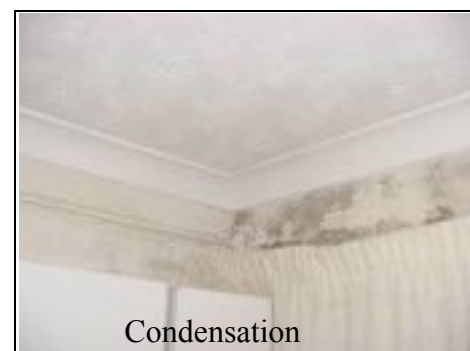
The adjacent photograph shows condensation occurring in Kitchen and deterioration to Artex/textured paint finish ceiling

Condensation

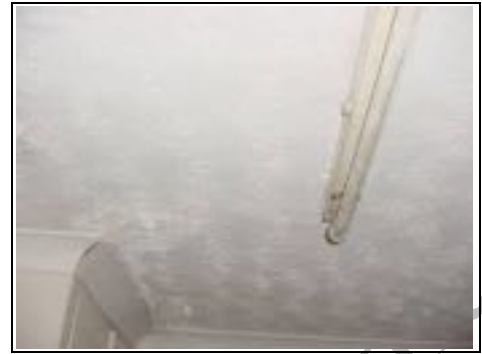
Condensation in ground floor bathroom
