DEFECTS REPORT

XXX
XXX
Dunstable
Beds
LU5 XXX

The following is a brief summary of the issues found at XXXX Dunstable, Beds, LU5 XXX during the course of our inspection.

We were re-instructed on XXX to carry out a review of the landlords work and therefore revisited the property on XXX and had a meeting with the landlord's surveyor XXX, Chartered Surveyor of XXX Management Ltd.

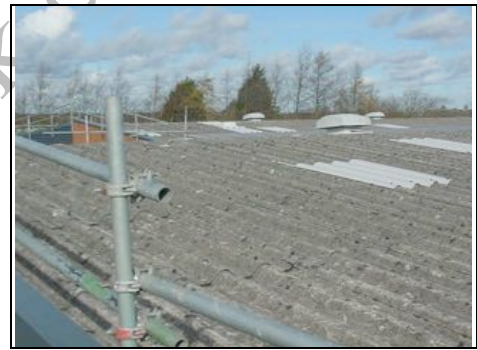
The property has an old asbestos style roof. We can see ad hoc/random overcladding has been carried out with GRP panels (Glass reinforced plastic panels), we assume to replace the leaking asbestos sheets. We can also see that the roof lights have been replaced.

General view of asbestos roof

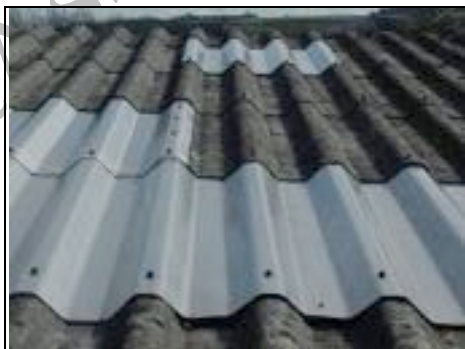
However we can still see that the asbestos is deteriorating, there are some signs of moss still present and we can see areas of patch repairs where flashband has been used.

GRP overcladding of asbestos panels

ACTION REQUIRED: All of these need further investigation. Our concern is that you will have a Dilapidations claim at the end for a new roof and not only a new roof but a new improved roof, as from what we understand the Building Regulation requirement for new roofs is about to change over the forthcoming years meaning that you would have to add additional insulation and green factors. The jury is still out as to exactly how this will affect you but it certainly will cost more and will mean, we believe, that patch repairing of roofs will not be acceptable.

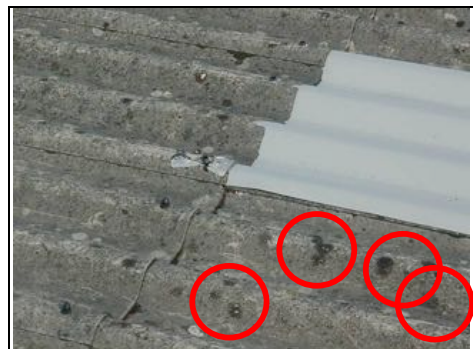
Moss

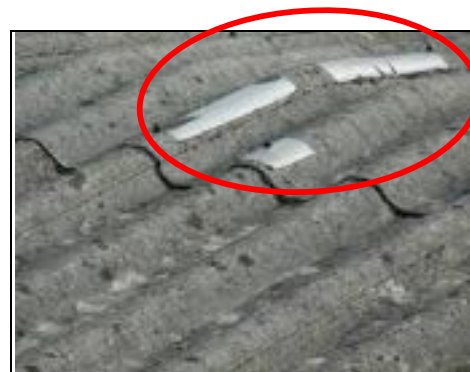
Flashband is a sticky backed felt which is best used for temporary repairs only.

Old flashband repairs

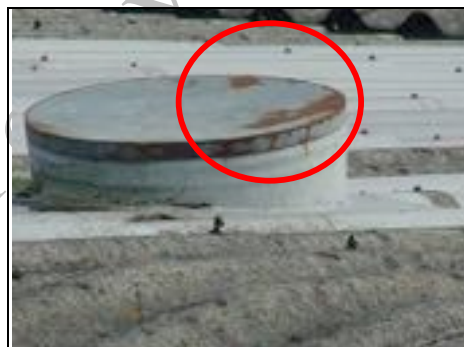
There are rusting vents and flues in the roof.

Rusting to top of the vent units

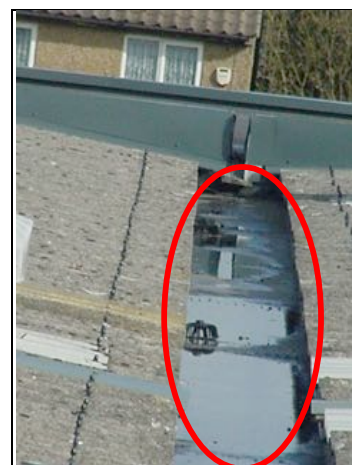
The gutter, we can still see, is full of rainwater.

Gutter full of water

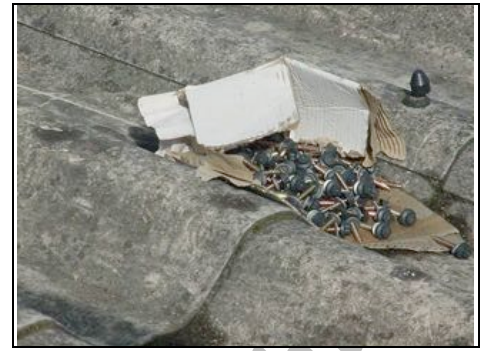
We noted debris on the roof.

Debris

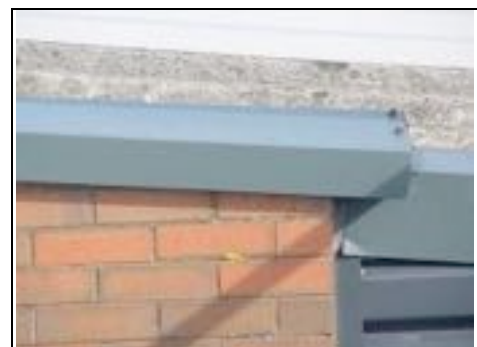
We are advised that cladding panels have been brush painted in situ. In our experience we generally find an inconsistency of thickness of paint applied and also quality. The only way to successfully refurbish old cladding panels in our opinion is to completely remove them or to provide new.

Upstand to the parapet wall

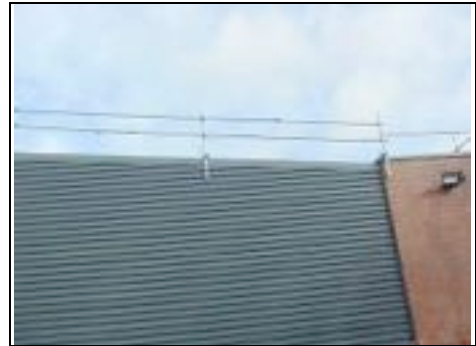
A dark coloured paint has been used which does tend to hide impact damage and other such things to the panels which then becomes visible as it weathers (rain, snow, sunlight, etc) over the years.

Wall cladding panels

ACTION REQUIRED: We feel that you are exposing yourselves to possible re-cladding of the building in eight years time and/or redecoration, which the landlord will always wish to have to a Rolls Royce standard.

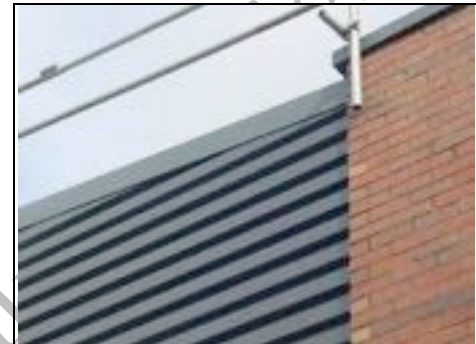
Close up of cladding panels

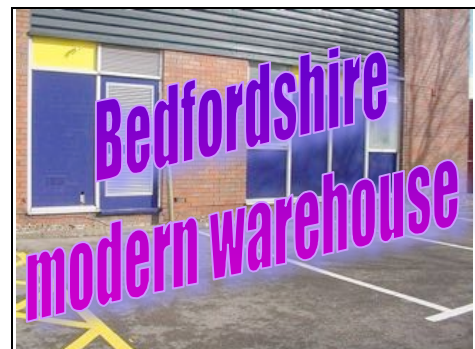
Whilst we noted that some panels had been painted yellow and blue, we also noted from what we could see that there has been no cleaning of the brickwork and no cleaning of the windows.

Painted panels

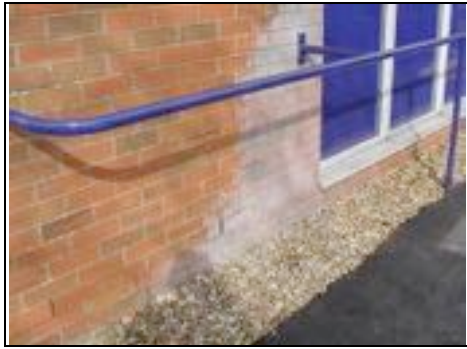
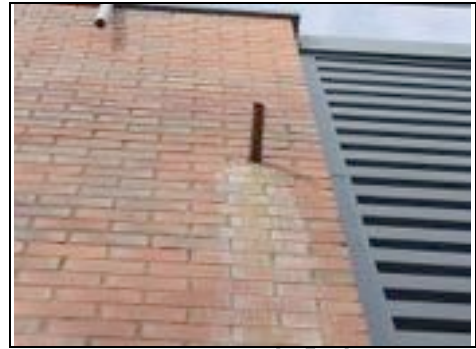
Staining to brickwork

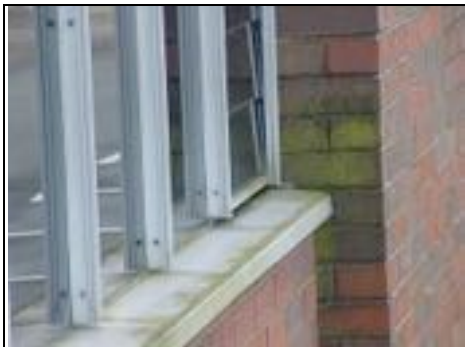
Green mould to brickwork and
window staining

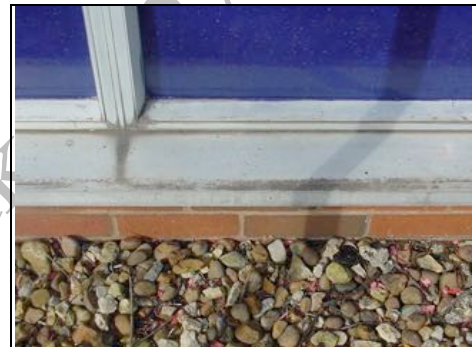
Staining to windows

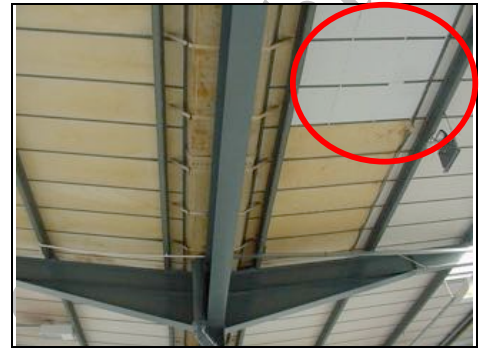
Patch repair of the underside of the warehouse roof. The majority of the cladding panels have not been cleaned.

Patch repair

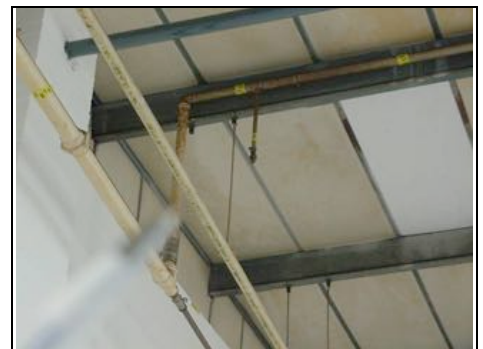
Pipework in conduit with rusting visible

Pipework in conduit

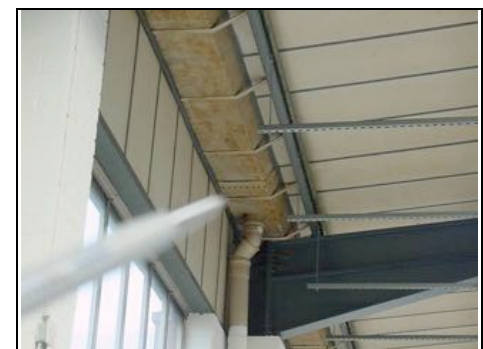
Water staining visible to underside of gutters

Water staining still visible

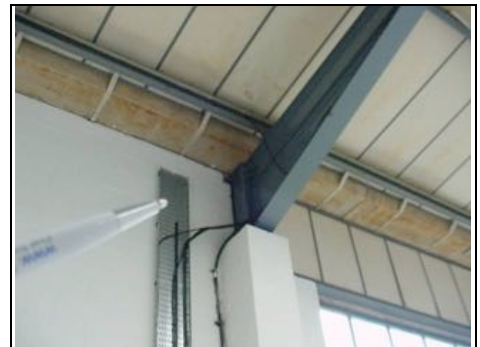
The structural frame has not been cleaned.

Structural frame not cleaned

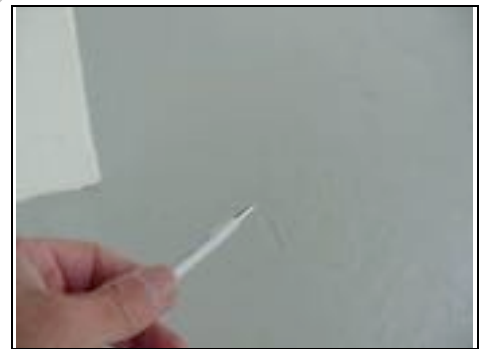
Painted over floor with minimal making good.

Painted over floor

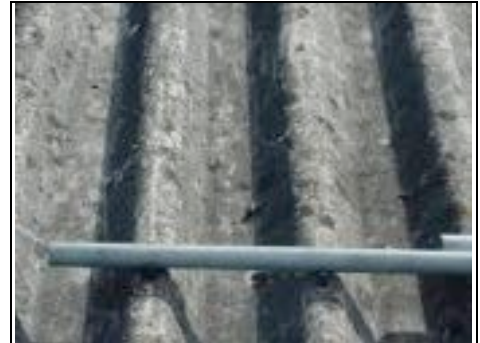
Close up of asbestos panel

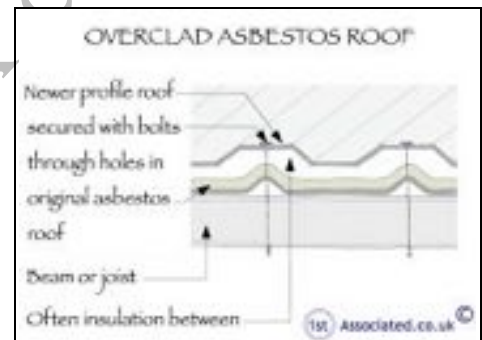
We would also question some of the repairs, without wishing to get too technical the covering of an asbestos sheet with a GRP cladding has the possibility of causing capillary action between the two materials and drawing water between them and then into the property.

Overclad asbestos roof

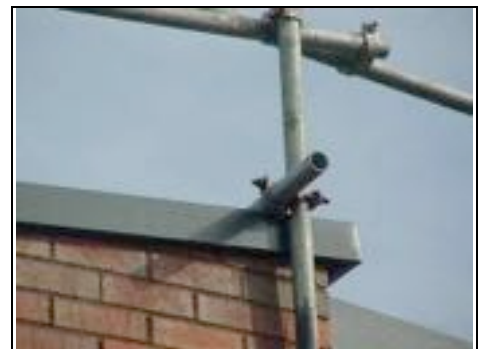
We would add that the safety scaffolding that has rightly been added around the perimeter of the roof has no protection to it and in our opinion there may be damage when the scaffolding is being taken down which we cannot ascertain at present.

Safety scaffolding

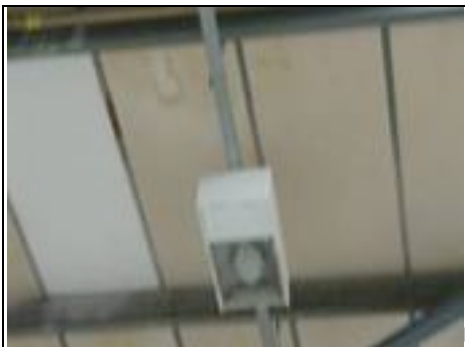
Different coloured undercladding
where repairs have taken place

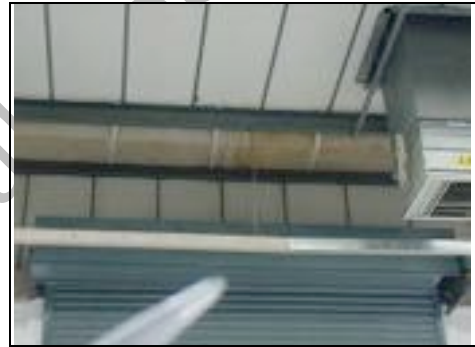
Staining and discoloration to the
undercladding panels and
underside of the gutter

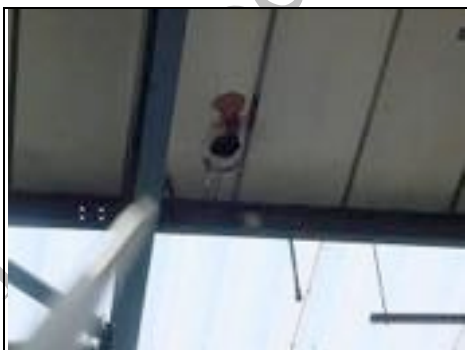
Holes remaining within the
undercladding

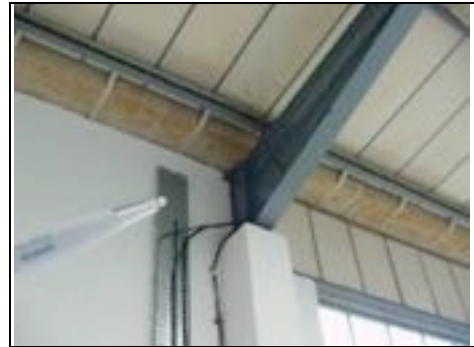
General lack of cleaning to the
structural frame
