RESIDENTIAL BUILDING SURVEY

Ely
Cambridgeshire
CB6 XXX

FOR

Mr X

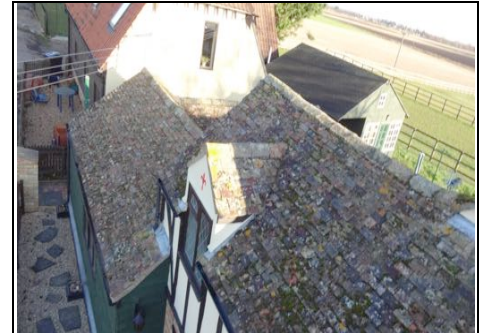
We can see that there is a heavy moss covering to the tiles which could cause deterioration and spalling to the tiles beneath. We are also concerned, given the roof construction that we can see, that there may be dips in the tiles that have been hidden by the sheer amount of moss on the roof.

Front roofs

ACTION REQUIRED: We would recommend during the summer months using a soft brush to remove small areas of the moss to see the condition of the tiles. We would then, based upon this, either carry out an overhaul of the roof replacing damaged tiles, etc and leave watertight or it may be more economical and better in the long term to actually partly re-roof. It is difficult to comment further without further investigation.

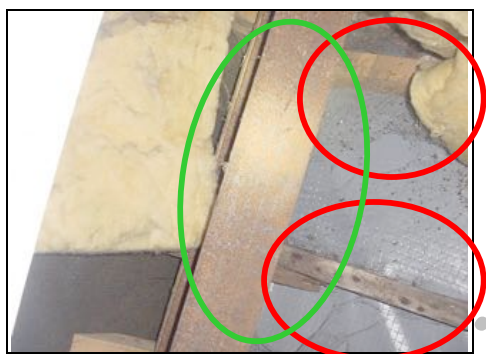
Very thin common rafters (red)
Rusting RSJ (green)

ACTION REQUIRED: Ultimately in the long term the entirety of this main roof will have to be re-roofed and at the same time we would recommend adding a new roof structure.

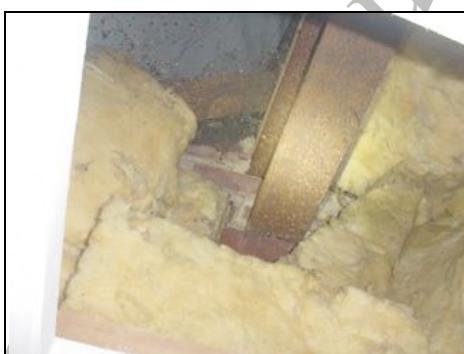
RSJ rusting in roof above
bathroom

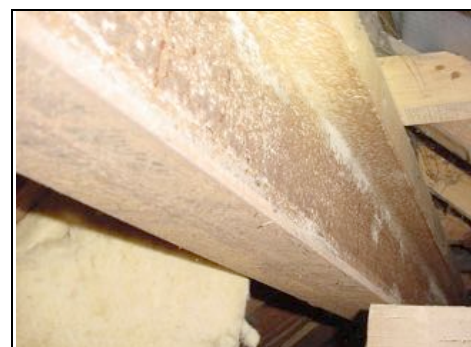
Rusting RSJ

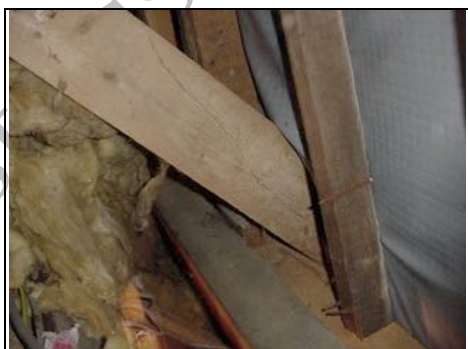
Split in common rafter

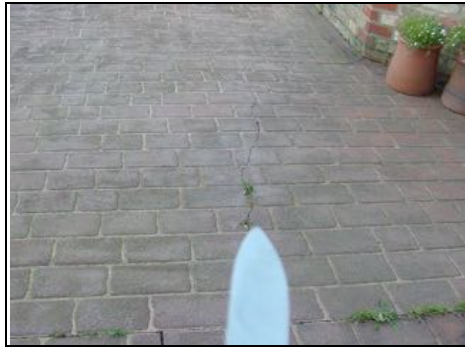
Crack in pressed concrete driveway

ACTION REQUIRED: On reflection we feel that there is likely to be progressive movement. If you are happy to take on a building with movement a way of resolving it is for the existing owners to take out an insurance claim, advising that the cracking has been noted by a structural surveyor (this should cost them nothing other than time to write the letter). This usually means that the insurance company will carry out a monitoring exercise (the Building Research Establishment recommend monitoring any cracks for a minimum of one year) to establish if there is any progressive movement. Your future liability will be limited to the cost of the excess on the insurance providing the insurance company is happy for you to take over the insurance claim.

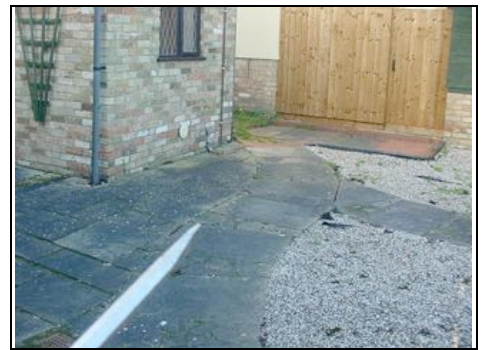
Movement in paving area

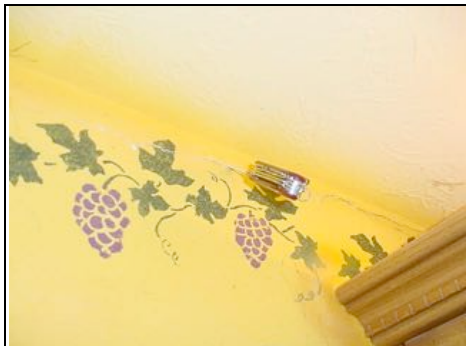
Crack in kitchen

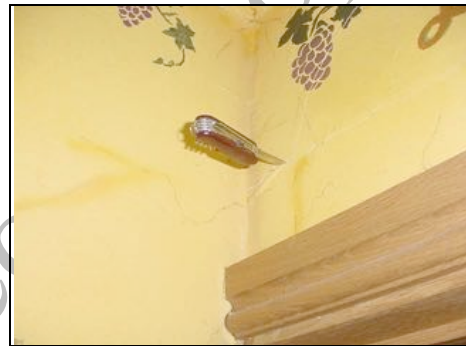
Crack in kitchen

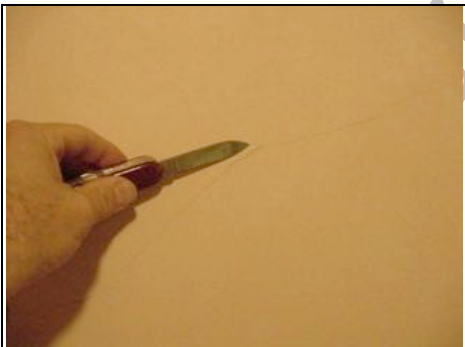
Crack in bathroom

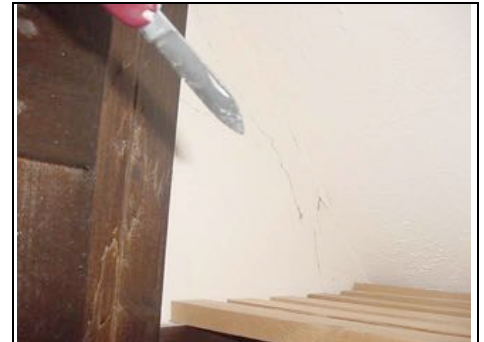
Crack in bathroom cupboard

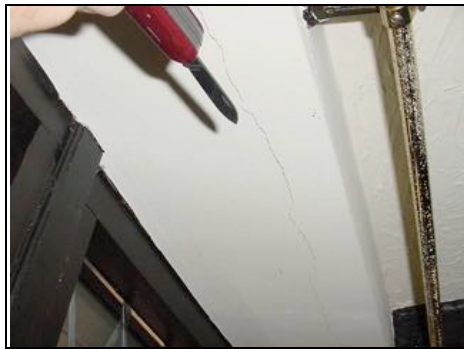
Cracking to middle reception room

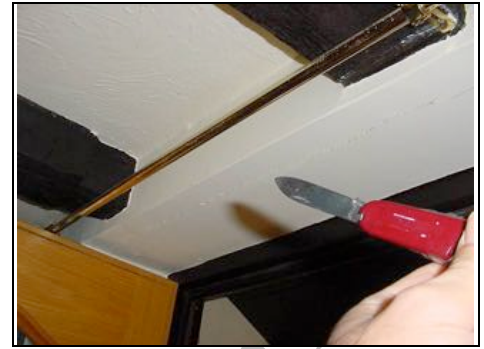
Cracking to middle reception room

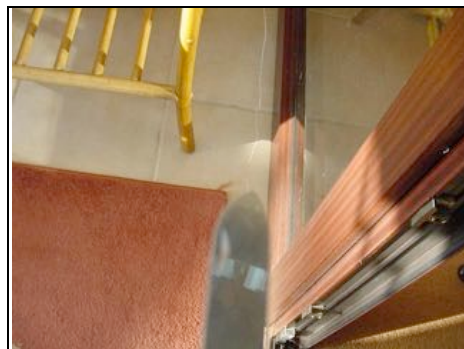
Crack in conservatory

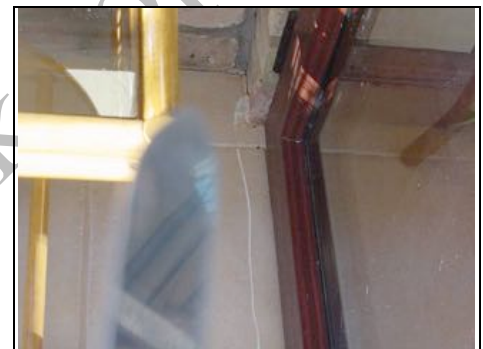
Crack in conservatory

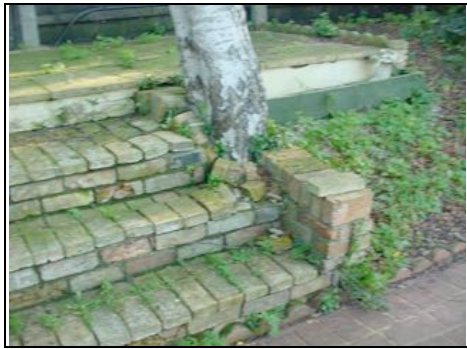
The property sits on a sloping site. Any property on a sloping site is more susceptible than one on a flat site; it is simply the laws of gravity. Foundations normally allow for such occurrences, particularly in new properties. There can still be some minor movement.

Sloping site

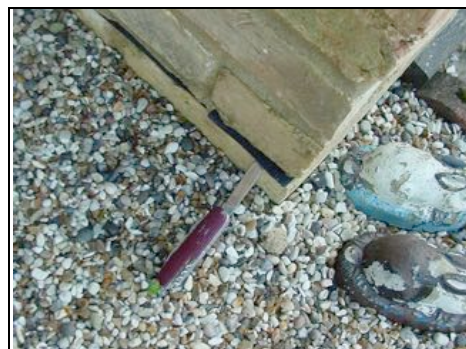
The ground is generally high around some parts of the property and there is a sloping site. We found dampness within the property. We believe it is coming up through the floor as well as through some of the walls. We can see in some areas that there is a low damp proof course and we can see in other areas there does not appear to be a damp proof course although we have been advised by the owner that they did put a damp proof course in (as he was a damp proof contractor).

Damp proof course too low

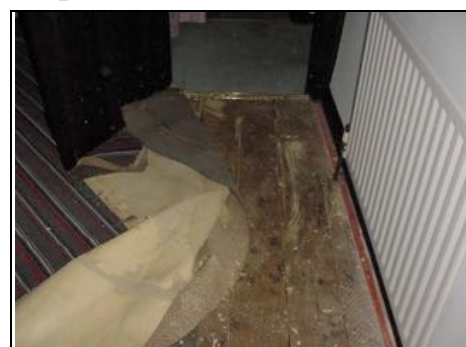
It was noted in the front bedroom there is considerable deflection in the floor. It seems very strange considering it is a relatively short span.

Lifted carpets

ACTION REQUIRED: We would recommend the floors are opened up. We did lift the carpets. It could be the joists had rotted where they are embedded into the walls, it could simply be that they are not big enough (note our comments on the roof timbers) or it could be that they have woodworm or some other similar problem.

ANTICIPATED COST: A few hundred pounds to carry out investigations and opening up the floors and then likely to be £1,000 or so to add stability to the floor. Please obtain quotations.

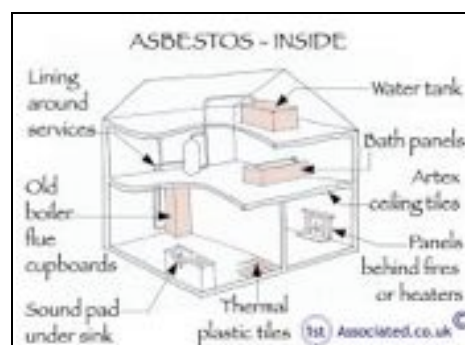
We found asbestos to the verge of the roof which does mean there could be asbestos to the rest of the property.

Asbestos - inside

ACTION REQUIRED: The only way to be a hundred per cent certain with regards to Asbestos in a property is to have an Asbestos report with samples taken and the recommended action carried out.

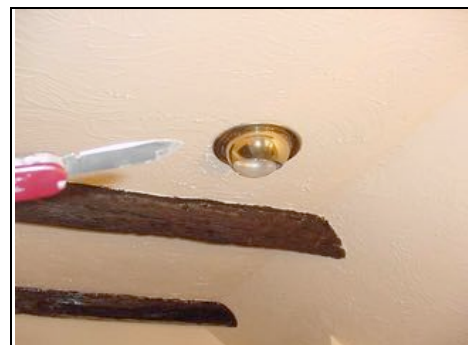
Where we could see the electrics they looked to be dated. We particularly noted the 1970's style ceiling lights.

1970s light on landing

ACTION REQUIRED: We recommend an Institution of Engineering and Technology (IET) test and report to be carried out by an NICEIC registered and approved electrical contractor or equivalent.

ANTICIPATED COST: £250 - £500 plus any work recommended; please obtain quotations.

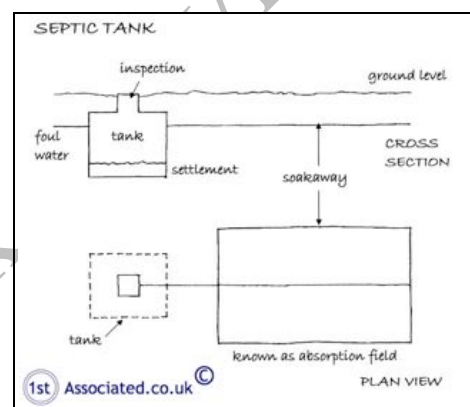
The property is served by a traditional septic tank installation, a private drainage arrangement that is entirely the responsibility of the building owner. Septic tanks can be of brick, concrete or modern GRP construction but should all operate on the principle of solids being broken down by bacteria, the partly treated foul water then being disposed of by discharge into adjacent ground by a system of soakaways, land drains or perforated pipes: we have been unable to determine the adequacy of treatment or the effectiveness of the disposal arrangements. We are advised the septic tank is a modern glass reinforced plastic (GRP) unit. It looked to be full.

Septic tank

ACTION REQUIRED: We recommend you get the existing owner to empty the septic tank and also get contact details of who regularly empties it. If you forward this information onto us we would be more than happy to talk to them to confirm the quality of the septic tank.

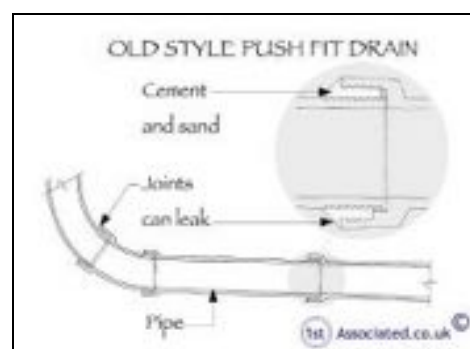
In older properties, such as this, drainage was often push fitted together rather than bonded together which means that they may leak over the years. Whilst we ran the tap for 15 minutes without any build up or blockages the only way to be 100% certain of the condition of the drains is to have a closed circuit TV camera report.

Push fit drain

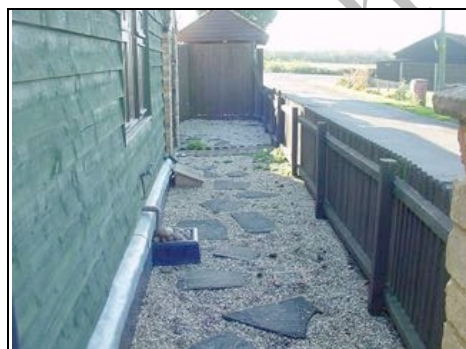
Once thing that kept also occurring to us was that the pea shingle to the front of the property and to some extent to the sides could be hiding all sorts of defects in the ground. Also the shiplap boarding looked relatively new and again it could be hiding things in the construction and that the property was on a considerable sloping site and has been hidden by pea shingle and the provision of retaining walls.

Pea shingle to front of property and newness of shiplap boarding

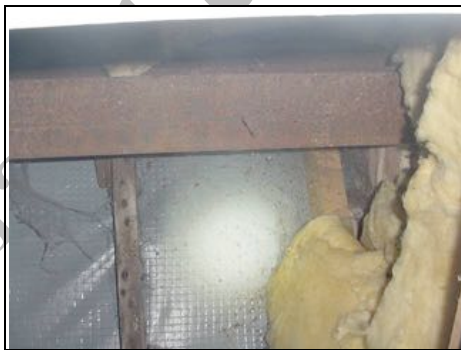
When we inspected the loft space we found a reinforced plastic sarking felt and a hessian underlayer. Reinforced plastic sarking felt was used in the 1970s/1980s and its use was generally stopped because it was susceptible to causing condensation unless the roofs are adequately vented, which they are usually not. Please see our further comments as a combination of a protective underlayer that causes condensation and thin roofing timbers is a problem.

Plastic protective underlayer that causes roof to sweat/condensate

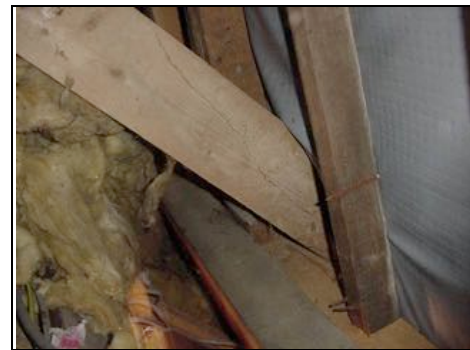
Nails coming through the plastic sheeting of protective underlayer

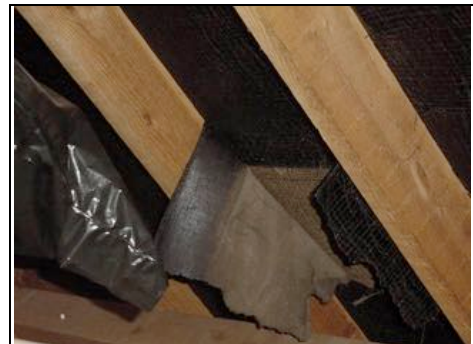
Deterioration

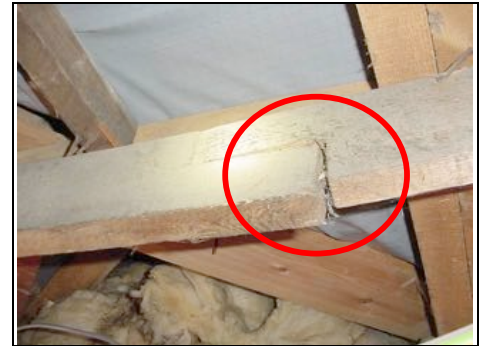
Purlin opening up

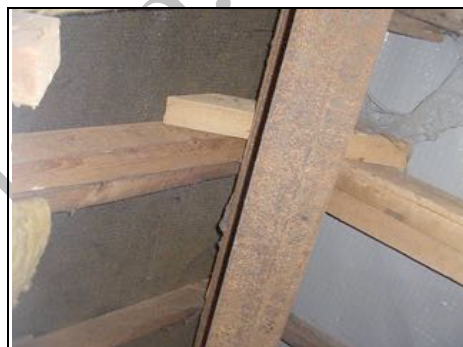
Rusting to RSJ in main roof

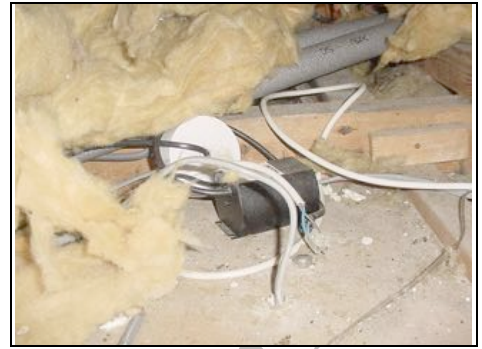
We can often identify the age of an electrical installation by the age of wiring found in the roof. We found a mass of wiring particularly in the front left roof which is one of the reasons why we believe you need an electric check.

Wiring everywhere in roof above front left cloakroom

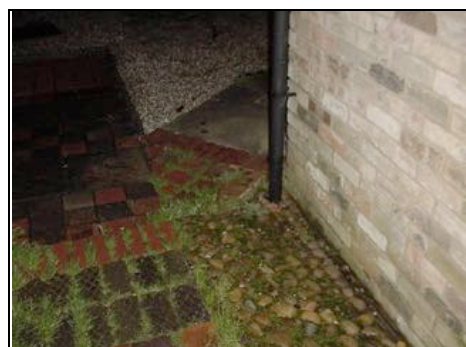
Downpipes discharging directly into ground

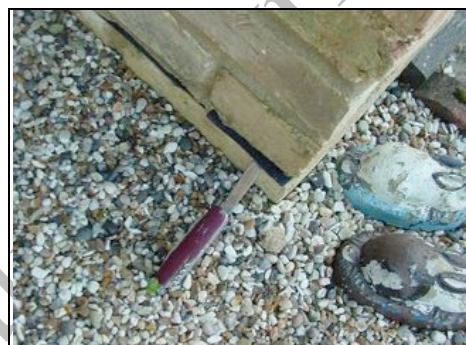
Damp proof course too low

ACTION REQUIRED: Please see our comments in the Executive Summary.

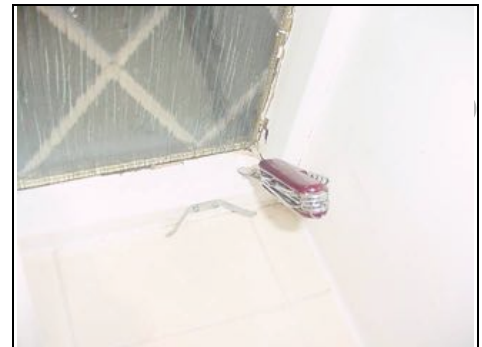
Wet rot to bathroom window

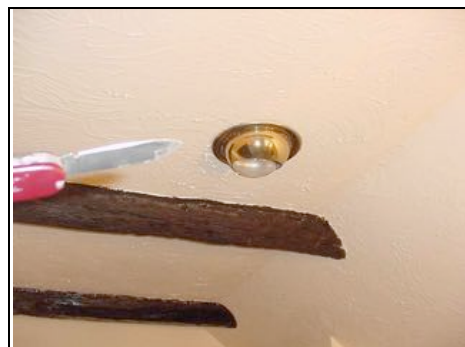
We noted a textured paint on some ceilings, for example the landing. Sometimes there is asbestos in older style artex. We do not believe this is the era of textured paint that has asbestos but as you have other asbestos in the property we would get it double checked just to be extra safe.

Artex on landing

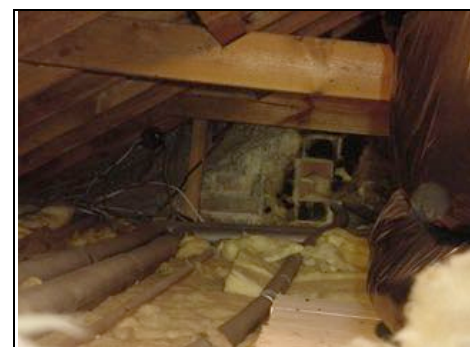
A chimney may have been removed on the left side of the property.

Looks like chimney has been removed on left side of property

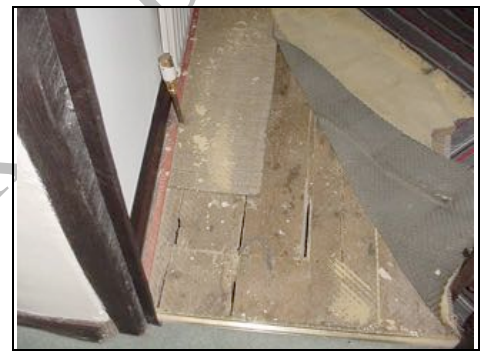
Floor in front right bedroom

ACTION REQUIRED: Please see our comments in the Executive Summary with regard to opening up the floors. Possibly the wrong sized timbers have been used and possibly there has been some deterioration to the end joists.

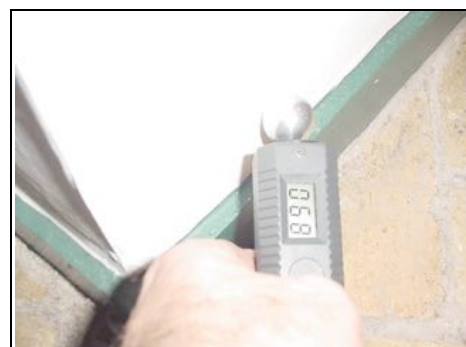
High damp reading

ACTION REQUIRED: Please see the Executive Summary.

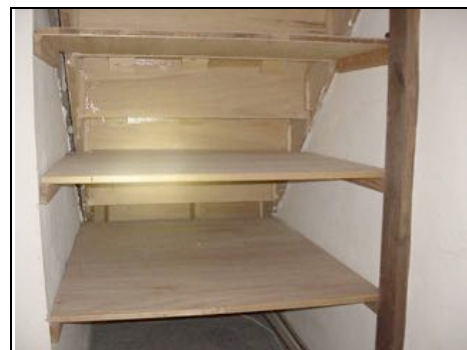
We noted that the underside of the staircase was exposed. It is more normal today to have a half hour fire barrier to stop fire spreading from the ground floor to the first floor in a worse case scenario. You may wish to take a view on whether you add this.

Exposed staircase

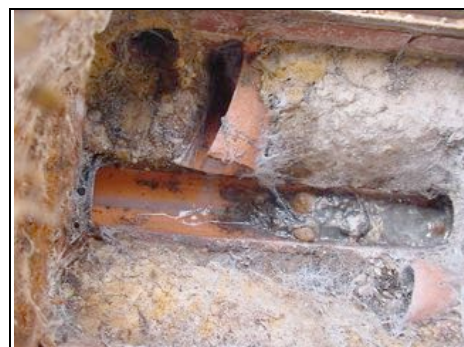
Partially blocked

ACTION REQUIRED: We would recommend this is checked and confirmed by your solicitors as it is very important.
