JOB REFERENCE: XXXXX

RESIDENTIAL BUILDING SURVEY

XXXX
Henlow
Bedfordshire
SG16 XXX

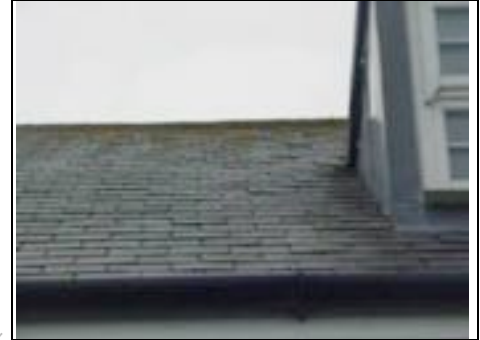
We noted an above average undulation on the slates to the main roof. There are signs of water damage inside on the rafters although this is very minor and minor staining to the top floor ceiling. Whilst we appreciate slate is a natural material and have different qualities they do look to be some darker slates which look to be deteriorating more quickly than their neighbours. It is possible there may be a defective number of slates in the batch that inadvertently have been used on the roof which is why we are recommending a roofer looks at roof level at the roof.

Undulation / lifting of slates which due to the height of the property and wind velocity could lead to lifting slates

ACTION REQUIRED: You will have to monitor the condition of the roof to see if any slates lift any further.

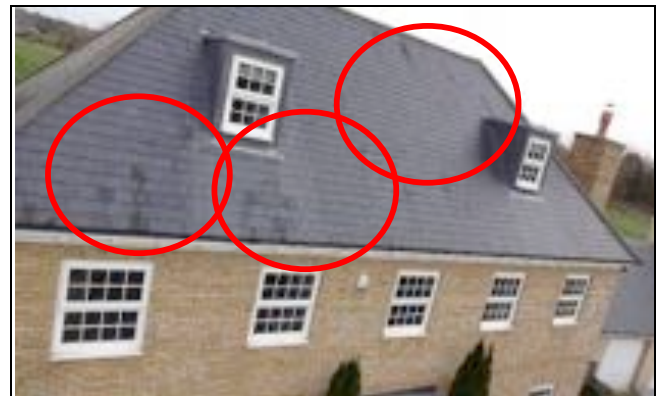
Darker deteriorating slates?

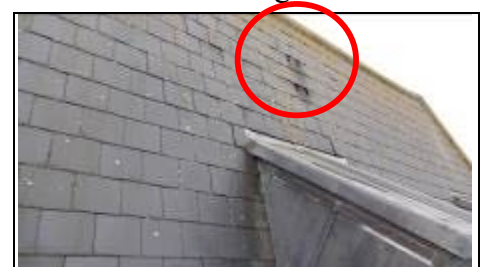
Vent

We noted a vent at high level, which may be allowing some wind driven rain in.

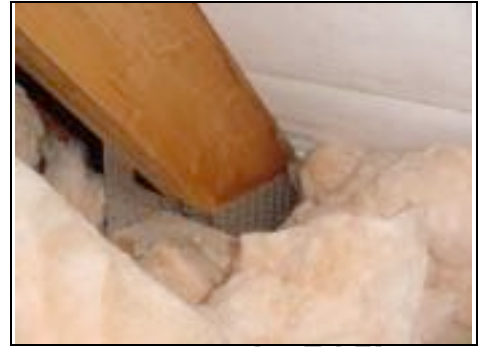
It looks like there is minor staining to the timbers indicating that some dampness is getting in. There is an outside chance it is the way the grain is but it did look to us like it was dampness staining.

Dampness to timbers

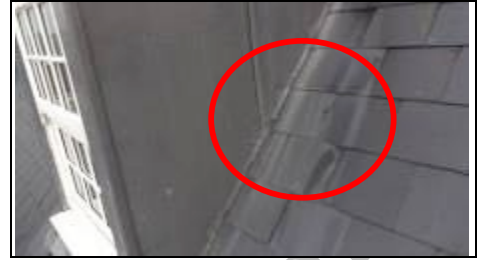
We can see that the front right dormer roof (all directions given as you face the property) is allowing some water in. There does seem to be a crack in the window sill board. We would not have expected so much rain in because of this however if it is in a high prevailing wind area as mentioned this could be the reason. The dormer looks to be clad with lead which is usually a good material for dormers but this may not have been lapped correctly; we simply cannot see from ground level. It is also possible there may be a defect in the slates around the dormer that is allowing wind driven rain in.

Problem with slates around front right dormer
Aerial view – 360 photo

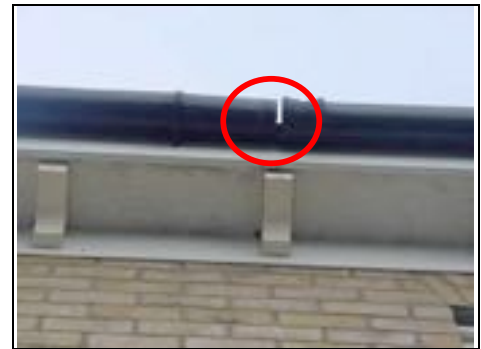
The guttering has become uncoupled at high level to the front left side. It may be that there are other areas which have become uncoupled/not working properly. We can also see grass growing out of some gutters together with an unusually high number of tennis balls! (we assume for the dog). We would not normally mention this but it is a high level gutter.

Gap in guttering to front

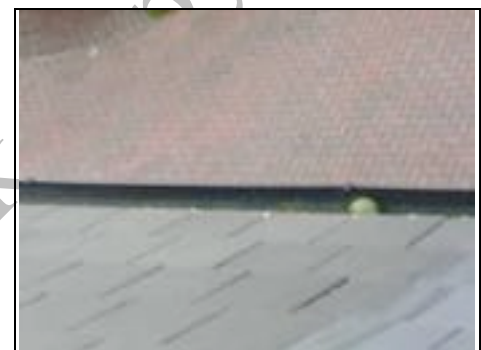
Tennis ball in gutter

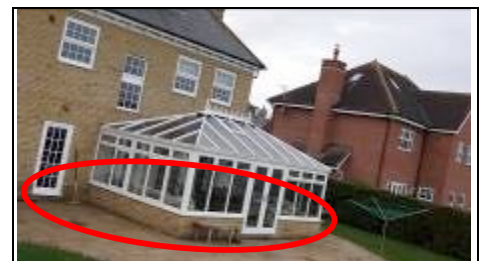
We noted dampness in the conservatory and we obtained high damp readings with our electronic damp meter and also thermal image pictures showed there was dampness in the area.

We believe this is due to the high ground level around the conservatory and indeed around the rear of the property where the patio has been laid. We were surprised how high the dampness reading were in the area.

Dampness to base

ACTION REQUIRED: We recommend you add a French drain around the conservatory. We would ideally recommend it around the whole of the property to ensure that water is kept away.

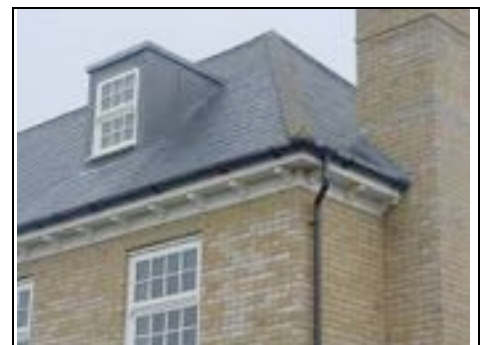
It is unusual to have efflorescence on brickwork of this Era. It may be that the brick is particularly porous but you do need to be aware that you may get the efflorescence in the form of a white powder/salt on the bricks forever and a day and it will be very difficult to remove. Even such products as a brick clean tend to be a temporary removal of such staining if the bricks are porous.

Efflorescence on brickwork

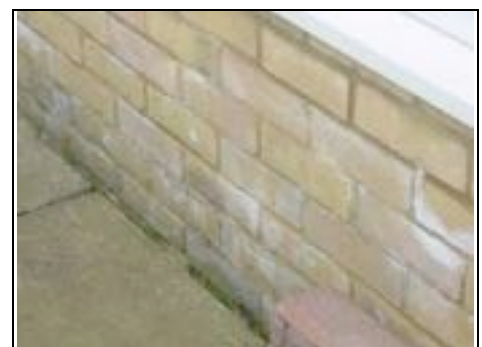
Efflorescence to base of conservatory

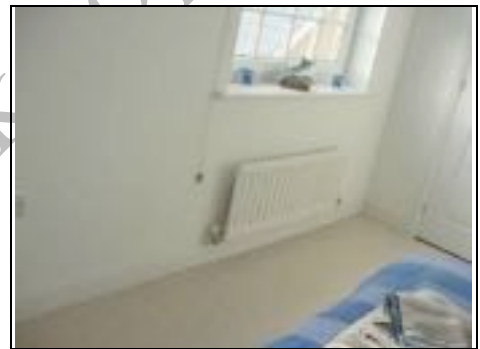
We assume, as the property is quite new, it has been built to modern thermal efficiency standards. We did note that there were relatively small single panel radiators in the rooms. It is more common to have larger double panel radiators so it may take some time to warm the house up. Alternatively and what is often recommended with modern properties is you need to keep the heating on constantly at a fairly low rate.

Small single panel radiator

ACTION REQUIRED: We recommend these are changed to double panel convection radiators.

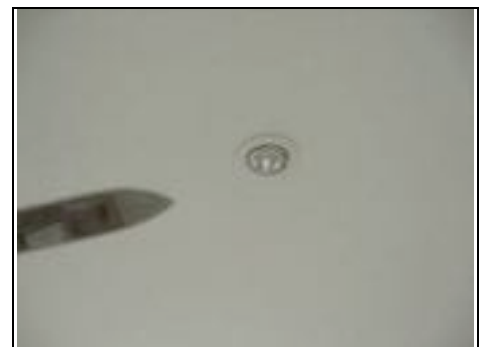
We noted dampness around the ceiling lights on the top floor – please see our comments with regards to the slates.

Dampness around ceiling light on top floor

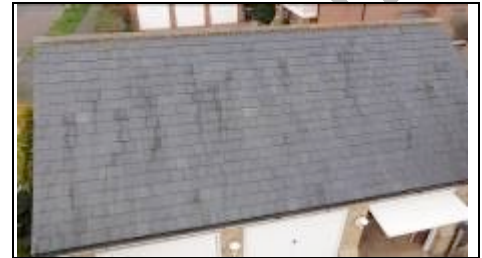
We have looked at the roof slate photographs again and again. There does look as if there are defects in some of the slates. In the adjacent photograph of the garage roof you can see where some slates are missing, our concern is that you will have this problem on the main roof which would be much more difficult to solve as this is a three storey property and a high main roof.

Garage roof where slates are missing

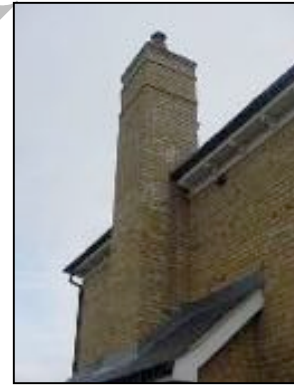
Left chimney

This chimney is brick finished with a lead flashing and one flue. From what we could see from ground level it looked in average condition considering its age, type and style although note the efflorescence.

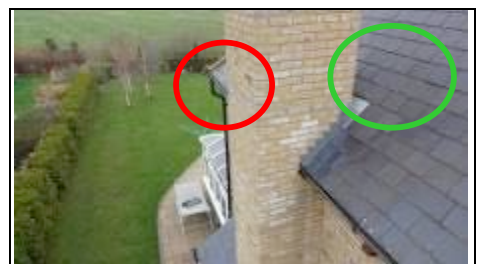
We also noted that the guttering adjacent to the chimney was positioned too close in our opinion which will mean that rainwater will overflow the guttering sometimes and down the side of the chimney.

There is an awkward detail to the rear of the chimney (green circle).

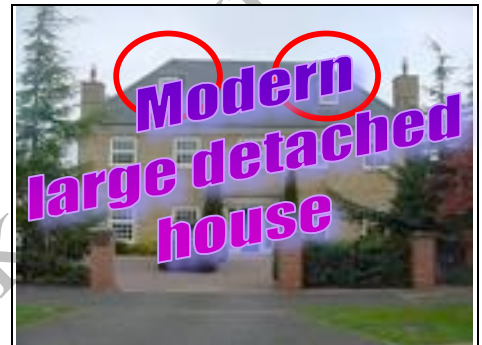
There are missing and lifting slates to some of the dormers.

Front dormer windows

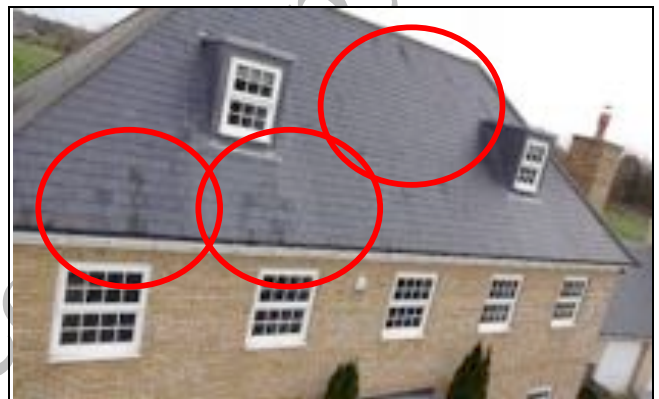
The main roof is hipped and pitched and clad with a slates and from ground level this looks to be patchy. We have used this term as we have not come across a modern roof quite like this before. It looks almost like a defective batch of slates has been used on this roof and also on the garage roof.

Darker deteriorating slates?

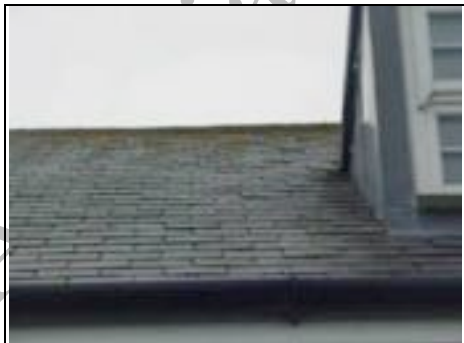
There is the slightest of undulation in the roof.

Undulation / lifting of slates which due to the height of the property and wind velocity could lead to lifting slates

ACTION REQUIRED: Please see our comments in the Executive Summary. We would be much happier if a roofer had a close up inspection of this roof so they could see exactly what was happening to the slates that look to be a different colour/darker/deteriorating. The problem with slate roofs is that it is very difficult just to remove one slate, you almost end up removing a triangle of slates which can be quite large sometimes just to repair one or two slates.

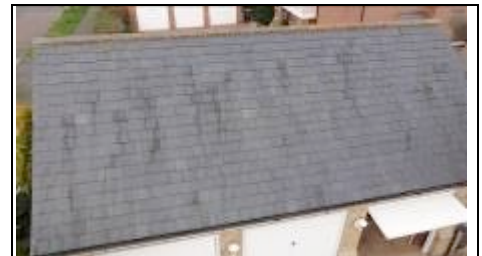
Garage roof where slates are missing

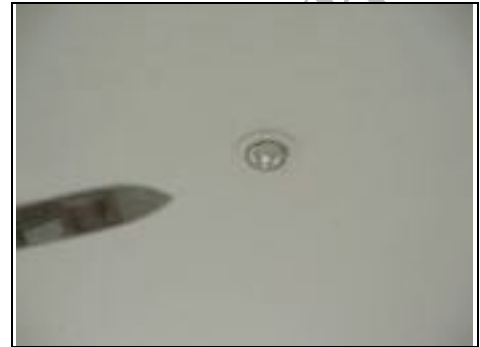
Our other concern is that we can see some water staining to the top floor which concerns us. This may be where wind driven rain is getting in and also the very small stain that we saw within the roof space.

Minor dampness around light

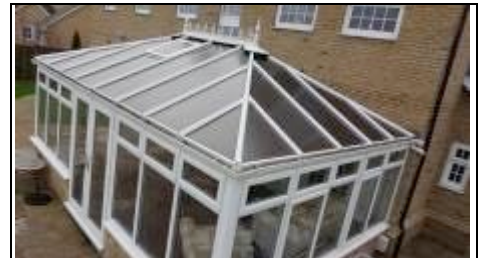
There is an awkward valley gutter detail where the roof meets the main building.

Conservatory roof
Aerial view – 360 photo

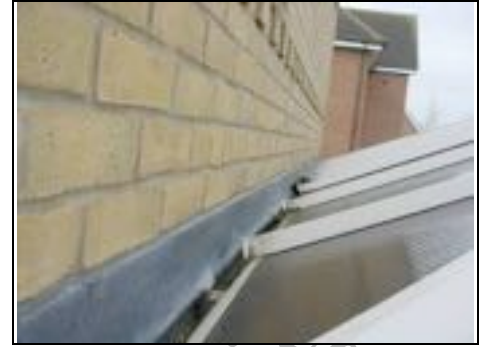
Close up of awkward valley between conservatory and main building

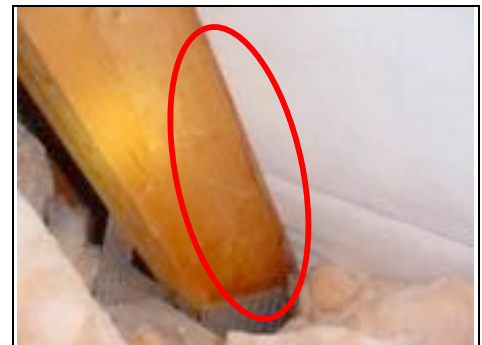
Damp staining to timbers

ACTION REQUIRED: The only way to be 100 per cent certain is to have the roof cleared and checked.

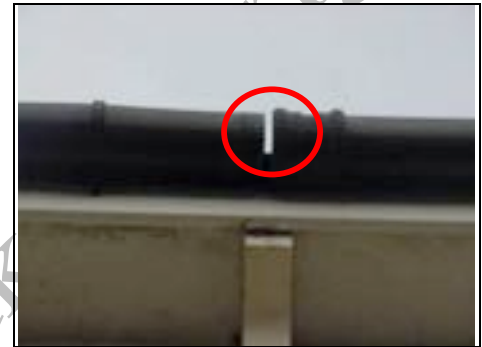
The gutters and downpipes are plastic. We noted a gap in the guttering to the front. The gutters and downpipes at high level need to work effectively as they are hard to get to. From what we can see they need some repairs, for example we noted a gap to the front and we noted grass growing from them and there is a gutter too close to the chimney.

Gap in gutter to front

There may be some minor leaks but most people would be happy to live with these providing repairs are carried out within the next six to twelve months.

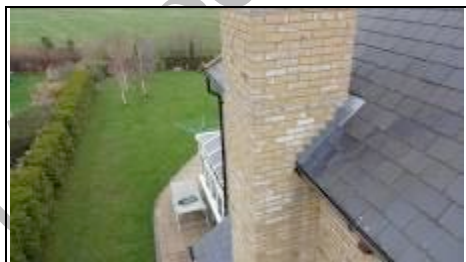
Staining

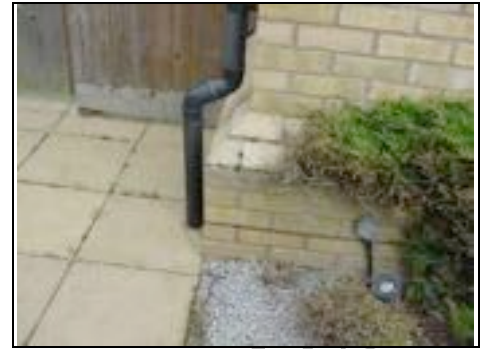
Whilst we are on the subject of gutters and downpipes, the downpipes feed directly into the ground which is a practice we are not keen on, and we much prefer to see a gulley as without a gulley where there is a blockage it can cause a back-up of water in the downpipes which can ultimately come out of the joints and allow dampness to get into the walls.

Downpipes feed directly into ground

We always recommend that the gutters and downpipes are cleaned out, the joints are checked and the alignment checked to ensure that the gutters fall towards the downpipes.

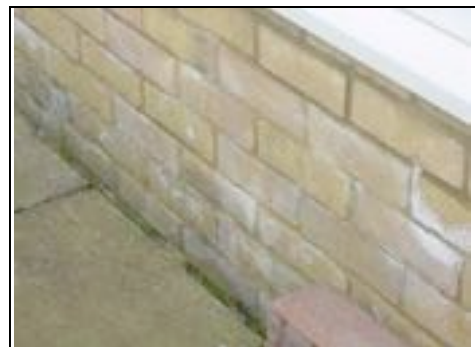
Efflorescence to base of conservatory

ACTION REQUIRED: Please see our comments in the Executive Summary.

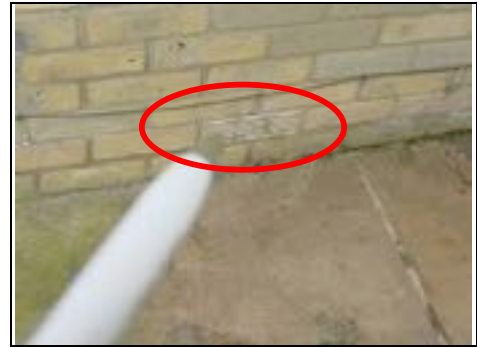
Air bricks are essential to have a through flow of air. In this case the airbricks to the rear conservatory are acting as gutters due to the high ground level from the patio.

Air brick

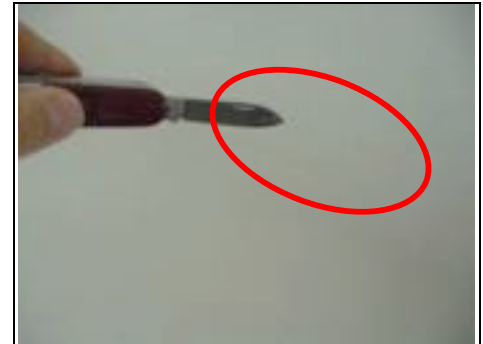
Hairline crack to ceiling

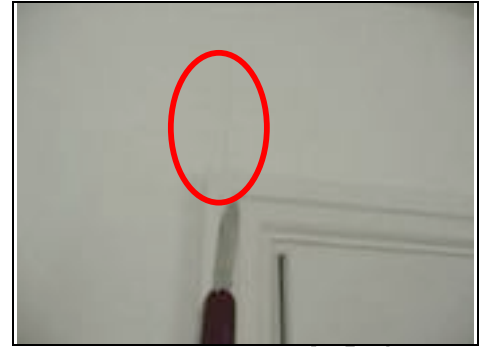
There is some hairline cracking in the property.

Hairline crack around one of the doors

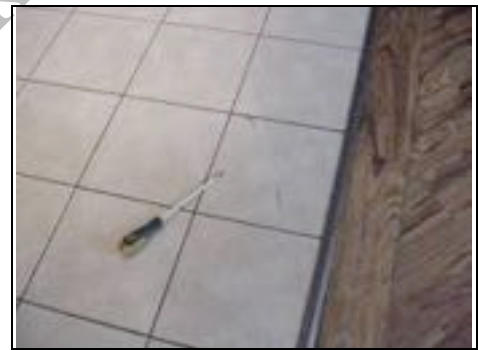
There are a number of different types of floor finishes to the property. We noted that one of the dining room tiles were cracked, there may be other cracks, you need to have a close inspection as this is not normally covered in a structural survey.

Cracked tile in kitchen/diner

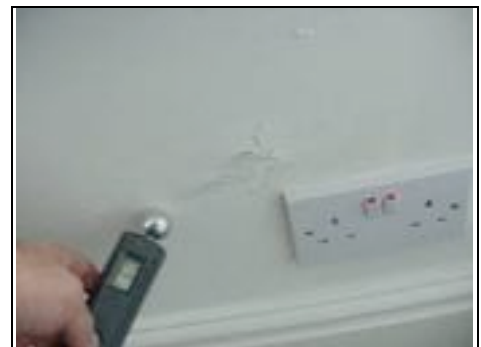
Obtaining high damp readings in the conservatory

ACTION REQUIRED: Please see the Executive Summary. Please also note our comments with regard to the airbricks acting as gutters and also note our comments with regard to the high levels of the patio and our comments with regards to a French drain.

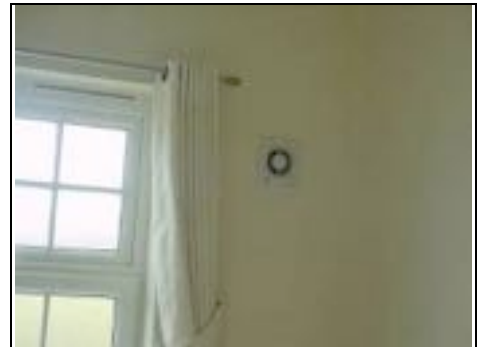
The extract fans are smaller than we would like to see. A way of helping to reduce condensation is to have good quality large extract fans with humidity controlled thermostats within the kitchens and bathrooms and also in any areas where you intend to dry clothes which are moisture generating areas.

Small extract fan

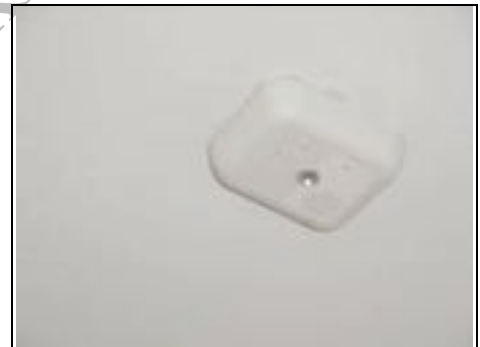
Some smoke detectors were noted we believe these to be battery operated. The current Building Regulations require that they be wired into the main power supply.

Smoke detector

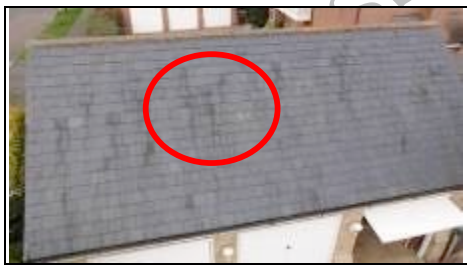
Missing slates to front
Aerial view – 360 photo

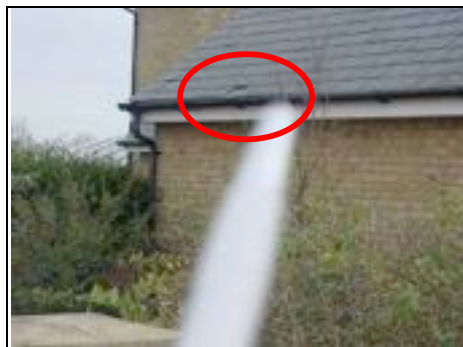
Missing slates to rear
