# RESIDENTIAL BUILDING SURVEY

Leighton Buzzard,  
Bedfordshire  
LU7 XXX

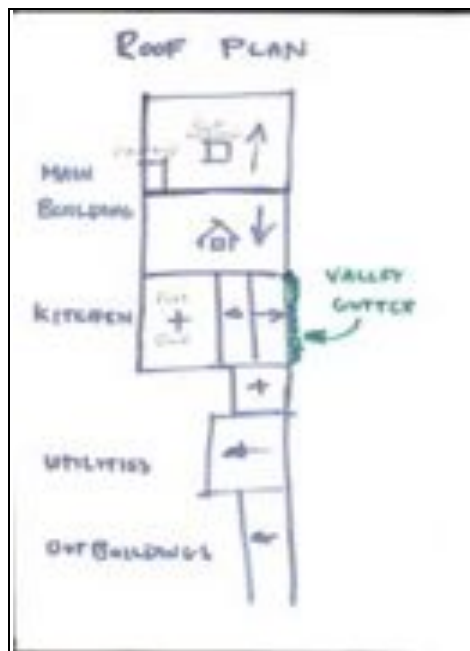
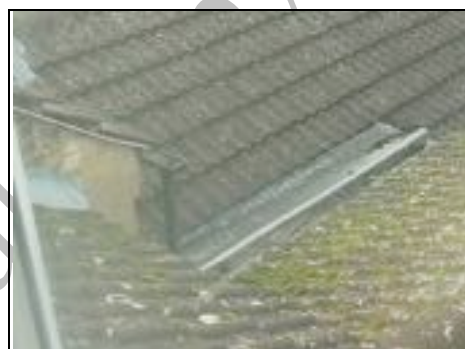
Where your pitched roof meets next doors pitched roof on the rear left hand side there is an awkward valley gutter. Whilst we were pleased to see it is finished in lead these can often overflow and water gets into the property.

Rear valley gutter

**ACTION REQUIRED:** This is a characteristic of this property, there is very little you can do to resolve it other than ensure the lead is kept in good condition which you will normally only know about with this sort of awkward detail when a leak occurs.

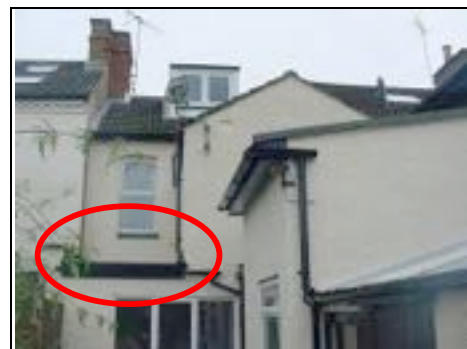
There is a flat flat roof over the kitchen (this is not a typing error, we mean the roof is flat). From the moss on it, it looks like water is sitting on it. You do need to be aware that it could get into the kitchen area particularly if you are carrying out alterations to the kitchen.

Flat roof over kitchen

**ACTION REQUIRED:** Ideally replace with a pitched roof. You can put an insulated roof on that is cut to falls and then this would both add a fall to the roof and also insulation to keep you warmer. We recommend a modern high performance elastomeric felt. Add lead flashings and amend parapet wall detail to the right hand side (all directions given as you face the front of the property).

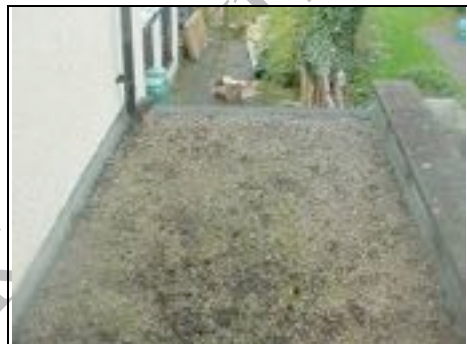
Rear flat roof

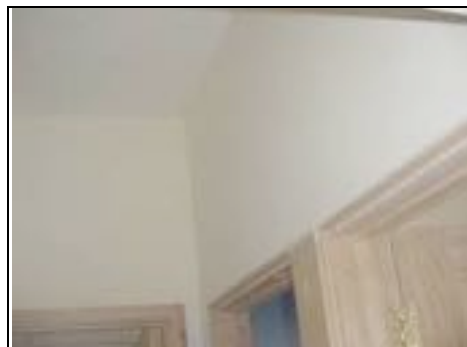
Unusually the majority of the walls on the first floor are studwork partitions and what we would term as lightweight studwork partitions which is practically what all modern studwork is as opposed to older studwork such as you would find in Victorian properties as this which were also structural.

When tapping the wall we noted that part of the original wall has been left in. As far as we can see this is just adding weight to this area.

Brickwork wall to front of property.  
Most walls on first floor replaced with studwork

**ACTION REQUIRED:** If it is an essential part of this purchase that you carry out the alterations in the kitchen then we would recommend a structural engineer has a look who can provide costs as our experience has found that you can remove practically any wall, it is just the amount of noughts in the end bill that changes considerably so the structural engineer needs to also be able to give you an indication of costs.

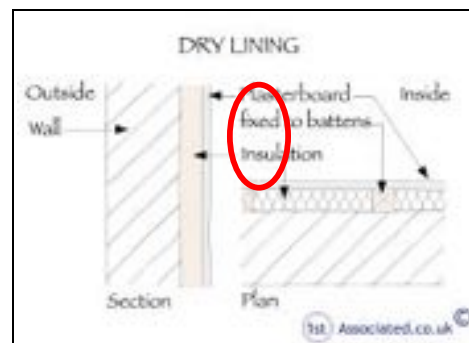
Dry lining (also known as false walls) is often carried out to hide dampness and other problems which is why we are highlighting this on the ground floor. We are also aware on the right hand wall if you look at roof level where it steps we believe dampness is getting in (see sketch below) and we noted the plaster key was loose beneath.

Dry lining

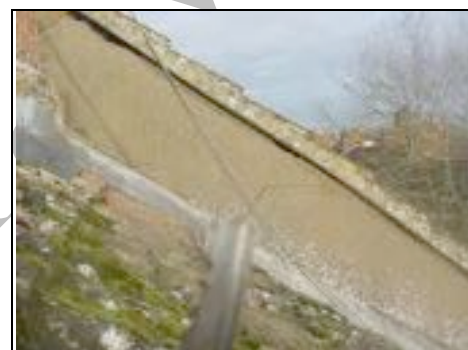
Cracking to render, flashing come away above rear blue bedroom where plaster has lost its key

We can see the cement mortar has come away from the flashing. This needs repairing.

**ACTION REQUIRED:** Repair/replace flashing. Unfortunately as it is high level you will need a set of long ladders or preferably a tower scaffolding.

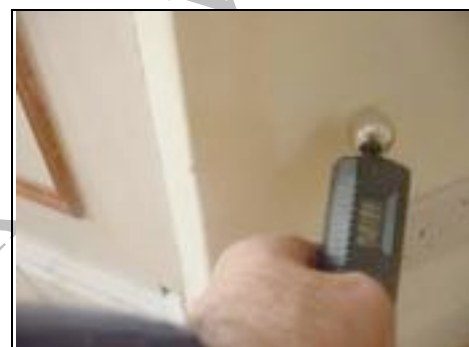
We believe the main reason is the lack of airflow underneath the floor. There is a suspended timber floor covered with a laminate floor so unfortunately we could not see its condition. Whilst we could feel the laminate flooring moving in areas we feel this may be down to the poor quality of the laying or something wrong with the floor.

High damp meter reading to bay

**ACTION REQUIRED:** Ideally we would like to open up the floor to check its condition.

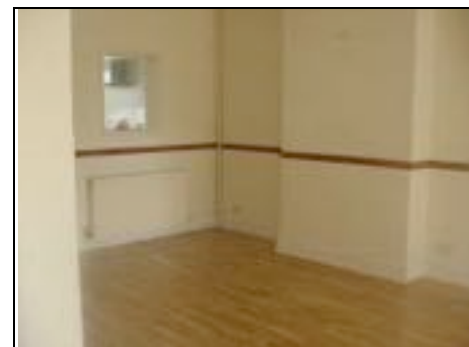
Laminate flooring

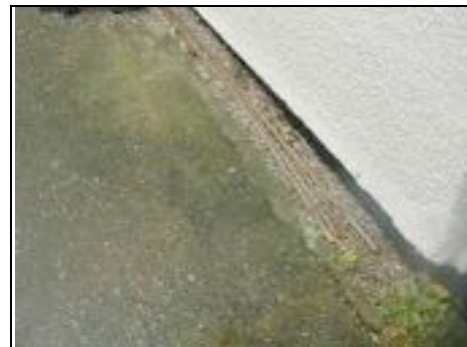
We also found dampness to the rear of the property. This, we believe, is a combination of the problems that we have mentioned and also the rear of the property feels to be a concrete slab which can act like blotting paper when it comes into contact with dampness. We think it may be coming into contact with dampness not only from the suspended timber floor side but also from the outside with rainwater being discharged against the bottom of the wall. We can see that a French drain type has been added but we do not believe it is working properly.

Does French drain to rear work?

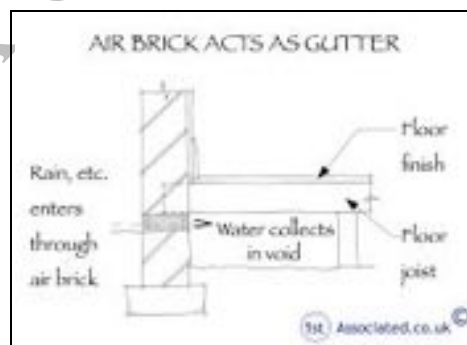
Airbrick acting as gutter

A way of improving things would be to ensure you have an airflow underneath the suspended timber floor. We would recommend adding airbricks to ensure this. You also have to ensure the airbricks are not acting as gutters so we would also protect them. This can be difficult as you would need to do this on a public footpath.

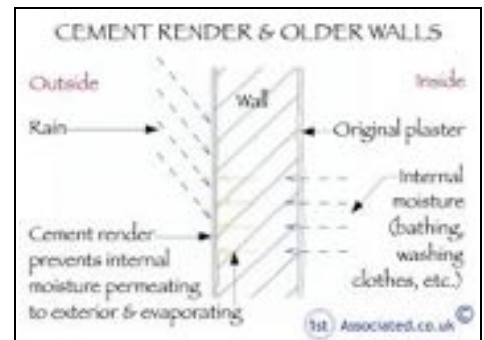
Cement render

**ACTION REQUIRED:** As we discussed the ideal solution would be to remove the render and expose the bricks but often doing this would just result in a layer of damaged brickwork. Therefore you do need to make sure that the rest of the building breathes as much as possible so such things as:

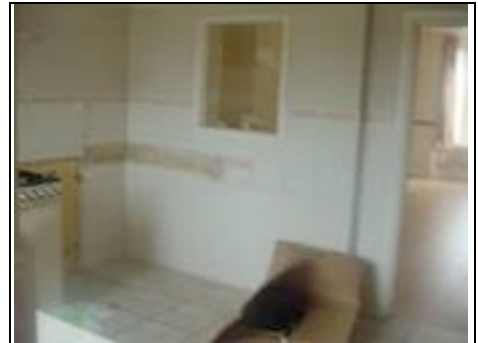
- 1) It will need structural support if you are removing walls particularly as you are looking to remove the main walls of the building. These may also need foundations underneath them which is why we have recommended a structural engineer is essential if it is a hundred percent requirement of buying this property that you do these alterations.

Wall to be removed is outside wall of original building

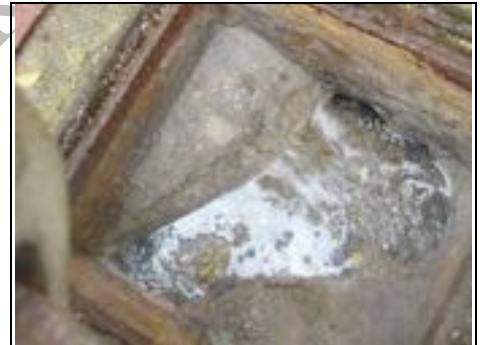
- 2) The drains need looking into. They are relatively shallow and therefore it may be limited as to what you can do to the drains. The haunching looked to be worn away which is also an indication of a regularly blocking drain. The drain was blocked at the time of the survey. The owner thought it was a tenant problem but it may well be a drainage problem or both!

Drain blocked. Looks DIY as haunchings not formed properly.

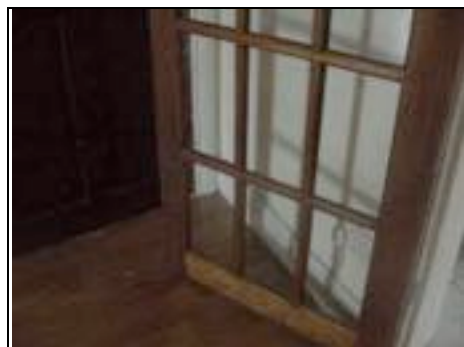
We cannot see a British standard safety kite mark and we believe that this glass is not safety glass therefore it can shatter. We would recommend changing the glass to safety glass.

Door without safety glass

**ACTION REQUIRED:** Replace glass with safety glass or replace the door.

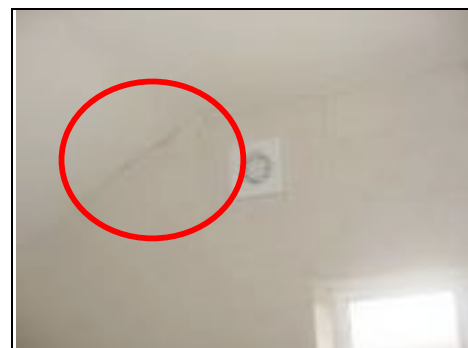
We did see what we thought may be signs of condensation and black mould. This may be as the property has been tenanted they do not tend to get lived in the same way as people that own the property or it may also be that the building is prone to it.

Small extract fan in bathroom  
Is this black mould (circled)?  
Conditions ripe for black mould

**ACTION REQUIRED:** We would recommend large humidity controlled extract fans are added to the kitchen, the bathroom and any areas that are used for drying clothes internally during winter months (we would assume that clothes will be dried externally during the warmer months). By large extract fans we mean 150mm.

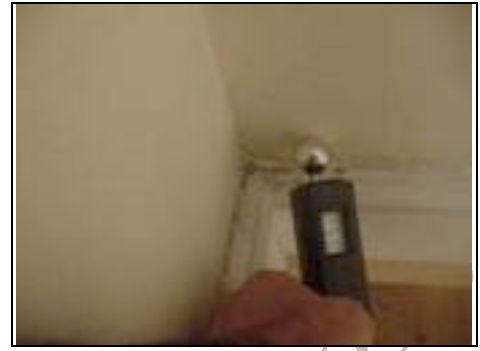
Signs of black mould

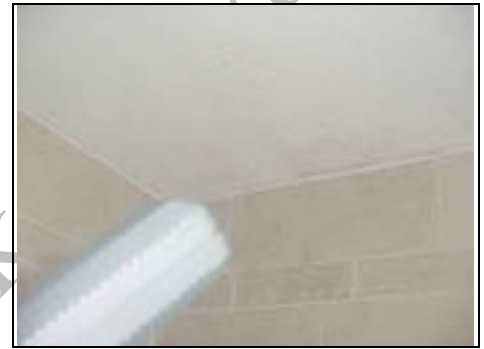
Black mould in utility room

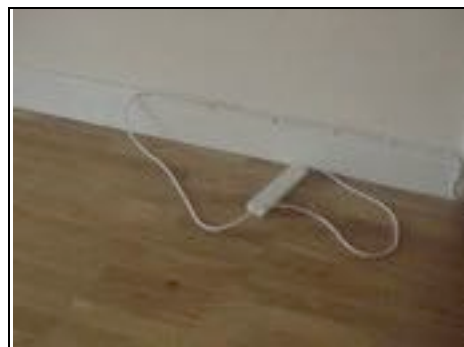
We noted what we would term as DIY electrics throughout the property and a lack of socket points to the kitchen and also in some of the rooms.

DIY electrics

**ACTION REQUIRED:** We recommend an Institution of Engineering and Technology (IET) test and report to be carried out by an NICEIC registered and approved electrical contractor or equivalent.

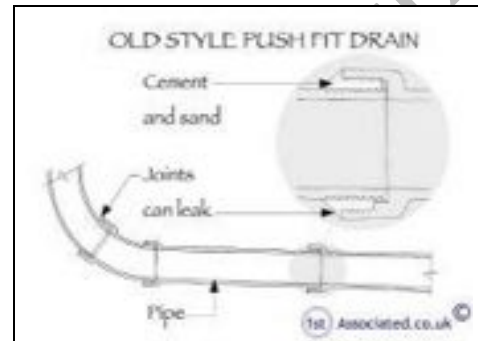
We would refer you to our previous comments. We would also add in older properties, such as this, drainage was often push fitted together rather than bonded together which means that they may leak over the years. We usually run the tap for 15 minutes however in this case the drains were backing up.

Push fit drain

**ACTION REQUIRED:** We would recommend a closed circuit TV camera report of the drains once the drains have been unblocked by the owners.

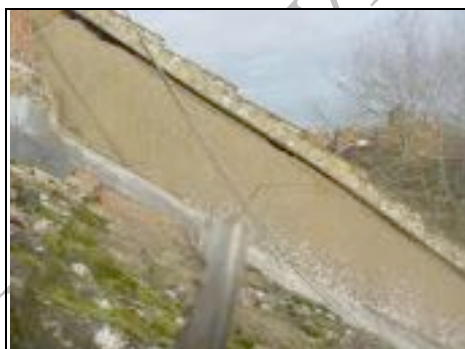
The property sits on a sloping site, both left to right and front to back. The left to right slope means there are steps in the roof. These steps are rendered with a lead flashing. We can see that the lead flashing is coming away and also there is cracking to the right hand side.

Flashings starting to come away  
pointing coming out

Cracking to render, flashing come  
away

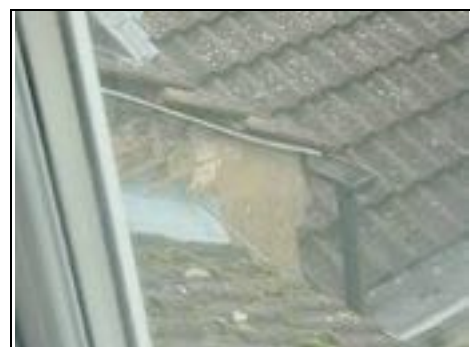
Next doors verge problem to roof could become your problem if it soaks into the wall and then goes down into the rooms below.

Next doors verge

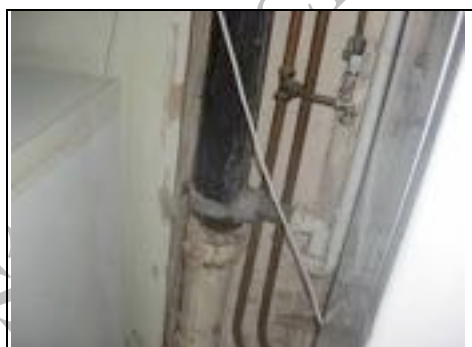
The soil and vent pipe looks to be leaking or has been leaking. It could be back up from the drains. These 'leaks' could be that the drain that is located behind the stairs is also blocked and this has been a back up of sewerage in the soil and vent pipe.

Soil and vent pipe leaking

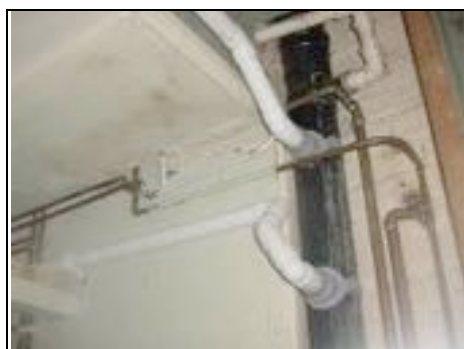
Downpipe originally in passageway that ran down side of building  
Plastic connections to cast iron pipes looks to have leaked

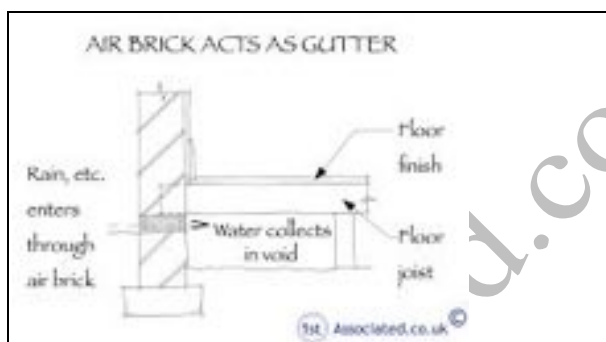
Air bricks are essential to have a through flow of air as this helps to reduce the chances of wet rot, dry rot and woodworm. In this case the airbrick to the front is acting as a gutter.

Airbrick acting as gutter

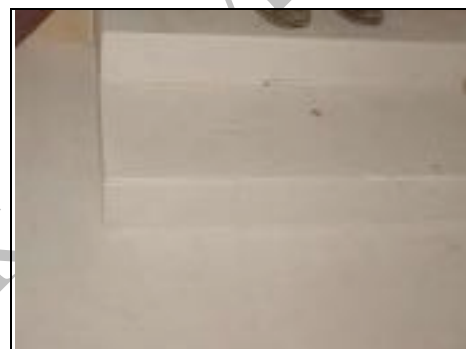
We noted broken tiles in the bathroom.

Broken tiles in bathroom

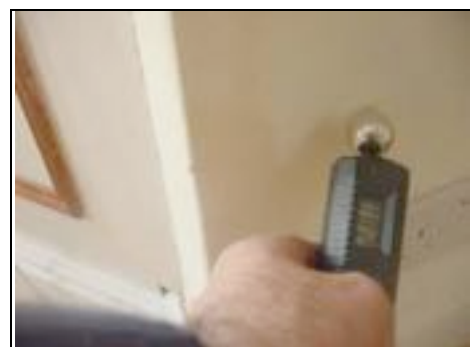
A visual inspection and tests with a moisture meter have been taken to the perimeter walls. In this particular case we have found significant rising damp.

High damp meter reading to bay

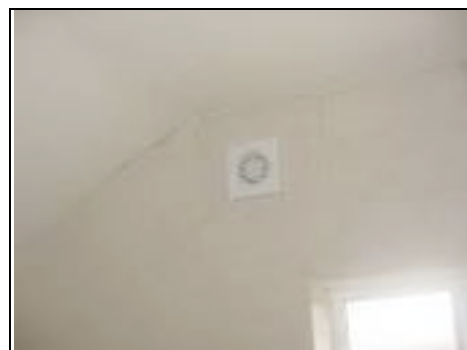
Small extract fan in bathroom  
Is this black mould  
Conditions ripe for black mould

**ACTION REQUIRED:** We would recommend large humidity controlled extract fans be added to kitchens, bathrooms and any rooms where you intend to dry clothes.

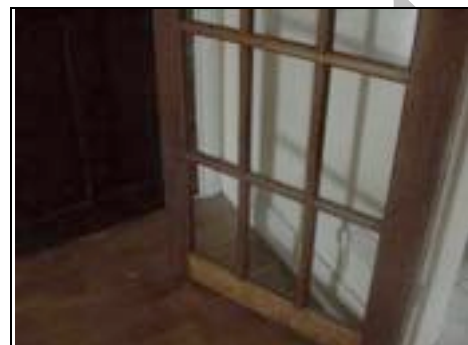
We cannot see a British standard safety kite mark to the glazed door and we believe that this glass is not safety glass therefore it can shatter. We would recommend changing the glass to safety glass.

Not safety glass

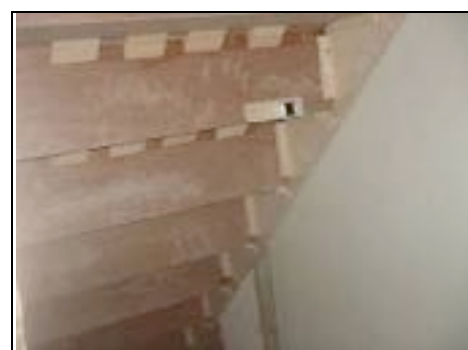
We noted that the underside of the staircases were exposed. We are surprised that building regulations passed the stairs without it being lined. It is more normal today to have a half hour fire barrier to stop fire spreading from the ground floor to the first floor in a worse case scenario. You may wish to take a view on whether you add this.

Stairs not lined

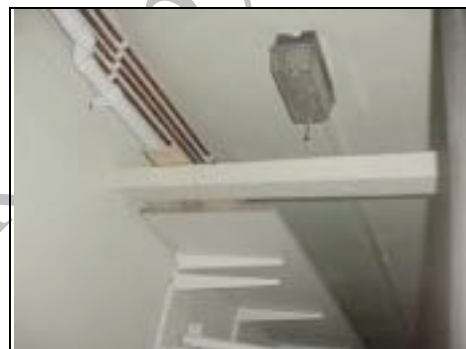
What is this horizontal bar?

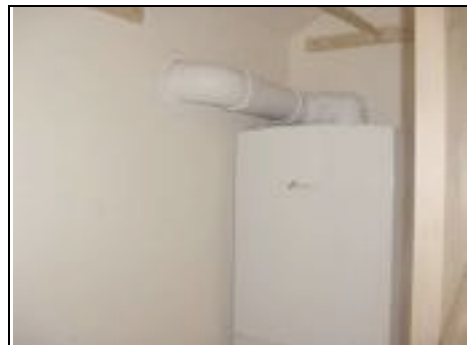
Boiler needs to be vented to outside air

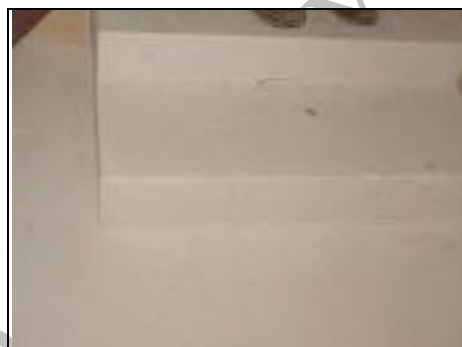
Cracked step hidden

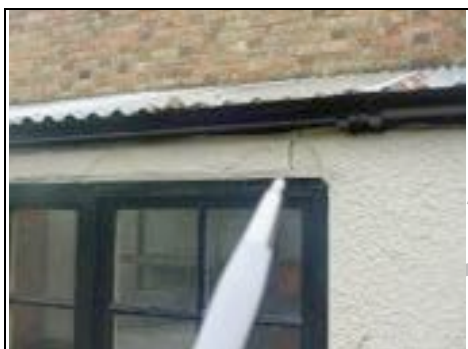
Crack in outbuilding

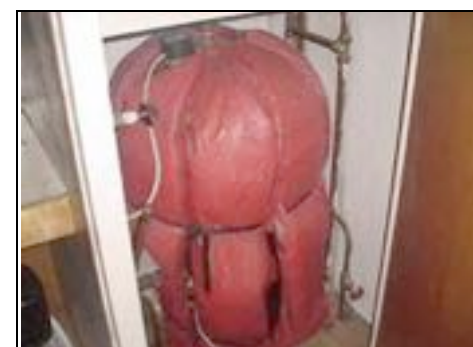
Older style cylinder with loose insulation jacket

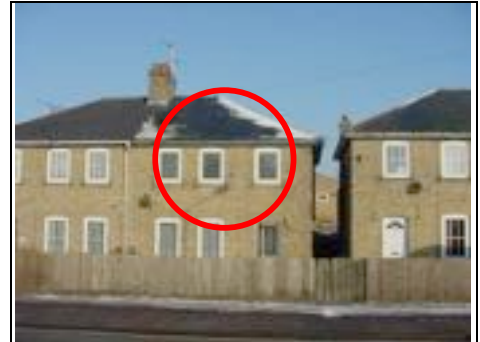
Inappropriate double glazed windows change the look of the property  
Red circle is insulated roof indicated as snow is not visible
