PROPERTY REPORT AND NEGOTIATION DOCUMENT

Biggleswade
Bedfordshire
SG18 XXX

We have been instructed to inspect and prepare a Property Report and Schedule of Condition for:

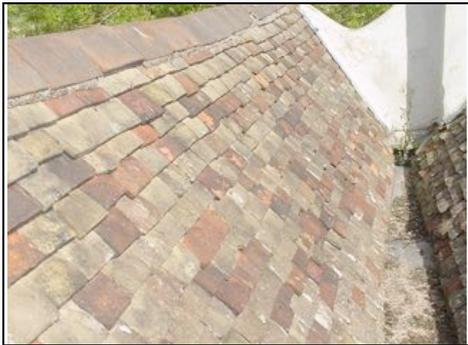
Where the roof has been repaired, in some areas the tiling does not look appropriate and looks to have been carried out with a concrete tile.

The Listed Building Officer could in theory ask you to replace this with the appropriate clay peg tile.

General view of tiling showing the variety of tiles used and some of them are not older style clay tiles

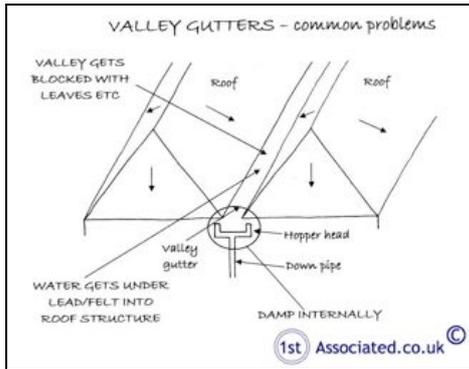
The roof to the right side consists of an old double pitched roof with hidden lead valley gutters and box gutters which are covered with a peg tile. We would say this is in poor condition, leading to dampness coming in which is visible in the private living accommodation beneath.

Common problems with valley gutters – and you have two valley gutters

ACTION REQUIRED: We recommend the roof is excluded from the Lease or the property owners/existing leaseholders carry out work to bring this into a good condition.

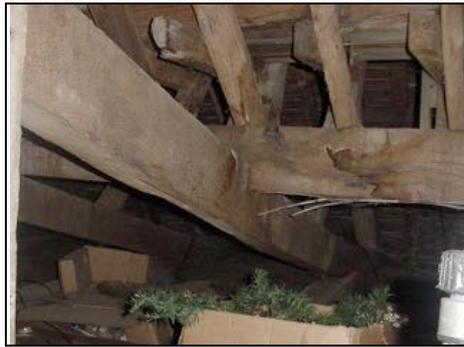
Underneath valley gutter dampness coming in

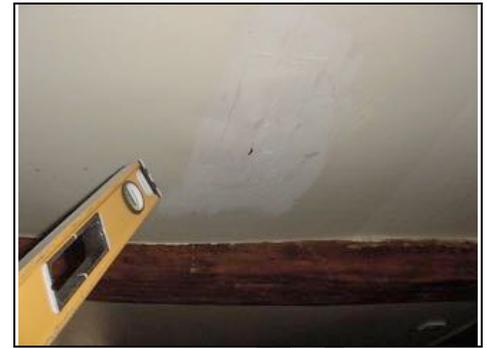
Dampness coming through the ceiling in one of the right hand bedrooms

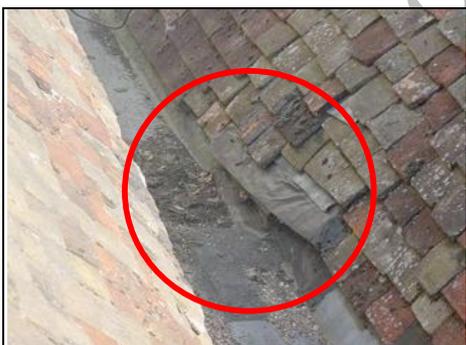
DIY repair to old roof

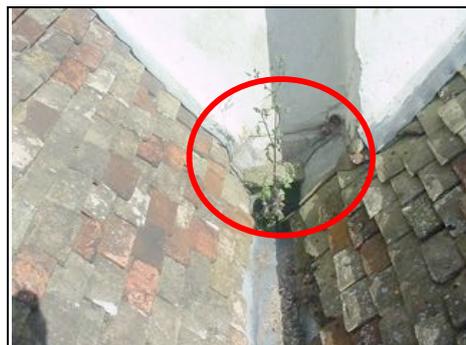
Plants growing out of the water outlet on the right hand roof

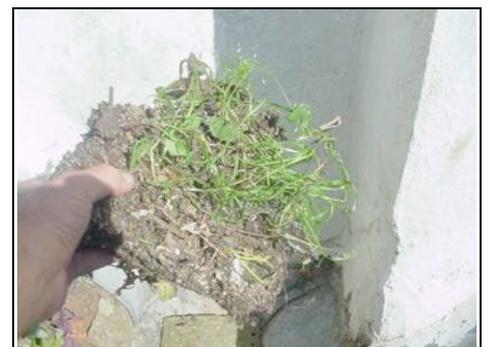
Removing mud and grass out of valley gutter – lack of maintenance

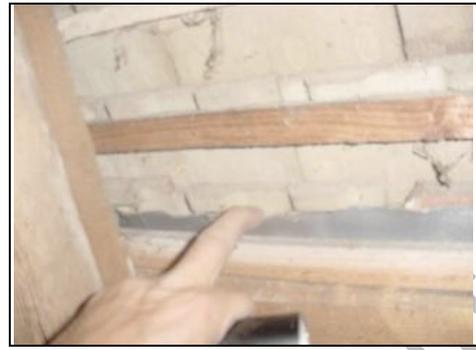
Back of lead lining on valley gutter damaged in some areas DIY repair

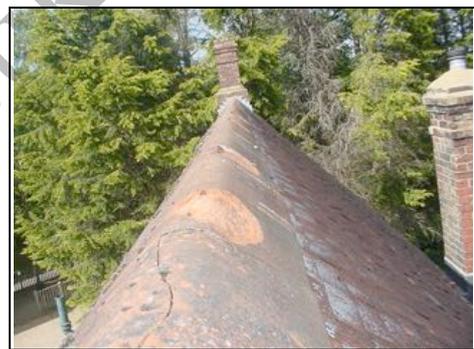
We could see that the left side pitched roof has roof tiles, which are spalling to the ridge and various other areas. With a Full Repairing and Insuring Lease you will be asked to replace these which is likely to be expensive as this will require high-level access and possibly scaffolding.

Spalling to ridge tiles

ACTION REQUIRED: We would recommend taking the opportunity over the next few years to replace the ridge tiles and from an operations point of view if dampness does get into the structure it would penetrate into the first floor function room area as well as causing deterioration to any timbers that the dampness meets on its way through to the function room area.

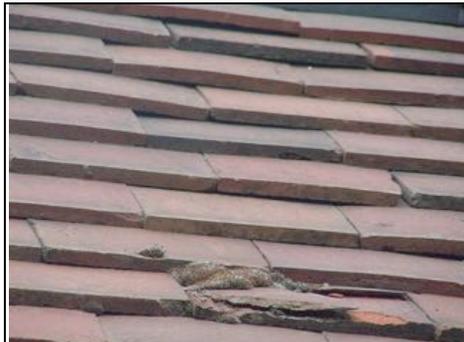
The rear right pseudo-pitched roof has modern tiles which are starting to spall and need repair and making good. We also noted the flat roof is full of rubbish.

Spalling tiles on the rear right pseudo-pitched roof

ACTION REQUIRED: Replace spalling tiles on pseudo pitched rear right roof, reinstate the safety rail on the left hand flat roof and clear both flat roofs.

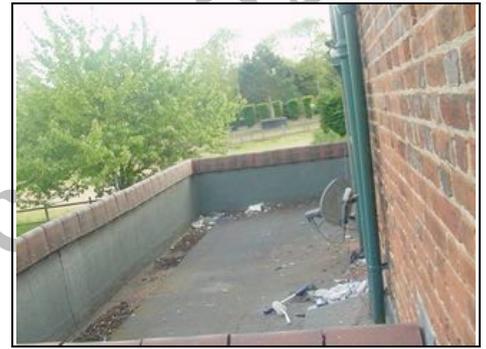
Rear right flat roof with rubbish on it which needs clearing

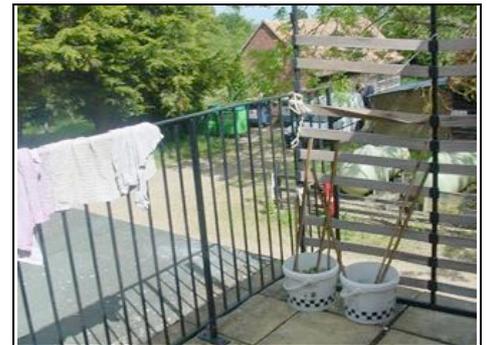
There is an access onto the left flat roof which is partly protected by a rail however there is a rail missing to the end of the flat roof.

Handrail replaced with carcass of a bed

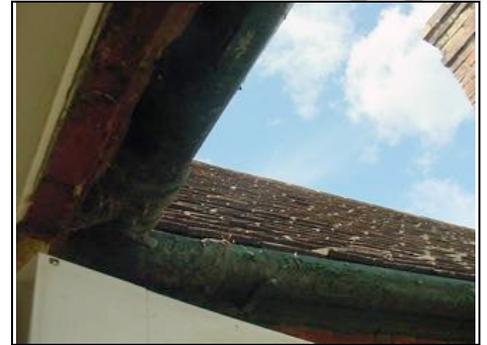
You have ogee cast iron gutters which are renowned for rusting to the rear, there was vegetation growing from many of them which would indicate that there is also rainwater sitting in them which will lead to rust etc.

Rusting cast iron guttering

ACTION REQUIRED: Initially clear the gutters then check on a rainy day which gutters are leaking and in need of repair or replacement, then carry out repairs the sooner the better to help resolve any dampness that is getting into the property.

ANTICIPATED COST: Few hundred pounds; please obtain quotations.

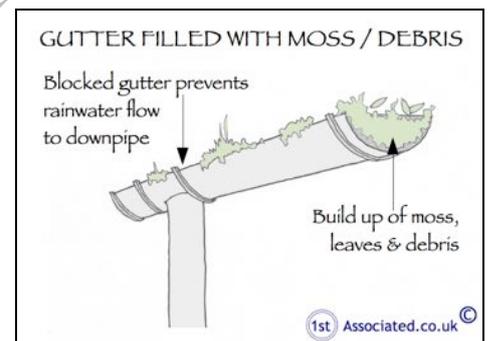
Gutter full of moss/debris

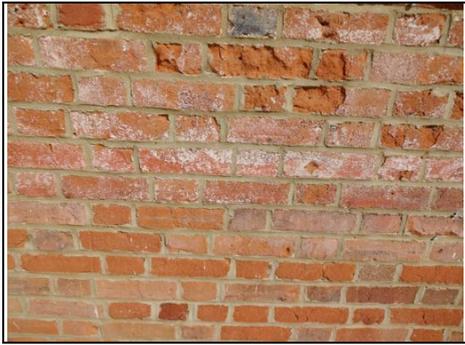
You have an older style soft red brick to much of the property which we could see has been incorrectly re-pointed using a cement mortar instead of a lime based mortar which is causing deterioration to the brickwork. This deterioration will only become worse with time. You again would be liable for this under the Full Repairing and Insuring Lease and also the use of cement mortar on an old property like this, we believe, is not compatible with general Listed Building/Conservation requirements.

Brickwork spalling which has been incorrectly re-pointed in cement mortar

ACTION REQUIRED: We recommend that all cement mortar is removed from the building and repointing in a lime based mortar, together with brick repairs.

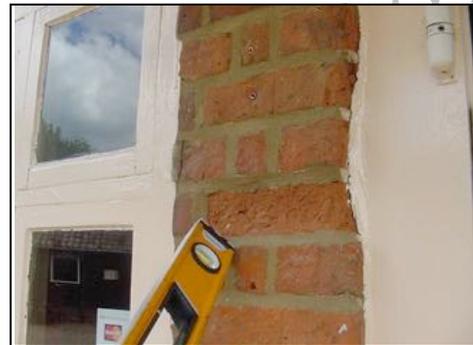
Low level brickwork incorrectly repointed in cement mortar

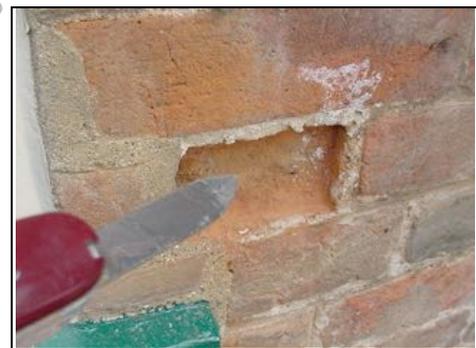
Brickwork breaking up

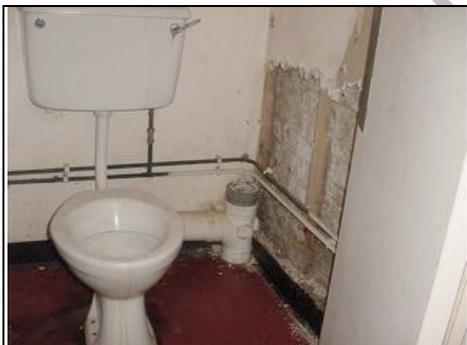
The dampness can effectively be seen within the kitchen/toilet area where the wall has deteriorated, exposing the dry lining/false wall.

Exposed dry lining in toilet

ACTION REQUIRED: Exclude any dampness from the Lease as we feel much of it has been hidden by the dry lining over the years when alterations have been carried out.

ANTICIPATED COST: We would set aside the sum of £500 to £1,000 to repair the deteriorating dry lining within the toilet area and general redecoration; obtain quotes.

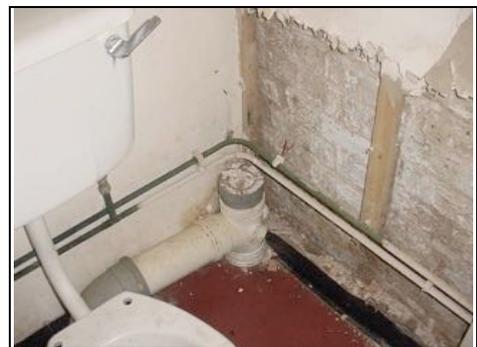
Close up view of dry lining where the dampness has taken the plasterboard off the wall

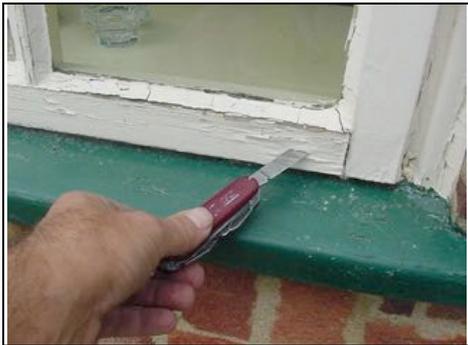
You have timber painted casement windows; many of them are in poor condition. We could see that rot has been painted over and we could push a knife several inches into many of the timber windows during our knife test.

Rot to window

ACTION REQUIRED: Repair, splicing in new timber and redecoration; possibly replacement in some cases may be more economical but do remember that you need to get Listed Buildings Approval if this is being carried out.

ANTICIPATED COST: In the region of £5,000 to £10,000, but we would not be surprised if costs were up to £20,000 if the windows have to be replaced and made to their existing profiles. Of course you will then have the associated dampness to resolve. Please obtain quotations.

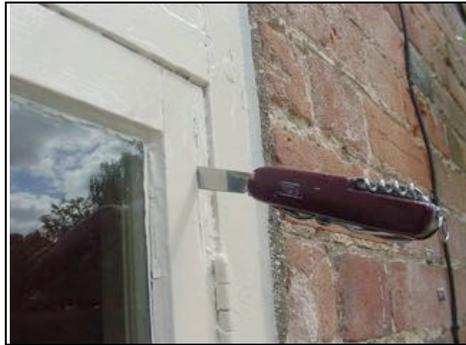
Rot to front window

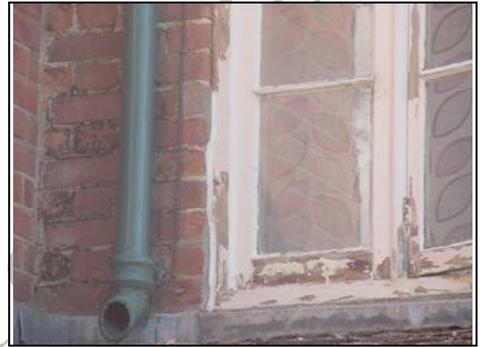
Rot to Managers office/front left bedroom window

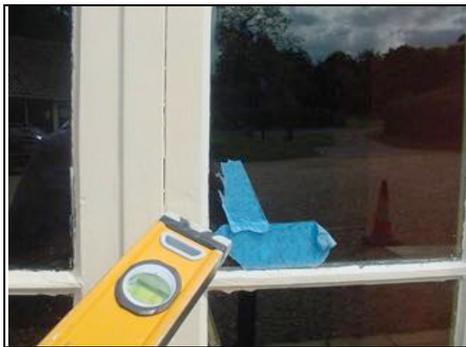
Broken front window pane

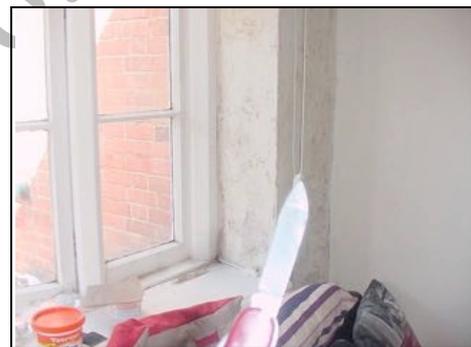
We would add that some of the windows have been redecorated but we would consider this to be to a DIY standard. The windows are in such a condition now that in some rooms dampness is getting in and around the windows.

Dampness coming in around Managers office/front left bedroom window

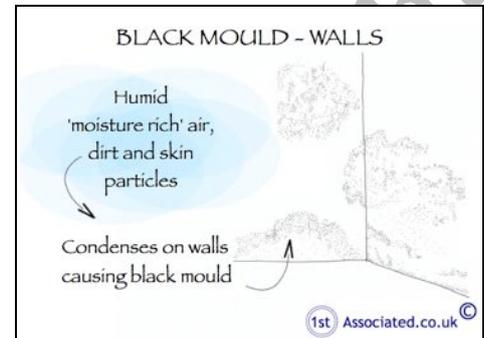
There is a considerable amount of dampness getting into the cellar area where black mould is visible.

Black mould to walls

ACTION REQUIRED: We recommend a meeting with the Environmental Health Officer both with regard to the cellar and also the kitchen in general explaining that you have run this particular public house before and agree an action plan over the next year.

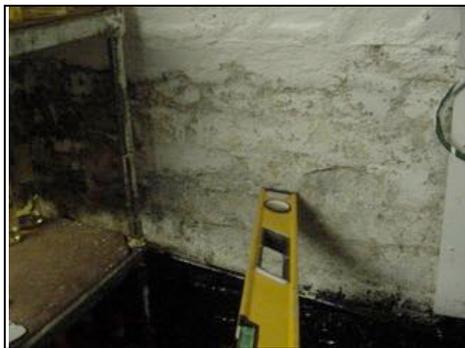
Dampness in cellar

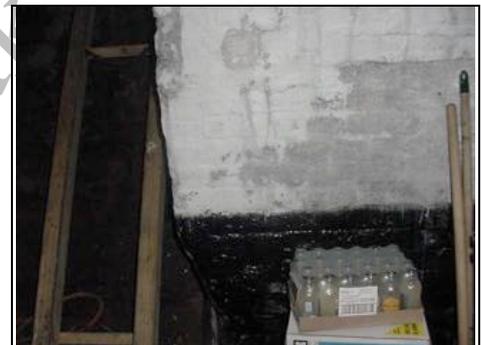
Damp in cellar

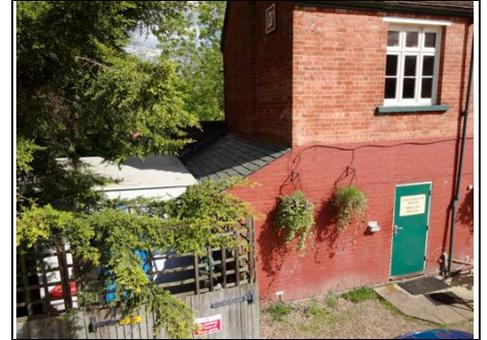
Overhanging trees

ACTION REQUIRED: Appoint an arboriculturalist (not a tree surgeon) to carry out a five year programme of maintenance work.

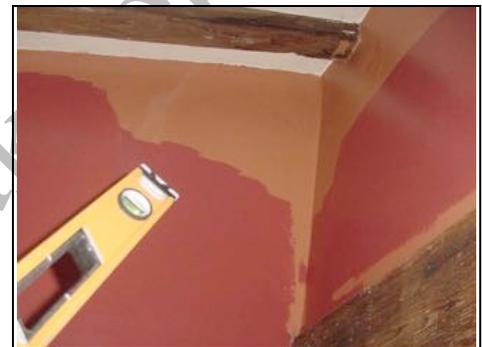
It would appear that the existing leaseholders have started to redecorate internally. We would consider the work that has been carried is a poor DIY standard at best, which has involved painting the public house in an inappropriate red. Interestingly when we spoke to the pub manager he advised that the maintenance and painting of the pub internally and repair/painting of the windows had been added to the list of jobs he has to carry out rather than having a professional to carry out the work.

Areas with paint missing

ACTION REQUIRED: Full internal redecoration.

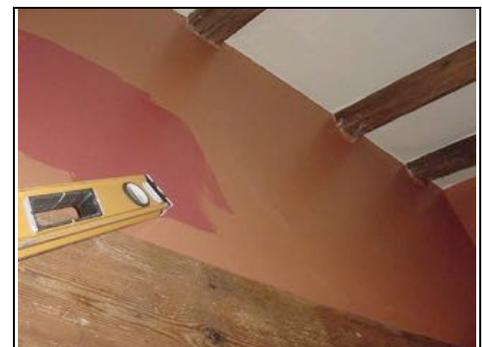
Poor quality painting

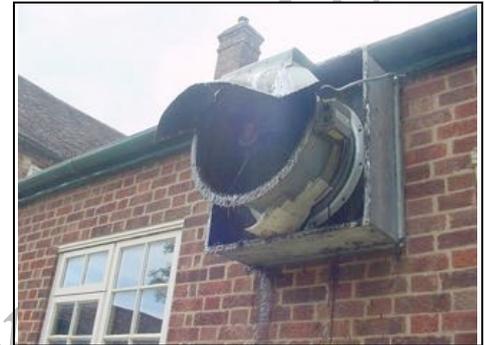
The extract fans do not look to have been cleaned for many years and grease is literally dripping out of the rear of the extract.

Rear extract fan needs clearing of grease

ACTION REQUIRED: Install grease traps.

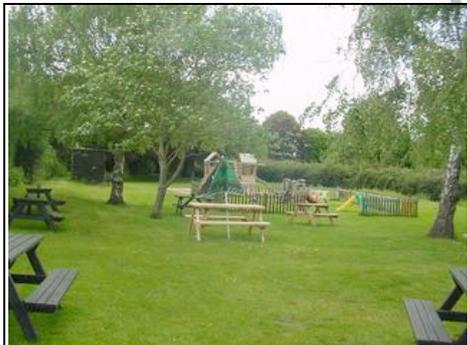
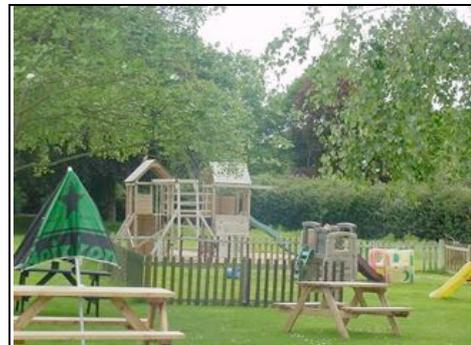
We think the play area may not potentially be to The Royal Society for the Prevention of Accidents (RoSPA) standards.

ACTION REQUIRED: Have this checked to ensure it is to RoSPA standards.
