PROPERTY REPORT AND NEGOTIATION DOCUMENT

XXX Industrial Unit
XXXX
Oakley
Bedfordshire
MK43 XXX

We have been instructed to inspect and prepare a Property Report and Schedule of Condition for:

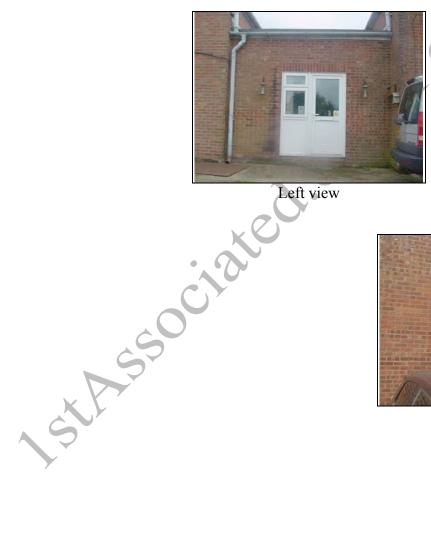
Flat roof

There is a reasonably large flat flat roof to the middle of the property. It has some wear. There are no obvious visual signs of leaks.
