JOB REFERENCE: XXXX

RESIDENTIAL BUILDING SURVEY

Wisbech
Cambridgeshire.
PE14 XXX

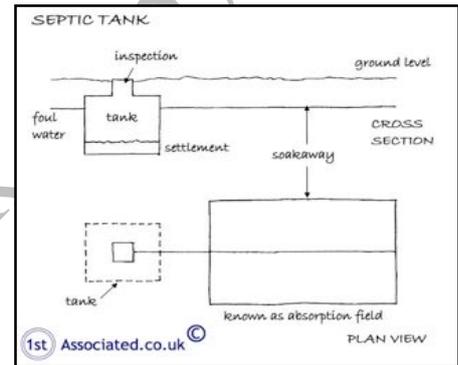
We suspect this to be a septic tank / cesspit. What we could see of it as it was full at the time of our inspection, indicates that it is brick built and these can leak.

Example sketch - Septic Tank

ACTION REQUIRED: Ideally you need to contact the company that drains the septic tank / cesspit as they will normally have an opinion on the condition of it, as they will have seen it when it is empty. Often they will offer a lining service or a worse case scenario would be a GRP tank (Glass Reinforced Plastic).

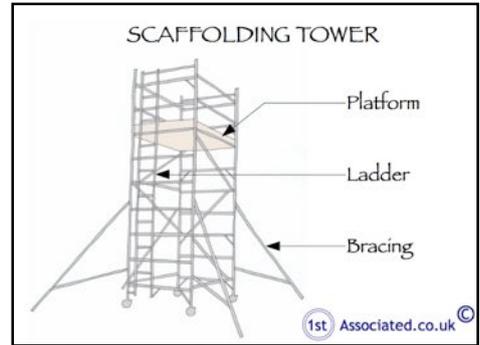
The fascias and soffits and shiplap boarding have suffered from a lack of maintenance over the years, both of which need repair and redecoration.

Example sketch - scaffolding tower

ACTION REQUIRED: We would recommend repair and redecoration.

ANTICIPATED COST: As it is high level work, we would expect costs to be in the region of £1,500-£4,000. We suggest that it may be worthwhile you getting your own tower scaffold; please obtain quotations.

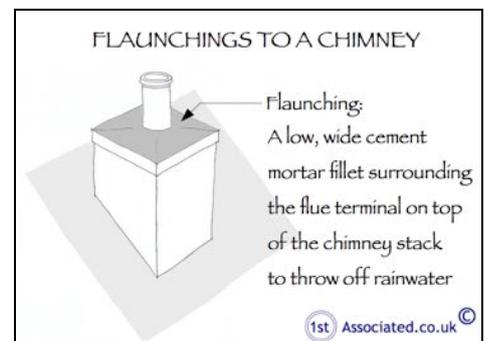
Flaunching

Unfortunately we were unable to see the top of the chimney properly known as the flaunching, we therefore cannot comment upon them.

ACTION REQUIRED: Periodically inspect the chimney.

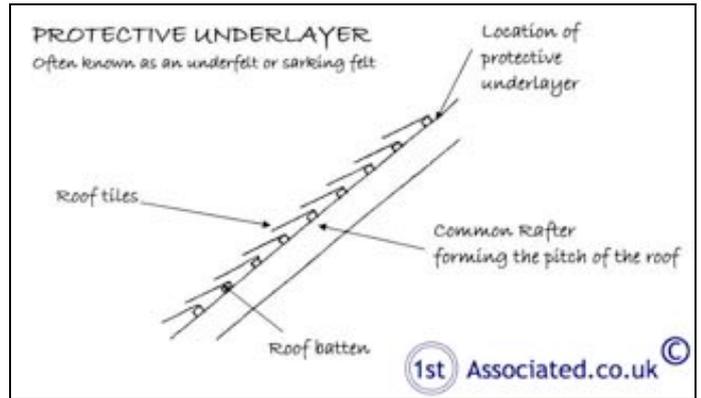
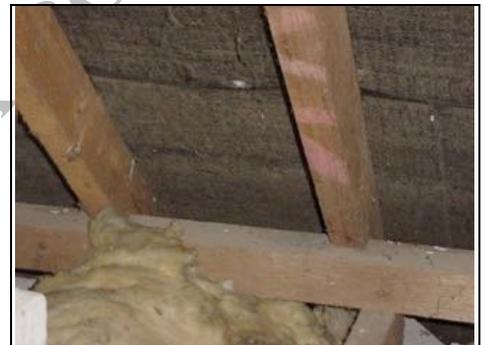
When we inspected the loft space we found a Hessian base Bitumen membrane. This type of membrane has been used since the 1960s. We generally found it to be in average condition, with damage in some areas which is what we typically find.

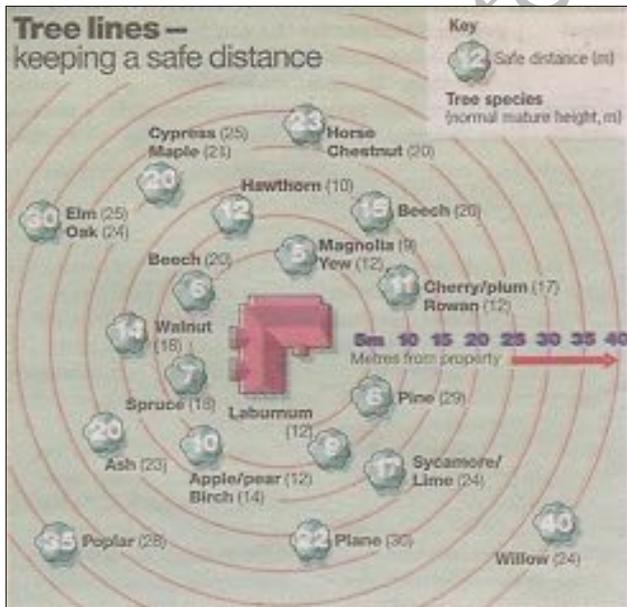
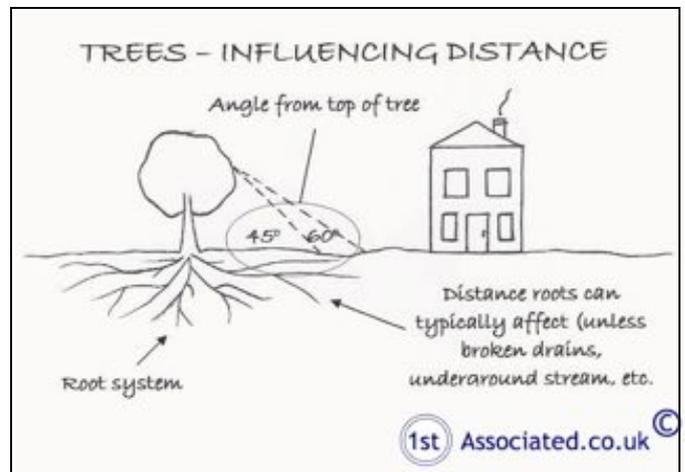
The tree is located next to the property on the left hand side

Influencing distance of trees to a property

ACTION REQUIRED: We would recommend you seek expert advice from an arboriculturalist (not a tree surgeon) is asked to view the property and give a ten year plan for maintenance. Please see our comments in the Executive Summary.

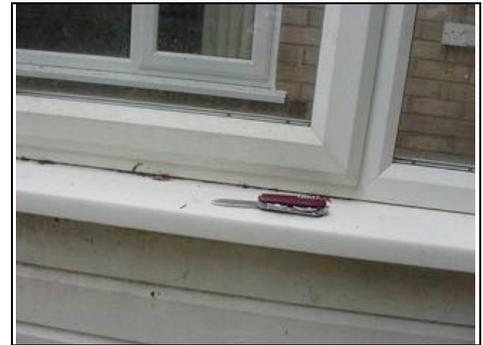
The property has predominantly plastic double glazed windows without trickle vents, which generally look to be of average quality and there are some timber windows with rot.

We would draw your attention to the fact that sealed double glazed units can fail, particularly as a result of poor workmanship during installation. Failure of the seal leads to condensation between the two panes of glass and simply replacing the affected units may not provide a satisfactory long-term solution.

Plastic windows

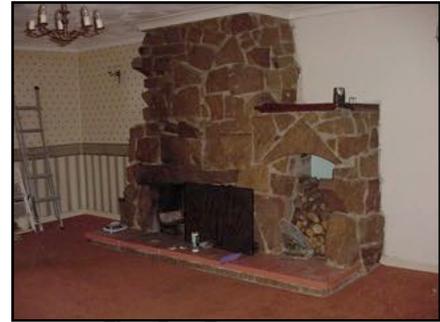
The chimney breast is located in the middle of the property and it is a 1970s style (all directions given as you face the front of the property). It was a feature fireplace, whether it be considered a feature today is a matter of personal taste.

1970s style 'feature' fireplace

Any chimneys you do intend to use should be swept and a check should be carried out that a lining is in place.

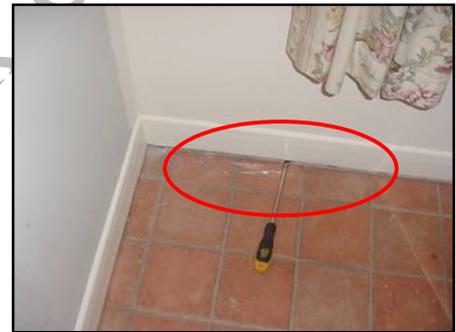
- (1) That this is related to the movement on the left hand side on the rear of the property.
- (2) That it could be movement underneath the property that is a separate issue, due perhaps to the made up ground from the railway line or the peat.

Gap between tiled floor and skirting board

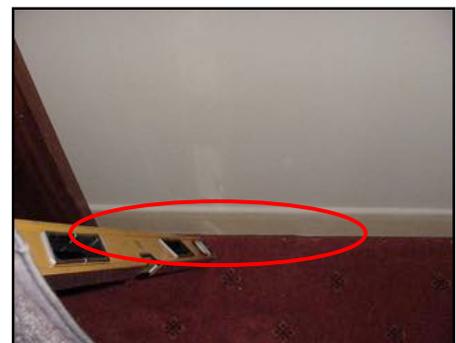
Gap between carpeted floor and skirting board

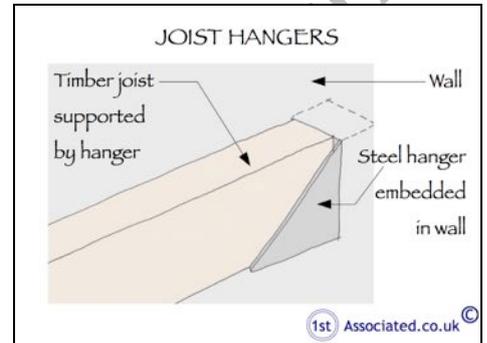
We have assumed that the first floor construction is joist and joist hangers with floorboard sheets.

Joist hangers

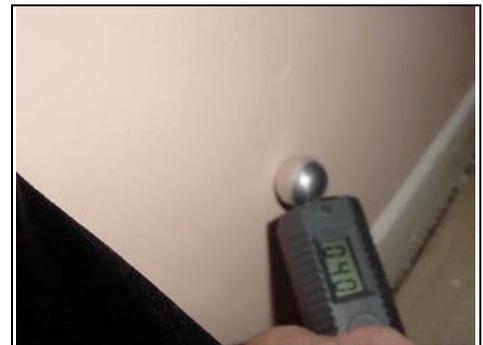
A random visual inspection and tests with a moisture meter have been taken to the perimeter walls. In this particular case we have not found significant rising damp.

Testing for Rising Damp

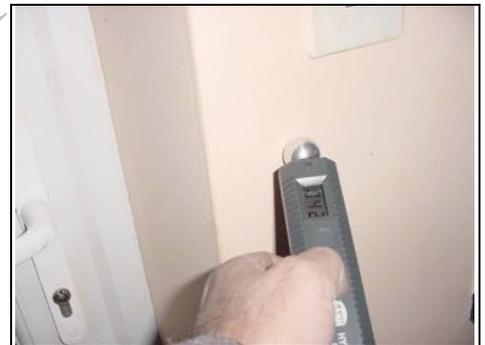
We used a resistance meter on the external walls. We have not found significant dampness.

Testing for lateral dampness

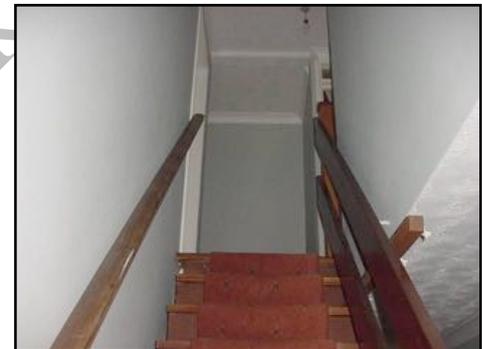
The property has an unusual staircase that has been made on site as opposed to being a pre-fabricated staircase.

We were unable to examine the underside of the stair timbers due to it being lined, which precluded our inspection, so we cannot comment further upon the stair structure. We can, however, say that the lining gives a resistance to the spread of fire if such circumstances were to occur.

Unusual staircase

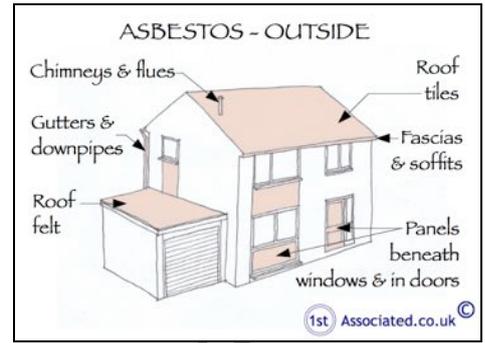
We have not noted any asbestos but it was very common in this era of property.

Asbestos externally

Our insurance company requires us to advise we are not asbestos surveyors and advises us to recommend asbestos surveyors are instructed and that you have your own asbestos survey carried out.

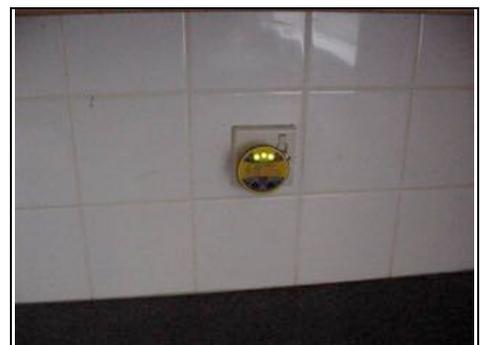
We carried out an earth test in the kitchen area to the socket point that is normally used for the kettle, this proved satisfactory.

Earth test

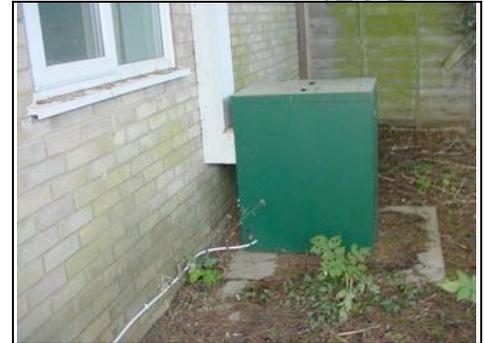
The Worcester oil boiler was located outside of the property and we were advised it is relatively new and you should obtain any records you can. You need to check that there is some oil available as many people leave the property literally without any oil.

Worcester oil boiler

Our limited inspection of the hot water and central heating system revealed no evidence to suggest any serious defects but we would nevertheless recommend that the system be tested and overhauled before exchange of contracts and that a regular maintenance contract be placed with an approved heating engineer.

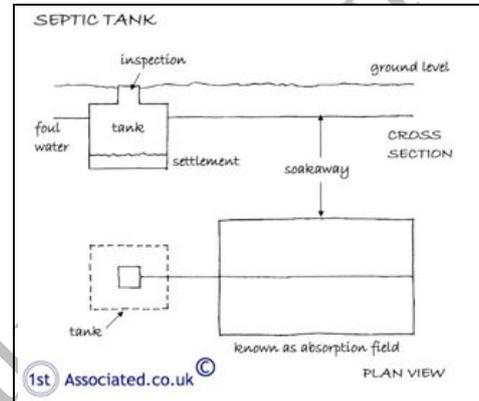
The property is on a septic tank or cesspit, however we are not certain. We think it is likely to be on a septic tank in which case works as explained below. The septic tank / cesspit was full at the time of our inspection.

Septic tank

We have been unable to determine the adequacy of treatment or the effectiveness of the disposal arrangements. The surface water discharges onto the ground.

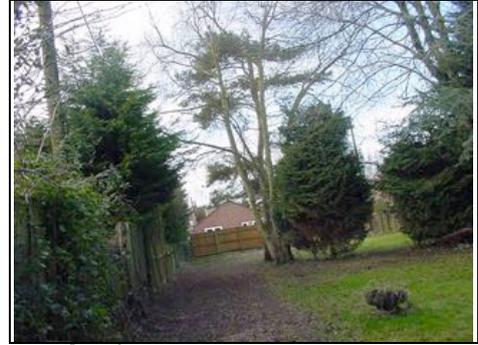
The front garden has mature trees and there are also boundary issues to deal with. Please see our previous comments.

Front Garden

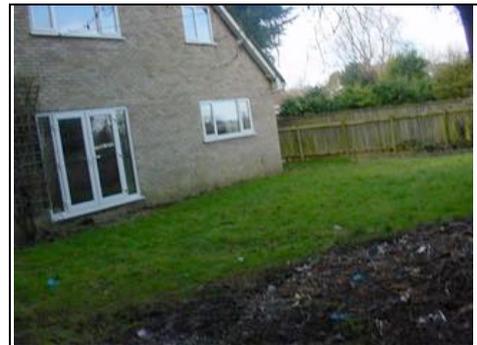
The rear garden has mature trees and there are also boundary issues to deal with.

Rear Garden

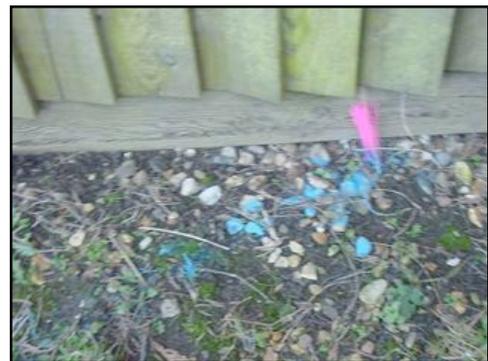
Boundaries: Usually we would say the boundary is on the left-hand side, however in this particular case we would refer to the Deeds. The left hand boundary (all directions given as you face the property) is usually the responsibility of the subject property.

Boundary markings using purple feathers and blue chalk dust
