RESIDENTIAL BUILDING SURVEY

OF
Luton, Beds LU2

1950's
Semi-detached Property

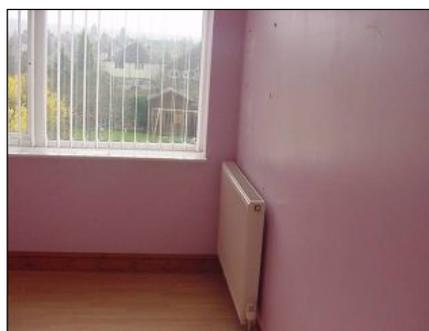
We note that the windows had no trickle vents and that some of your radiators were internal. This means there is a lack of general air movement and airflow within the property which increases the likelihood of condensation. You need to ensure that any moisture/humidity created in the bathroom and kitchen needs to be extracted from the area as quickly as possible.

Internal radiators

ACTION REQUIRED: Relocate the radiators underneath the windows

ANTICIPATED COST: A few hundred pounds per radiator; quotations required.

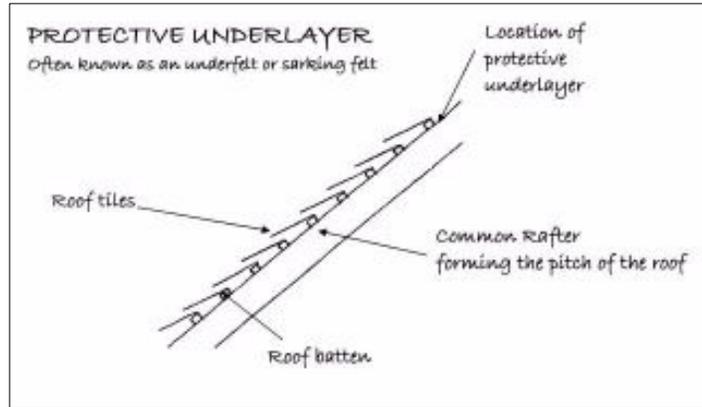
When we inspected the loft space we found a Hessian base Bitumen membrane. This type of membrane has been used since the 1960s. We generally found it to be in average condition, it is damaged in a few more places than we normally find.

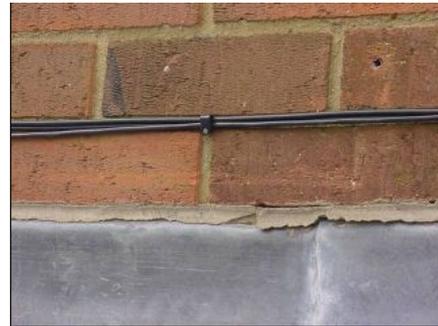
Roof tile

The garage to the left hand side has a shallow pitched large concrete tile roof. From what we can see it is in reasonable condition. However, we would comment that the angle of it is relatively low and may allow wind driven rain in and also it has a very awkward gutter detail that you need to see. The flashing is coming away as it has been wrongly pointed.

ACTION REQUIRED: Please see our comments in the Executive Summary and repair the flashing.

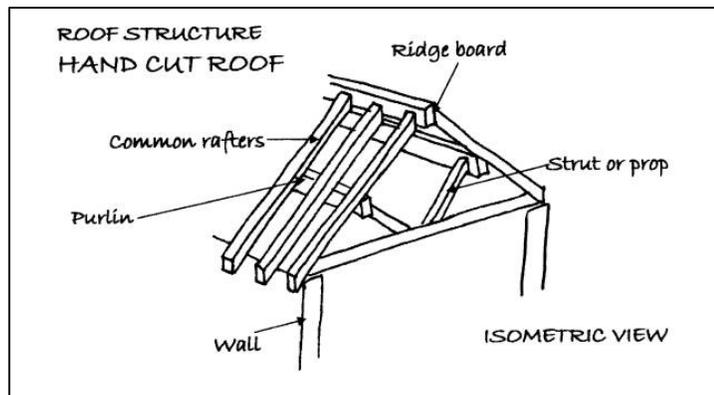
Roof Timbers

We found the roof timbers generally in average condition considering their age. There was an unusual stepped purlin detail. We have inspected the roof structure for:

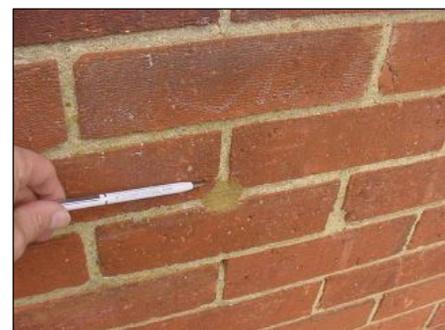
Circular holes drilled in wall

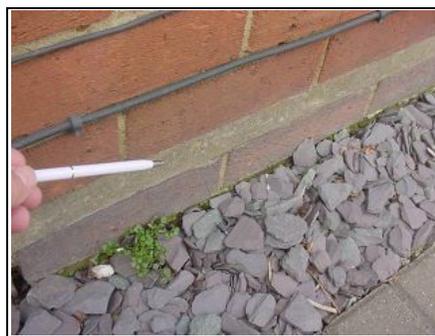
All modern properties should incorporate a damp proof course (DPC) and good building practice dictates that a differential of 150mm (6 inches) should be maintained between the damp proof course and ground levels. In this case we noted a thickening of the cement, which usually means a built in DPC.

DPC – thickening of cement mortar

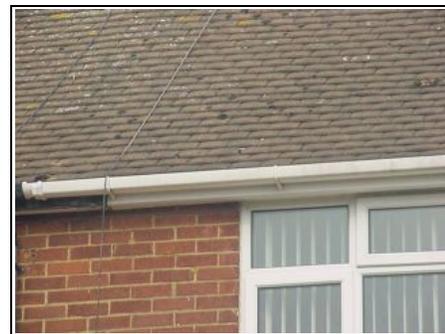
Fascias and soffits/bargeboards

The property predominantly has plastic fascias and soffits, which are in average condition. We are uncertain as to whether these are in place of the original timber or if they are covering the timber. It is very difficult to be certain without opening them up.

ACTION REQUIRED: Ideally add a vent to the soffit, which will allow ventilation to the loft space and help to prevent condensation forming.

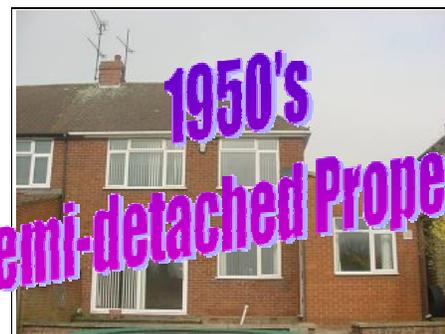
Plastic windows

We would draw your attention to the fact that sealed double glazed units can fail, particularly as a result of poor workmanship during installation. Failure of the seal leads to condensation between the two panes of glass and simply replacing the affected units may not provide a satisfactory long-term solution. In this case they are in average condition.

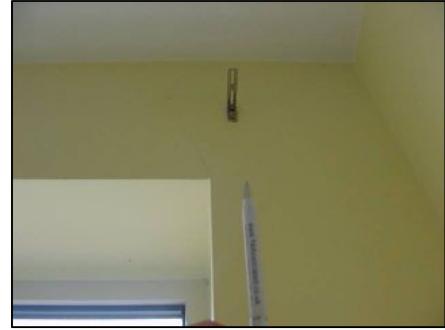
The internal walls of the property are mainly solid. We notice some hairline cracking in some of them. There could be latent defects hidden behind the decoration and we have no way of knowing.

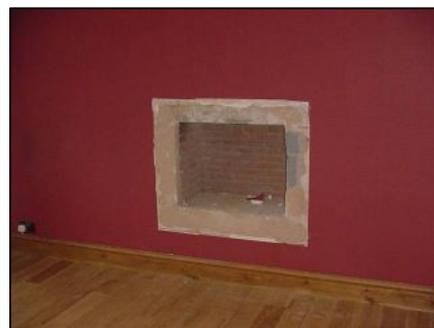
The fireplace has been removed in the main lounge but was obviously a feature of the room.

Any chimneys that you do not propose to use should be capped and ventilated to prevent dampness. In this case we have identified problems with the chimneys that need to also be rectified prior to using them. We are not able to advise whether a lining has been added.

ACTION REQUIRED: You should specifically request your solicitor asks the vendor's solicitor if any linings have been added to the chimney.

Finally, it is strongly recommended that flues be cleaned and checked for obstruction prior to use to minimise the risk of hazardous fumes entering the building.

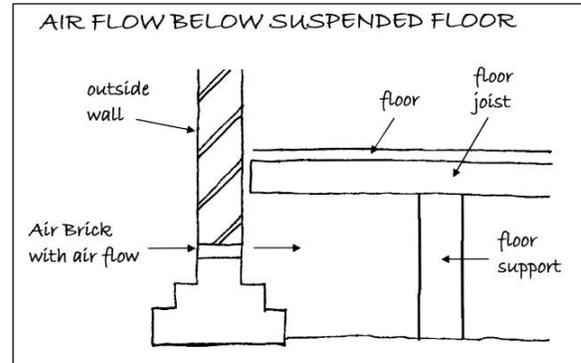
The ground floor construction is predominately a suspended timber floor. This type of floor needs air circulation under it to reduce deterioration from wet rot and dry rot; please see our comments in these sections.

The remainder of the floor is solid under foot and assumed to be concrete.

The floor covering means we cannot see the floor structure.

ACTION REQUIRED: We are concerned that we are unable to see the floor timbers and the floor structure. There may be dampness beneath it due to the way the air bricks are acting as gutters to the front of the property. We strongly recommend the floors are opened up prior to purchasing the property. If they are not opened up there is an element of risk you are taking on.

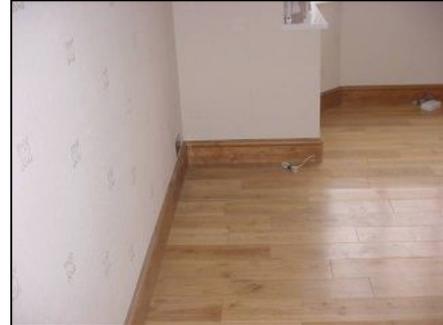
Floor covering not allowing you to see floor beneath

Finally, we have not been able to view the actual floors themselves due to them being covered with floor coverings, laminated flooring and tiles. The comments we have made are based upon our experience and knowledge of this type of construction. We would emphasise that we have not opened up the floors in any way or lifted any floorboards.

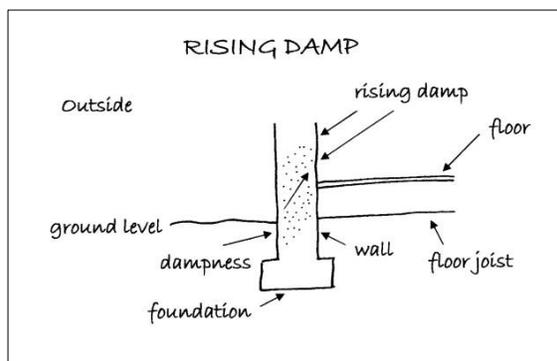
No evidence of any significant rising dampness was detected in the areas checked. It is not usual in a property of this type and age to have minor damp particularly to the front where the slope at the front discharges water against it.

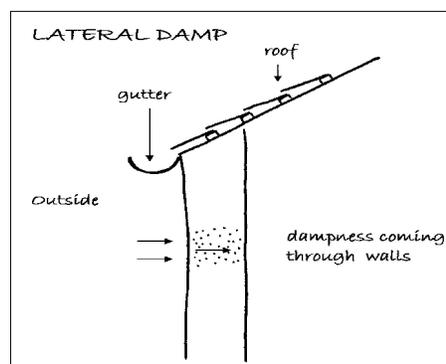
A visual inspection was carried and tests were taken with an electronic conductivity meter at selected points to walls. No significant penetrating/lateral dampness was seen or detected considering the properties age type and style.

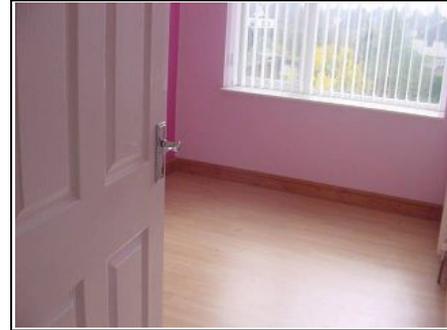
Panelled door

The property has pressed panelled doors. These are from the cheaper end of the market. Unfortunately if they get damaged they are difficult to repair.

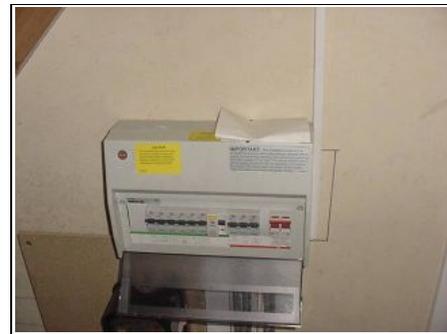
Fuse board

The electric fuses and consumer units were located under the stairs. We would date the fuse board as being from the 1990s – 2000s and, whilst not the best now available, it is reasonable.

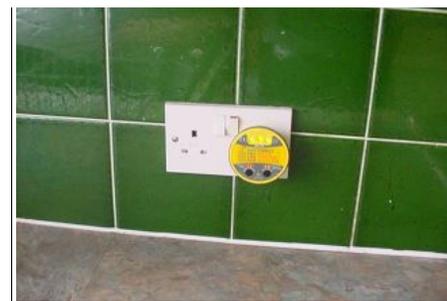
Earth Test

We carried out an earth test in the kitchen area to the socket point that is normally used for the kettle and this proved satisfactory.

Neither of these indicators can give certainty as to the condition of the rest of the wiring.

ACTION REQUIRED: If there is no record of an electrical test having

been undertaken within the last five years, it is recommended that the installation be tested by a competent electrician (NICEIC registered) and all recommendations implemented. Thereafter, the installation should be re-tested every five years.

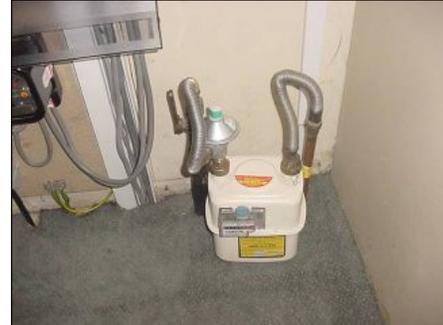
The gas meter cupboard is located under the stairs. All gas appliances, pipework and flues should be the subject of an annual service by a Gas Safe registered heating engineer; works to any gas appliance by an unregistered person is illegal. Unless evidence can be provided to confirm that there has been annual servicing we would recommend that you commission such a service prior to use to ensure safe and efficient operation.

Gas meter cupboard located under stairs

ACTION REQUIRED: As a matter of course it is recommended that the entire gas installation is inspected and made good, as necessary, by a Gas Safe registered contractor. Thereafter the installation should be serviced annually.

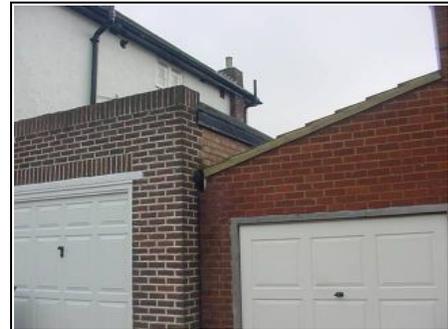
Garages are a useful addition, there was no car at the time of our inspection so it is difficult to gauge if cars can go into it and you do need to be aware that it is likely to leak.

ACTION REQUIRED: Please see our comments in the Executive Summary with regard to the roof.

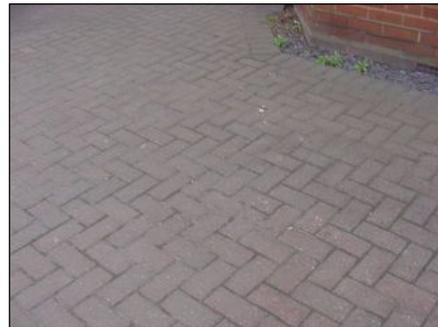
Given over mainly to parking with a hard standing area.
