JOB REFERENCE: XXXX

RESIDENTIAL BUILDING SURVEY

XXXX
Odell
Bedford
Bedfordshire
MK43 XXX

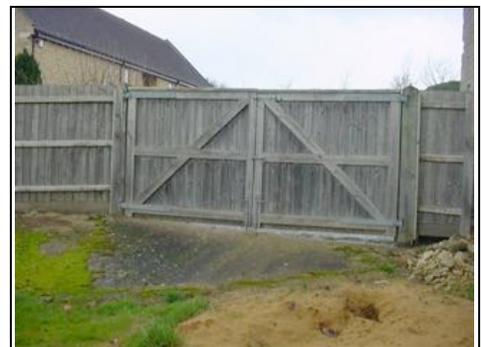
Gate adjacent to barn, which needs further investigation regarding rights of access, etc.

ACTION REQUIRED: Your legal Advisor needs to check and confirm.

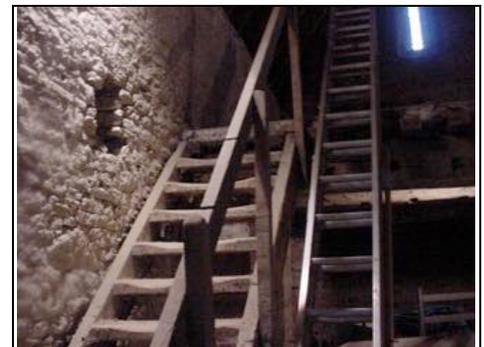
Stairs have become uncoupled with ladder access

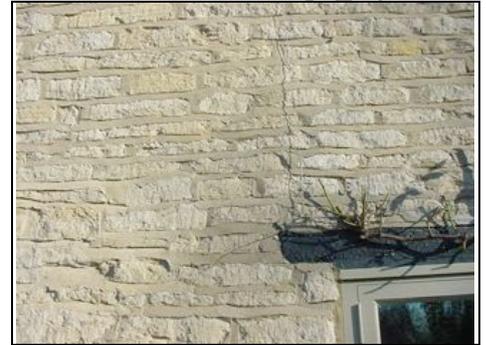
1.0) Re-pointed wrongly in cement mortar – prone to dampness

Originally this property would have been built in stone on a bed of lime mortar. The advantage of lime mortar has over cement mortar is that it allows the structure to breathe. With older buildings such as this the outer wall gets wet and then dries out/disperses dampness over time. This is sometimes known as the overcoat type system referring to the way an overcoat works where the outer section gets damp and then dries out. This is as opposed to a modern property that uses cement mortar and repels/deflects the rain similar to a raincoat. The reason why this is important is when you get a mixture of old and new construction such as this it effectively stops the property from breathing, which means in turn it is susceptible to dampness. Unfortunately in this particular case the property has been wrongly repointed in a cement mortar which means this building will be more prone to having and holding dampness as the building simply cannot breathe to allow the moisture out.

Wrongly repointed in cement mortar

ACTION REQUIRED: We would recommend that you find the oldest stonemason you can and every summer for the foreseeable future employ them to use a soft brush to remove any defective cement mortar and replace it with lime mortar. Then gradually over the years you will improve the situation albeit a slow process.

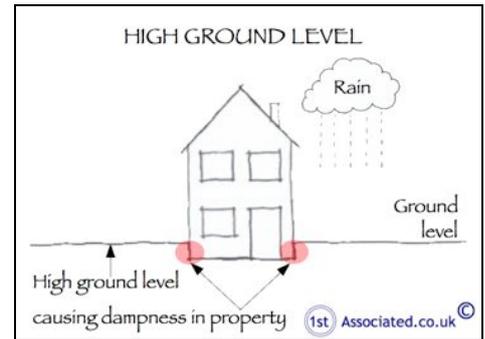
2.0) High ground level and Rising Damp

Around the property the ground level is slightly high. We are very keen on adding French drains where at all possible and/or lowering the ground level around the property.

High ground level

ACTION REQUIRED: Add French drain.

ANTICIPATED COST: In the region of £2,500 - £5,000; please obtain quotations.

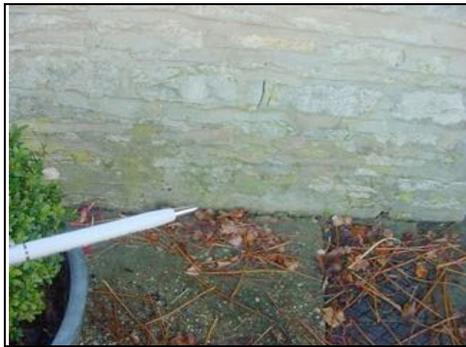
High ground level

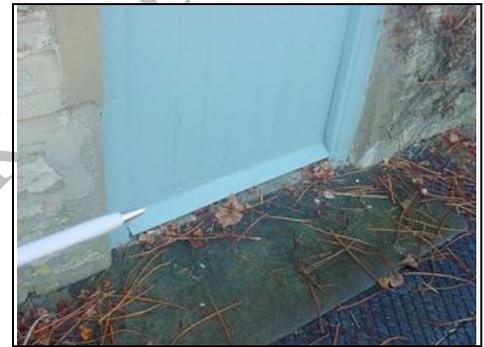
High ground level to doorway and building as a whole

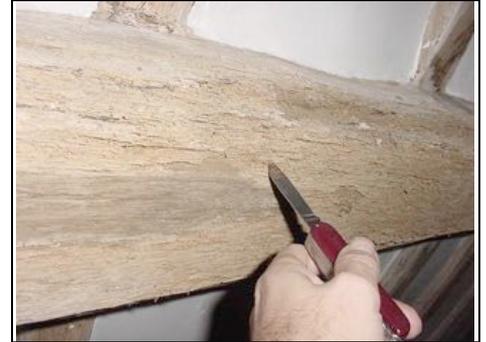
5.3) Active woodworm or not?

Most buildings of this age would have had woodworm, the question is whether it is active or not? During our question and answer session we discussed this matter with the owners who advised that they had woodworm treatment and also deep woodworm treatment (which we must admit that we are generally sceptical about). Although the guarantee is now void they advised that they did believe that the woodworm treatment has been effective.

Checking for active woodworm

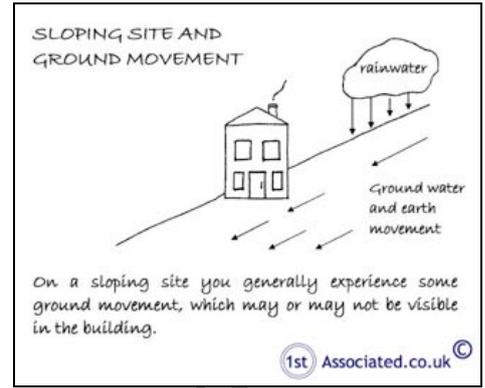
The property has a mixture of different floors and also the property sits on a sloping site. With a sloping site the water needs to get from the top to the bottom and as such it will travel underneath your building.

Sloping site

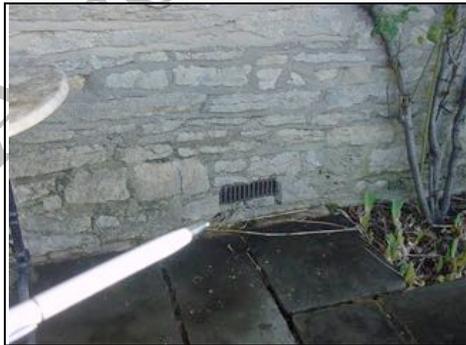
Airbrick

There is a part suspended timber floor to the middle of the property which we suspect there will be wet rot within this area (we have not opened it up as there is no way from what we could see of doing this without damaging the property). We believe it is a suspended timber floor because of the airbricks that we can see outside to the front of the property. Unfortunately we can also see that there are downpipes discharging close to the property as well.

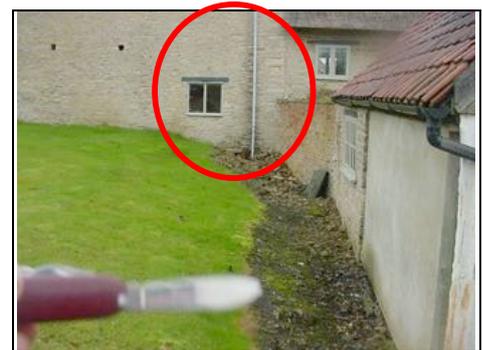
Sloping site.
Downpipe discharging (circled)

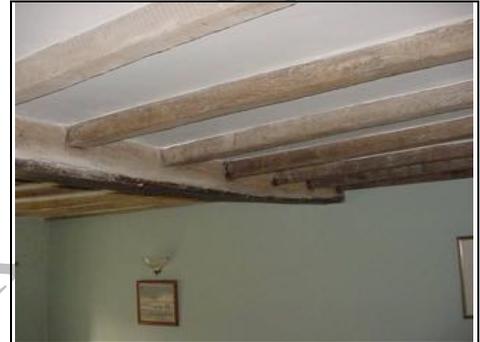
You need to appreciate there will be a high level of maintenance internally, generally with re-decorating of the walls and particularly the re-decorating between the joists in the rooms in the roof, which can be very time consuming.

Ceiling in end bedroom

ACTION REQUIRED: This is a characteristic of this property. We would add that the beams, of course, make a great feature to the property.

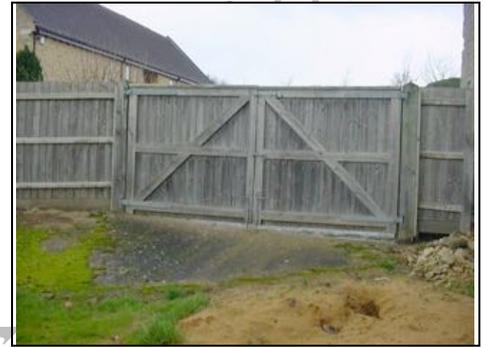
On the rear right hand side, there is a gate next to the barn, which looks to go into the Grange property area; you need to have clarification with regards to rights of access.

Is there a right of way to the gate?

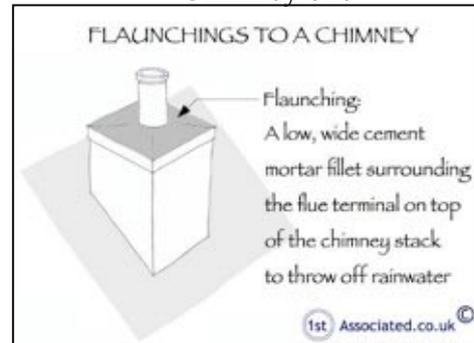
Unfortunately we were unable to see the flaunching properly, we therefore cannot comment upon them.

Flaunching

ACTION REQUIRED: Periodically inspect the chimney.

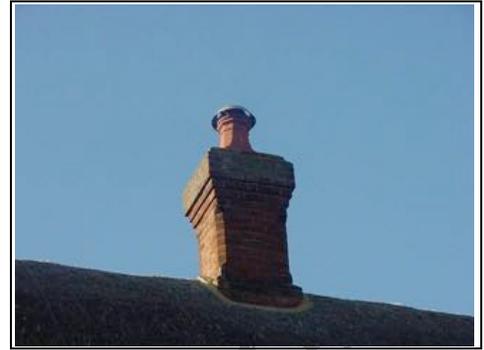
Chimney two

This chimney is also brick built with one chimney pot/flue and is in average condition.

ACTION REQUIRED: Periodically inspect the chimney.

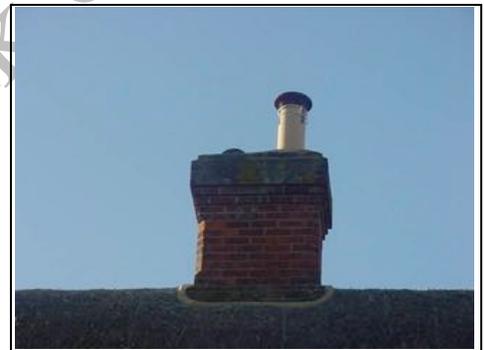
Chimney three

Again, this chimney is also brick built as the first two chimneys with one chimney pot/flue and is in average condition.

ACTION REQUIRED: Periodically inspect the chimney.

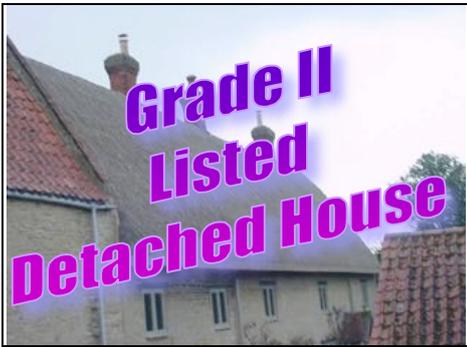
Thatched roof

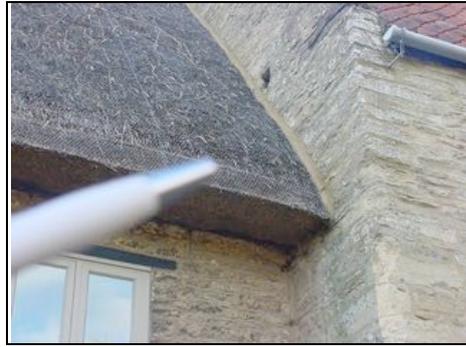
Fill in between thatch and the main building

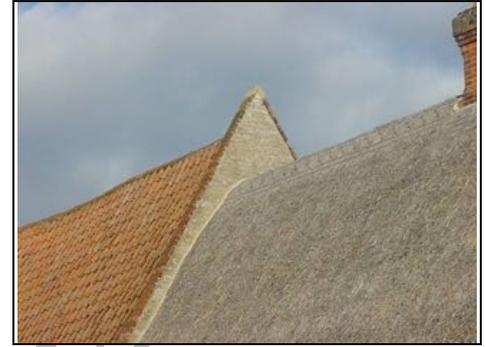
Join of thatch to tiles

ACTION REQUIRED: Your legal advisor to check and confirm.

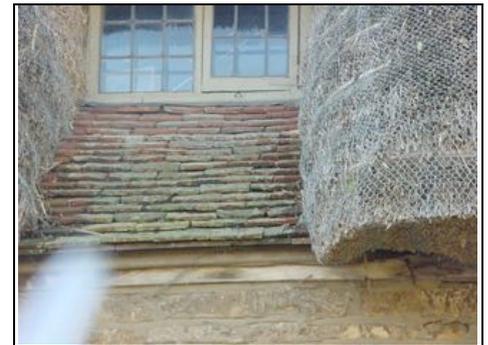
There are tiled areas beneath the dormer windows on the thatched roof. They have a slight moss covering.

The next time it rains heavily you need to check how the guttering is working to the tiled areas. If we recall correctly there was no guttering to the right hand side.

Tiled roof within thatch roof

ACTION REQUIRED: Please see our comments in the guttering section.

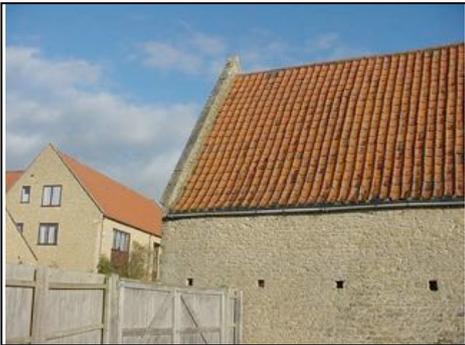
The barn roof to the right hand side of the property (all directions given as you face the front of the property) is pitched and clad in roman tiles/pantiles. From ground level, this looks in average condition considering the roofs age type and style. Please see our comments with regards to the parapet wall detailing.

We would also advise that some of the guttering does not look even and there is an end cap missing which may be allowing water to discharge down the property. You need to inspect it when it is next raining.

Tiled roof

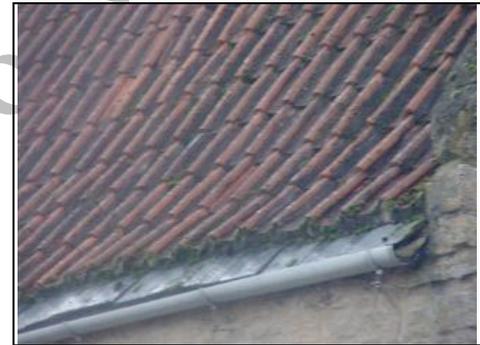
Tilting fillet at base of tiled roof

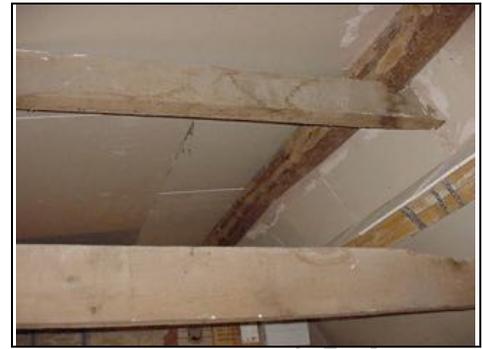
Additional support added

Please see our comments in the Executive Summary.

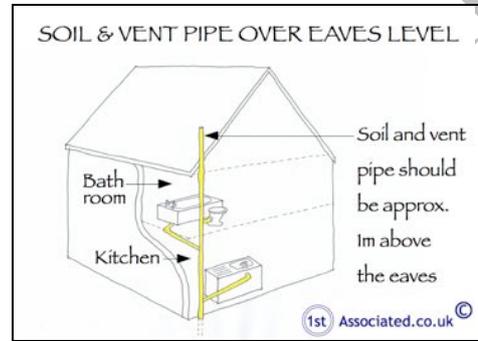
The property has plastic soil and vent pipes to the rear, which looks relatively new. This should in theory discharge above the height of the eaves but obviously this is very difficult with a thatched property.

Soil and vent pipe over eaves

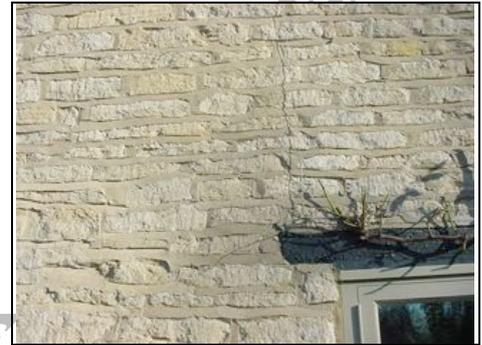
Wrongly re-pointed in cement mortar

The use of cement mortar causes deterioration to stonework and does lead to the face of the stone deteriorating, which in turn, leads to dampness. This is a very important point.

ACTION REQUIRED: Please see our comments in the Executive Summary.

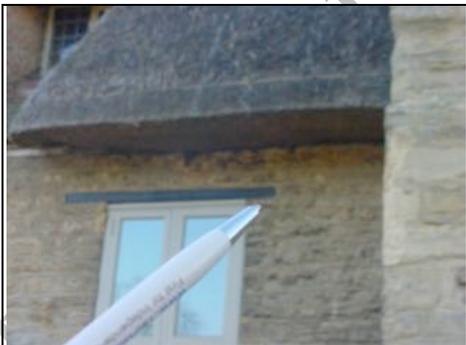
Before the 19th Century, the practice of building timbers into external walls was almost universal as they were aware of the strength of stone being good in compression but not in tension. Some of the timber lintels did not seem to have that much end bearing. Having said that, we assume that when the new windows were put in, if there was rot it would have been repaired.

Timber lintel over window

ACTION REQUIRED: Obtain details with regard to the window replacement to see if it included for lintel repair and replacement. As shown in the photo there does look to be relatively poor end bearing to some of the lintels.

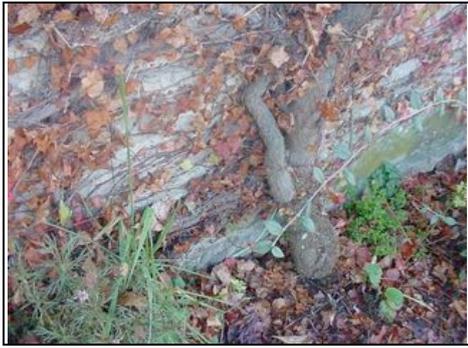
There are trees that have come down to the front of the property. Ivy is growing to the front of the property; please see our comments in the Executive Summary with regards to damage that can be caused by ivy and how water can sit against the property and get into the property.

Ivy to front of property

ACTION REQUIRED: Please see our comments in the Executive Summary.

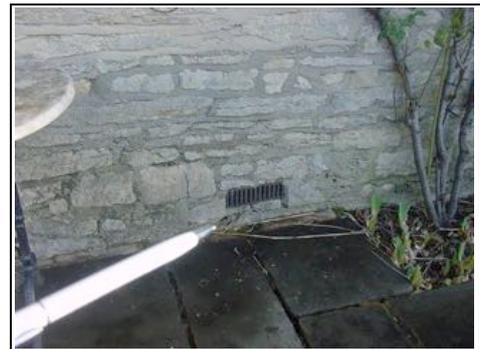
Air bricks are essential to have a through flow of air as this helps to reduce the chances of wet rot, dry rot and woodworm. In this case we found airbricks to the rear but none to the front of the property.

Air brick to rear

ACTION REQUIRED: Please see our comments in the Executive Summary.

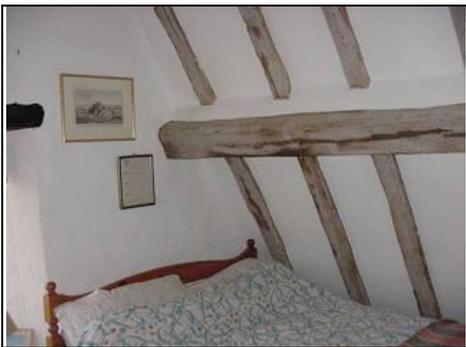
Within the roof we could see the common rafters. Some of these timbers were darker indicating to us that there may be some dampness getting in but in this case the timbers may still be drying out from when the thatch was added. There was no area where we could physically see the thatch. If you wish, and obtain permission in writing, we would be more than happy to employ a builder on your behalf to remove the plasterboard in the end right hand room. We do think this would be particularly useful as there are areas of water staining to the timbers.

Timbers in room in roof

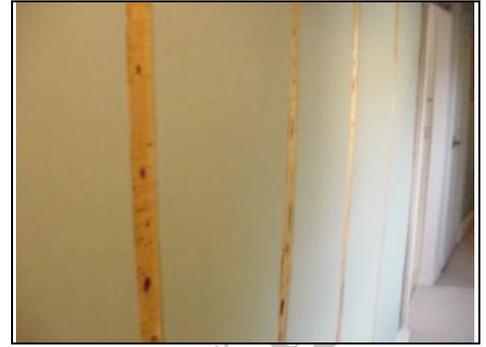
These are, we believe a mixture of solid and studwork construction. We asked the owners had they changed the studwork during their time at their property and they advised they had not. We would say this studwork looks relatively new and not typical of what we would expect in this property.

Example of studs on first floor where studs can be seen

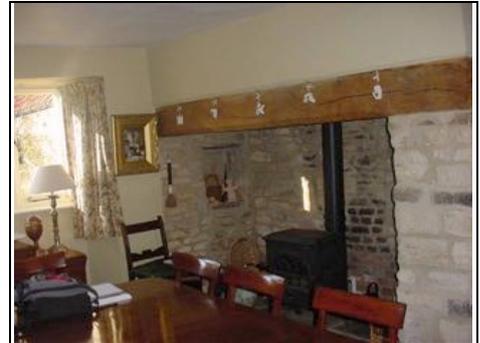
At the time of the survey no chimneys were in use. Any chimneys that you do not propose to use should be capped and ventilated to prevent dampness. We have been advised that they have been tested recently.

Fireplace in dining room

ACTION REQUIRED: Your legal Advisor needs to check and confirm.

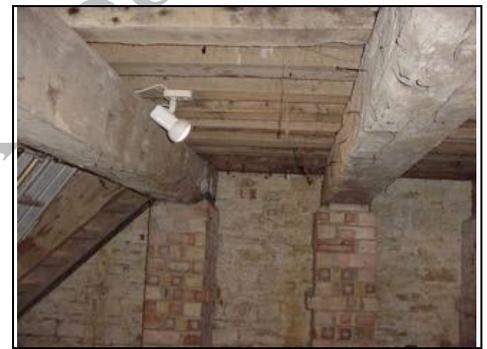
Timbers of first floor in barn

Please note our comments with regard to the crack on the right hand side. As mentioned elsewhere within this report the barn is a relatively high-risk element of this property.

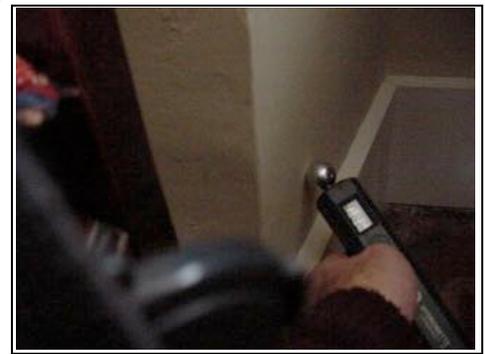
A random visual inspection and tests with a moisture meter have been taken to the perimeter walls. In this particular case we have found relatively minor rising damp, we were surprised it was not higher.

Testing for rising damp

ACTION REQUIRED: Please see the Executive Summary.

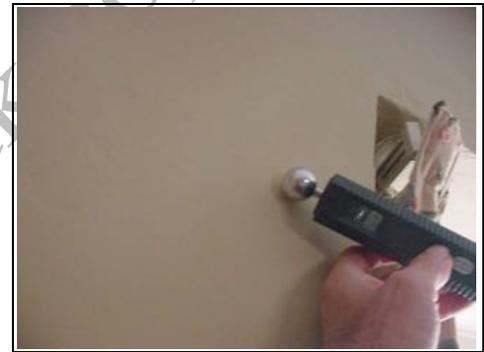
We used a resistance meter on the external walls. We have found minor lateral dampness. Again, we were surprised it was not higher.

Testing for lateral dampness

ACTION REQUIRED: Please see our comments in the Executive Summary.

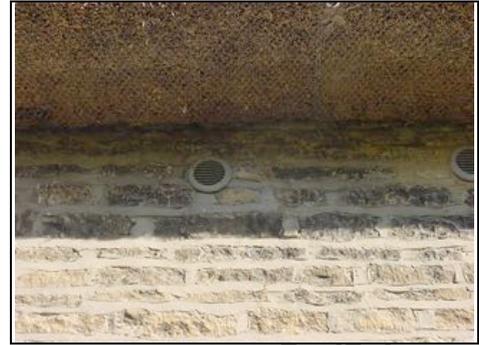
High level vent to shower room

ACTION REQUIRED: We would recommend large humidity controlled extract fans be added to kitchens, bathrooms and drying areas. These would need to be carried out in sympathy with the building being listed. Also, we would recommend that you check with the Listed Building Control Officer that they are happy for you to carry out the work.

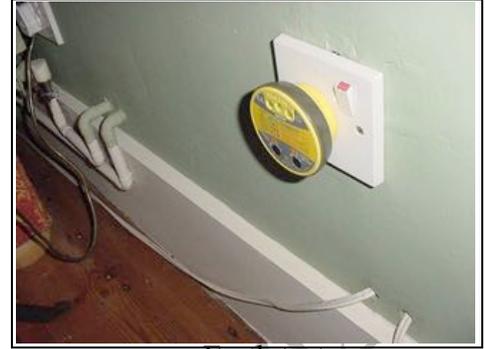
We carried out an earth test in the kitchen area to the socket point that is normally used for the kettle, this proved satisfactory.

Earth test

ACTION REQUIRED: As the property is changing occupancy an Institution of Engineering and Technology (IET) test and report should be carried out by a NICEIC registered and approved electrical contractor or equivalent.

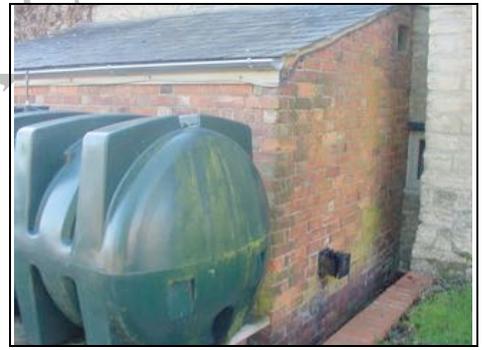
We were pleased to see that the oil tanks are plastic. These usually replace the older metal tanks that can rust and they typically have a double lining, meaning that if they leak they leak into the outer lining.

Plastic oil tank

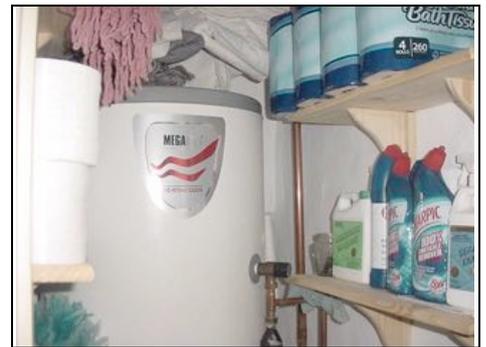
There is a Modern hot water cylinder located on the first floor in the airing cupboard, which will have good thermal efficiency.

Megaflow hot water cylinder

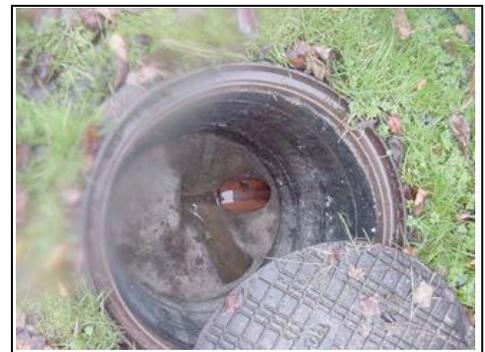
We duly lifted the cover and found it to be blocked at the time of our inspection.

From what we could see it is brick built.

Manhole opposite barn

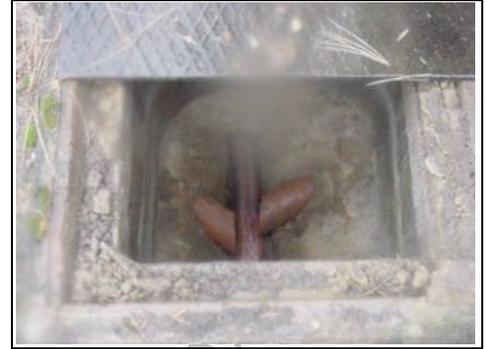
We duly lifted the cover and found it to be free flowing at the time of our inspection.

From what we could see it is concrete built.

Manhole in middle of road

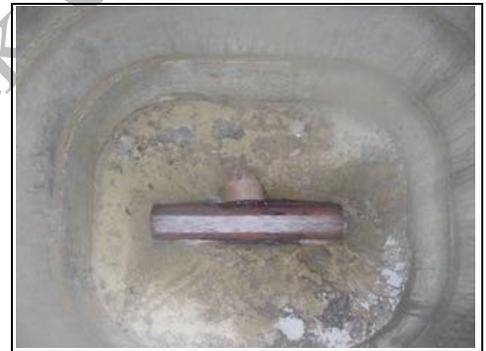
Inspection Chamber / Manhole Three located to the front right side

We duly lifted the cover and found it to be free flowing at the time of our inspection.

From what we could see it is concrete built. This is a modern manhole cover which may have been added in recent years.

Manhole to front right side

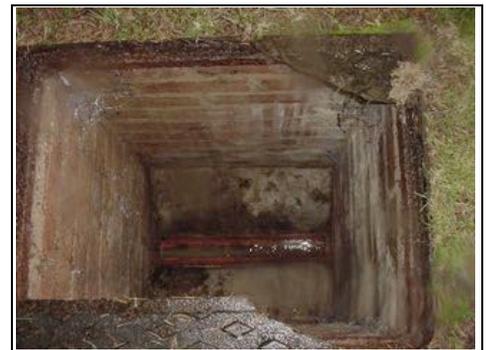
Inspection Chamber / Manhole Four located to the left of the rear garden

We duly lifted the cover and found it to be free flowing at the time of our inspection.

From what we could see it is brick built.

Manhole rear garden left side

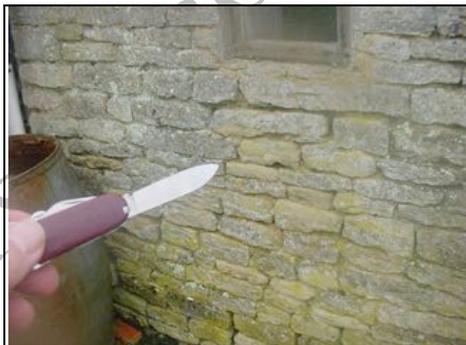
The walls are built in stone with corrugated iron to the rear. There is weathering to the stonework.

Weathering to wall

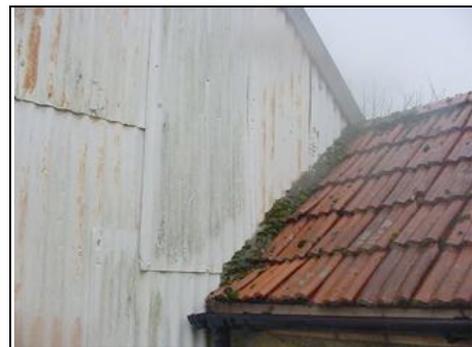
Corrugated iron to the rear of outbuilding

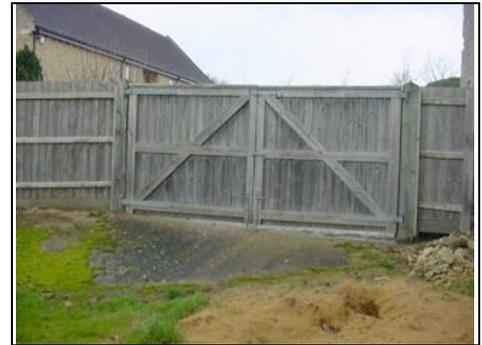
Is there a right of way to the gate?

ACTION REQUIRED: Your legal Advisor needs to check and confirm.

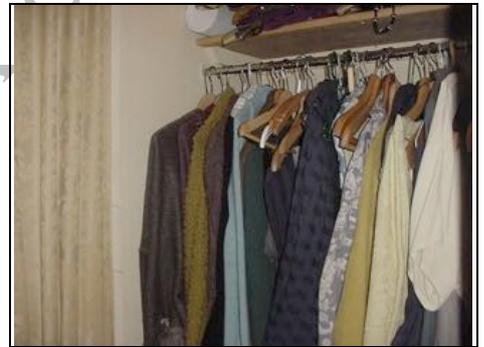
Stored items limited view

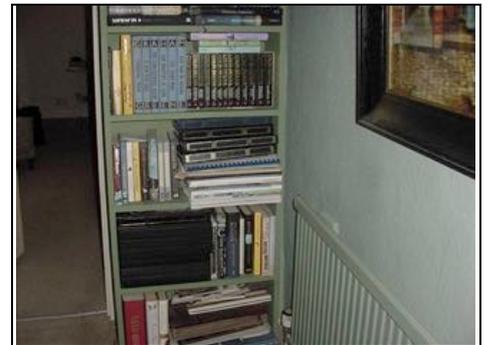
Bookcases limited view
