RESIDENTIAL BUILDING SURVEY

XXX
HARPENDEN
Hertfordshire
AL5 XXX

Prepared by:
XXXX
INDEPENDENT CHARTERED SURVEYORS

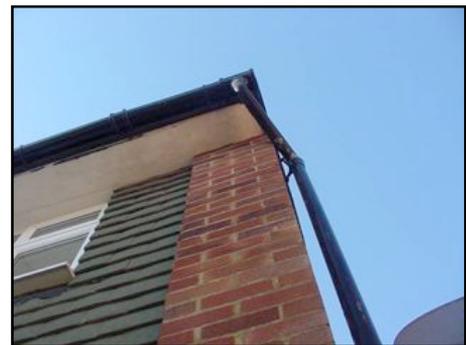
Traditionally when we build all the outer walls are supporting walls, with some of the inner walls (known as structural walls). In cross wall construction it tends to be the walls running on the sides and centrally in the property that are structural, with the other walls, such as the vertically tiled walls, being effectively walls which are non-structural and cladding.

Cross wall construction - structural wall on the side of the property with tile cladding to the front

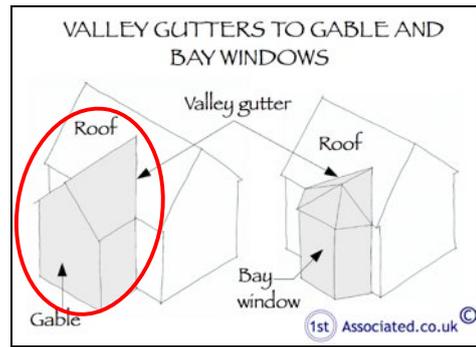
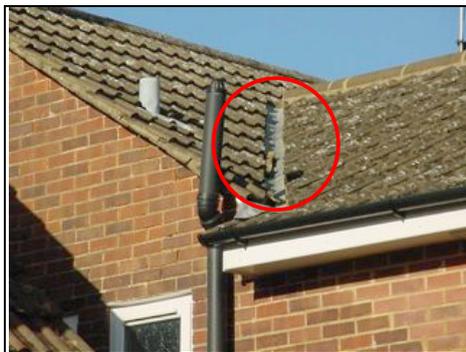
The front extension shows a good example of why extensions have to be thought through as there is an awkward/problematic valley gutter detail. Here we can see the concrete fillers have come out of the valley gutters, which in turn will lead to dampness getting in to the structure.

Valley gutters

Valley gutter

ACTION REQUIRED: Repairs are needed to stop water getting into the roof structure. We would take the opportunity to check all the valley gutters.

ANTICIPATED COST: The most expensive part will be actually getting access to the valley gutters. Expect costs in the region of £750 to £1,500. You do need to ensure that the builders have good access as this will mean they will carry out a good job. It may well be worth insisting that they use a tower scaffold to access the area rather than ladders and crawler boards.

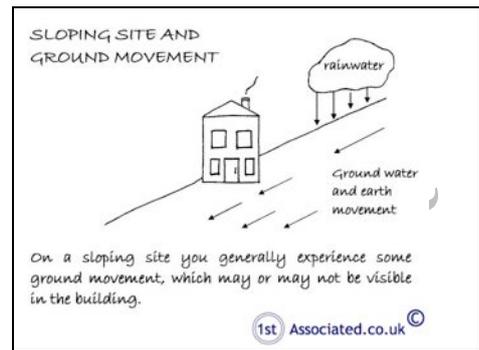
The property sits on a slight sloping site. This can particularly be seen in the rear garden which discharges water towards the patio area. You may wish to add a running gully or a French drain to limit any water building up against the back of the property.

Sloping site

ACTION REQUIRED: Before you do anything we would live in the property and see if water does accumulate to the rear when it rains. At the time of inspection the garden was very muddy.

ANTICIPATED COST: Difficult to say as it depends upon whether a running gully or French drain is more appropriate (we can advise on this once you see how much water travels towards the house – it may be that nothing is necessary). Costs for a French drain range to the rear of the property from £1,000 to £3,000; please obtain quotations.

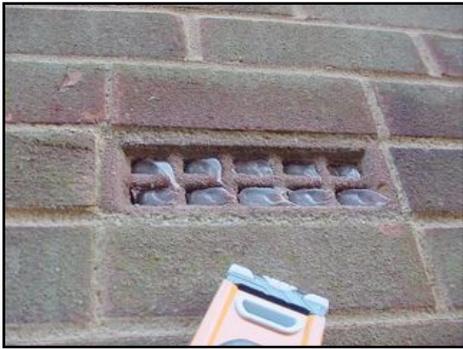
There is potential for black mould and condensation due to lack of air within the property and extract ventilation. When we went around the property we were surprised to see some areas, which seems to be being affected by condensation and black mould. This normally occurs due to lack of air circulation and extraction of humid air within a property.

Blocked high level air brick

ACTION REQUIRED: Add large humidity controlled extract fans to kitchen, bathroom and any areas used for drying clothes.

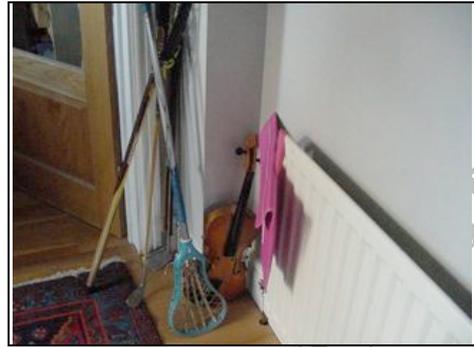
Other factors that affect air movement in a house is having windows without trickle vents and internal radiators.

Internal radiator

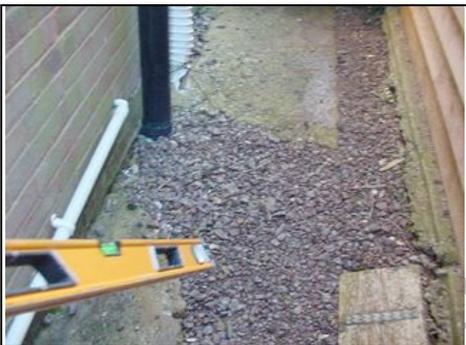
On the left hand side, there looks to have been some work to the drains. We assume these are new, added in or altered drains when the extension was carried out on the left hand side. This can often lead to an awkward drainage run that can block from time to time.

Alterations to the drains

ACTION REQUIRED: Awkward drains following an extension we believe in this instance have to be considered as a characteristic of the property due to the extension and limited space available on the left hand side to put the drainage run in.

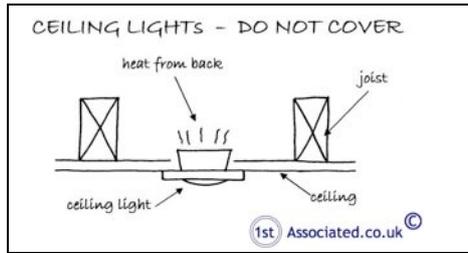
Ceiling lights

ACTION REQUIRED: Replace with modern ceiling lights.

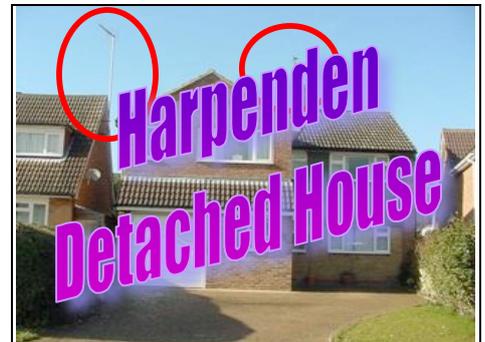
There is an aerial attached to the chimney which we do not recommend as it can cut into the brickwork rather like a cheese wire cutting into cheese. Given the height of the aerial (and next door's aerial) we wonder whether there is a problem with getting a reception in this area.

Tall aerials

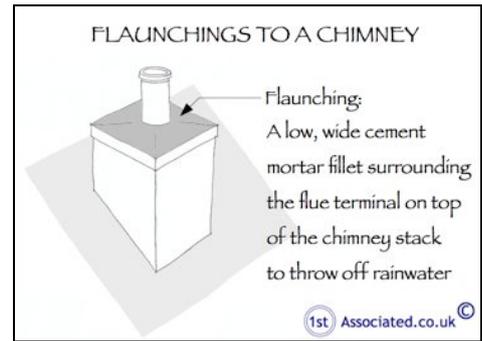
Flaunching

Unfortunately we were unable to see the top of the chimney properly known as the flaunching, we therefore cannot comment upon them.

ACTION REQUIRED: Periodically inspect the chimney.

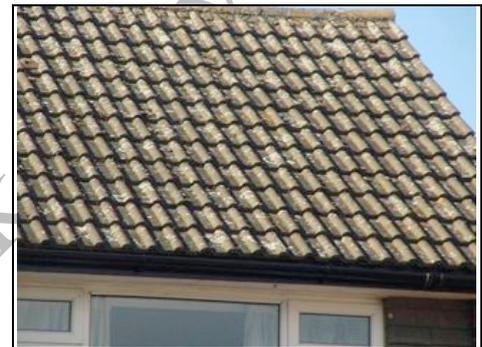
Main Roof

The main roof is pitched and clad with a concrete tile and from ground level this looks in average condition considering the roofs age type and style. There is a light covering of moss, which often occurs on concrete tiles. This can ultimately lead to a problem where moss/lichens fall into the gutter and blocks it. If it does get to this stage we recommend you brush it with a soft brush in the summer months (we would not recommend chemicals).

ACTION REQUIRED: Carry out periodic inspections and maintenance of the roof, as required.

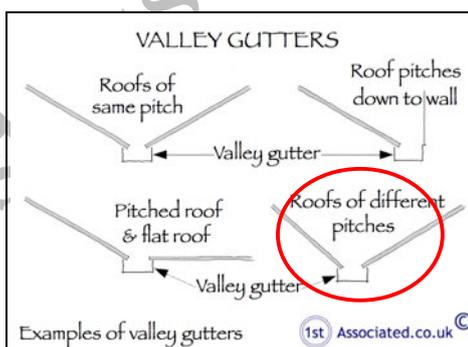
Valley gutters

The property has valley gutters, which are often problematic areas as they are often difficult to access.

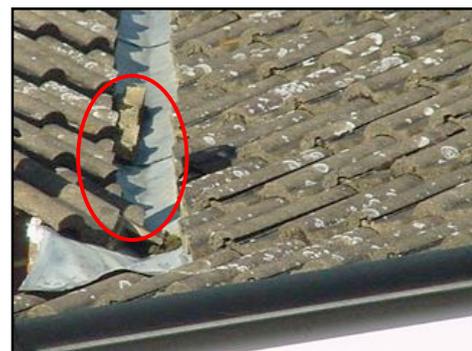
Concrete fillets have come out of the valley gutters

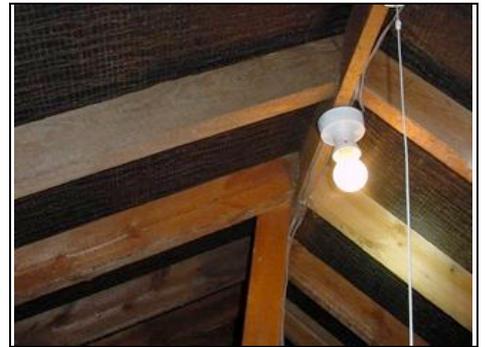
When we inspected the loft space we found a Hessian base Bitumen membrane. This type of membrane has been used since the 1960s. We generally found it to be in average condition, with damage in some areas, which is what we typically find.

This photo shows the common rafters (the ones that form the pitch of the roof) and the dark area between is the underlayer.

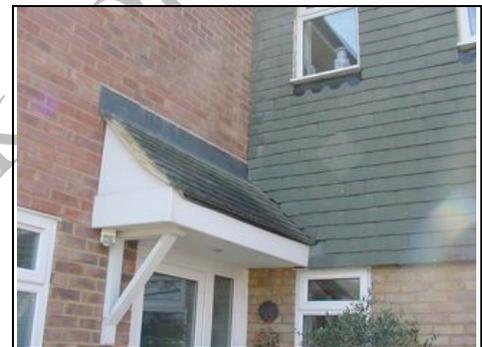
Front porch roof

There is a small pitched porch roof to the front, clad with a small concrete tile. The sides of the porch are painted timber.

ACTION REQUIRED: Periodic inspection and redecoration of timber.

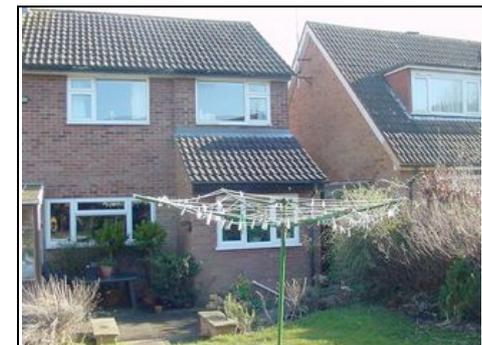
Rear kitchen extension roof

This is pitched and clad in the same concrete tiles as the main roof and is in average condition for its age, type and style.

ACTION REQUIRED: Periodic inspection.

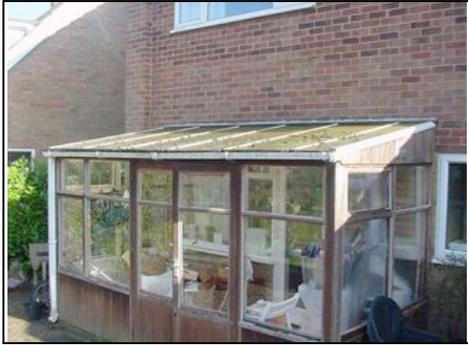
Polycarbonate roof

There is a shallow pitched lean-to polycarbonate roof to the rear of the property. It has moss sitting on it.

Assuming we are accepting this is a below average quality rear lean-to it is the join where it meets the roof that is probably the problem area as this is likely to leak when it rains.

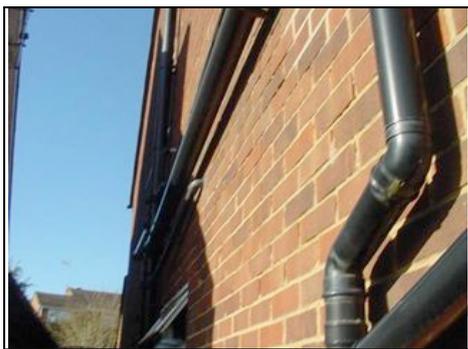
Downpipe

It is fairly unusual these days to have painted aluminium and you may wish to look at replacing these.

There may be some minor leaks but most people would be happy to live with these providing repairs are carried out within the next six to twelve months.

ACTION REQUIRED: We would always recommend you stand outside the property next time it rains heavily and see how well the drains cope with the rainwater particularly looking at the guttering and the joints.

We also recommend that the gutters and downpipes are cleaned out, the joints are checked and the alignment checked to ensure that the gutters fall towards the downpipes.

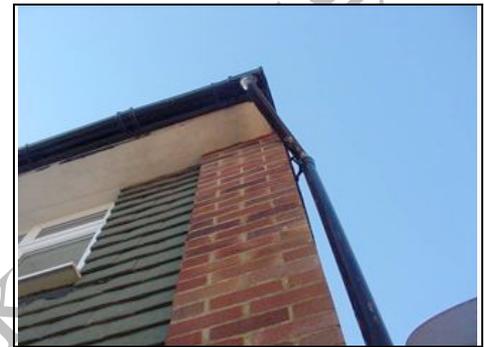
We believe this to be originally a cross wall construction which was a 1970s/1980s way of having a cheap construction. The weight tends to be taken on the side walls as opposed to a traditional property where the weight is taken on all the walls.

Cross wall construction - structural wall on the side of the property with tile cladding to the front

ACTION REQUIRED: Please see our comments in the Executive Summary.

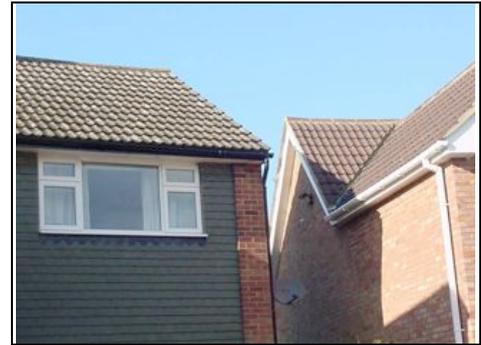
Vertical tiling to front

There is vertical tiling to the front of the property and what looks to be in-fill brickwork to the rear (as the brickwork is in a different colour). This is fairly common with cross-wall construction. The vertical tiling is effectively cladding.

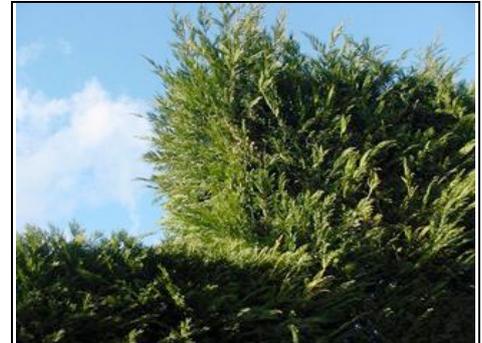
There are no trees within what we would term as influencing distance but you do need to speak to your insurance company as they may have a different interpretation for insurance reasons.

Conifers to rear of property

Please see our comments in the Executive Summary regarding conifers.

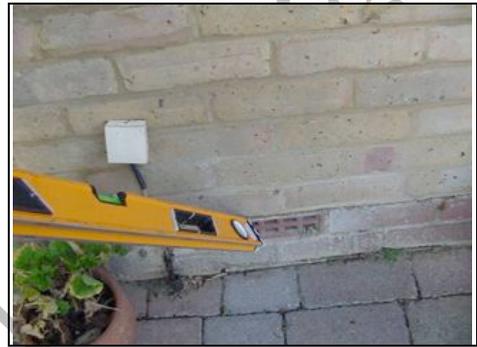
All modern properties should incorporate a damp proof course (DPC) and good building practice dictates that a differential of 150mm (6 inches) should be maintained between the damp proof course and ground levels. In this case, we believe it has been built in as work proceeded. There is a slight thickening of the mortar joint in some areas which we believe is where the DPC is.

Thickening of mortar joint
near air brick

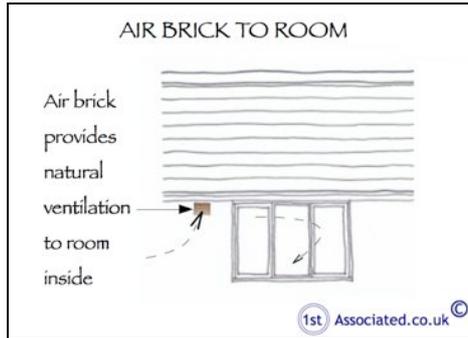
High level airbrick

In the 1950's and 1960's it was relatively common to have high level vents in rooms to help reduce condensation. These vents were then carried on in some cases to later design. We can see a high level vent in this instance to the left side of the property, which has been blocked up. We are a great believer in good ventilation in modern properties as we are now insulating to such a high level and also heating to such a high level we need air movement to minimise condensation.

ACTION REQUIRED: Add large humidity controlled extract fans, as described elsewhere within this report. If you still get condensation we would then add/open up high level air bricks.

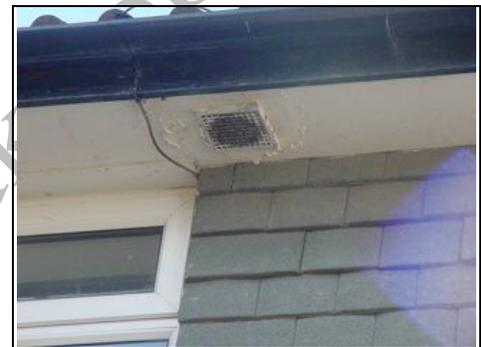
Vent in fascias and soffits

The fascias and soffits are timber. They are painted and we would comment they are in average to slightly below average condition for their age, type and style.

The lean-to to the rear is generally in a poor condition, including the fascias and soffits.

ACTION REQUIRED: Make sure gutters and downpipes are watertight before carrying out any work on fascias and soffits.

Ideally the fascias and soffits would benefit from redecoration in the summer of XXXX. We would also suggest that you consider adding a vented soffit to help with air circulation in the roof space and also the lean-to needs repair and redecoration.

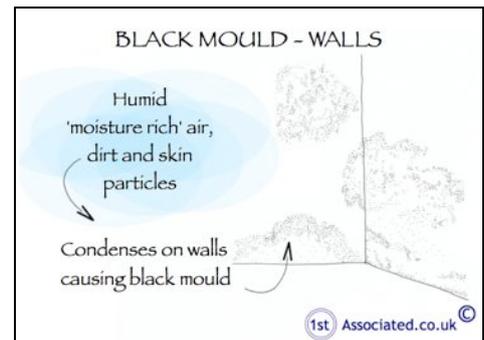
Black mould

Minor black mould was found to the windows. There seems to be a problem in the property with condensation, which is

creating minor black mould. It may be how the present occupiers are living in the property. We have suggested some ways to help improve the ventilation in the property which should help reduce condensation.

ACTION REQUIRED: Please see our comments in the Executive Summary.

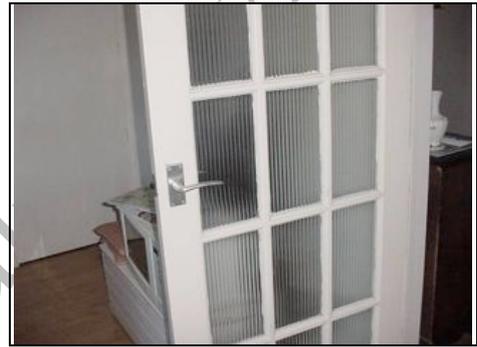
The property has a mixture of older and newer style doors, together with some older style glazed doors, which you may wish to replace as they are unlikely to have safety glass.

Older style glazed door

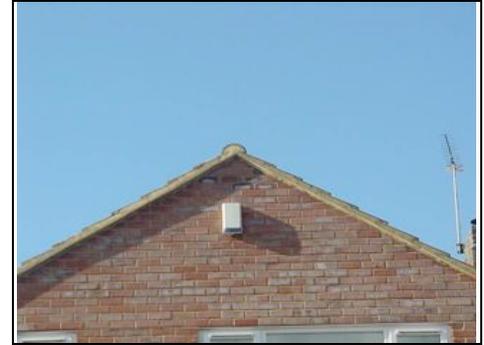
A security system has been installed. A good alarm system should not only help reduce break-ins but also your insurance. We are not experts in this field and therefore cannot comment further.

Alarm box to front of property

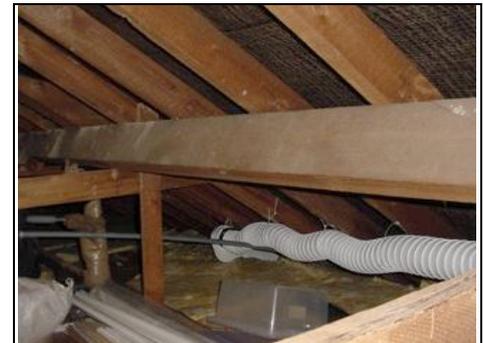
We can see the Elephant trunk ventilation system travelling through the roof. We would much prefer to see this going directly out through the wall, as there is the chance of condensation occurring within the roof space, as roof spaces can be cold or warm areas depending on the time of year.

Elephant's trunk vent system

ACTION REQUIRED: Please see our comments in the Executive Summary.

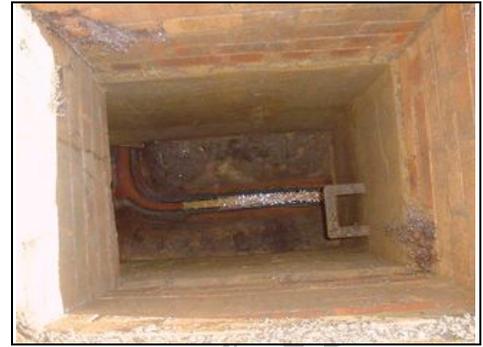
Rear right drain

We duly lifted the cover and found it to be free flowing at the time of our inspection.

From what we could see it concrete built.

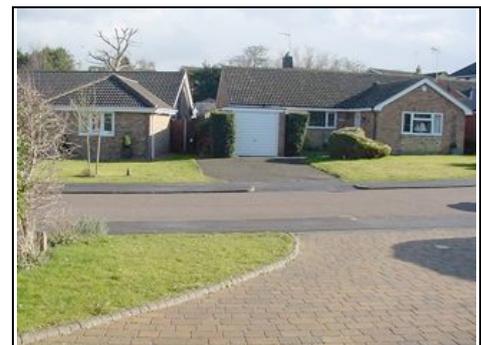
There is a reasonable sized front garden with a fall. We were pleased to see a running gulley to stop water discharging onto the road, which you can be liable for.

Front garden and driveway

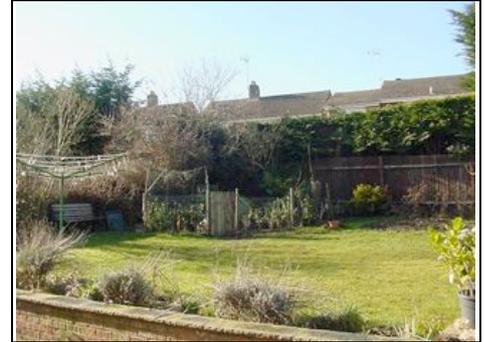
Rear Garden

There is a good sized garden to the rear which is on a slight sloping site.

ACTION REQUIRED: Please see our comments in the Executive Summary with regard to adding a French drain/running gully.
