# RESIDENTIAL BUILDING SURVEY

Biggleswade  
Bedfordshire  
SG18 XXX

**Two storey  
mid terraced  
modern property**

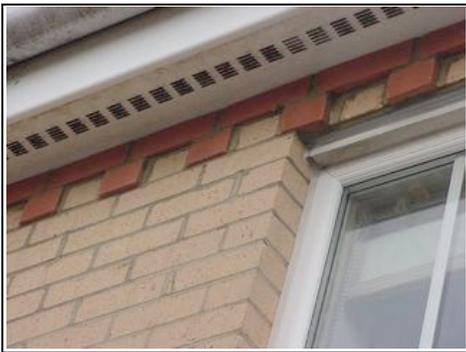
Property not square – twist in lintel

Left hand side of window

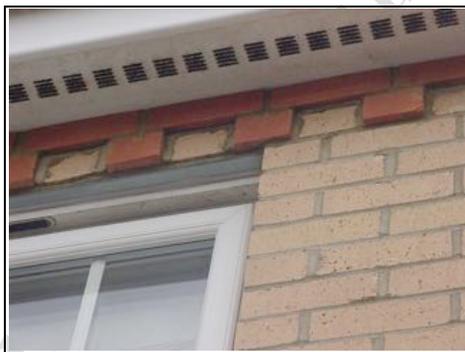
Right hand side of window

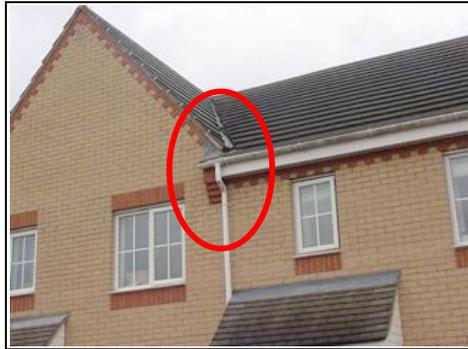
The property has a valley gutter which we noted the cement mortar has come away which in turn means you will get leaks into the roof.

Valley gutter

**ACTION REQUIRED:** Check all valley gutters and verge details and remove the cement mortar and replace.

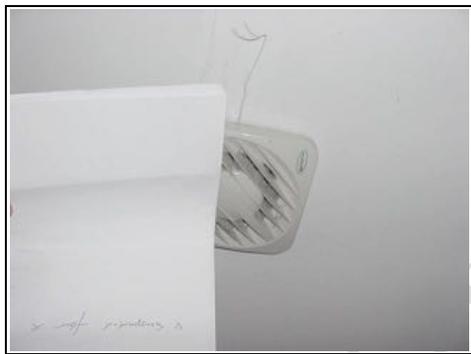
We would just like to reiterate the internal bathroom problems. We noted that the extract fan was not drawing the air from the bathroom which ultimately results in condensation occurring in the property.

Extract system not working  
- Testing suction of extract fan by putting some paper against it

**ACTION REQUIRED:** Please see our previous comments regarding replacing the extract fan with a humidity controlled large extract fan but still internal bathrooms can struggle.

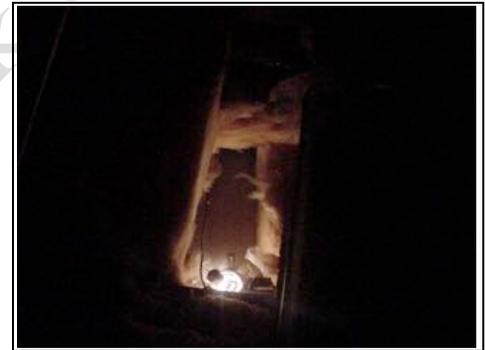
The property has electric lights to the ceiling. In some instances these can cause problems as the heat given off has in some cases lead to outbreaks of fire; these tend to be in the older type of ceiling lights and we recommend that where ceiling lights are used that the rear of the light is not covered; this is particularly the case in rooms with a loft space above it where stored items are placed in it.

Heat and light being given off by the ceiling lights

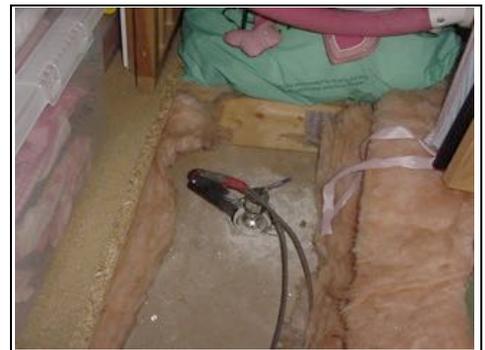
Ceiling lights cannot be covered

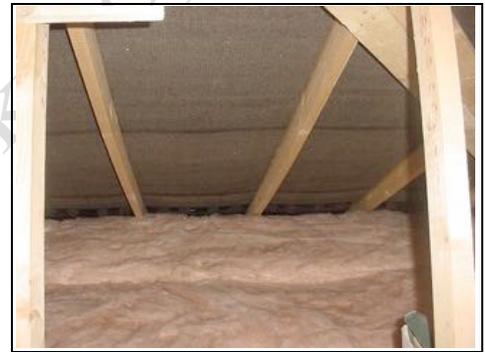
When we inspected the loft space we found a Hessian base Bitumen membrane. This type of membrane has been used since the 1960s. We generally found it to be in average condition, with damage in some areas which is what we typically find.

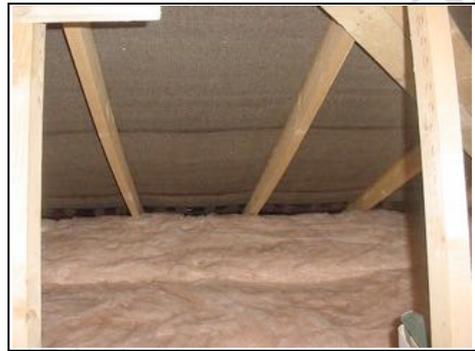
Ventilation is via the soffit boards. We are finding that ventilation is often blocked by companies adding a lot of insulation.

Mass of insulation in roof space

**ACTION REQUIRED:** The roof needs to be re-checked during the summer of 2013.

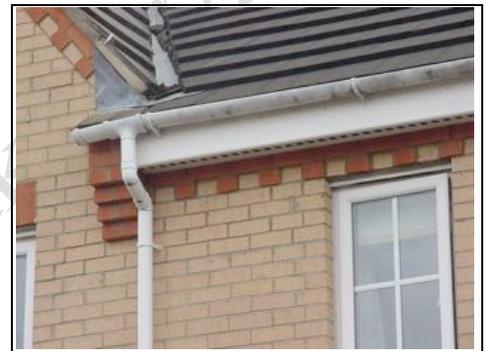
There is moss present to the gutters which indicates they may be overflowing and require clearing.

There may be some minor leaks but most people would be happy to live with these providing repairs are carried out within the next six to twelve months.

Gutter and downpipe

**ACTION REQUIRED:** Clear guttering of any blockages and moss. We would recommend you stand outside the property next time it rains heavily and see how well the drains cope with the rainwater particularly looking at the guttering and the joints. We would also recommend that the gutters and downpipes are cleaned out, the joints are checked and the alignment checked to ensure that the gutters fall towards the downpipes.

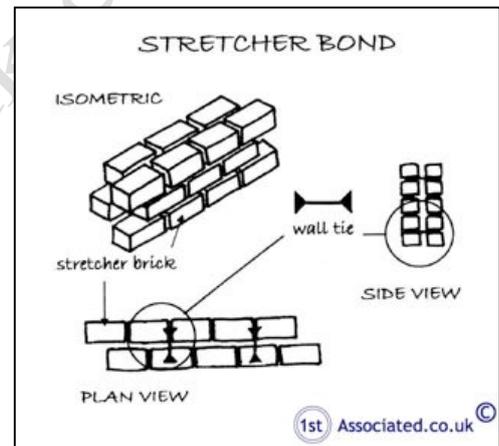
Please note are comments in the Executive Summary regarding spalling to soft red brickwork.

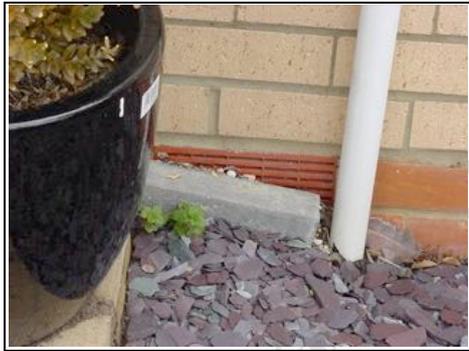
The property has low level airbricks which need to be cleared.

Air brick

**ACTION REQUIRED:** Clear airbricks. Add airbrick protection.

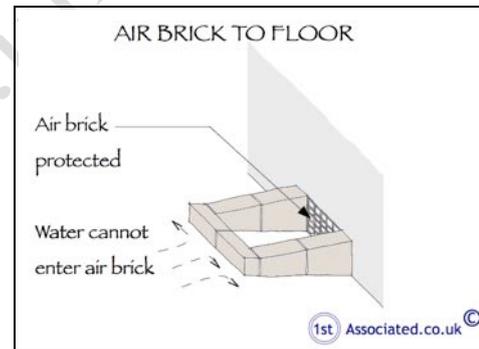
Add protection to airbrick

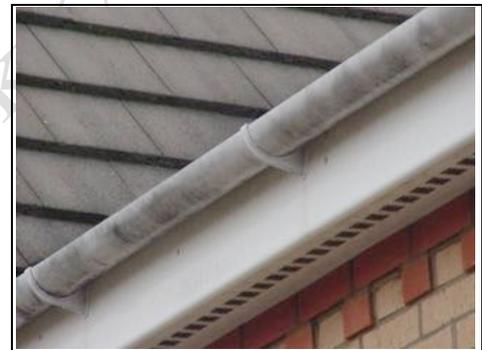
The fascias and soffits are plastic and we would comment they are in average condition for their age, type and style. Ventilation is present which needs to be kept clear in the roof space to minimise condensation which can occur in a property that has internal bathrooms and a kitchen vent which is not used.

Fascias and soffits with vents

**ACTION REQUIRED:** Make sure gutters and downpipes are watertight before carrying out any work on fascias and soffits.

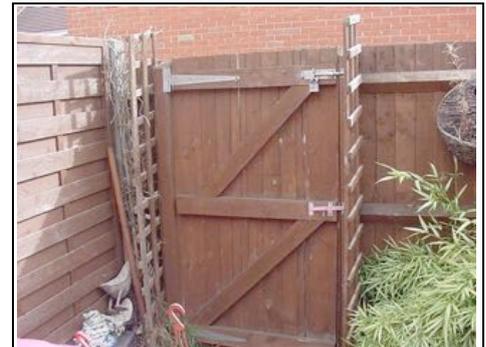
There is little required in regard to external decoration other than re-staining to the garden fence, shed and gate.

Rear gate

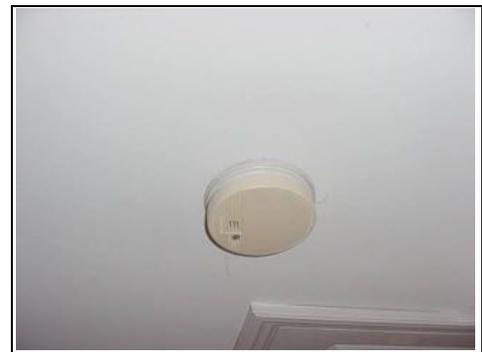
Some smoke detectors were noted. The current Building Regulations require that they be wired into the main power supply. Obviously in a property of this age this is difficult, as it would mean having surface mounted wires or cutting wiring into the plaster.

Smoke alarm

**ACTION REQUIRED:** We would recommend, for your own safety, that smoke detectors be installed. We would always recommend a hard wired fire alarm system and are also aware that some now work from a wireless signal which may be worth investigating. Whilst fire is relatively rare it is in a worst case scenario obviously devastating.

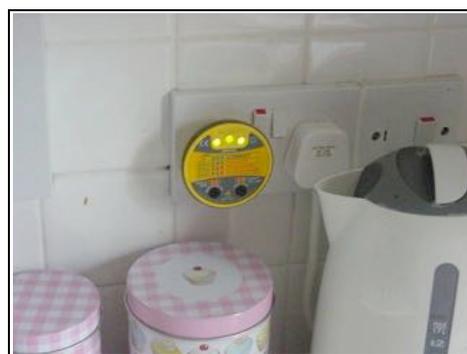
We carried out an earth test in the kitchen area to the socket point that is normally used for the kettle, this proved satisfactory.

Earth Test

**ACTION REQUIRED:** As the property is changing occupancy an Institute of Electrical Engineers (IEE) test and report should be carried out by a NICEIC registered and approved electrical contractor or equivalent.

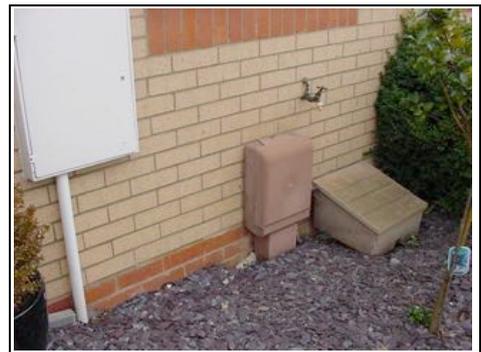
We assume as this unit was not opened up that the consumer unit is within this white cupboard

**ACTION REQUIRED:** As a matter of course it is recommended that the entire gas installation is inspected and made good, as necessary, by a Gas Safe registered contractor. Thereafter the installation should be serviced annually.

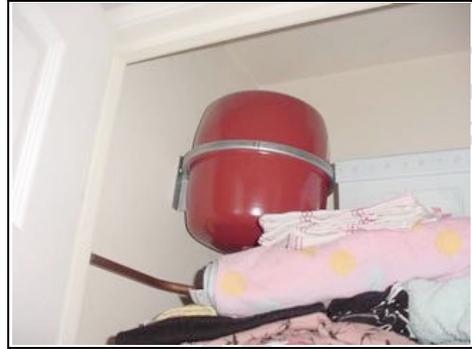
Pressurised unit

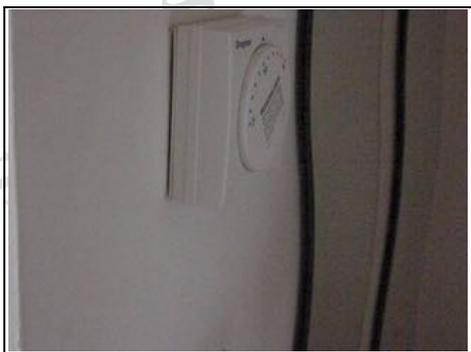
Thermostat

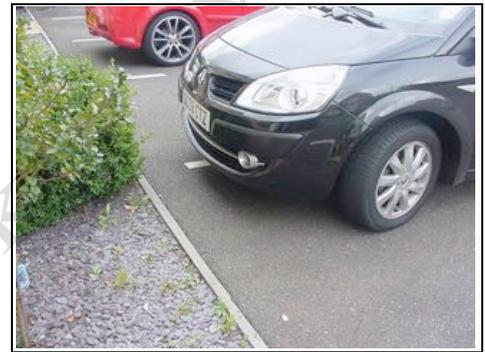
There is parking in front of the property although not immediately in front of your door. Further parking is at roadside on a first come first served basis. There may be parking permits. The current owner advised there are two parking spaces.

Parking – two spaces

**ACTION REQUIRED:** Your Legal Advisor to check and confirm. Parking can be a problem in this era of property where for some reason developers seem to forget about the need to park a car.

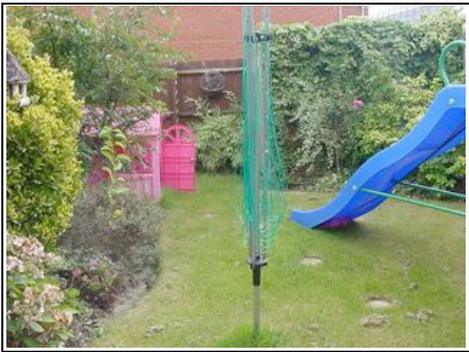
Rear Garden

There is a good sized rear garden laid predominately to lawn and with a patio area close to the property. There is a garden shed which at present is covered in ivy which you may or may not like.

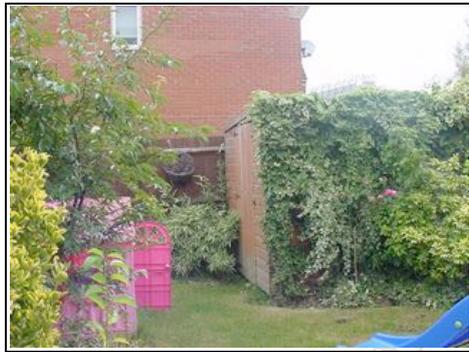
Shed covered in ivy

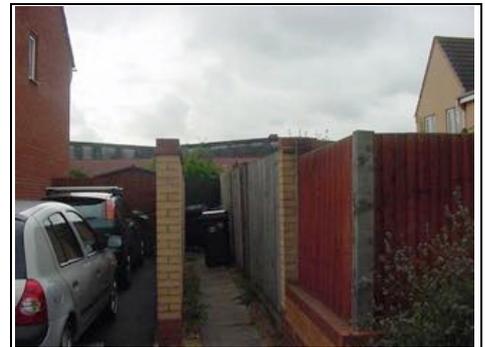
Passageway

There is a passageway to the rear of the property with access into your rear garden.

**ACTION REQUIRED:** Your Legal Advisor to check and confirm your responsibilities and liabilities.

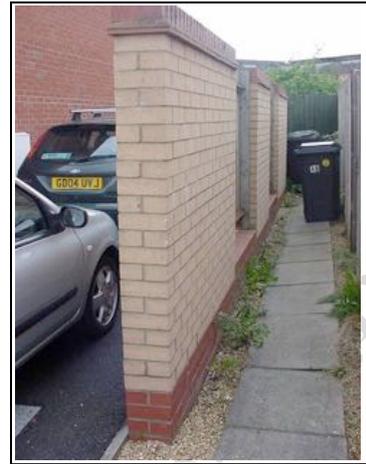
Rear wall to passageway

We are finding that boundary walls of this size, the left hand boundary wall, fall outside the Building Regulations which means that they have not had to be built necessarily on a foundation. You may find you have responsibilities and liabilities in relation to this wall.

Finally, whilst we note the boundaries, these may not be the legal boundaries. Your Legal Advisor should make further enquiries on this point and advise you of your potential liability with regard to any shared structures, boundary walls and fences.

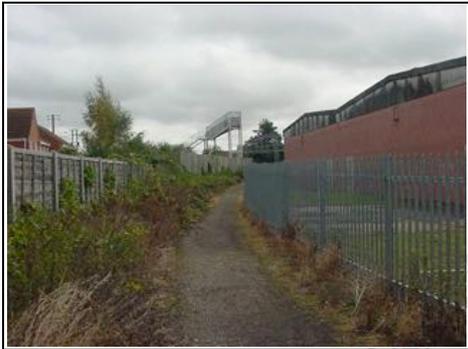
As mentioned earlier there are industrial buildings nearby and a railway line which is a personal decision as to whether you wish to live in this location.

Industrial buildings close by and bridge over rail line

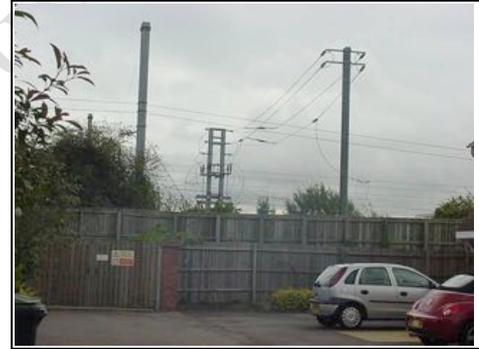
Railway line at end of the road

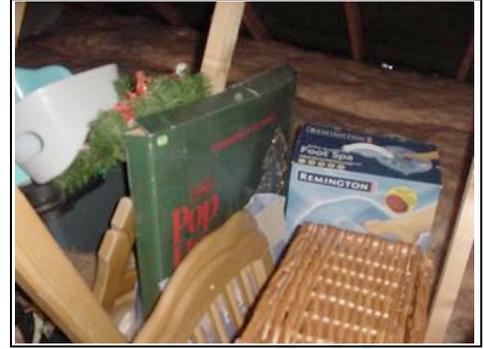
- 2.0) as we were not able to open up the ground floor or the first floor.

Stored items in the roof space
