JOB REFERENCE: XXXX

# RESIDENTIAL BUILDING SURVEY

XXX Peterborough,  
Cambridgeshire,  
PE7 XXX

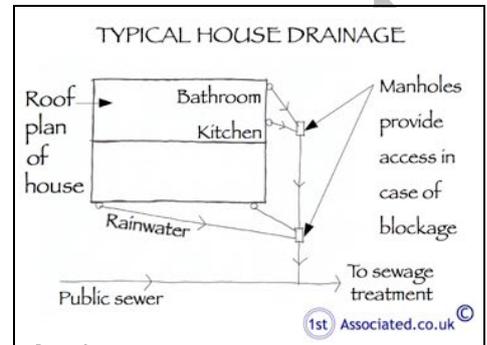
Drainage

Drains can be a problem when they leak causing damage and deterioration to foundations. We noted a dip in the ground where the drainage run is likely to be, on the right hand side of the property. This could be from poor back filling but we would then ask why this is not occurring to all the drains? This then leads us to believe there could be a problem in this area.

**ACTION REQUIRED:** Your Legal Advisor to check and confirm if the drains have been replaced. We would also recommend that a closed circuit TV camera report of the drains is carried out.

**ANTICIPATED COST:** £250 to £500 for the closed circuit TV report and further costs for investigations such as digging up sections of the drains which, in our experience, is the only true way of understanding any drainage problems; please obtain quotations.

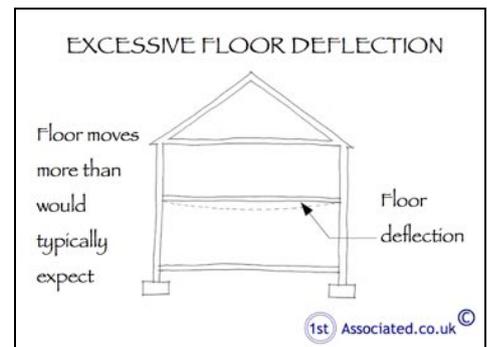
Deflection

Another consideration we will draw to your attention to is the deflection/movement to the first floor when you walk upon it and during our impact test (literally jumping up and down). This is much more than we would expect for this age, type and style of property.

Sometimes speculative buildings, which we think this probably was, can use what we would term as lightweight construction with minimum standards. The result as we have mentioned is deflection to the floor which we feel is excessive and, as stated, could relate to minimum standards/lightweight construction or could also be the result of movement in the structure as a whole.

We can see also see a dip in the bathroom floor and we feel that the deflection is an effect of other things that are going on at the property. Whilst the deflection can be reduced, by the adding of herringbone strutting or similar to brace the property, again we are not dealing with the cause of the problem but just the effects.

**ACTION REQUIRED:** Adding of herringbone strutting to the joists, checking the joist ends and the joists in general to ensure they are not cracked or defective. This will make a stronger first floor level but as mentioned it is only dealing with the effect rather than the cause.

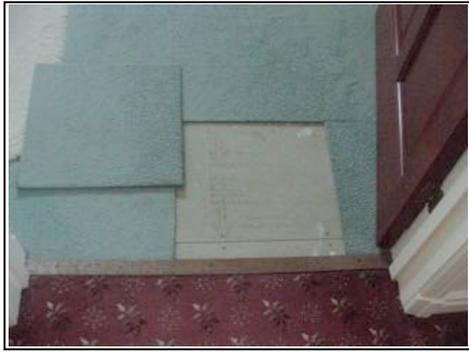
Exposing floor in bathroom

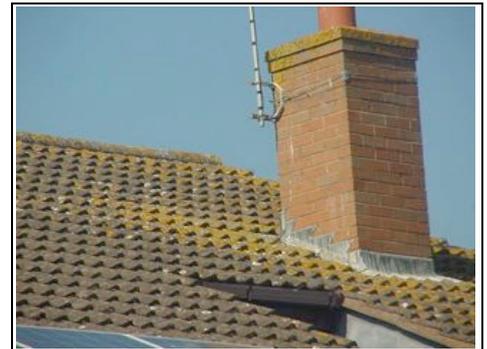
Right chimney

We believe this staining relates to the chimneys and the detailing to the rear. It is possible this has been aggravated by minor movement to the building but we often find in this era of property that it is down to poor workmanship. In particular we often find that flashings around chimneys are poorly carried out.

**ACTION REQUIRED:** Check the lead work and pointing on the chimney. Unfortunately we had a limited view of the chimney and the detailing.

**ANTICIPATED COST:** £1,000 to £2,000 as scaffolding may be required; please obtain quotations.

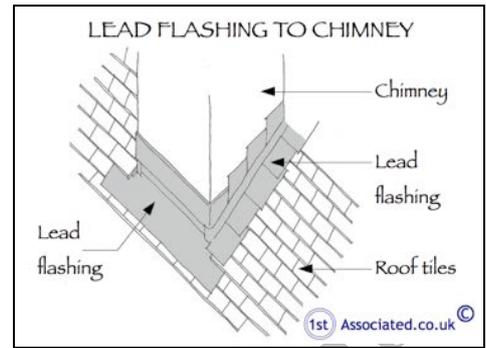
Lead flashing to chimney

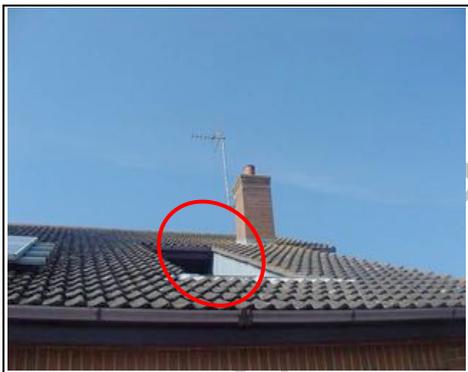
The roof window to the front right hand side of the property has a lead detail. We can see from within the roof that this is allowing water to come through, although this is at a relatively early stage.

Roof window and lead surround area /detailing

**ACTION REQUIRED:** Check lead and make watertight.

**ANTICIPATED COST:** £500 to £1,000; please obtain quotations.

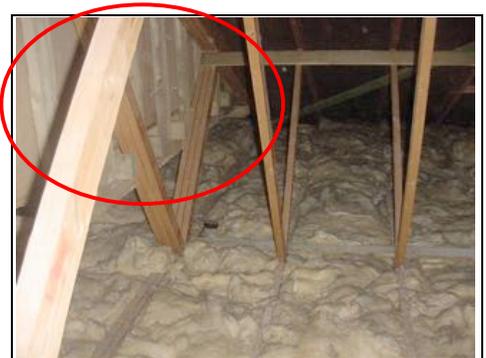
Boxing around the roof window in loft area

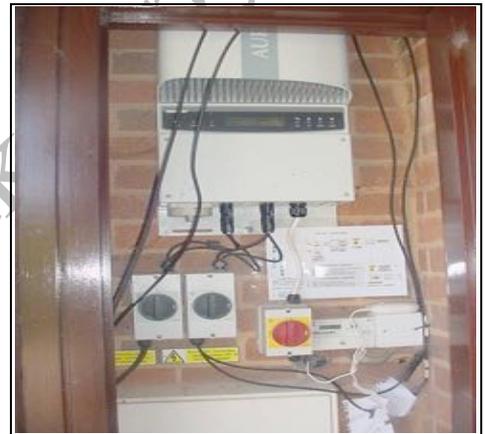
Solar panel workings

We would add that we do not believe that sufficient testing has been carried out with regards to the long term problems associated with solar panels on roofs and we would say the jury is still out. We would comment, however, that effectively you are adding a large sail type structure onto the roof. Where roof tiles allow wind to go through the solar panels deflect the wind.

**ACTION REQUIRED:** You need to carry out repairs to the chimneys if needed and check the solar panel fixings. We would also draw to your attention that you need to check and confirm who owns the solar panels.

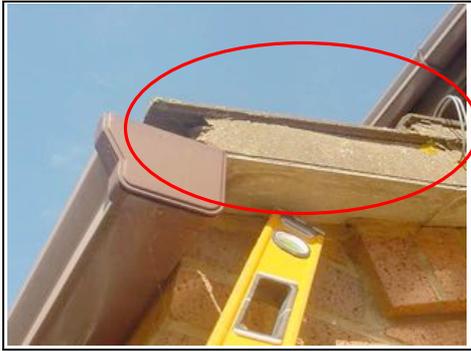
Asbestos was noted to the perimeter of the roof and is fairly common in this age of property.

Asbestos roof verge

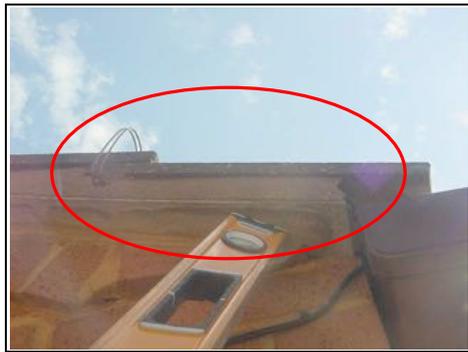
Asbestos

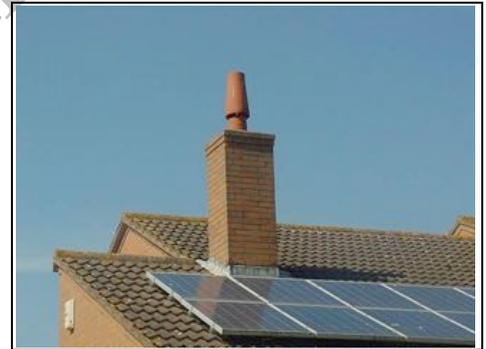
Left chimney

We could see moss appearing indicating that water is sitting on the chimney.

**ACTION REQUIRED:** Please see our comments within the Executive Summary.

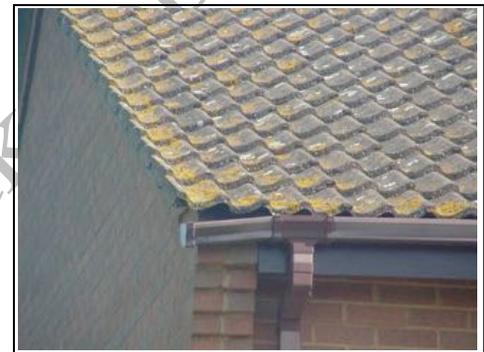
As we often see with concrete tiles there is moss visible on the roof which can cause deterioration and cause blocked gutters and downpipes.

Main roof – pantile style  
concrete tiles

**ACTION REQUIRED:** Carry out periodic inspections and maintenance of the roof, as required.

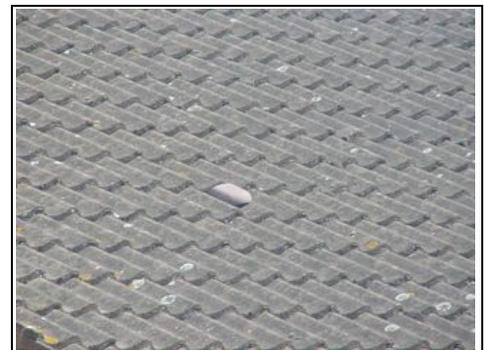
We believe areas of the main roof have been built at different times as there are vents visible to part of the roof but not to others.

Vents in the roof

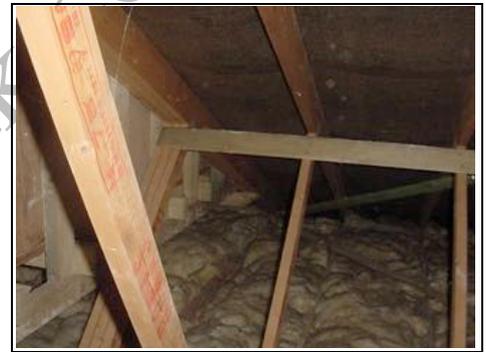
When we inspected the loft space we found a Hessian base Bitumen membrane. This type of membrane has been used since the 1960s. We generally found it to be in average condition, with damage in some areas which is what we typically find.

This photo shows the common rafters (the ones that form the pitch of the roof) and the dark area between is the underlayer.

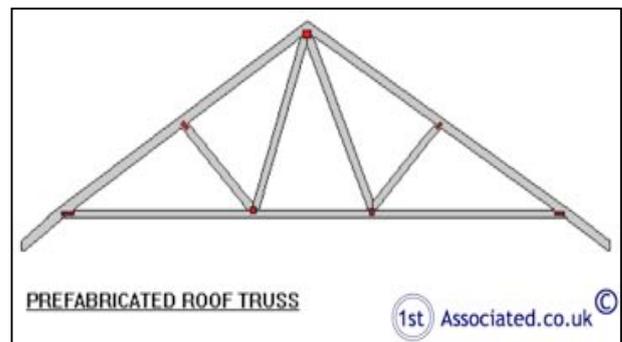
The property has a pre-fabricated trussed roof rafter. These are made in a factory and transported to site and then lifted into place. Without the manufacturers calculations and installation details we cannot comment categorically on the roof other than to say that the roof trusses are wider than we would typically find, 500-600mm, and the timbers looked to be on the small side.

Pre-fabricated roof truss

**ACTION REQUIRED:** Your Legal Advisor to request details of the roof construction.

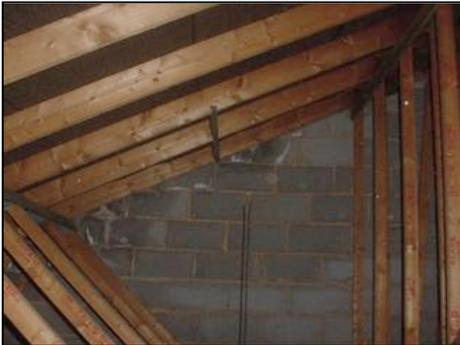
Dampness coming in the roof

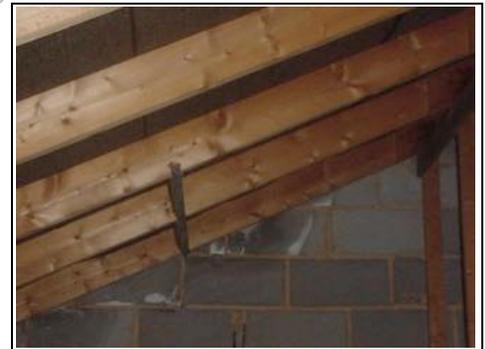
Dampness in the roof

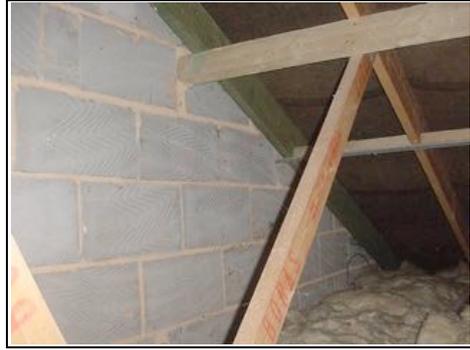
No cracking in wall – far right

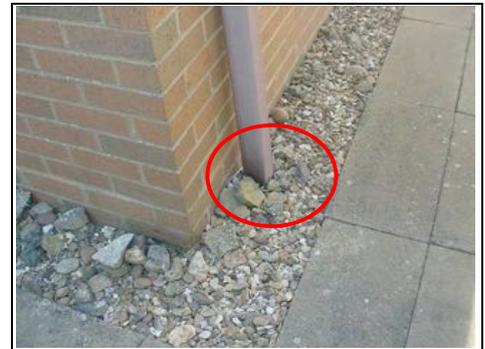
The downpipes feed directly into the ground. This is a practice we are not particularly keen on.

Downpipes feed directly into ground

**ACTION REQUIRED:** We would always recommend you stand outside the property next time it rains heavily and see how well the drains cope with the rainwater particularly looking at the guttering and the joints as some of the guttering looks to be out of alignment.

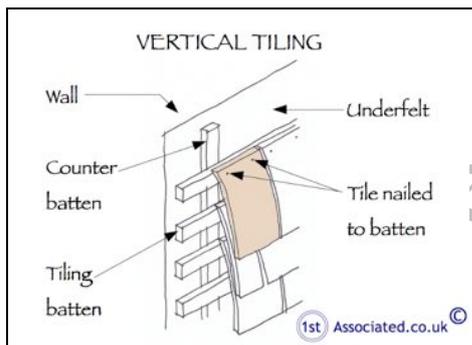
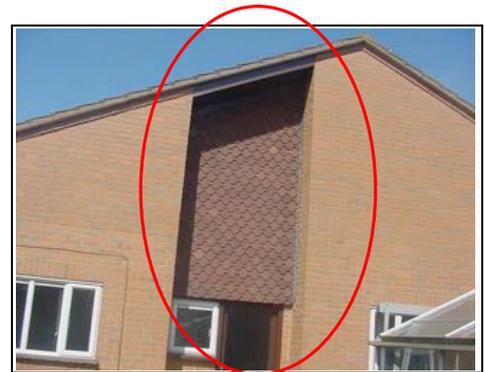
There is an area of vertical tiling to the left hand side of the property that looked to be in average condition.

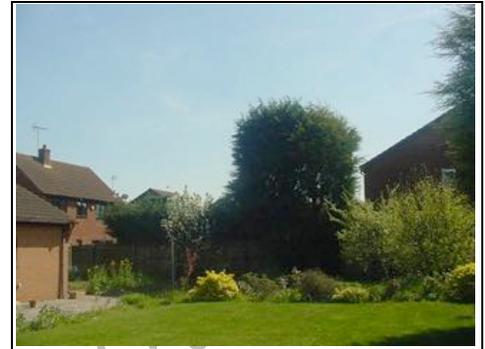
There are trees fairly nearby however we believe these to have a shallow root ball and are a fair distance away from the drains.

Nearby tree- shallow root ball

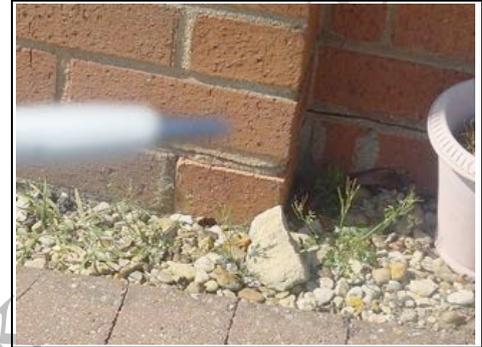
All modern properties should incorporate a damp proof course (DPC) and good building practice dictates that a differential of 150mm (6 inches) should be maintained between the damp proof course and ground levels. In this case, we could see a DPC, this was slightly low in some areas.

Damp proof course

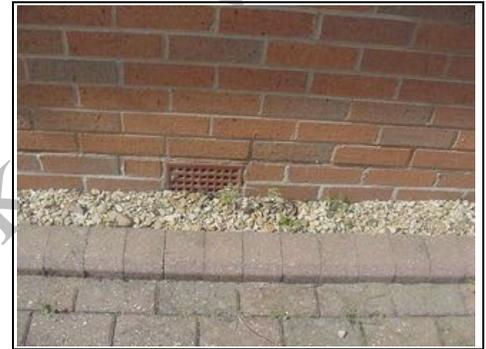
There were low level air bricks noted.

Air brick

**ACTION REQUIRED:** Please see our comments within the Executive Summary.

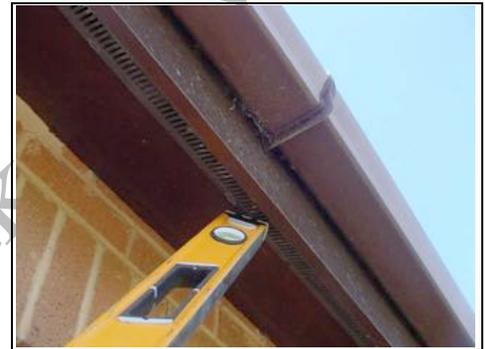
The fascias and soffits are timber. They are stained and we would comment that they are in average condition for their age, type and style. We could see that the soffits have a running vent which we were pleased to see.

Vented soffit

**ACTION REQUIRED:** Make sure gutters and downpipes are watertight before carrying out any work on fascias and soffits. We would recommend redecoration within the next three years.

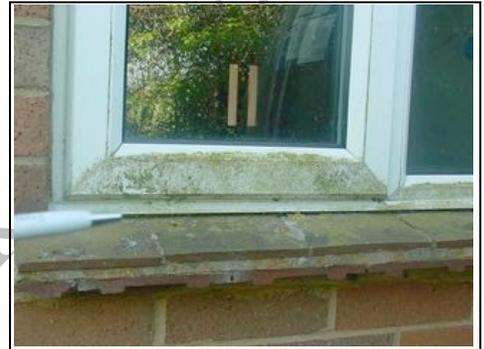
The property has older style plastic double glazed windows with some trickle vents, which generally look to be of average quality. Some of the window frames need a clean as there is moss visible on them.

Window frame covered in moss

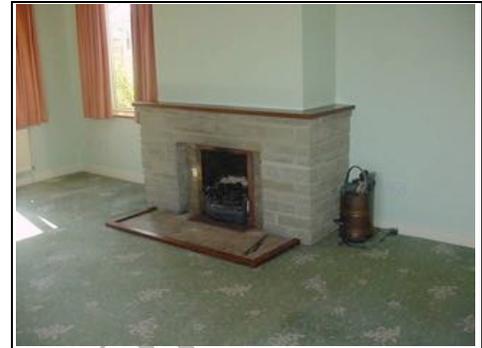
Chimney breast in reception room

At the time of the survey no chimneys were in use. Any chimneys that you do not propose to use should be capped and ventilated to prevent dampness.

It is strongly recommended that flues be cleaned and checked for obstructions prior to use to minimise the risk of hazardous fumes entering the building.

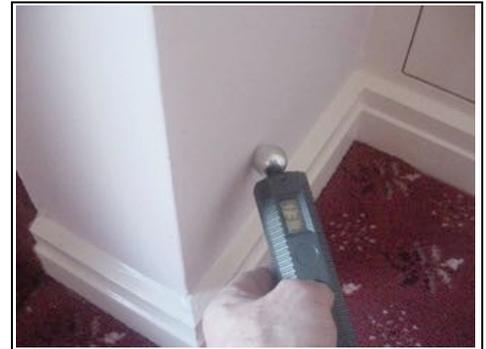
A random visual inspection and tests with a moisture meter have been taken to the perimeter walls. In this particular case we have found no significant rising damp.

Testing for rising damp- none found

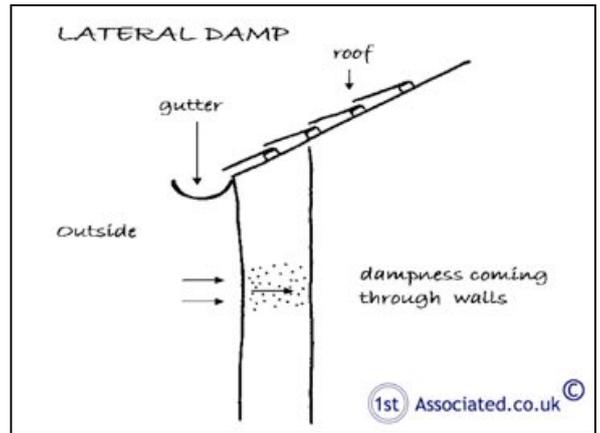
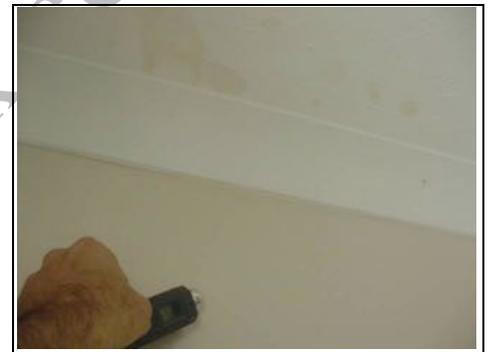
We used a resistance meter on the external walls. We have not found significant dampness.

Testing for lateral dampness

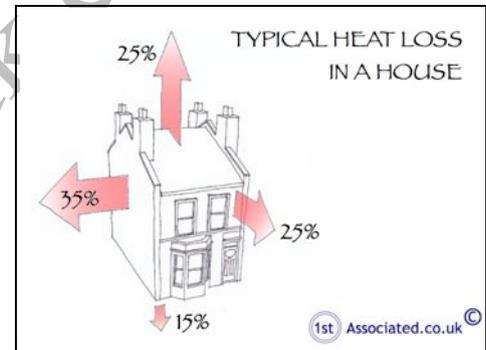
Typical heat loss

Some roof insulation was present although not to current Building Regulations requirements of 300mm. In this instance there is approximately 250mm in the roof.

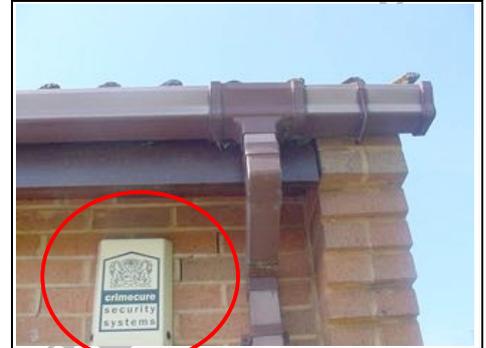
Security alarm box

A security system has been installed. A good alarm system should not only help reduce break-ins but also your insurance. We are not experts in this field and therefore cannot comment further.

**ACTION REQUIRED:** We do not know if this is working or not. Further information should be obtained from the vendor and the installer.

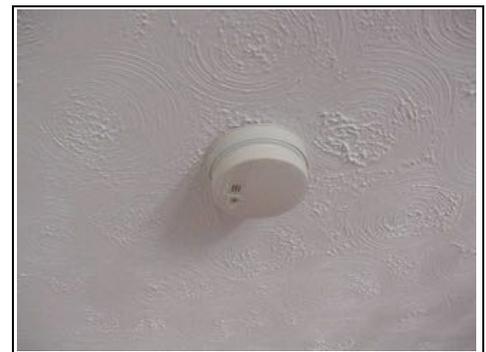
Hard wired smoke alarm

Hardwired smoke alarms were noted. Current Building Regulations now require that they are wired into the main power supply. We much prefer to see these as of course they literally cannot run out of batteries.

**ACTION REQUIRED:** These need to be tested and checked confirming they are working.

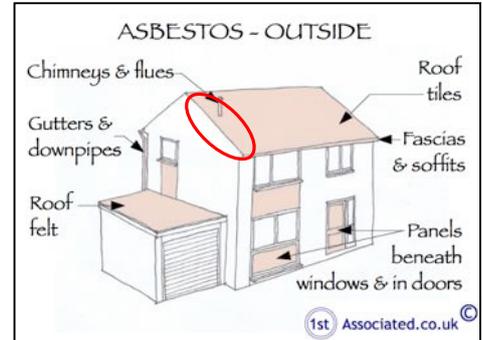
Asbestos externally

In a property of this age there may well be some asbestos. In this case we have noted asbestos to the roof perimeter.

**ACTION REQUIRED:** Please see our comments within the Executive Summary. If you wish to confirm you are 100 percent free of asbestos you need to have an asbestos survey carried out.

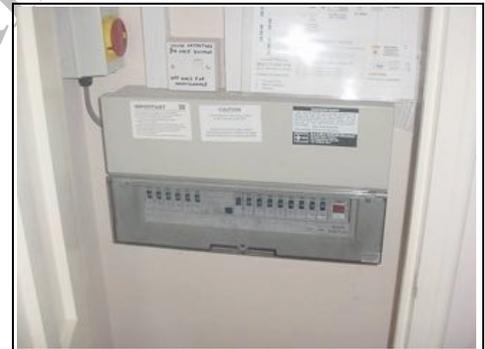
Fuse Board

The fuse board is circa 1990's and better are now available.

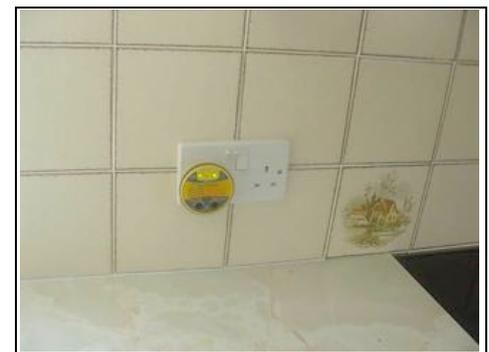
Earth test

We carried out an earth test in the kitchen area to the socket point that is normally used for the kettle, this proved satisfactory.

**ACTION REQUIRED:** As the property is changing occupancy an Institute of Electrical Engineers (IEE) test and report should be carried out by a NICEIC registered, or equivalent, approved electrical contractor or similarly approved.

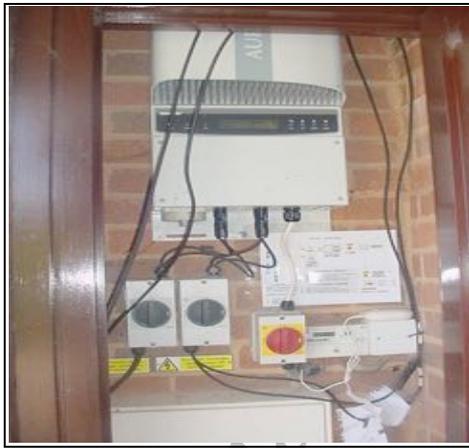
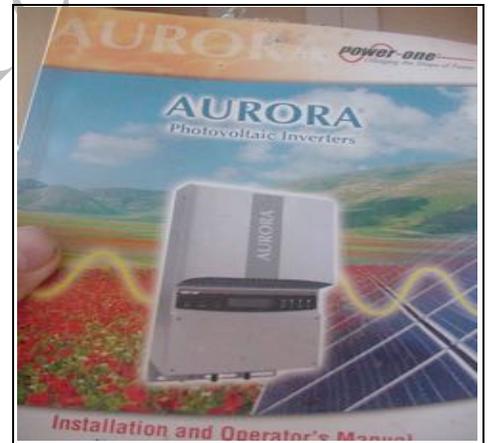
We have not been able to talk to anyone about this system but it is located to the front left hand side as you enter the property.

**ACTION REQUIRED:** Please see our comments within the Executive Summary.

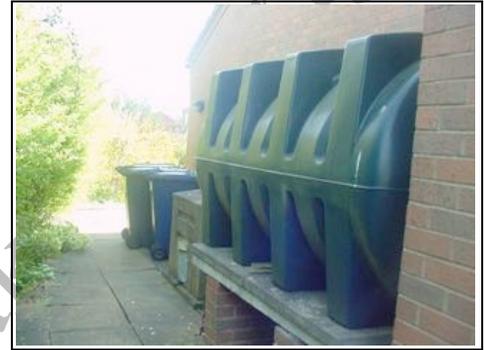
Oil tank

We were pleased to see that the oil tank is plastic. These usually replace the older metal tanks that can rust and they typically have a double lining, meaning that if they leak they leak into the outer lining.

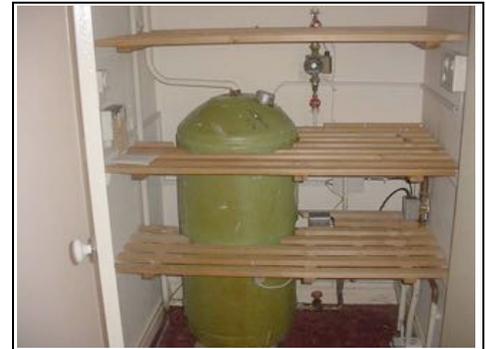
Hot water cylinder

There is a factory insulated hot water cylinder located on the ground floor off of the entrance hallway. This cylinder will therefore have a good thermal efficiency, although not as good as the more modern hot water cylinders.

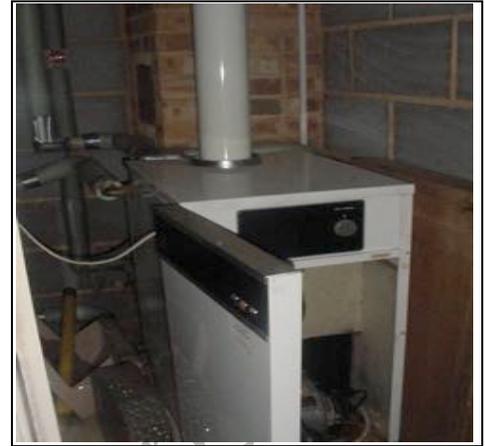
Boiler

The oil fired boiler was located in the service room, off of the garage, it is manufactured by Triton.

Our limited inspection of the hot water and central heating system revealed no evidence to suggest any serious defects but we would nevertheless recommend that the system be tested and overhauled before exchange of contracts and that a regular maintenance contract be placed with an approved heating engineer.

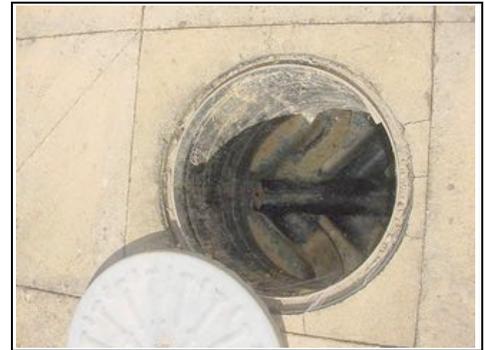
Manhole – opposite cloakroom

We duly lifted the cover but the water was turned off and we could not carry out our basic drainage test.

From what we could see it is plastic built.

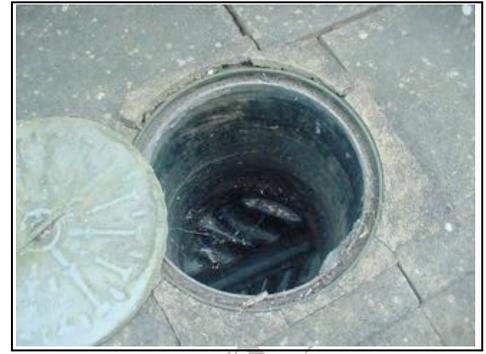
Manhole - right

We duly lifted the cover but the water was turned off and we could not carry out our basic drainage test.

From what we could see it is plastic built.

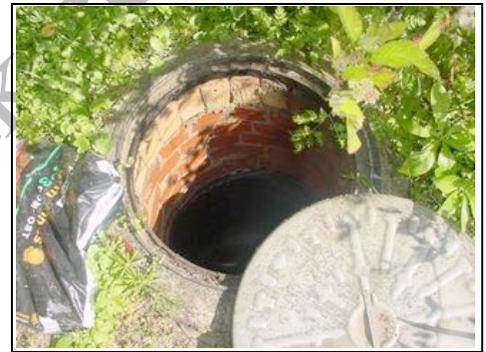
Manhole – front right

We duly lifted the cover but the water was turned off and we could not carry out our basic drainage test.

From what we could see it is brick built.

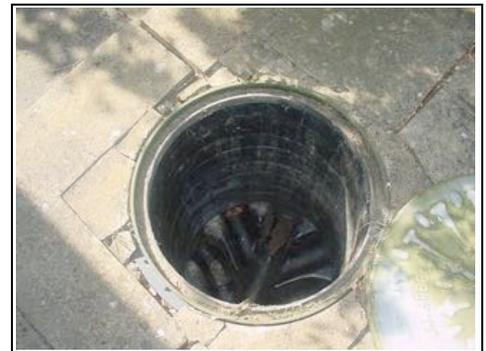
Manhole – rear right corner

We duly lifted the cover but the water was turned off and we could not carry out our basic drainage test.

From what we could see it is plastic built.

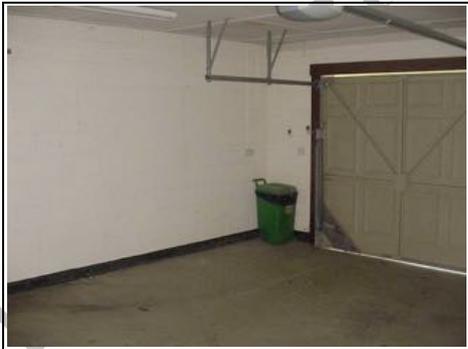
Garage

The property has a good sized attached double garage.

**ACTION REQUIRED:** Please see the Executive Summary.
