RESIDENTIAL BUILDING SURVEY

xxxxxxx,
London,
W10 xxxx

INTRODUCTION
REPORT FORMAT
SYNOPSIS

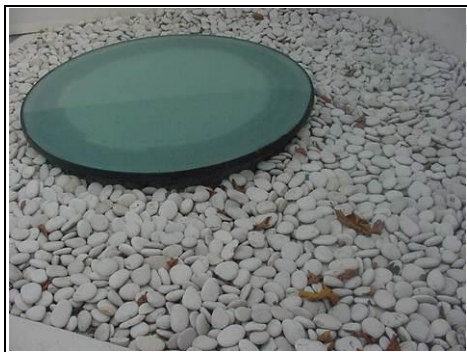
We think that some of the roof windows will leak. In our opinion they are poorly detailed as the edges of the windows have a tape around them rather than a proper frame. We do appreciate that the water does have to run off the glass but we feel this tape may come away over the years and allow dampness in and in turn break the double glazed seal.

Roof window into the front bedroom below

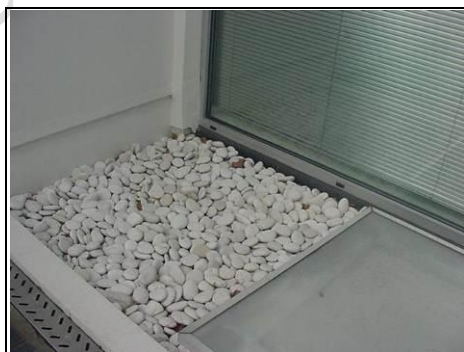
Roof window to the front

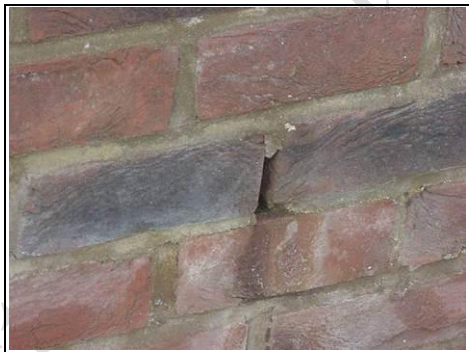
We can see that the wall design has been thought through i.e. having a soil bed at high level. It also has weep holes to allow the water to drain out but unfortunately efflorescence is visible and also staining around the weep hole. This will be an on-going maintenance issue.

Weep hole

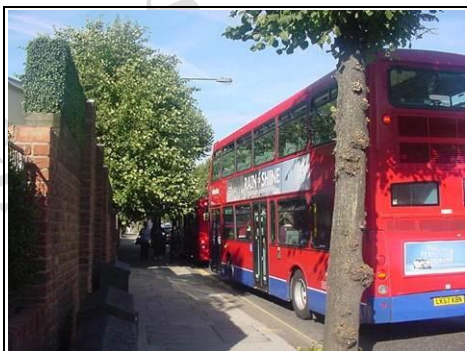
We noticed a lot of buses whilst we there, in fact a surprising number of buses. This may or may not bother you. We wondered if privacy would be an issue.

Buses pass the property often

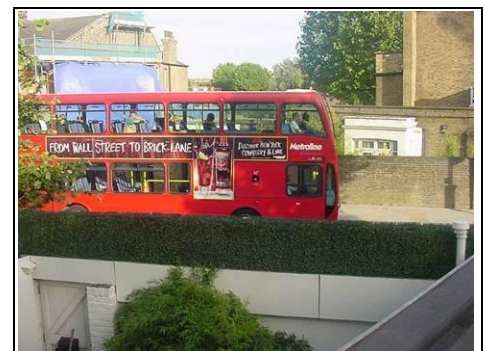
Can people on the bus see into the garden?

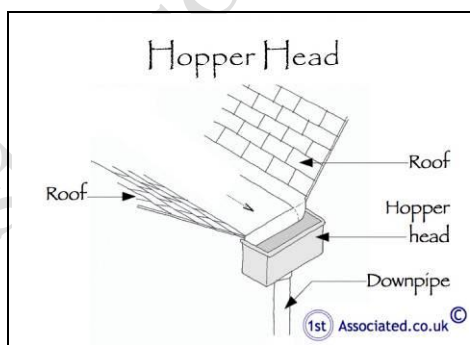
Small hopper head

Sketch shows normal size of hopper head in relation to downpipe.

Whilst we have spoken about the small box gutter that goes with this we feel that with the amount of rain we get, this could over flow and we would look to replace it with a larger hopper head.
