RESIDENTIAL BUILDING SURVEY

XXXX St Albans, Hertfordshire. AL3 XXX

INDEPENDENT CHARTERED SURVEYORS

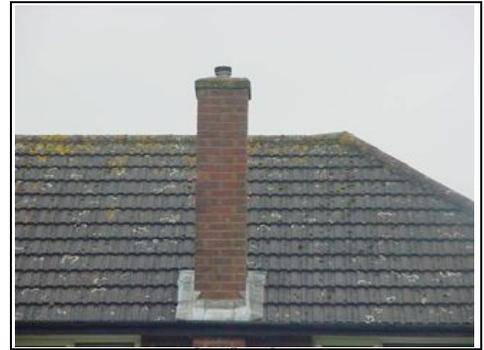
Chimney Two – Located at the rear of the Property

We would comment in a similar manner to the previous chimney. This has a single flue at the top, which we believe is the flue from the boiler in the kitchen.

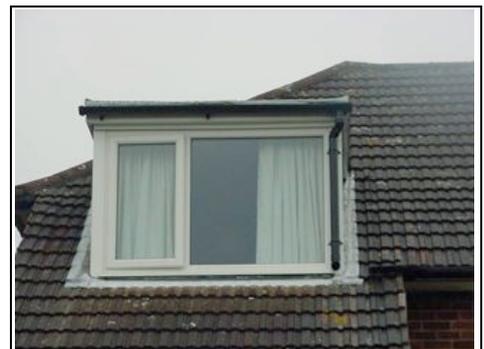
There is one dormer window to this property. The roof is clad with felt, but our view was limited, the cheeks/sides are in timber, we are not certain of the type. Generally as viewed from ground level it looked in reasonable condition.

Dormer windows have been viewed from ground level and literally from the dormer windows themselves.

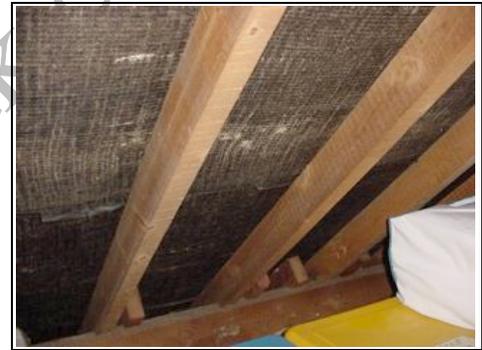
When we inspected the loft space we found a Hessian based bitumen membrane. This type of membrane has been used since the 1960s. We generally found it to be in average condition, although it is damaged in a few places but this is not unusual considering its age.

This photo shows the common rafters (the ones that form the pitch of the roof) and the dark area between is the underlayer.

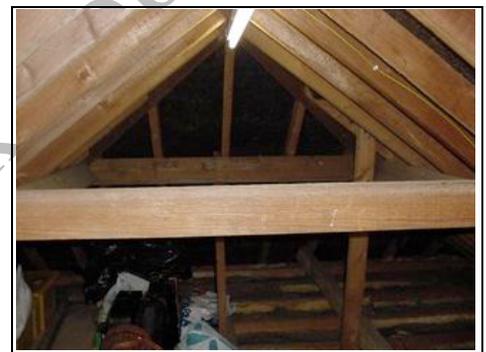
The main roof is accessed via the loft hatch located on the landing. There is no loft ladder, there is an electric light and the area is partially boarded. We recommend that a loft ladder and full secured floor boarding are added to make the loft space safer and easier to use. The loft (perimeter) has been viewed by torch light, which has limited our viewing slightly.

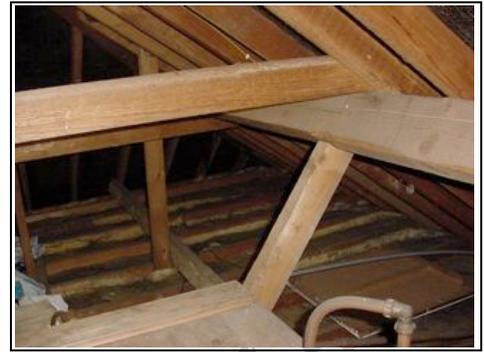
We found the roof timbers generally in average condition considering their age. We have inspected the roof structure for:

Our examination was limited by the general configuration of the roof, the insulation and stored items. As mentioned what we could see was generally found to be in average condition considering its age. It is, however, feasible that there are problems in the roof that are hidden.

ACTION REQUIRED: The only way to be 100 per cent certain is to have the roof cleared and checked.

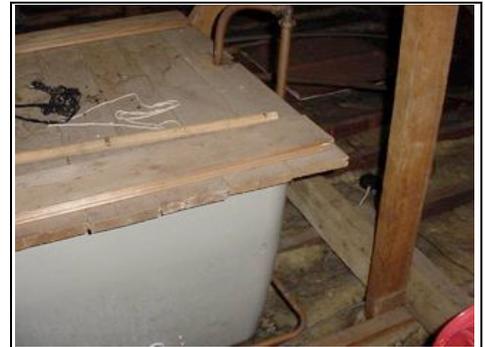
The water tank is plastic, possibly fibre glass, with a timber lid. We would always recommend that water tanks be drained down and cleared of any debris etc. (we have seen dead birds and other unmentionable things in these tanks). As you are cleaning your teeth with this water it is best that it is as clean as possible!

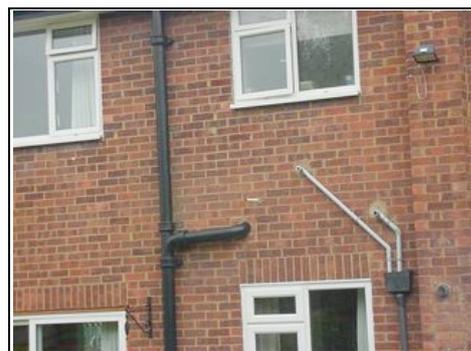
The soil and vent pipes are cast iron; they appear to be satisfactory where a surface inspection is possible, although cast iron of this age will need regular maintenance such as repair and painting and can rust and crack.

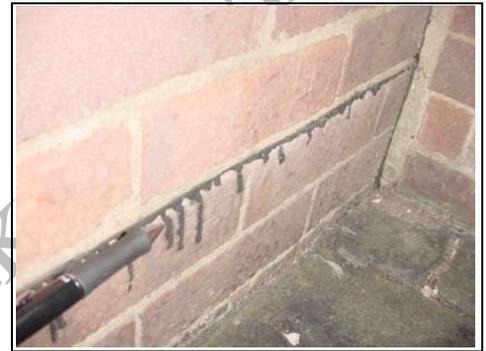
Bitumen damp proof course

We noted that the damp proof course to the rear of the property was slightly low on the rear left hand side (it should have two courses of brickwork between the ground level and the damp proof course and it only had one). This was causing some spalling to the brickwork.

All modern properties should incorporate a damp proof course (DPC) and good building practice dictates that a differential of 150mm (6 inches) should be maintained between the damp proof course and ground levels. In this case, we could see a bitumen damp proof course. It is slightly low to the rear particularly on the rear left hand side of the property with the bricks starting to deteriorate. Your attention is drawn to the section of the report specifically dealing with dampness.

ACTION REQUIRED: We recommend that you have a look the next time there is a heavy downpour of rain just to see how the rainwater passes from the rear of the property to the front to see if there is any obvious signs where it can/is causing damage and deterioration and then take appropriate action.

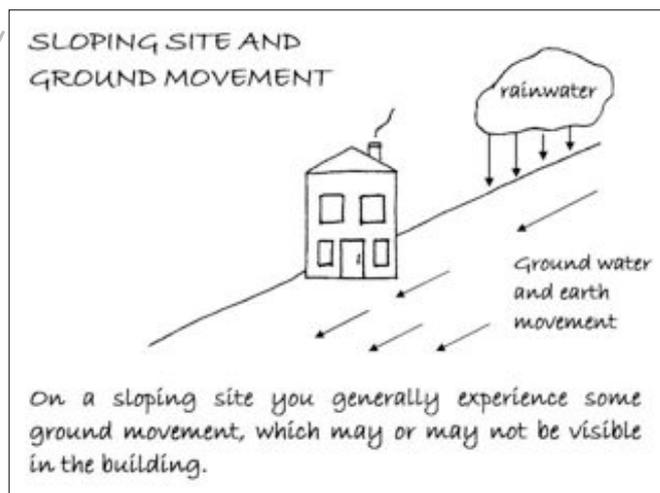
Sloping Site

Any property on a sloping site is more susceptible than one on a flat site; it is simply the laws of gravity. Foundations normally allow for such occurrences, particularly in new properties, however here can still be some minor movement.

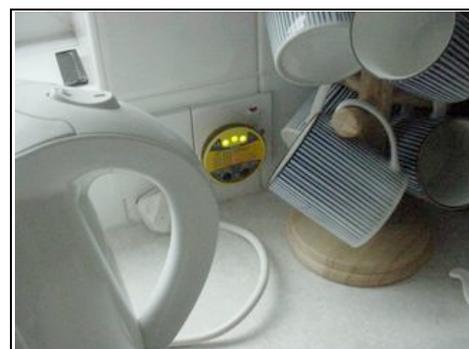
We carried out an earth test in the kitchen area to the socket point that is normally used for the kettle, this proved satisfactory.

Neither of these indicators can give certainty as to the condition of the rest of the wiring.

ACTION REQUIRED: As the property is changing occupancy an IEE report should be carried out by a NICEIC registered and approved electrical contractor.

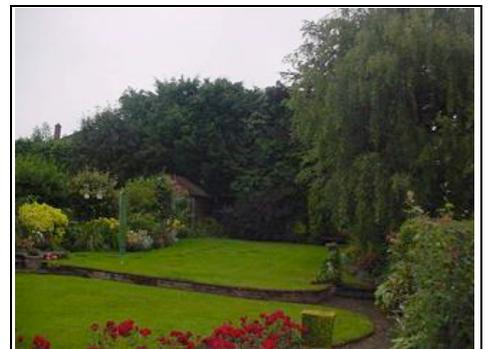
Rear Garden

You have a mature garden with larger trees. All trees will need regular maintenance.
