# RESIDENTIAL BUILDING SURVEY

**XXX**

**Roxton**

**Bedfordshire**

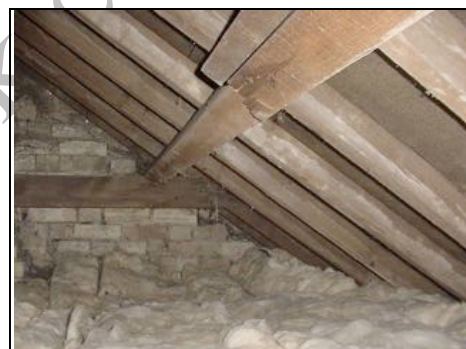
The original roof covering would have been slate. This has been replaced with a heavier concrete tile. Modern Building Regulations require a traditional structural support is provided where this takes place. We can't see any obvious additional support that has been added and equally we cannot see any significant movement in the timbers.

We did note that the purlins were running a long length without getting support.

Long purlin without support

**ACTION REQUIRED:** Your Legal Advisor to check and advise when the property was re-roofed and if Building Regulations permission was approved/obtained. We will advise further.

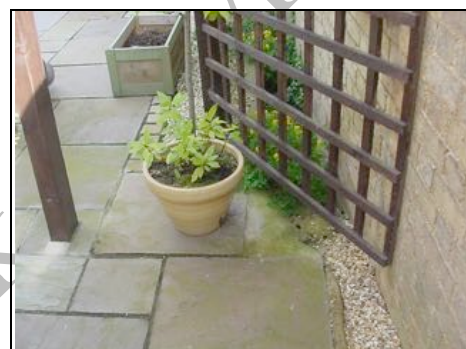
We are getting slightly high damp readings in the front right hand corner bedroom (all directions given as you face the front of the property). This could be due to the need for some repointing at high ground or it could be due to lack of air movement in the area due to the nearby tree.

Damp to the right hand side

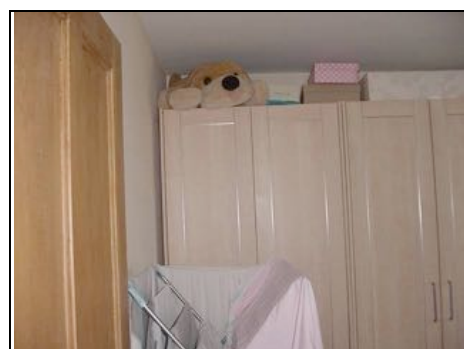
There may also be cold bridging occurring in the corner of the property as we noticed that washing was being dried here.

Washing drying in the right hand bedroom

**ACTION REQUIRED:** Improve the extraction to areas of high humidity with the installation of good large humidity controlled extract fans to the bathroom (we appreciate it has already got one but better are available) and the kitchen.

If the room is regularly used for the drying of clothes (it was being used at the time of the survey) and you intend to do the same then you need to make sure this room is well aired with a good large humidity controlled extract fan!

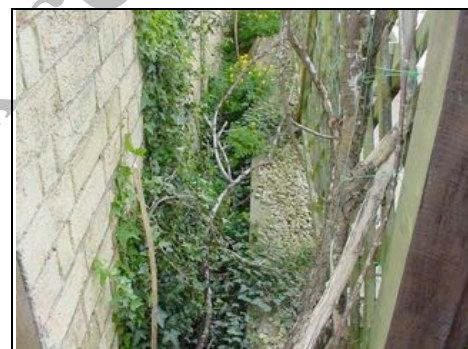
We believe there are some high ground levels to the property. We are recording high damp meter readings to the right hand side of the property. If you recall we visited next door and the existing owner, we believe, agreed to reduce the ground level in that area. The vegetation also needs to be cleared out.

Vegetation to right side area

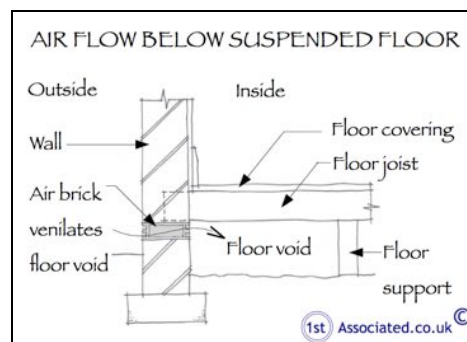
As discussed whilst at the property, there should be an airflow under the suspended timber floor. We can see the ground level has increased to the front of the property hiding some of the airbricks. These need to be exposed and cleared and checked they are venting; this is a relatively easy operation.

Suspended timber floor

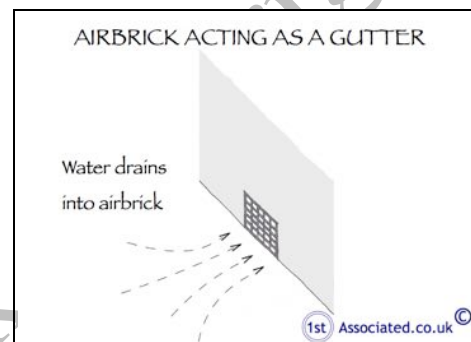
Airbrick acts as gutter

**ACTION REQUIRED:** Ideally a French drain should be added to the rear of the property. As mentioned this is complicated by the garage to the rear which we have not seen inside. You do need to check this to see if there are airbricks within and if there is a concrete floor because a concrete floor will act like blotting paper against the property.

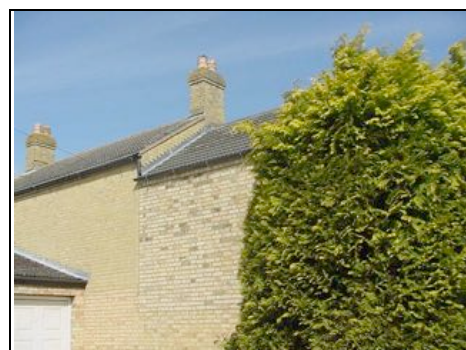
Large bush / tree

**ACTION REQUIRED:** Have another 'cup of tea' meeting with the rear neighbours (the neighbours with the high ground level and garage to rear) and ask them about the tree and advise that the Surveyor was concerned about it (there looks to have been some historic cracking that could relate to this on the gable end).

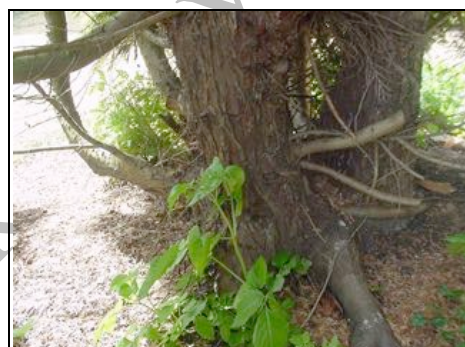
Base of large tree

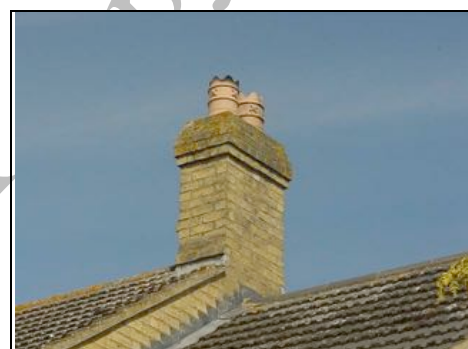
Left hand chimney

This chimney is brick built with two chimney pots. There is some moss at the top, at some stage this should be cleared off and some repointing carried out.

**ACTION REQUIRED:** In the next few years have a close inspection of the chimney.

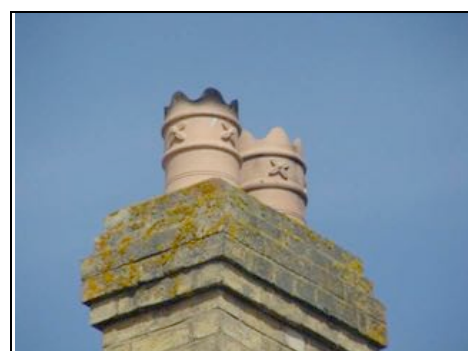
Minor moss

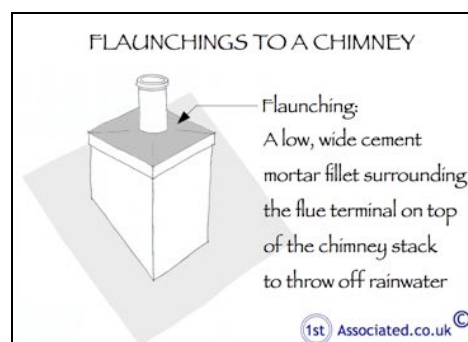
Flaunching

Unfortunately we were unable to see the flaunching properly, we therefore cannot comment upon them.

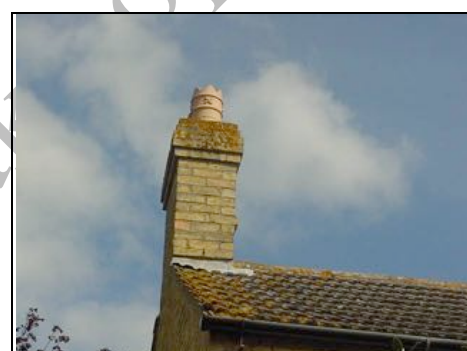
Right hand chimney

This chimney is brick finished with a lead flashing and two decorative chimney pots. From what we could see from ground level it looked in average condition considering its age, type and style. There is some moss at the top and there is a slight lean to the chimney.

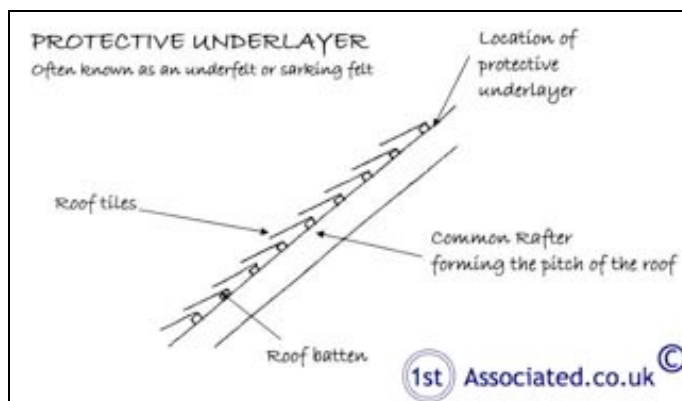
Protective underlayer

When we inspected the loft space we found a Hessian base Bitumen membrane to the right hand side. This type of membrane has been used since the 1960s. We generally found it to be in average condition, with damage in some areas which is what we typically find.

This photo shows the common rafters (the ones that form the pitch of the roof) and the dark area between is the underlayer

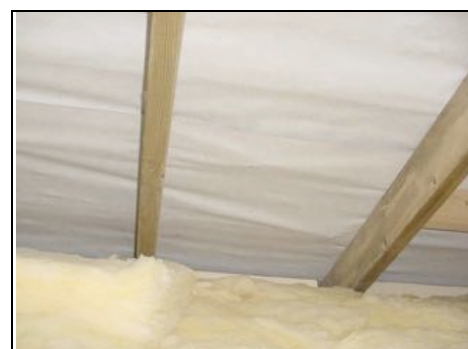
Modern breathable felt

To the left hand side there is a modern breathable sarking felt. This type of sarking felt, as far as we are aware, has been used since 2002.

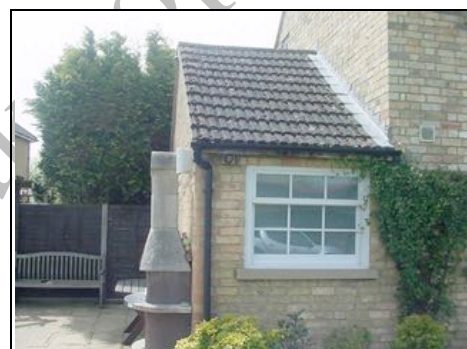
Pitched rear low level roof

There is a pitched low level roof to the rear, which is clad with concrete tiles with a lead flashing.

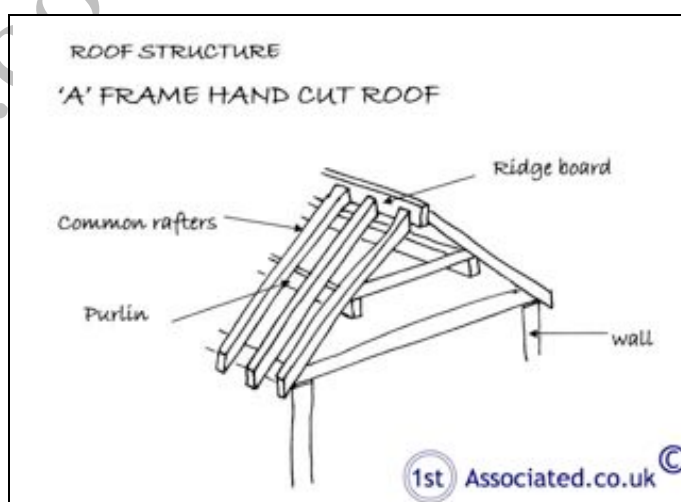
'A' frame roof

This type of roof structure has what is known as an 'A' Frame cut timber roof. This is a roof that is purpose made and hand built on site. Without the original design details we cannot categorically confirm that there are no defects; however it is in line with what we typically see with the exception that we would have expected more supports to the purlins particularly as there has been a concrete tile added.

**ACTION REQUIRED:** Please see our comments in the Executive Summary.

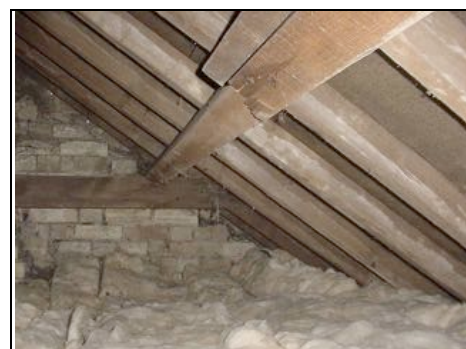
Long length of purlins without support

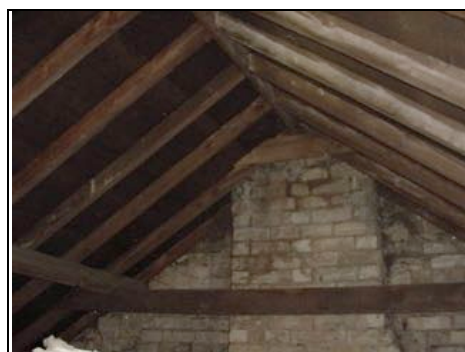
General view of inside of roof

Our examination was limited by the general configuration of the roof and the mass of insulation. What we could see was generally found to be in average condition considering its age. It is, however, feasible that there are problems in the roof that are hidden.

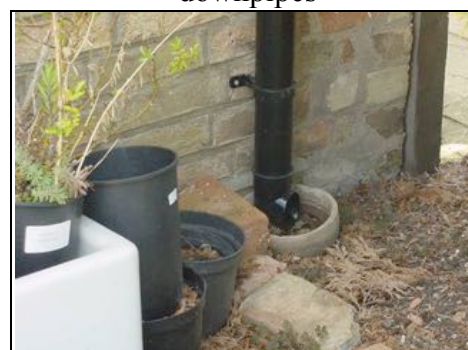
Downpipe

The property has plastic gutters and downpipes and are fairly typical of what we see; they are in average condition for their age, type and style.

**ACTION REQUIRED:** We would recommend you stand outside the property next time it rains heavily particularly to the rear of the property (obviously gaining permission from the neighbours first) and see how well the drains cope with the rainwater particularly looking at the guttering and the joints.

We also recommend that the gutters and downpipes are cleaned out, the joints are checked and the alignment checked to ensure that the gutters fall towards the downpipes.

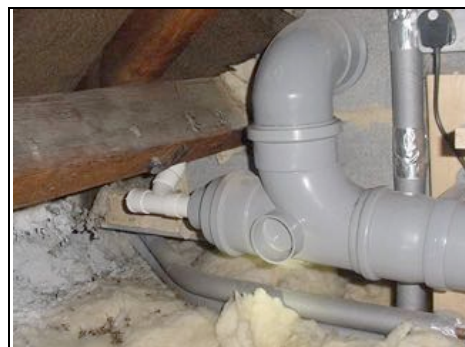
Soil and vent pipe within roof

The property has internal soil and vent pipes.

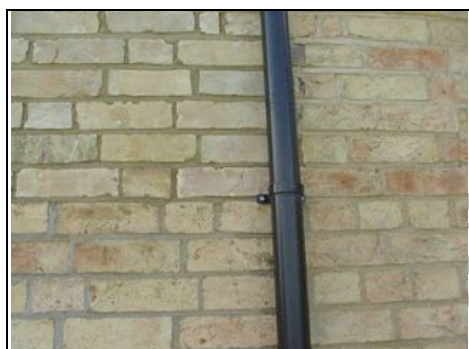
The property is predominantly in Flemish bond brickwork, which is a solid wall construction with a cement mortar although originally it would have been lime mortar. There is an almost random brick coursing in some areas.

Flemish bond brickwork to right side, random brickwork to left side

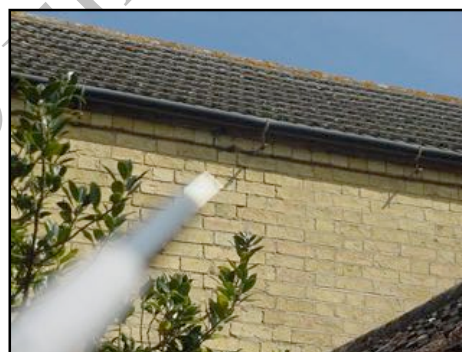
Weathered pointing

Generally Flemish Bond brickwork is liable to penetrating dampness internally, dependent upon the condition of the brickwork and the exposure to the weather. It is essential that external faces be kept in good condition. In this case the brickwork has some weathering.

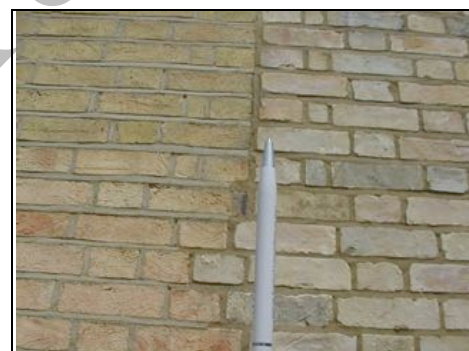
New extension

The new extension has followed the Flemish bond brickwork in some areas, we assume it has building regulation permission and as such may well be a cavity wall construction with insulation within.

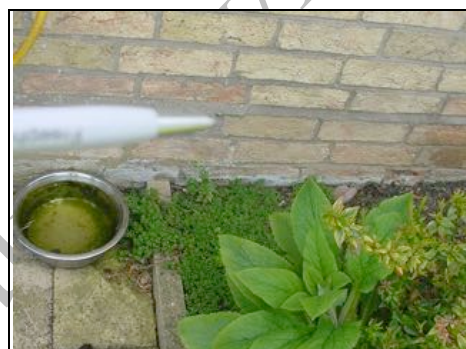
Damp proof course

In properties of this age it is unlikely that a damp proof course would have been built in originally. However, often they have had damp proof courses added at a later date. In this case we can see a DPC in some areas with the thickening of the ground indicating there is a slate or similar present.

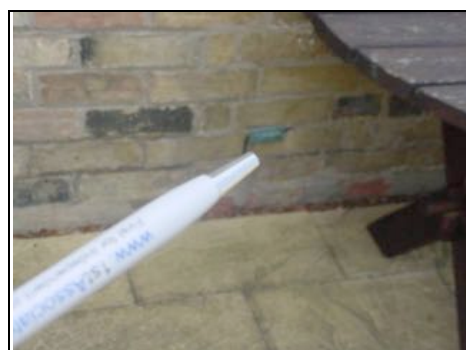
Metal electric damp proof course

There is a metal electric damp proof course to the left hand side of the property. These were popular at one time. From the information we have read in relation to them, we generally find that they do not work. They are in the area of the boiler room which we should imagine is kept fairly warm and dry.

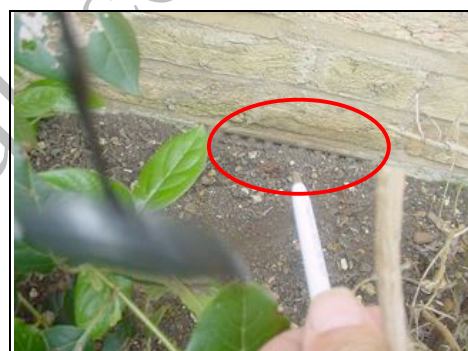
Air bricks are essential to have a through flow of air as this helps to reduce the chances of wet rot, dry rot and woodworm. In this case the airbricks are acting as gutters and certainly not venting the floor.

Air brick – ground level needs to be reduced

**ACTION REQUIRED:** Please see our comments in the Executive Summary.

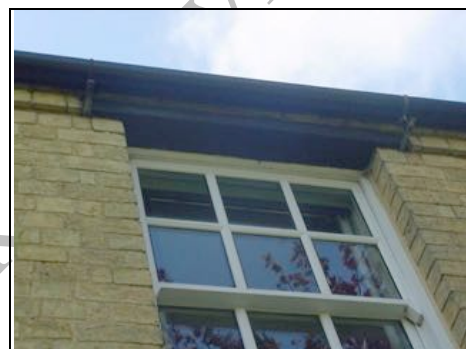
Fascia

We believe there is a fascia board hidden behind the gutters; it is very difficult to see.

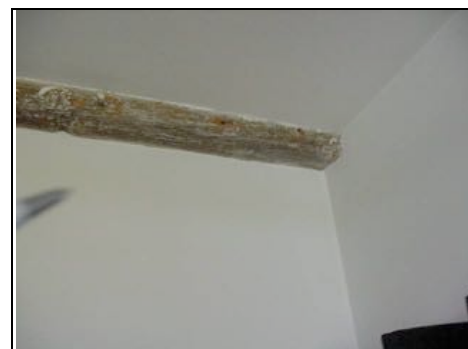
Timber in the lounge

We are not one hundred percent certain but it seems it is a very unusual detail.

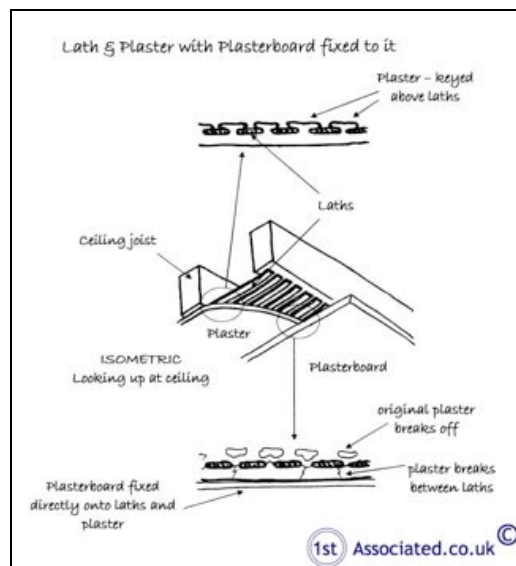
In the older part of the property on the right hand side there was originally lath and plaster ceilings; when we lifted the insulation in the roof space we could see the lath and plaster. It is not in very good condition and had loosened the grip on the lath.

Lath and plaster ceiling overclad with plasterboard

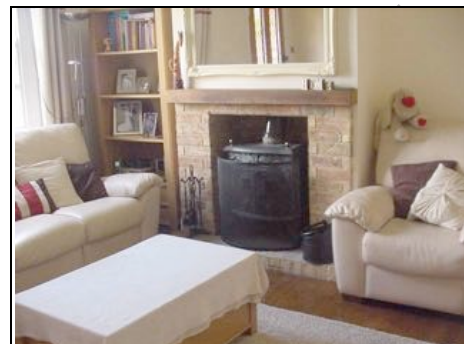
Feature fireplace

The chimney breasts are located to the left and right hand sides (all directions given as you face the front of the property). The property had what we would term as a feature fireplace in the lounge which looked to have a wood burner.

At the time of the survey no chimneys were in use. Any chimneys that you do not propose to use should be capped and ventilated to prevent dampness.

It is strongly recommended that flues be cleaned and checked for obstructions prior to use to minimise the risk of hazardous fumes entering the building.

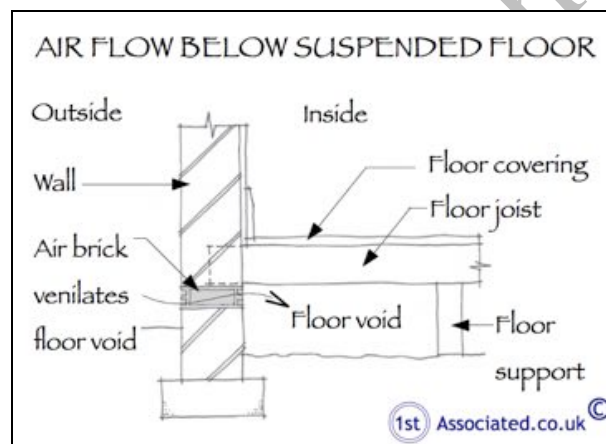
Suspended timber floor

There is a mixture of a suspended timber floor to the middle of the property and possibly the right side, which require air movement underneath to minimise wet rot, dry rot and woodworm. Our concern with regard to the airflow is that it will be difficult to get effective airbricks to the rear of the property due to the way the garage has been built against the building. In the Executive Summary we have mentioned about putting a French drain to the rear of the building. We would have a meeting with the neighbours and get permission before you legally commit to purchase.

**ACTION REQUIRED:** Please see our comments in the Executive Summary.

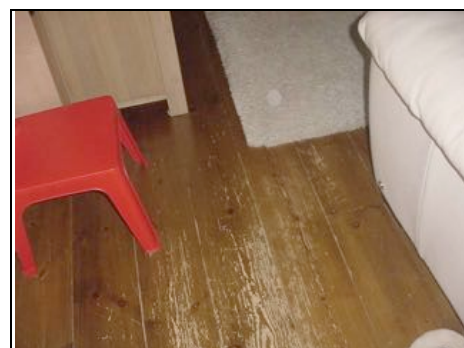
Marks to the floor in the lounge

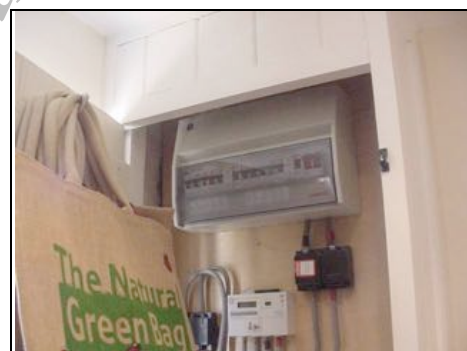
Fuse Board

The electric fuses and consumer units were located in the left hand side entrance area. The fuse board looked 1990's/2000's and better are now available. We are advised the electrics were tested in 2009; certificate required.

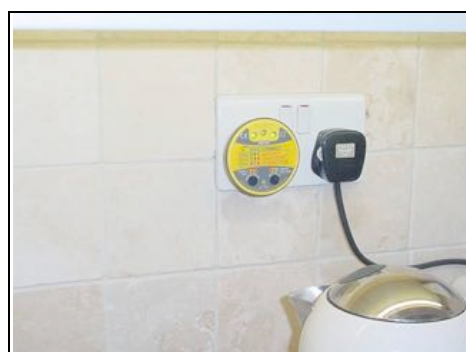
Earth test

We carried out an earth test in the kitchen area to the socket point that is normally used for the kettle, this proved satisfactory.

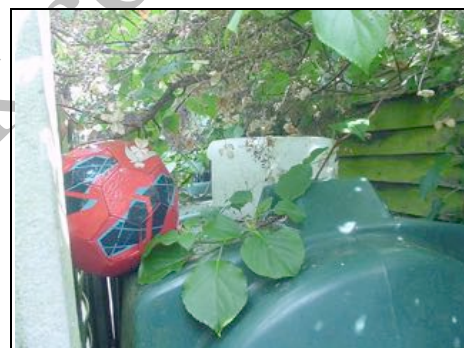
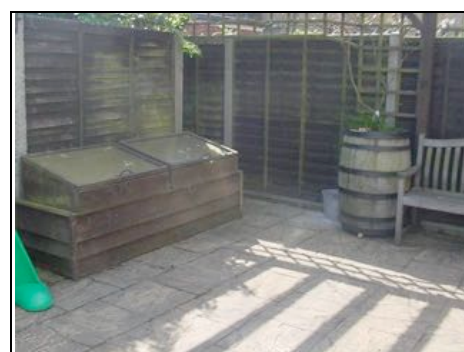
We were pleased to see that the oil tanks are plastic. These usually replace the older metal tanks that can rust and they typically have a double lining, meaning that if they leak they leak into the outer lining.

Oil tank hidden behind fence to left side of property

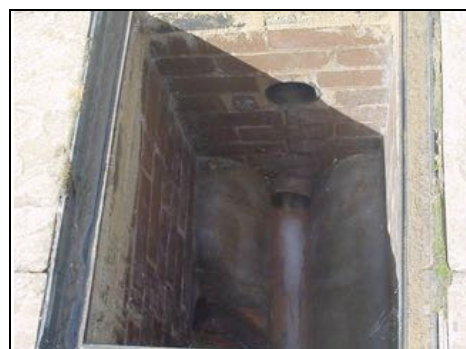
Front left hand manhole

We duly lifted the cover and found it to be free flowing at the time of our inspection.

From what we could see it is brick built.

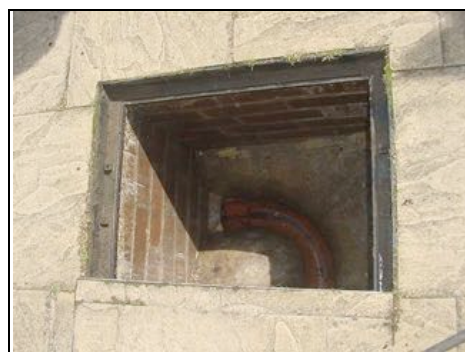
Rear left hand manhole

We duly lifted the cover and found it to be free flowing at the time of our inspection.

From what we could see it is brick built.

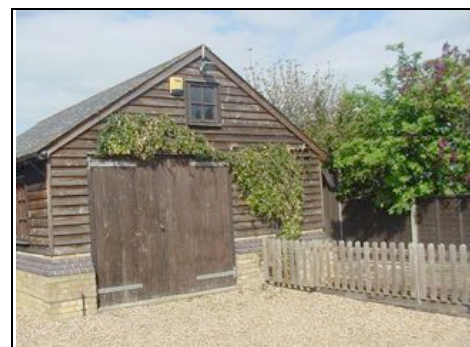
Garage and workshop

There is a substantial garage/workshop area. We were shown that it has electricity and an outside water supply. The current owner has put a lean-to type structure around it; we discussed the roofing of this with them and they said they had found problems with the corrugated roof that they had used and that it sagged and seemed to need a lot of support.

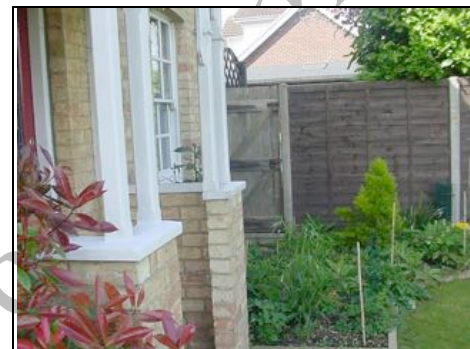
Access gate to next door property

**ACTION REQUIRED:** Your legal advisor needs to check that the access gate to next door property is not a right of way
