## RESIDENTIAL BUILDING SURVEY

Ravensden,  
Bedfordshire  
MK44 XXX

INDEPENDENT CHARTERED SURVEYORS

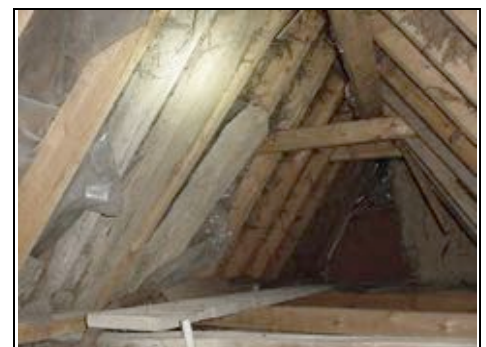
Mixture of new and older timbers to the centre roof

Unfortunately, the environment with insulation being added can improve the woodworm and encourage to breath from what we understand. There is a fair amount of insulation in the roof; all of this will have to be removed to properly view the roof to assess the damage to the timbers. We do feel that some of it is what we would term as a structurally significant in nature although there is of course woodworm in the roof that is not structurally significant. We found woodworm to the centre roof and we believe it also to the left roof.

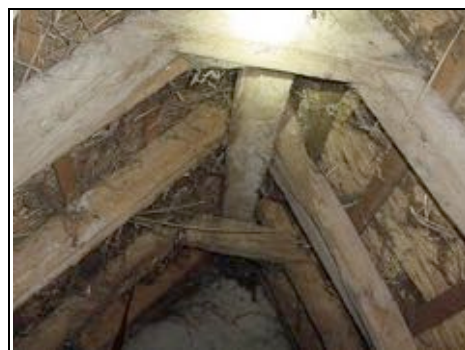
Timber to the right roof

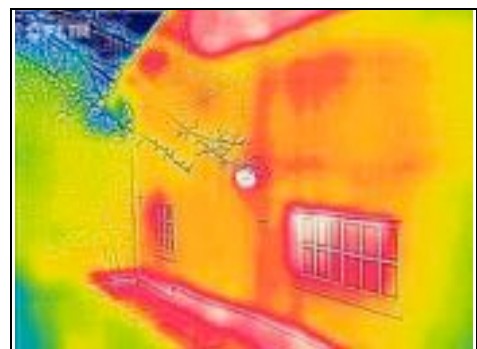
Thermal image indicates left side may be timber frame

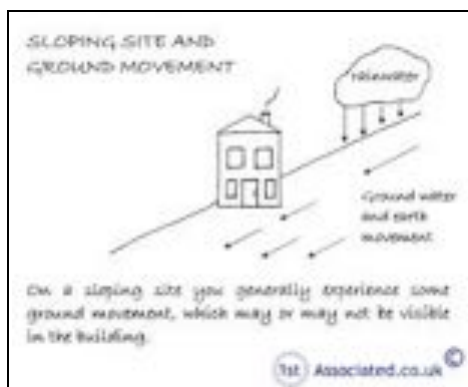
Historically this building has had a considerable amount of movement leaning from side to side. Also as it is on a sloping site it is integrally more unstable than the property on a level site.

Sloping site

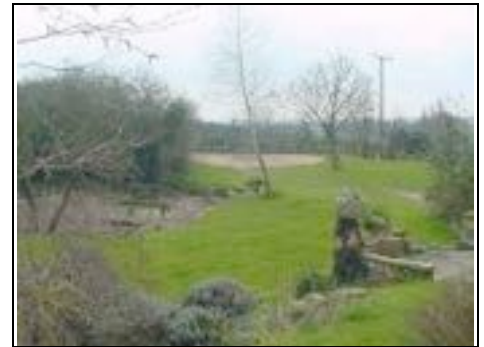
Slope towards pond

When you are in the property you can see the extent of the slop on the property, in particular you can see that there has been a considerable amount of packing under the furniture.

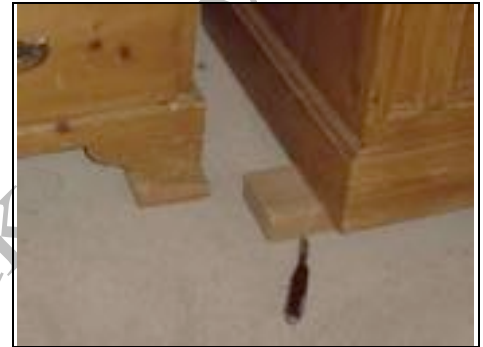
Furniture propped on uneven floors

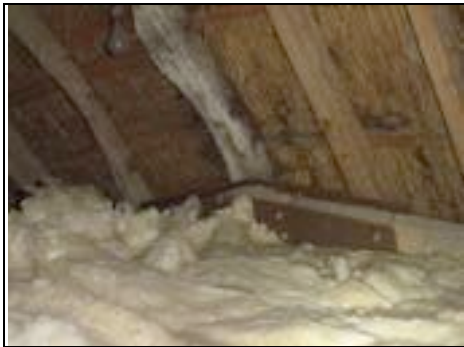
We can also see metal brackets in some areas of the property. Specifically, we can see them in the left roof and we can also see them in the middle wall of the left hand room. These indicate there has been historic movement in this property. It is very difficult from a one off inspection to conclude whether it is still what is known as progressive.

Brace at base of timber in left roof

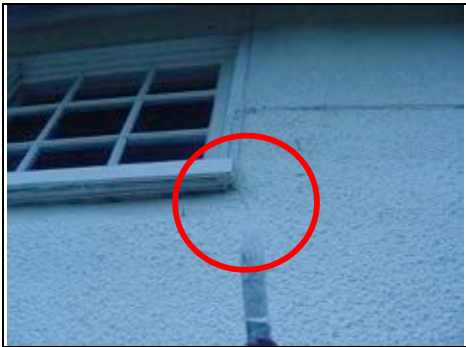
There is hairline cracking visible to some of the internal walls where the wall and ceiling joists meet and there is also hairline cracking to the gable end of the property. You do have to remember that the whole of this property has been repainted in the last few years hiding any usual indications. Again, these cracks are indicating sideways movement left to right.

Cracking to the window

**ACTION REQUIRED:** Ideally we would recommend the existing owners take out an insurance claim, advising that the cracking has been noted by a structural surveyor (this should cost them nothing other than time to write the letter). This usually means that the insurance company will carry out a monitoring exercise (the Building Research Establishment recommend monitoring any cracks for a minimum of one year) to establish if there is any progressive movement. Your future liability will be limited to the cost of the excess on the insurance providing the insurance company is happy for you to take over the insurance claim.

Monitoring is the only true way of establishing in this particular case of whether it is still moving (which it probably is not due to the amount of wall replacements although it is very difficult to confirm without opening up the walls, etc).

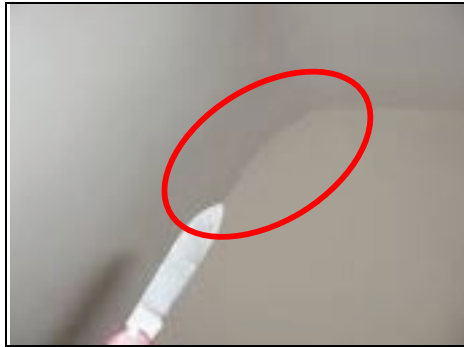
Hairline cracking in master bedroom

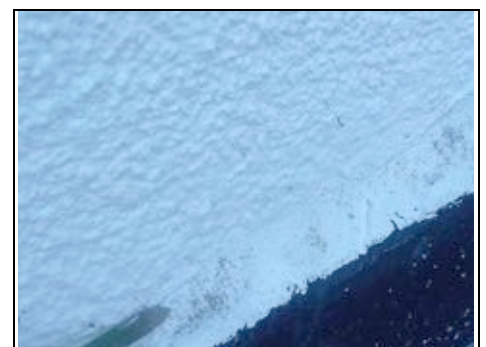
We can see that the render has been painted over. When discussed during our question and answer session the owner advised that it was the last few years. We can see moss where it has not been painted over properly. The painting of the render has hidden a lot.

We would also comment that the render appears to be a cement based render. The owner, during our question and answer session, advised this was already present when they bought the property.

Moss visible

**ACTION REQUIRED:** Ideally as mentioned we would like to open up a section of the render just to see what it is made of. We would also be able to see what is behind it. We would be looking for opening up to be on the left hand side of the property.

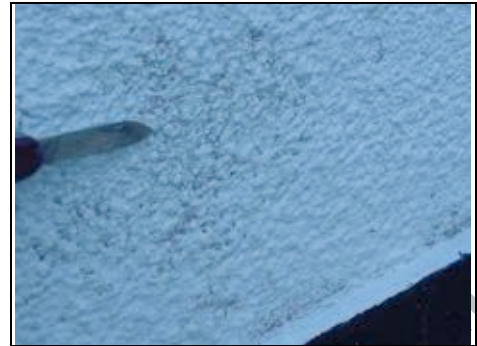
The listing describes a rough cast render which normally relates to a lime based render and this is certainly not the case as far as we can see.

Moss showing through painted render

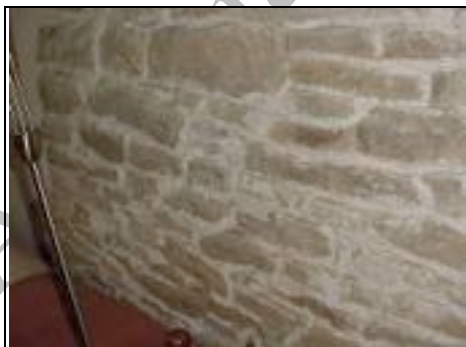
In various areas we found dampness coming in through the stonework for example and we can also see sulphate where there is orange/brownish staining where the soot is being drawn through.

Dampness coming through and various repairs

**ACTION REQUIRED:** We would recommend the adding of a French drain around the property. Currently there are paving slabs around the property, which unfortunately discharge water against the building.

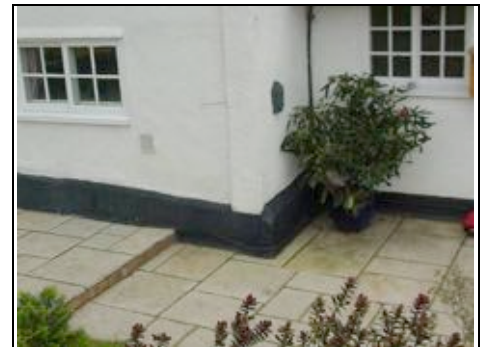
You can see the full extent of the slope of the site with the pond directly behind the rear of it. You do need to remember that you will be getting not only water from your adjacent gardens but also from the adjacent fields and road, etc.

Paving around property

**ANTICIPATED COST:** £5,000 - £10,000; please obtain quotations.

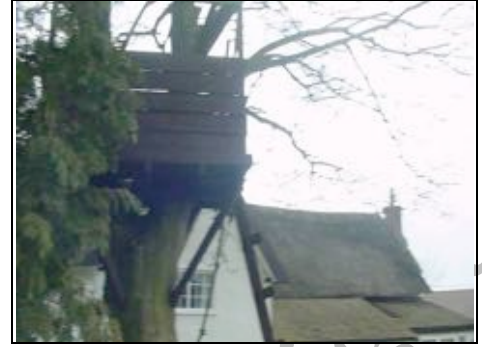
There is a tree in close proximity to the house. It does not look to have been maintained for many years, when we spoke to the owner he advised us that he had had advice with regard to the tree but in the end decided to do it himself.

A large tree close to the property

**ACTION REQUIRED:** Advice from an arboriculturalist (not a tree surgeon) is asked to view the property and give a ten-year plan for maintenance.

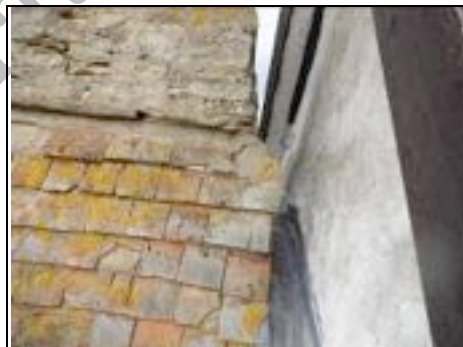
This chimney is a predominantly stone built chimney which has been finished in brick and has one chimney pot. There are tiles running down the side of the property in various stages, where it meets the main building there is a lead flashing. The problems were there is dampness getting in between the chimney and the main building into the stonework which forms the gable.

Gap between chimney and main building

**ACTION REQUIRED:** The whole of the chimney would benefit from appropriate repair work as we can see there has been inappropriate repair work using cement mortar. We can also see that the lead work detailing could be improved to reduce the amount of water getting into the right gable end. From our experience we don't think this will ever be completely dry but it could be we feel improved. We can also see that the render that adjoins the chimney would benefit from being pre-paired, repaired and redecorated.

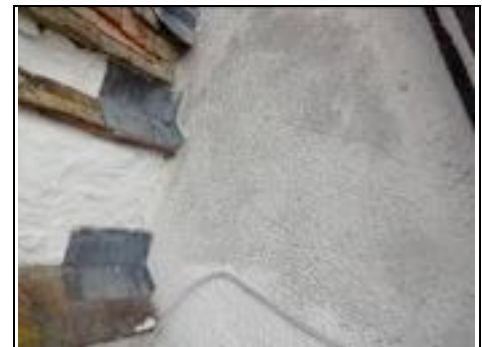
Mastic on lead to right gable

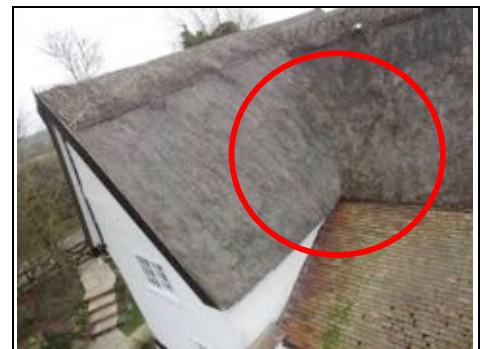
When we went partly into the left roof we were able to see what once may have been a chimney or a smoke hood which interestingly in years gone by were made out of timber. It is very difficult to confirm. It seems a logical place for a chimney to be however we have to add that we have had a very limited view.

Hidden chimney

**ACTION REQUIRED:** Further investigation required. As a general comment in an older property such as this all rooms would have originally been heated with a coal fire.

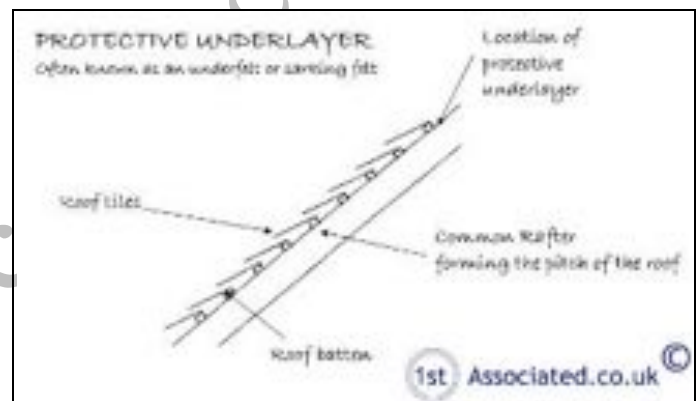
We did not expect to see a protective underlayer under the thatch however we can see some areas where a plastic sheet has been used which we thought was unusual and indicates that part of the thatch has been repaired more recently. We spoke to the owners about this in our question and answers session and they could not recall any specific repairs to the thatch in their time at the property.

**ACTION REQUIRED:** Your legal advisor to specifically ask what thatch repairs they have carried out and ask them for information regarding it which we would be more than happy to comment on.

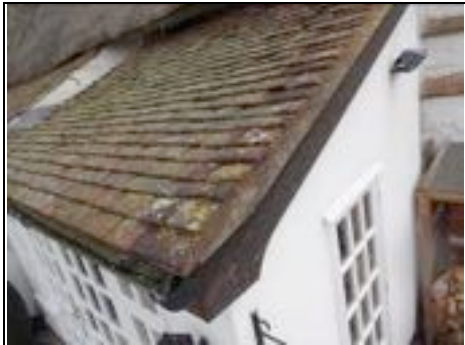
Spalling to tiles  
~ Aerial View - 360 Photo ~

**ACTION REQUIRED:** Please see our comments in the Executive Summary.

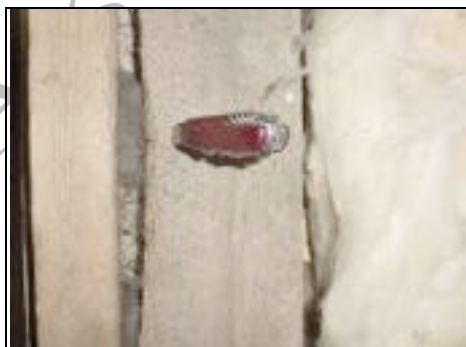
Woodworm

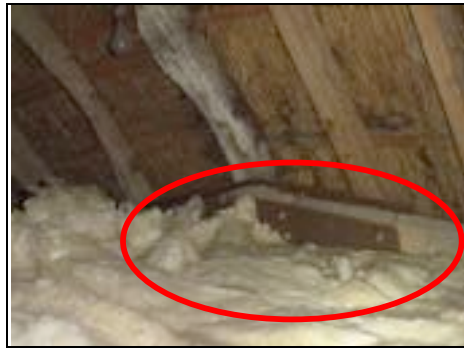
Brace at base of timber

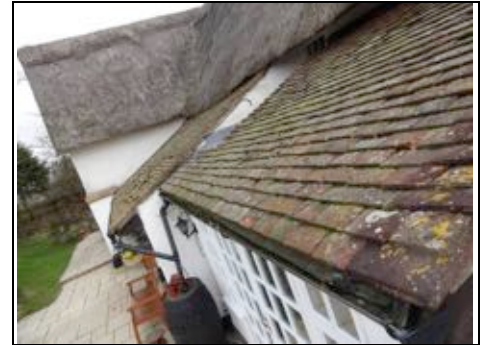
There are no gutters and downpipes to the thatch, they are only present to the tiled area which are plastic gutters and downpipes. Our concern always with gutters and downpipes on older properties is that they may be discharging into the ground nearby and causing dampness as traditionally they discharged on the ground.

Gutters and downpipes to tiled roof

**ACTION REQUIRED:** We would recommend you stand outside the property next time it rains heavily and see how well the drains cope with the rainwater particularly looking at the guttering and the joints and where they discharge onto the ground.

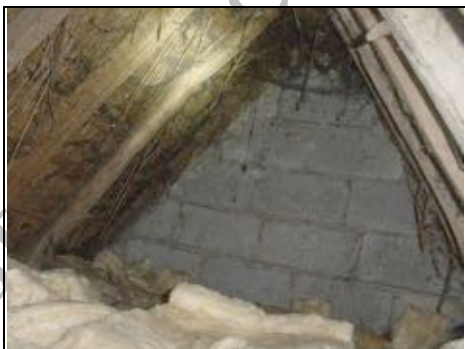
From the hollowness when we carried out our tap test to the centre of the property we do believe the majority of this is timber framed however to the left side of the property we are not completely sure of the construction particularly as within the roof we have seen what looks like stonework or blockwork (we could not physically get into this roof as we were not happy that the timbers would take our weight particularly bearing in mind the metal bracing that we could see and there was no direct access into it). However, we will first of all assume that the property is timber framed and discuss this.

Stonework or blockwork?

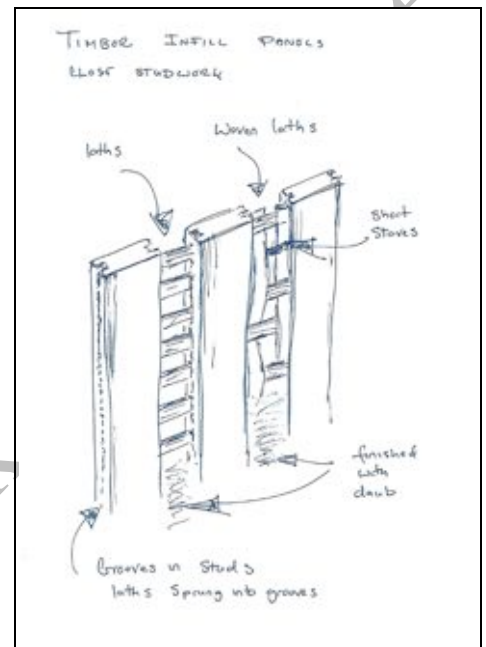
These are the sections between the box timber frame that originally would have been filled with a locally found material (vernacular). In this instance from the thermal imaging we are not sure if there are any infill panels or not, we would normally obtain a type of noughts and crosses pattern on the building. We must add the building was specifically preheated for thermal imaging although there did seem to be a fair difference in temperature on the day which should have given us good patterns.

Render

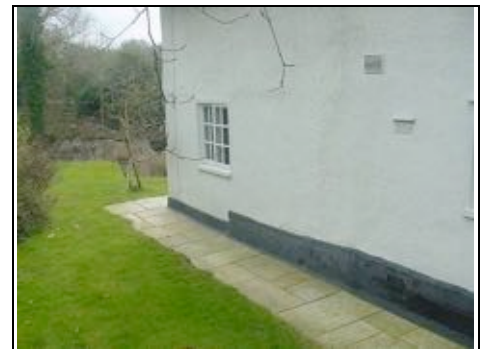
Often the most important part of a timber frame structure is the timber at ground floor level and this will be affected by dampness, causing wet rot and dry rot and general deterioration as this timber effectively forms the base of the timber frame. In most cases it sits on a wall and is very difficult/impossible to see it so we have to make assumptions. In this case we can see the black base of the property which is very regular and regimented and looks like it may have been replaced with a brick or stone or concrete or a mixture of all three.

Base

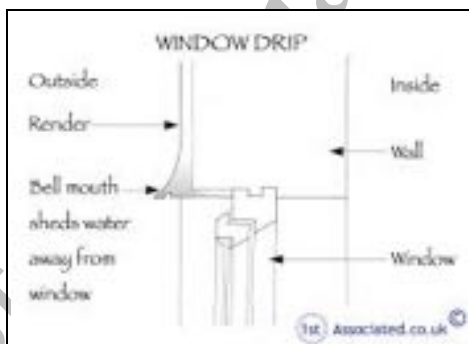
In this case we found a drip detail to the windows which is a traditional timber drip.

Window drip

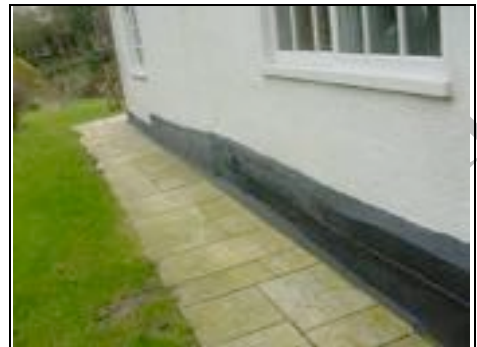
Stone or brick base

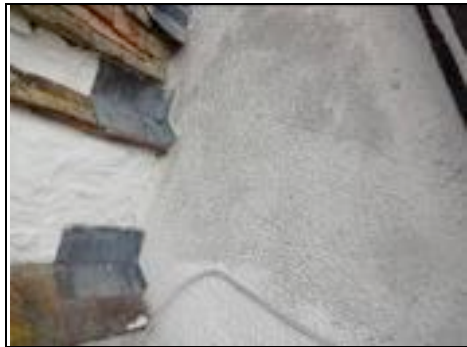
Hairline cracking to right gable  
~ Aerial View - 360 Photo ~

We would remind you that any hairline cracks that appear need to be sealed as soon as possible to stop dampness and water getting in.

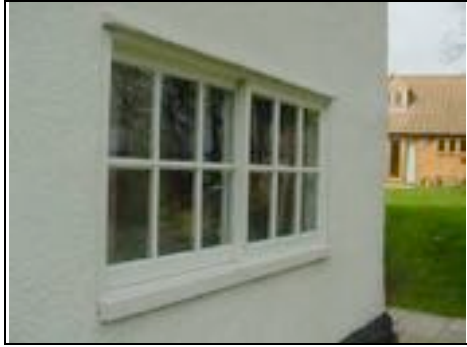
The property has timber single glazed windows with secondary glazing, many are horizontal sliding sash otherwise known as York windows. We noted rot to one of the windows.

York windows

**ACTION REQUIRED:** General repairs and easing and adjusting of the windows and doors.

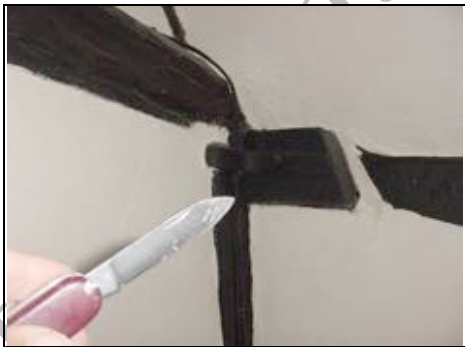
The infill panels can be made from a mixture of materials such as lime plaster or replaced as in this case we believe with a modern plaster.

Infill panel with metal brace

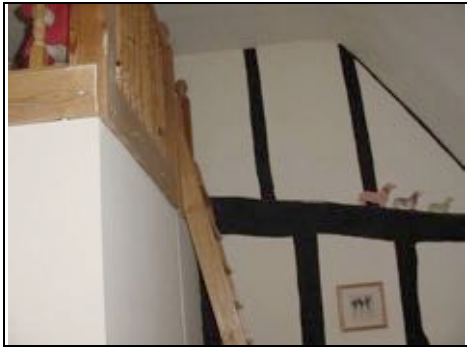
Wall structure showing the studs and infill panels

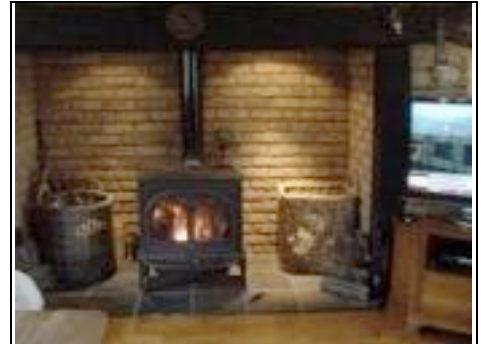
At the time of the survey the chimney was in use and burning brightly. We spoke to the owners about this and they advised that they had lined the inside of the chimney with brickwork which we would be surprised if the Conservation Officer was keen on this and they may well when reviewing the whole property when they look at the thatched work and comment on this. Generally, it would be argued we feel that a stone chimney should have a stone inner. As with lots of things in this property further investigation needs to take place.

Inglenook fireplace

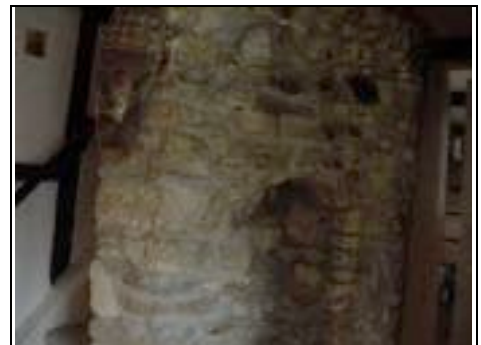
There also looks to be a central chimney built in stonework and one found within the roof. With further investigate it may well be what is known as a smoke hood which is one of the earlier chimneys which would be another historic element in the building.

Old chimney?

Any chimneys that you do not propose to use should be capped and ventilated to prevent dampness.

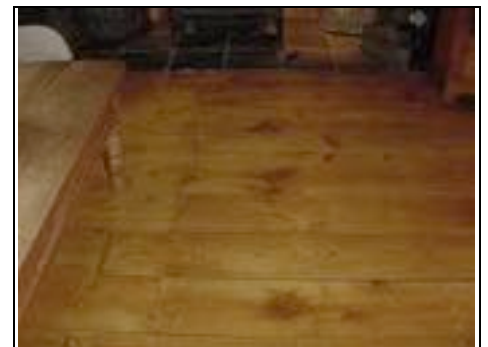
Over the years this has been replaced with various different floors including a suspended timber floor to the lounge area. We were advised the original boards were lifted and re-laid. We think the original boards were unlikely to have been cut that well, lifted, sanded, varnished and re-laid. We also think it is unlikely the original boards would have been so well cut. Our concern is the lack of ventilation to this timber floor. The solid floors as far as we could see throughout the rest of the property these can draw in cold.

New floor made out of old flooring in main reception room

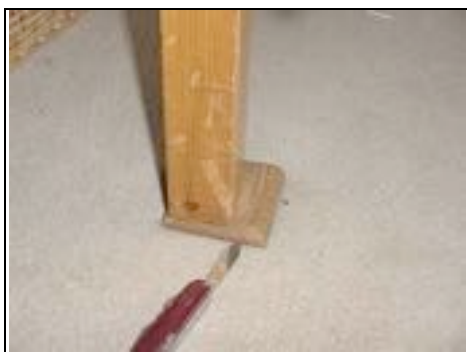
Floor undulating

Again, as with most older properties the floors are uneven and you may need to pack underneath the furniture. This is caused by general settlement and movement within the property over the years.

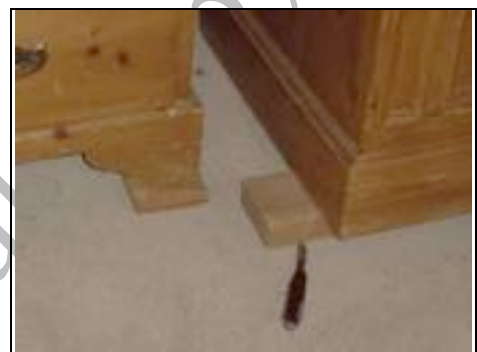
Floors undulating

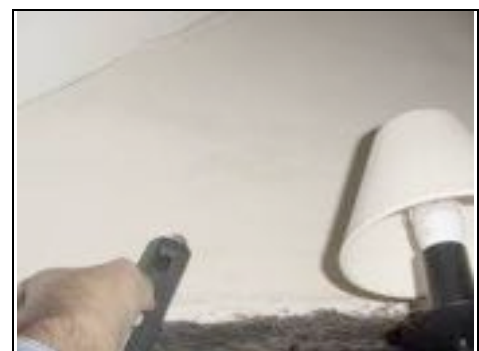
We used a resistance meter on the external walls. We have found significant dampness.

Dampness coming through plaster in right bedroom

**ACTION REQUIRED:** Please see our comments in the Executive Summary.

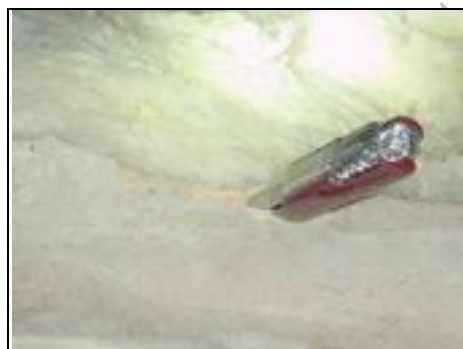
Woodworm/rot in timber in middle roof where it meets left roof

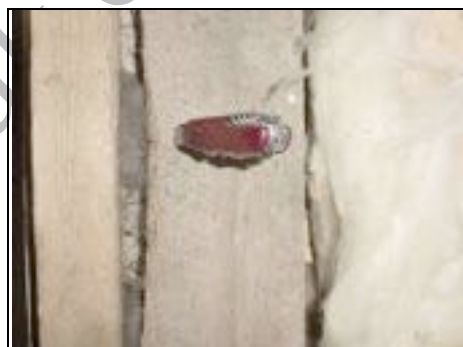
Woodworm

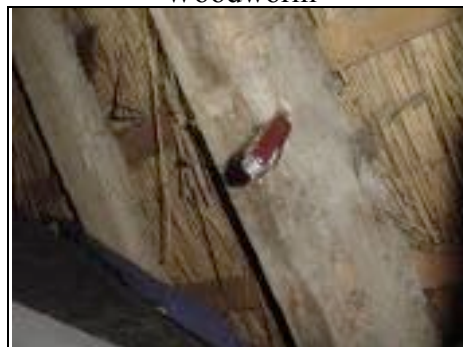
Woodworm and soft rot

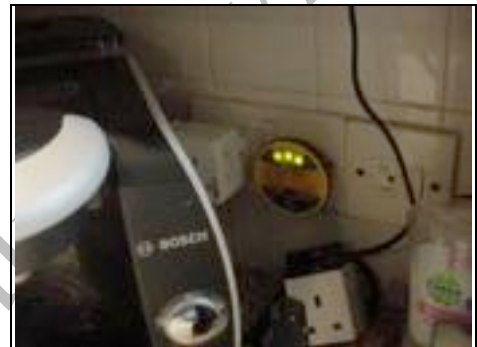
Earth test

We carried out an earth test in the kitchen area to the socket point that is normally used for the kettle, this proved satisfactory.

**ACTION REQUIRED:** As the property is changing occupancy an Institution of Engineering and Technology (IET) test and report and any recommendations should be carried out by a NICEIC registered, or equivalent, approved electrical contractor or similarly approved.

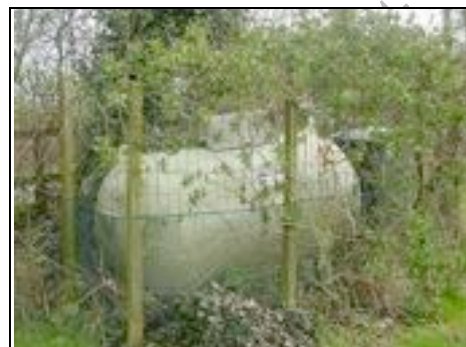
Propane gas

The property has propane gas. There are wood burners as well; we are not sure whether these are multi-burners or not.

**ACTION REQUIRED:** As a matter of course it is recommended that the entire gas installation is inspected and made good, as necessary, by a Gas Safe registered contractor. Thereafter the installation should be serviced annually.

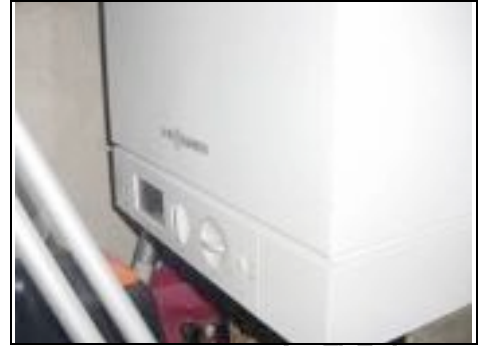
The boiler is a model that we rarely come across so it may be difficult to obtain spare parts.

Viemann Boiler in services room

Our limited inspection of the hot water and central heating system revealed no evidence to suggest any serious defects but we would nevertheless recommend that the system be tested and overhauled before exchange of contracts and that a regular maintenance contract be placed with an approved heating engineer.

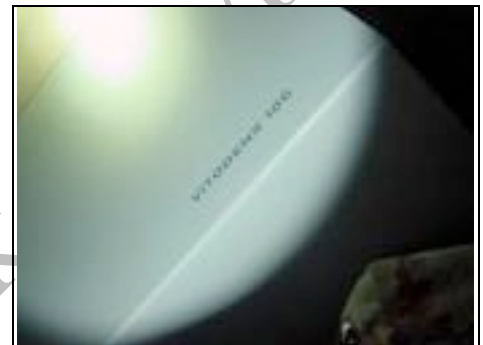
Model type - Vitodens 100

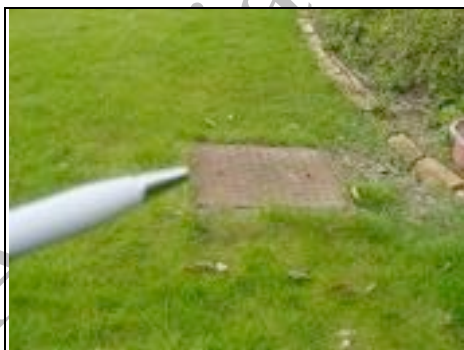
We duly lifted the cover and found it to be free flowing at the time of our inspection. From what we could see it is concrete built.

Manhole adjacent to garage

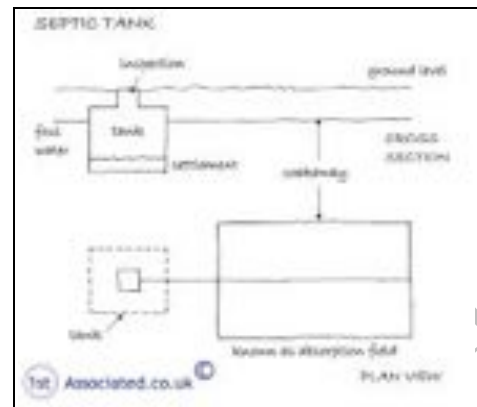
Septic tank

We have been unable to determine the adequacy of treatment or the effectiveness of the disposal arrangements. The surface water discharges onto the ground.

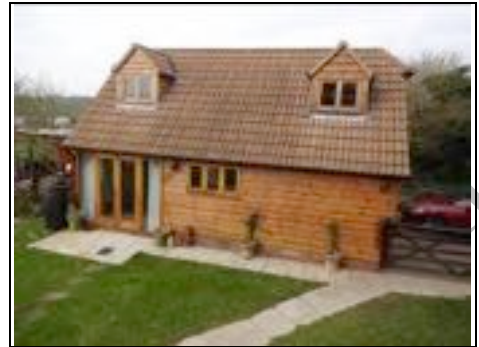
It was noted that the windows to the garage would benefit from re-staining.

Double garage and annexe  
~ Aerial View - 360 Photo ~

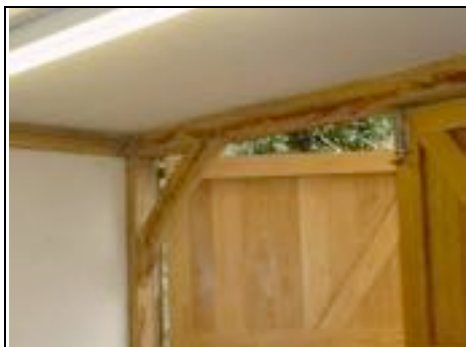
Dampness coming into garage

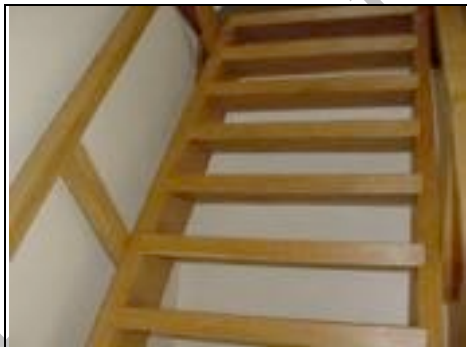
Steep steps

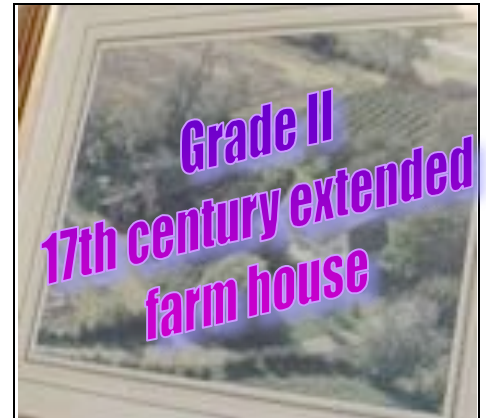
During our question and answer session with the owners we were advised about the barns that fell down which have now been replaced with the garage and annex and the office area. In our experience it takes a lot for these type of barns to fall down.

Barns that no longer exist

We would recommend you speak to the Listed Building Officer with regard to this property to see if they have a photographic record of its condition as many local authorities do have. It will then be worth comparing this against the condition and way the building presently is, as we do feel a lot of alterations and amendments have been carried out.
