SCHEDULE OF CONDITION

**XXXX Industrial Estate
XXXX
Oakley
Bedfordshire
MK43 XXX**

**FOR
Mr X**

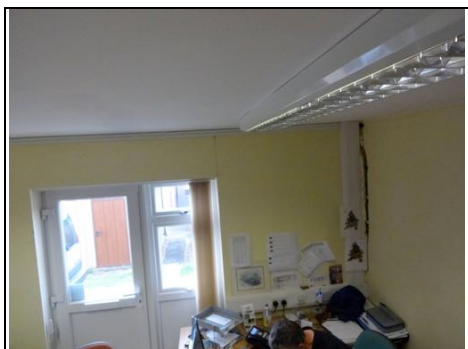
Front Office

DESCRIPTION	CONDITION	ACTION REQUIRED
Ceilings: Painted plasterboard	Average	Repair, prepare and redecorate
Walls: Painted plasterboard and dry lining	Average	Repair, prepare and redecorate
Floors: Carpet	Average	Clean or replace
Detailing: Glazed panel to middle area	Average	Repair, prepare and redecorate
Doors: Vision panel door	Average	Repair, prepare and redecorate
Door to left	Average	Repair, prepare and redecorate
Services:		See Services Section

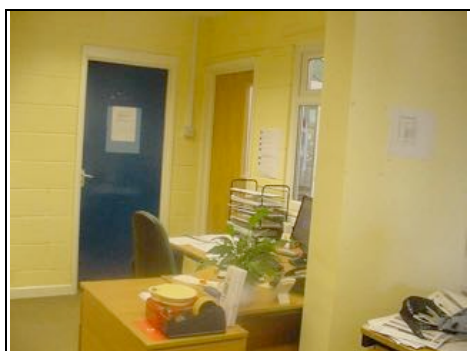
Middle office entrance door

DESCRIPTION	CONDITION	ACTION REQUIRED
Ceilings: Painted plasterboard	Average	Repair, prepare and redecorate
Walls: Painted plasterboard and dry lining Painted blockwork to rear Access hatch

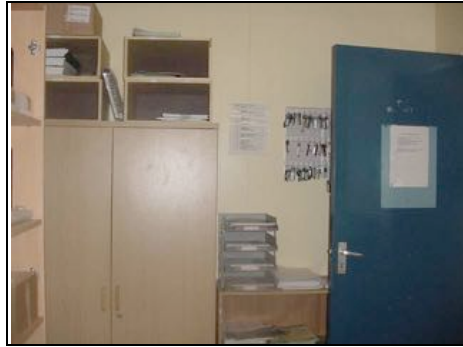
Store

DESCRIPTION	CONDITION	ACTION REQUIRED
Ceilings: Painted plasterboard Access hatch	Average	Repair, prepare and redecorate
Walls: Boarded	Old fixing points	Repair, prepare and redecorate
Floors: Carpet	Dated	Clean or replace
Detailing: Windows: Timber Doors: Timber	Dated Dated	Repair, prepare and redecorate Repair, prepare and redecorate
Services: One extract fan		See Services Section
