COMMERCIAL BUILDING SURVEY

Luton

FOR

Mr X

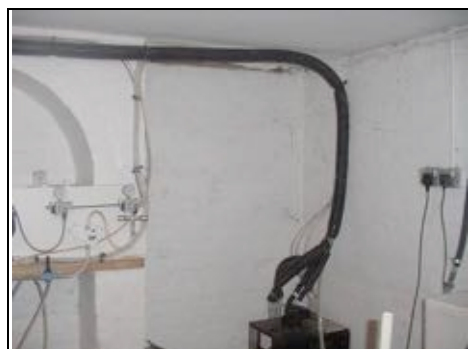
Electrics and pipes in the cellar

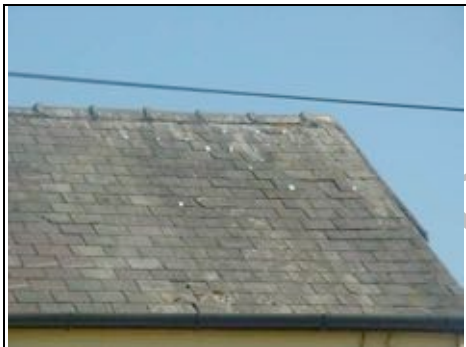
To the roof there are a number of areas of slates that have been repaired with lead tingles.

We would generally comment where there are a dozen plus lead tingles, as there are in this instance, we would normally be recommending to re-roof. However, bearing in mind you are looking to do alterations and improvements to the property you may wish to wait on this work.

Slate lead tingles to the main roof

ACTION REQUIRED: We would recommend you monitor the roofs and be aware if they do leak they are likely to need replacing rather than repairing. The work is likely to require scaffolding, which could be quite costly.

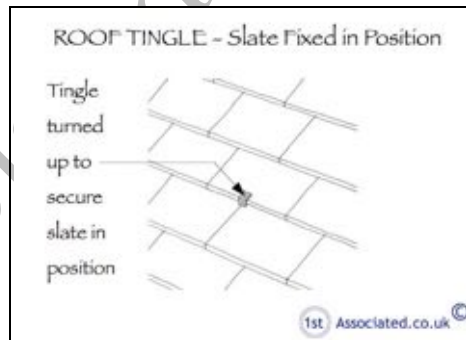
Slate tingles

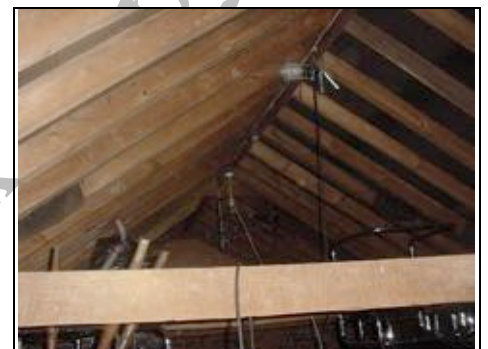
Within the roof space accessed from the first floor lounge we can see what is known as an A Frame cut timber roof. When we inspected this it did look like some extra timbers have been added to help stabilise it. It is difficult to be certain but we do feel it is best to be safe than sorry.

Main A Frame roof structure

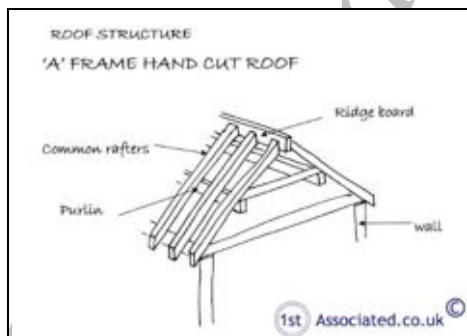
A Frame roof structure

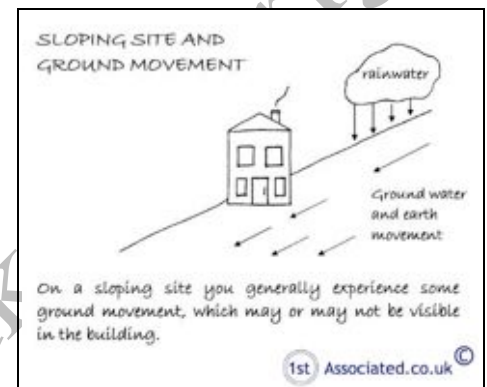
Sloping site

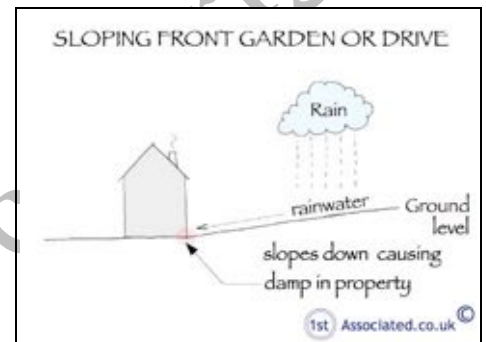
We can see there has been a long term problem here and that a half round gully has been formed to the left side and to the rear of the property. It can be affective but it does not seem to be working well in this particular case so we would recommend the adding of a French drain or an equivalent.

Sloping front garden

ACTION REQUIRED: We would recommend adding a French drain to minimise dampness.

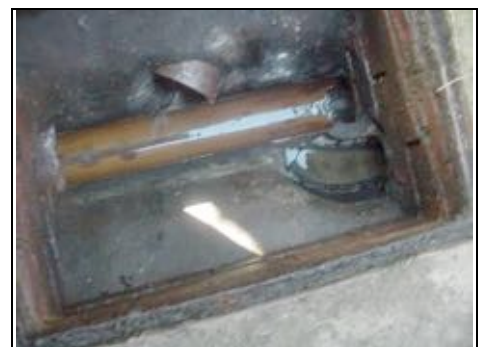
Clear drain to rear of the property

ACTION REQUIRED: Your legal advisor needs to check and confirm you have permission to do this. We would also recommend a closed circuit TV camera report of the drains.

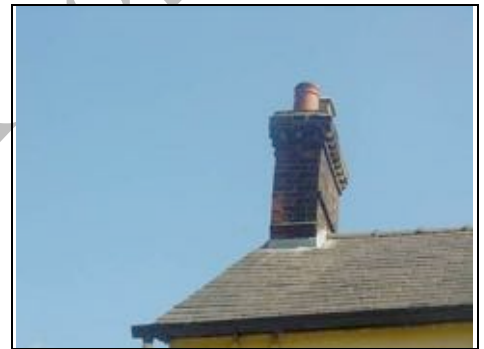
Chimney to the left

This chimney is brick finished with a lead flashing and has two chimney pots. From what we could see from ground level it looked in average condition considering its age, type and style.

Unfortunately, we were unable to see the flaunching, we therefore cannot comment upon them.

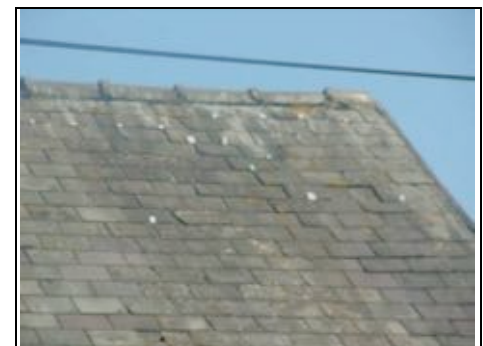
Main front roof

The main roof is pitched and clad with slate. From ground level, this looks in below average condition considering the roofs age type and style.

With this age of roof there will usually be a few missing or displaced slates, this is nothing unusual.

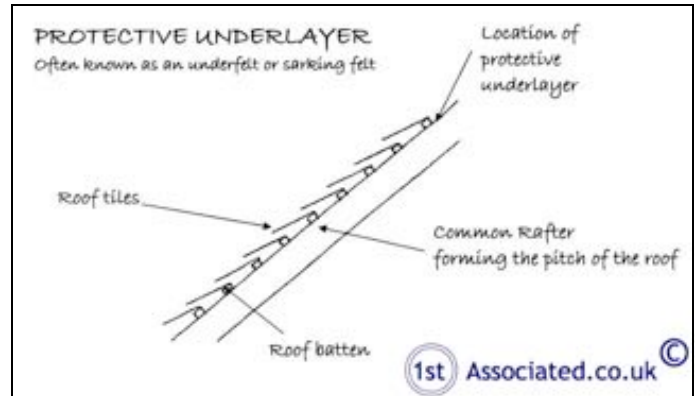
Protective underlayer

When we inspected the loft space we found a Hessian based Bitumen membrane. This type of membrane has been used since the 1960s. We generally found it to be in average condition, it is damaged in a few more places than we normally find.

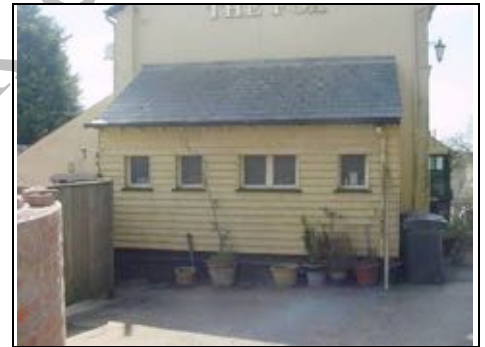
Left side pitched roof

This is over the toilet area and this is in average condition for its age type and style.

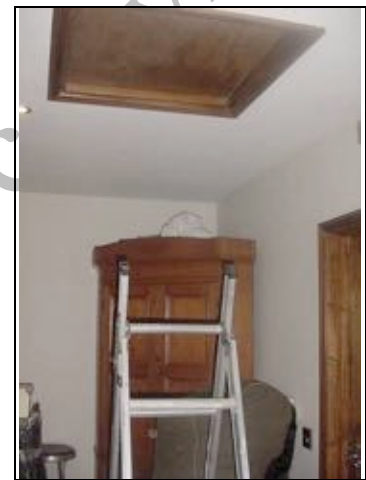
Roof access

The main roof is accessed via the loft hatch located in the left side lounge. There is no loft ladder or electric light. There were secured floorboards within the roof. We recommend that a light and a loft ladder is added, as it will make the loft space safer and easier to use.

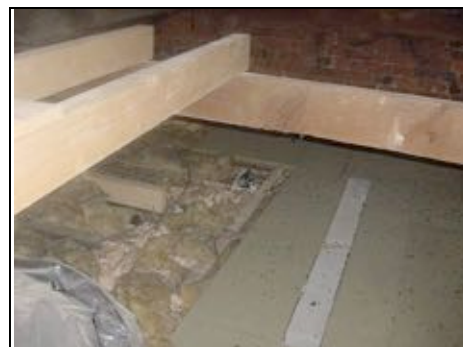
Insulation and boarding of the roof

Our examination was limited by the general configuration of the roof, the insulation and the boarding of the roof. What we could see was generally found to be in average condition (although it does look to be amended) for its age, type and style. It is, however, feasible that there are problems in the roof that are hidden.

ACTION REQUIRED: The only way to be 100 per cent certain is to have the roof cleared and checked.

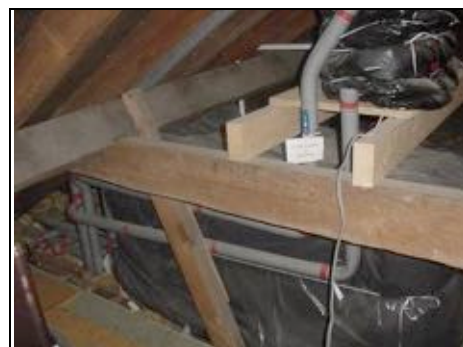
Water tank within the roof

There is a water tank in the roof.

We would always recommend that water tanks be drained down and cleared of any debris etc. (we have seen dead birds and other unmentionable things in these tanks).

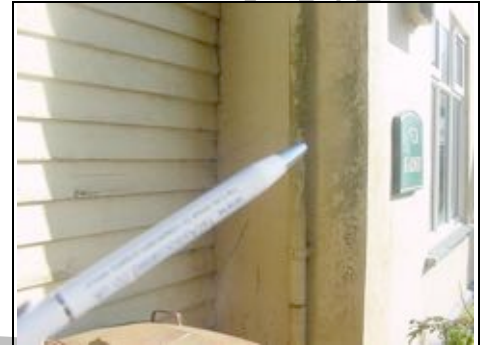
Downpipe to the front Left

The gutters and downpipes are plastic (there may be some original cast iron remaining). There is quite a bit of moss to the left side of the gutters and downpipes.

They are in average condition for their age, type and style.

ACTION REQUIRED: We would always recommend that the gutters and downpipes are cleaned out, the joints are checked and the alignment checked to ensure that the gutters fall towards the downpipes.

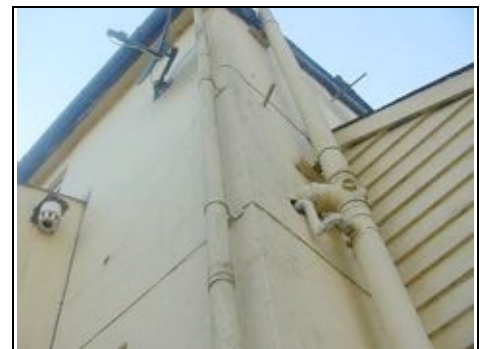
Soil and vent pipe

The property has had the original cast iron soil and vent pipes replaced with plastic to the rear left side.

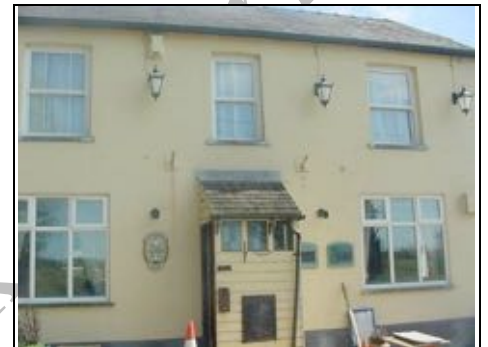
Painted render

We have carried out a tap test (literally hitting the render with the back of a hammer). We found it to be in average condition for its age, type and style.

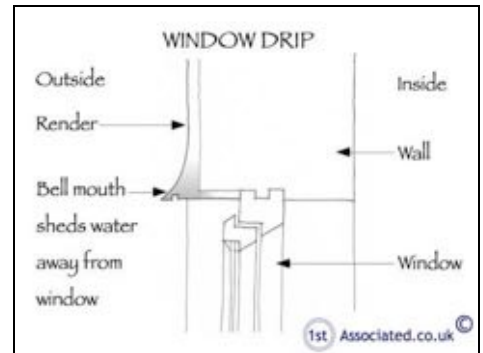
Window drip

In this case we found no drip detail to the windows.

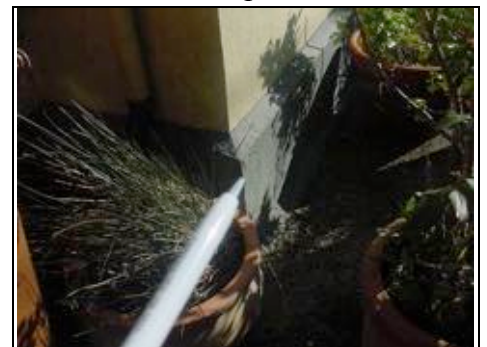
Plinth detail
located to the front left

To the base of the render there was a Plinth detail rather than a bell mouth detail.

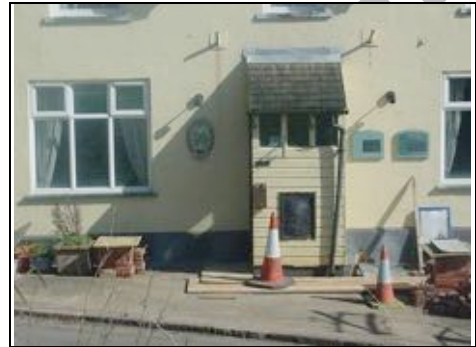
Black painted plinth to the front of the property

All modern properties should incorporate a damp proof course (DPC) and good building practice dictates that a differential of 150mm (6 inches) should be maintained between the damp proof course and ground levels. In this case, cannot see a damp proof course (DPC) due to the render over the top of the structure.

There is a plinth painted black as you can see in the adjoining photo. Beneath the thickening of the plinth there may be a slate damp proof course.

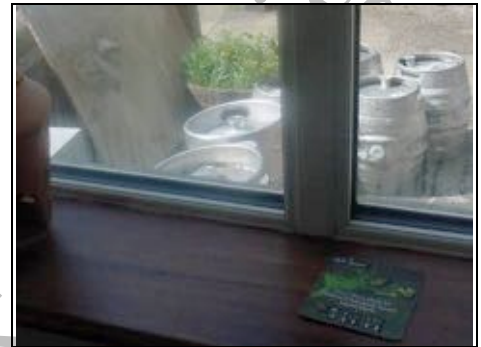
Older style double glazed window

The property has plastic double glazed windows, which generally look to be of a reasonable quality. We would draw your attention to the fact that sealed double glazed units can fail, particularly as a result of poor workmanship during installation. Failure of the seal leads to condensation between the two panes of glass and simply replacing the affected units may not provide a satisfactory long-term solution.

Although these windows are old enquiries should be made as to the existence of any transferable guarantees by your legal advisor. Generally, it is considered that double glazed units have a life of about ten years.

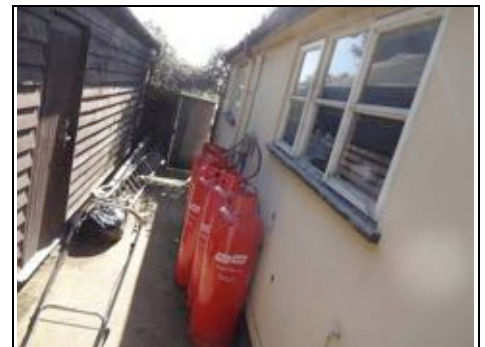
Timber windows to the rear

The entrance and fire exit doors are made of timber as are some of the windows to the rear for example the kitchen windows.

ACTION REQUIRED: Redecorate the kitchen windows in the summer of 2016 to stop any further deterioration. However, as you are planning your development you may wish to wait until work on this is taken place.

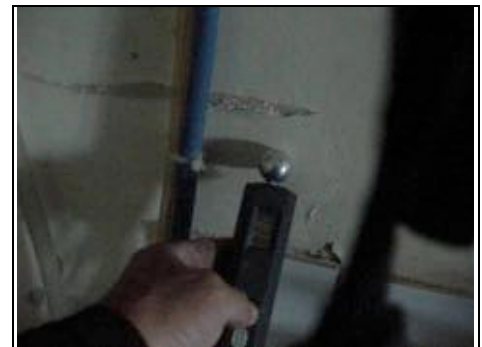
Testing for rising damp

A visual inspection and tests with a moisture meter have been taken to the perimeter walls. In this particular case we have found rising damp to the rear of the property.

ACTION REQUIRED: Please see the Executive Summary.

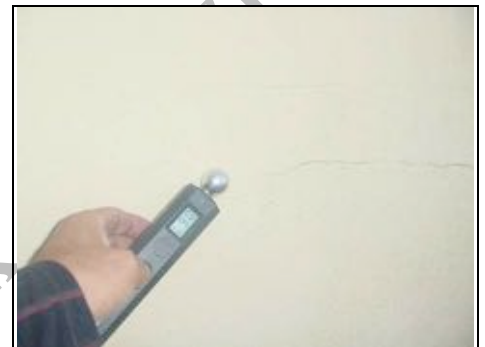
Testing for lateral dampness

We used a resistance meter on the external walls. We have not found significant dampness.

ACTION REQUIRED: Please see our general comments on dampness in the Executive Summary.

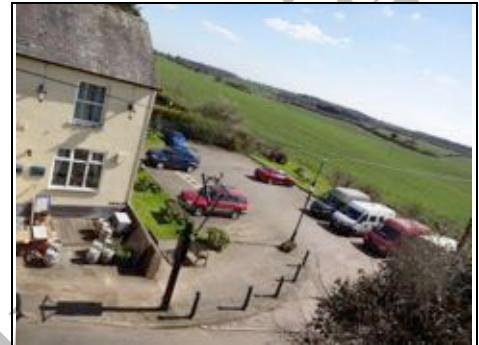
Car park
Ariel view – 360 photo

There is a car park and entrance to the right side of the property. Please note our comments with regard to the ordnance survey map that does not show the car park in or the sitting out area / beer garden.

ACTION REQUIRED: You need to ensure that your legal advisor checks exactly what area you are purchasing.

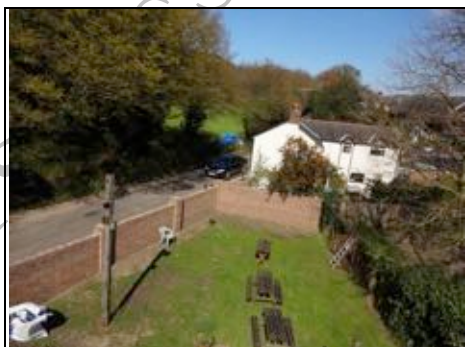
Garden to the left

There is a private garden to the left side with a new wall being built around it and a sitting area on the far right next to the car park.

ACTION REQUIRED: Again, your legal advisor needs to check and confirm exactly what area you are purchasing.

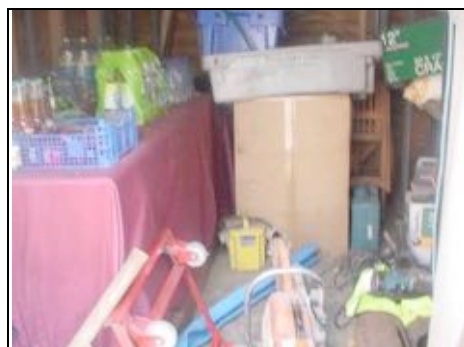
Garage

Stored items inside the shed
