SCHEDULE OF CONDITION

**Eversholt
Bedfordshire
MK17 XXX**

We have been instructed to inspect and prepare a Schedule of Condition for XXXX, Eversholt, Bedfordshire MK17 XXX.

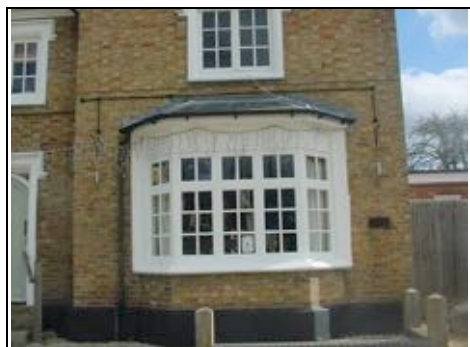
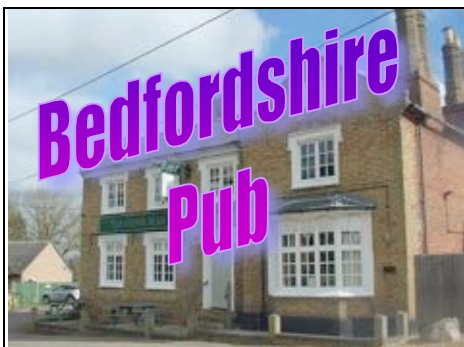
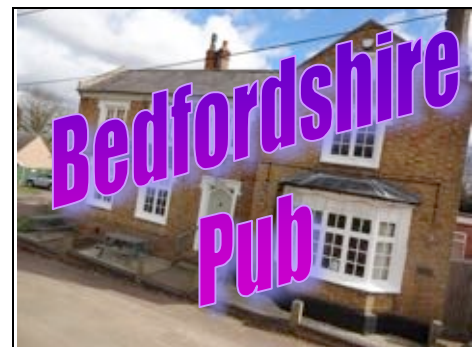
Front External Elevation

DESCRIPTION	CONDITION	ACTION REQUIRED
Chimneys:		See right and rear elevations
Roofs: Shallow pitched slate roof Limited view of roof from ground level	Displaced slates Lead tingles	General overhaul required; approximately two to three days' work plus materials. Joint high level inspection with the landlord's surveyor to be carried out prior to signing of the lease or legal completion of the lease from high level cherry picker or equivalent Or exclude from lease.

<p>Cracking visible to both left and right sides.</p>

<p>Repair, prepare and redecorate</p> <p>Recommended immediate health and safety check and repair as necessary.</p>
-------------------------------------------------------------------------------------------------------------------------------------------------------------------------------------	--------------------------------------------------------------------------------------------------------------------------------------------------------------------------------------------------------------------------------------------------------------

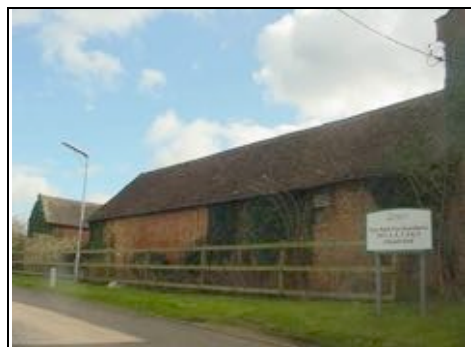
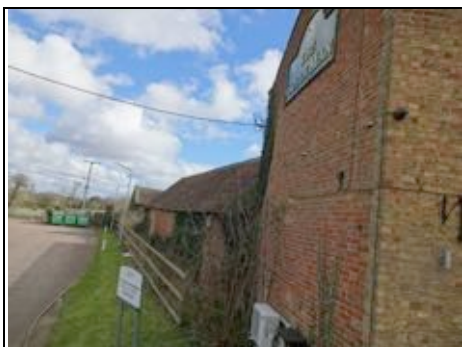
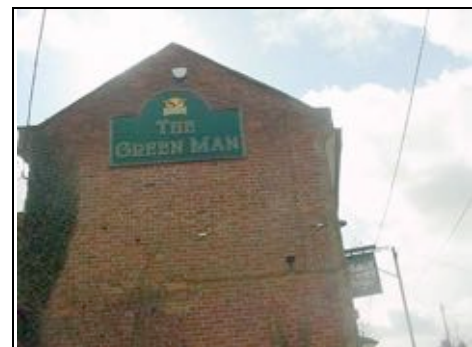
Left External Elevation

DESCRIPTION	CONDITION	ACTION REQUIRED
Roofs: Single storey pitched barn roof with red tiles. Parapet walls Viewed from ground level.		See front elevation See front elevation
Fascias and Soffits: Painted timber	Dated	Repair, prepare and redecorate
Gutters and Downpipes: Cast Iron and Plastic We viewed the gutters from ground level	Average	Ensure all gutters are watertight and falling towards the downpipe and clear. Repair downpipes and secure as necessary, ensure downpipes are clean and clear

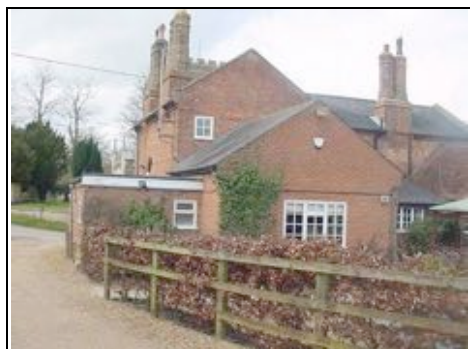
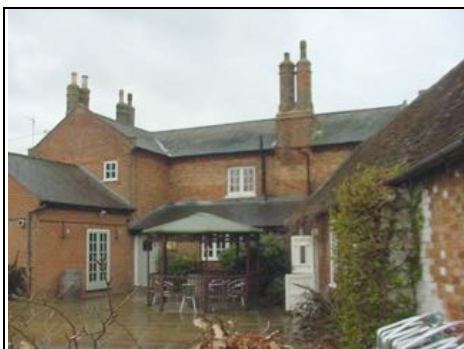
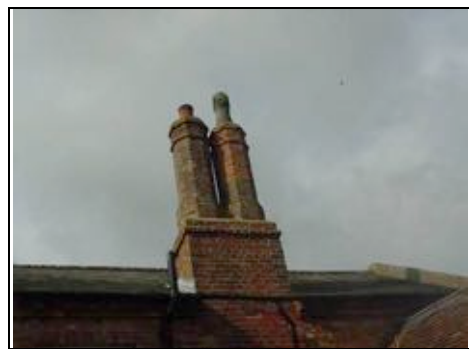
Rear External Elevation

DESCRIPTION	CONDITION	ACTION REQUIRED
Chimneys: Large brick chimney with chimney pots and flues.	Weathered Cement repointing  	Ad hoc repointing in a lime mortar. Clearing of excessive moss and lichens
Roofs: High level Shallow pitched slate roof Valley gutter   Parapet wall	Displaced slates Lead tingles  	See front elevation See front elevation
Low level Pitched slate roof Lead flashing where it meets the main building. Viewed from ground level.	Average  	Periodic inspection

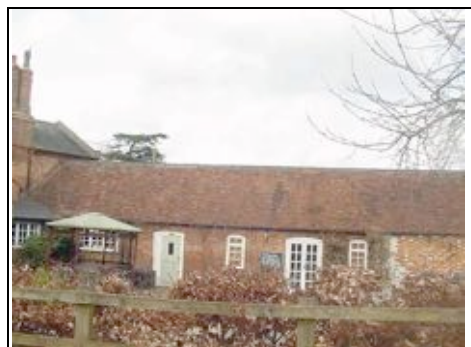
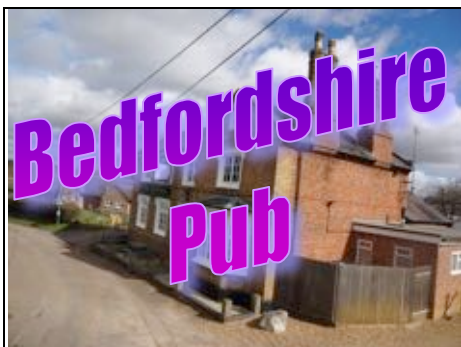
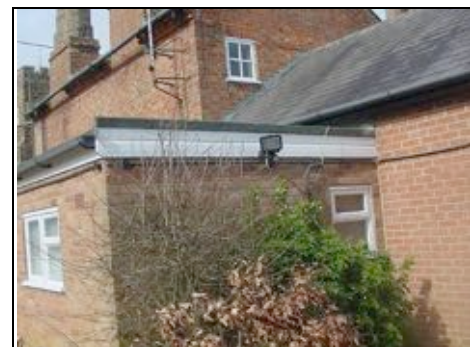
Right External Elevation

Rear right chimney	Ad hoc repointing Clearing of excessive moss and lichens.
Roofs: High level roofs Two storey shallow pitched slate roof to front area Parapet brick wall with a coping stone. Roofs viewed from ground level. Single storey pitched clay tile roof to rear area	Some displaced slates Spalling brickwork and cracking

<p>Roofs viewed from ground level.</p>	<p>Missing and displaced tiles</p>

<p>Some slipped and deteriorating slates Lead flashing where it meets the main building</p>

<p>Moss sitting on it indicating this is a flat, flat roof that will accelerate deterioration.</p> <p>New felt flashing, indicating possible movement between main building and extension.</p>

<p>Weathered Spalling brickwork extension below leaking downpipe from toilet</p>

<p>Cracking to barn walls</p>

<p>Ad hoc repairs. The roof is in a fragile state and damage is likely to be caused when the roof is accessed so care should be taken.</p> <p>See front elevation</p> <p>Clean, periodic inspection</p> <p>Landlord to place an insurance claim to monitor the movement</p>
<p>Fascias and Soffits:</p>

<p>Repair and repoint.</p> <p>Remove / maintain ivy and add trelliswork beneath it to stop if damaging brickwork.</p> <p>Landlord to place an insurance claim to monitor the movement for at least one year.</p>

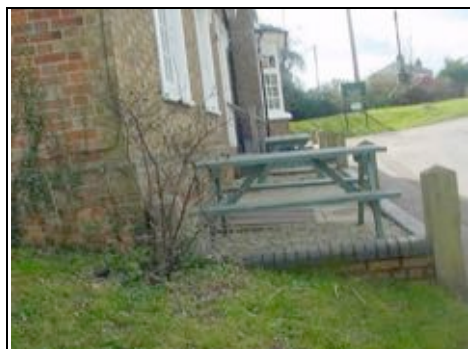
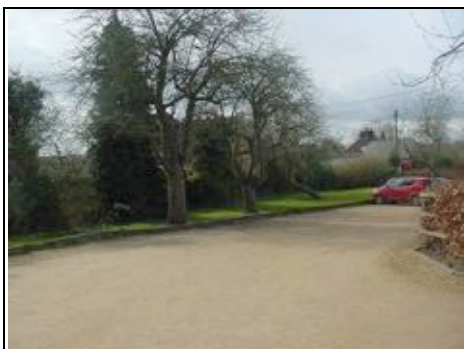
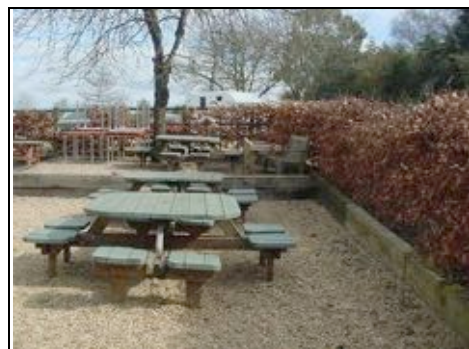
Outside Areas

<p>Rear:</p> <p>Patio seating area, finished with a mixture of paving slabs and pea shingle</p>  	<p>Uneven slabs when you walk on them/trip hazard. The paving slabs are causing rainwater to discharge against the rear of the pub.</p>   <p>Spalling brickwork around slabs.</p>  	<p>Possible drainage required. Re-lay uneven slabs.</p>
<p>Soil and vent pipe</p> <p>Car Park:</p> <p>Levelled shingle finish Grassed area to rear of car park</p>  	<p>May indicate there are deep drains in the area.</p>   <p>Various dips and undulations. Water sitting in dips at time of survey.</p>  	<p>Fill and make good.</p>

Ensure safe, use rust stop agent and repair Check ownership of this area
Left Side:	Overgrown at time of inspection	Check ownership and maintain grounds as required.

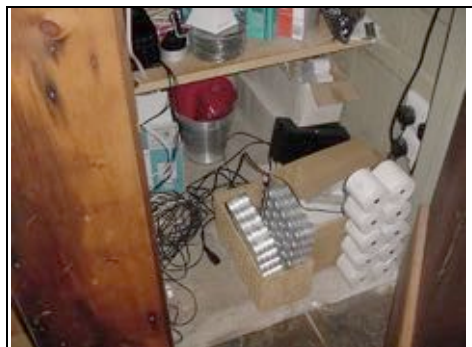
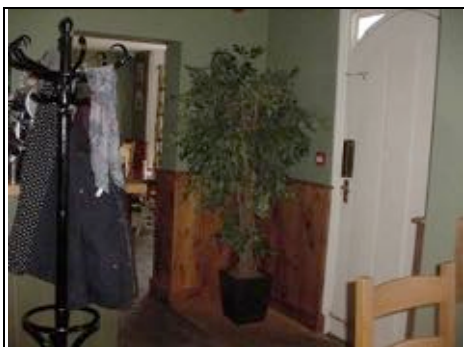
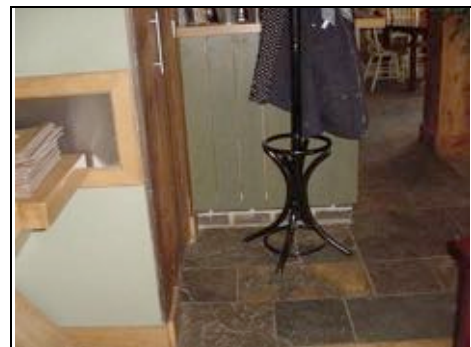
Entrance Area

DESCRIPTION	CONDITION	ACTION REQUIRED
Ceiling: Painted modern plaster	Average	Repair, prepare and redecorate
Walls: Painted modern plaster Timber dado rail Cupboard under stairs	Average	Repair, prepare and redecorate.
Floors: Stone paving slabs Mat well Believed to be a suspended timber floor	Ingrained dirt

Ingrained dirt No air ventilation noted.	Deep clean Deep clean or replace.
Detailing: Doors: Painted timber entrance door	Dated	Repair, prepare and redecorate
Services: Lighting		See Services Section

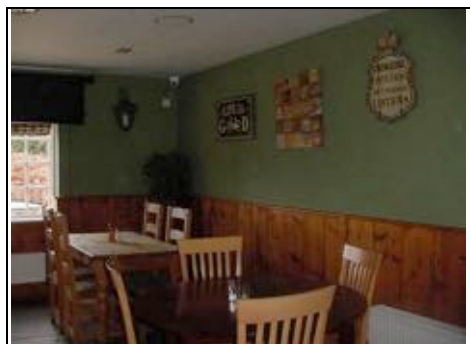
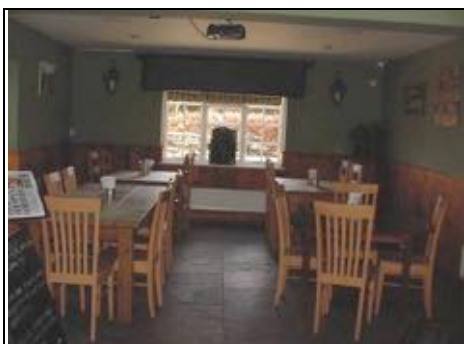
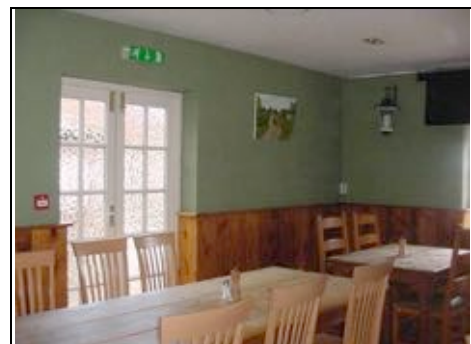
Main Bar Right Side

DESCRIPTION	CONDITION	ACTION REQUIRED
Ceiling: Painted modern plaster	Average	Repair, prepare and redecorate
Walls: Painted modern plaster Timber dado rail and vertical boards Two brick fireplaces Wood burning stove	Dated and marked   Wall removed centrally Marked    	Repair, prepare and redecorate. Repair, prepare and re-stain.

Floors: Stone paving slabs	Ingrained dirt	Clean or replace
Detailing: Windows: Timber casement	Average	Repair, prepare and redecorate
Services: Lighting		See Services Section

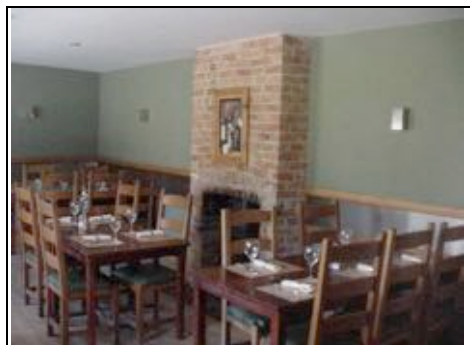
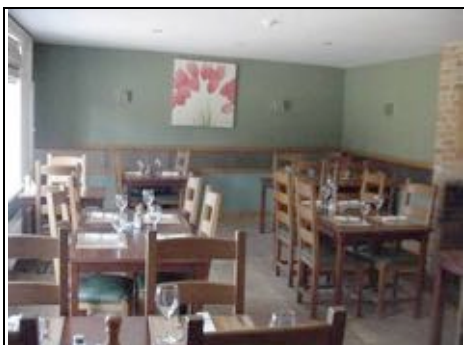
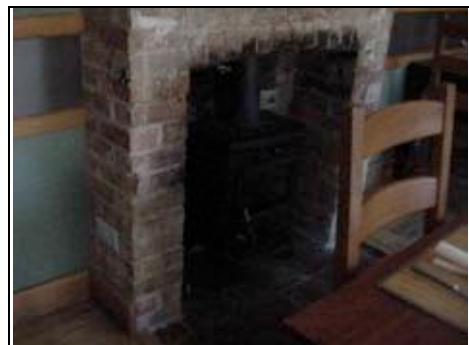
Dining Area Left Side

DESCRIPTION	CONDITION	ACTION REQUIRED
Ceiling: Painted modern plaster	Average	Repair, prepare and redecorate
Walls: Painted modern plaster Modern dado rail Brick chimney with wood burning stove Under stairs cupboard	Dated and marked Marked

Worn

Clean, sand or replace. Note, this appears to be a suspended floor without any ventilation.

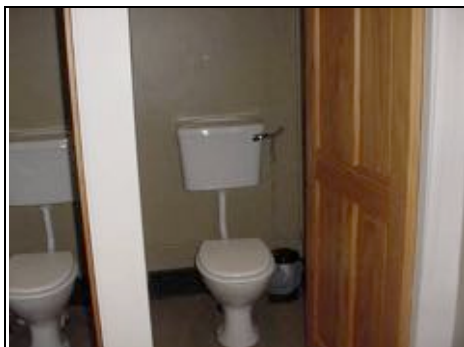
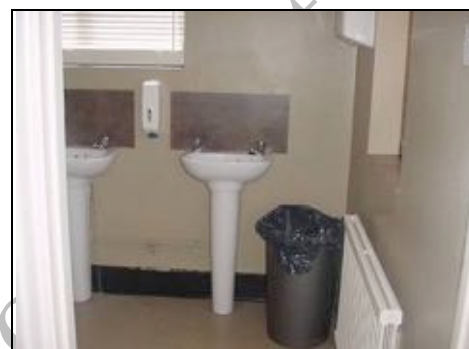
DESCRIPTION	CONDITION	ACTION REQUIRED
Ceiling: Painted modern plaster – double sheet of plasterboard	Hairline cracking	Repair, prepare and redecorate
Walls: Painted modern plaster	Dated and marked	Repair, prepare and redecorate.
Floors: Safety style flooring	Ingrained dirt	Clean or replace
Detailing: Windows: Three timber casement windows	Dated	Repair, prepare and redecorate
Doors: Pine WC doors Door to inner lobby removed	Dated	Repair, prepare and redecorate

Repair, repair and redecorate Add floor finish
Services: Lighting Ceiling lights Internal radiator High and low level vents	No extract fans	See Services Section Add large good quality humidity controlled extract fans

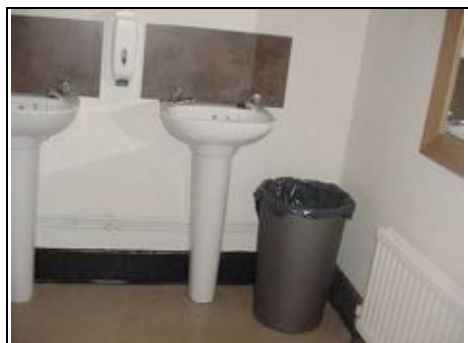
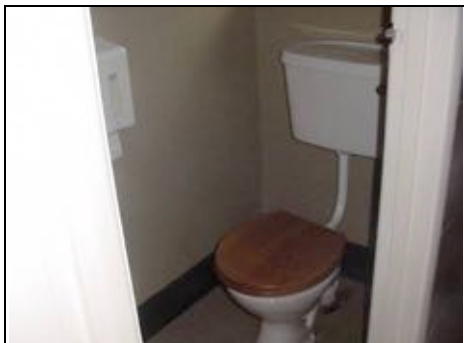
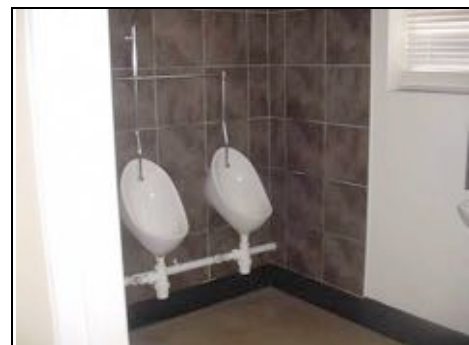
Gents Toilets Right Side

DESCRIPTION	CONDITION	ACTION REQUIRED
Ceiling: Painted modern plaster – double plasterboard	Hairline cracking

Repair, prepare and redecorate
Walls: Painted modern plaster Splashback tiles behind wash hand basins Splashback tiles behind and WC's	Hairline cracking around windows

Average Ingrained dirt	Repair, prepare and redecorate. Landlord to place insurance claim with regard to movement in property to be monitored for one year. Please see other comments. Clean Deep clean
Floors: Safety style flooring	Ingrained dirt	Deep clean or replace

Repair, prepare and redecorate Landlord to place an insurance claim with regard to movement to monitor property for one year. Add flooring
Services: Lighting		See Services Section

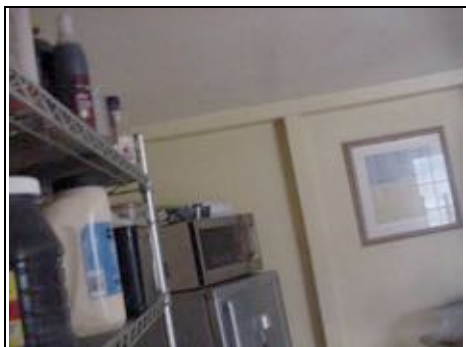
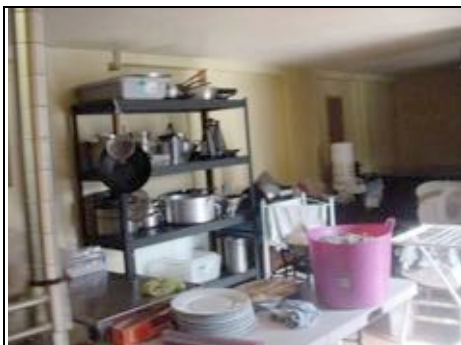
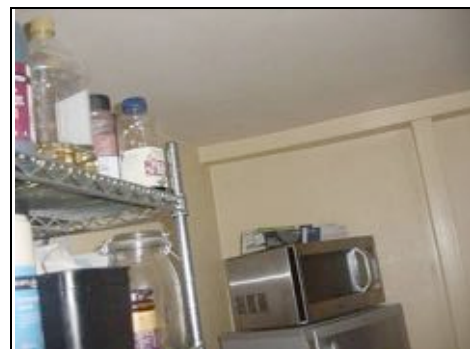
Store with Cupboard

DESCRIPTION	CONDITION	ACTION REQUIRED
Ceiling: Painted Access to roof space.	Grease stained

Deep clean Repair, prepare and redecorate
Walls: Painted and melamine	Dated and marked	Repair, prepare and redecorate
Cupboard: We were unable to access due to stored items.

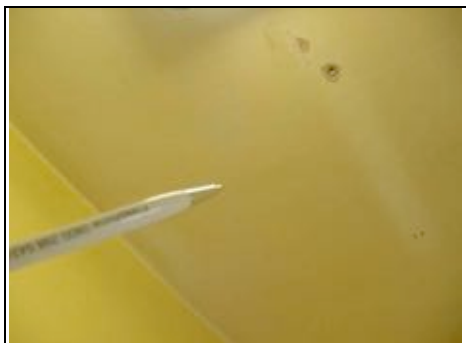
(Majority of room taken up by Arneg freezer which we did not access)

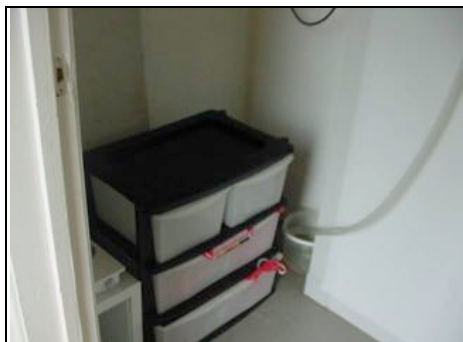
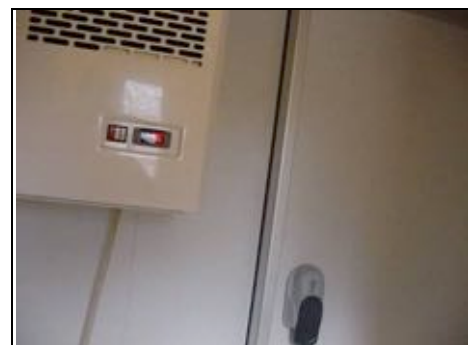
DESCRIPTION	CONDITION	ACTION REQUIRED
Ceiling: Painted modern plaster	Dated and dirty

Repair, prepare and redecorate
Walls: Painted	Dated

Repair, prepare and redecorate.
Floors: Safety style flooring	Dated Majority hidden by Arneg walk in freezers.

Clean/replace

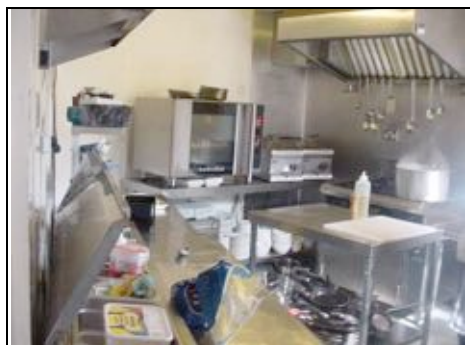
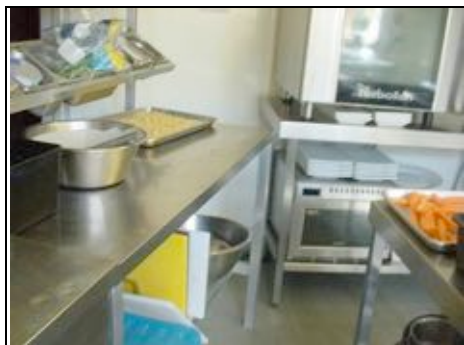
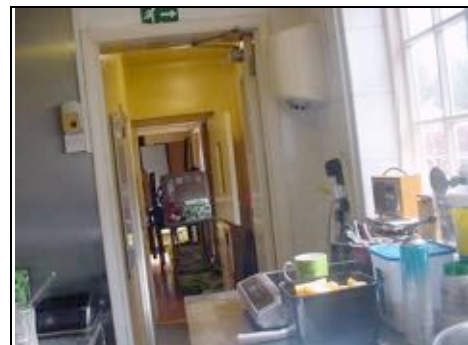
Catering Kitchen

DESCRIPTION	CONDITION	ACTION REQUIRED
Ceiling: Painted	Ingrained grease

Deep clean, Repair, prepare and redecorate
Walls: Stainless steel Tiled Melamine	Dated Old fixing points Old fixing points	Deep clean, repair, prepare and make good.
Floors: Safety style flooring	Ingrained dirt

Deep clean or replace

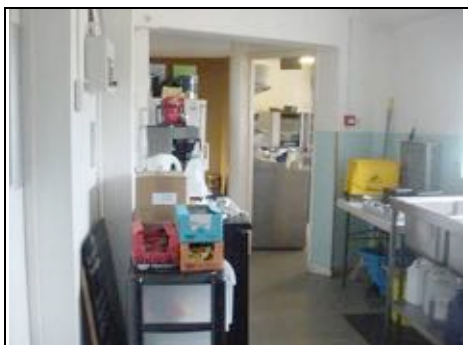
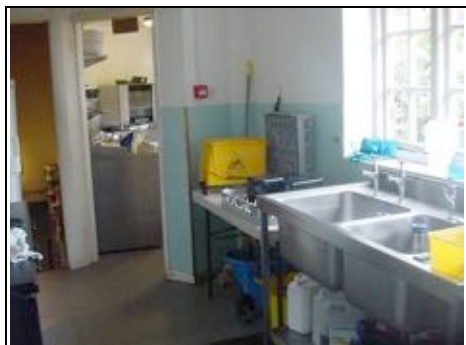
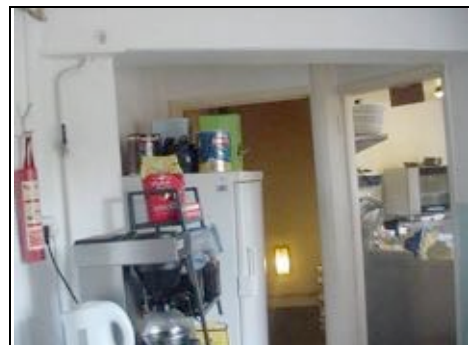
Wash Up Area

DESCRIPTION	CONDITION	ACTION REQUIRED
Ceiling: Painted Access hatch to roof space.	Dated	Repair, prepare and redecorate
Walls: Painted dry lined walls Painted embossed wallpaper Brickwork	Dated Dampness	Repair, prepare and redecorate.
Floors: Safety style flooring	Ingrained dirt	Clean or replace
Detailing: Windows: Timber casement	Average No fly mesh	Repair, prepare and redecorate Add fly mesh.
Doors: Door	Average	Repair, prepare and redecorate
Services: Lighting		See Services Section

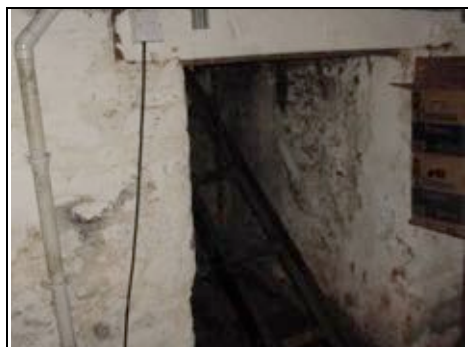
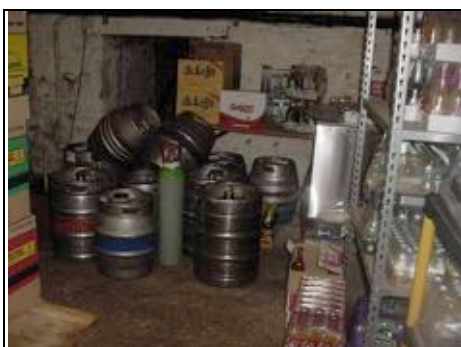
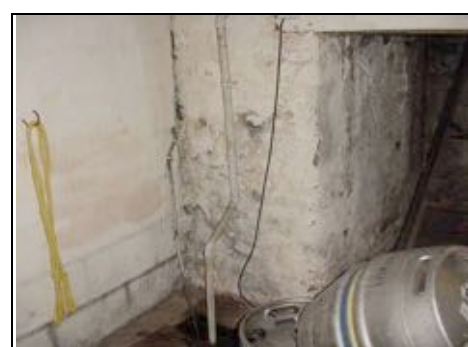
Wine and Beer Store / Python Area

DESCRIPTION	CONDITION	ACTION REQUIRED
Ceiling: Painted Timber Spine beam	Dated

Repair, prepare and redecorate
Walls: Painted brickwork Cellar drop	Dampness

Dampness	Resolve dampness, repair, prepare and redecorate. See comments on cellar flaps
Floors: Concrete	Marked and worn	Repair, prepare and apply floor paint

Detailing: Doors: Painted timber	Worn	Repair, prepare and redecorate
Services: Lighting Sump pump		See Services Section Check in working order.

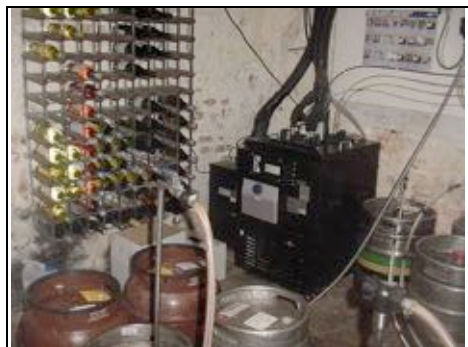
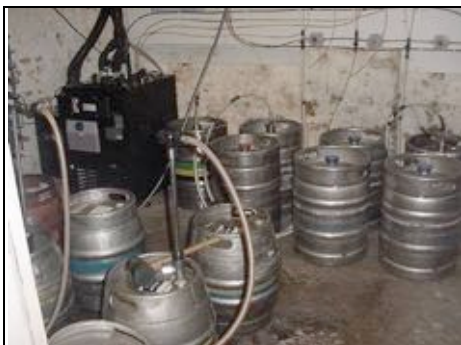
Cold Cellar

DESCRIPTION	CONDITION	ACTION REQUIRED
Ceiling: Painted plywood	Black mould	Resolve dampness, repair, prepare and redecorate
Walls: Painted brickwork Painted blockwork	Black mould Dampness

Resolve dampness, repair, prepare and redecorate.
Floors: Concrete	Ingrained dirt and worn Water sitting on floor

Repair, prepare and make good
Detailing: Doors: Painted timber	Worn	Repair, prepare and redecorate
Services: Lighting		See Services Section

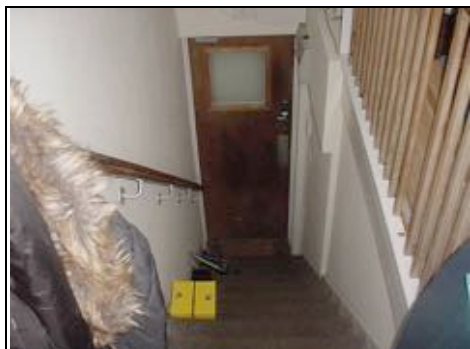
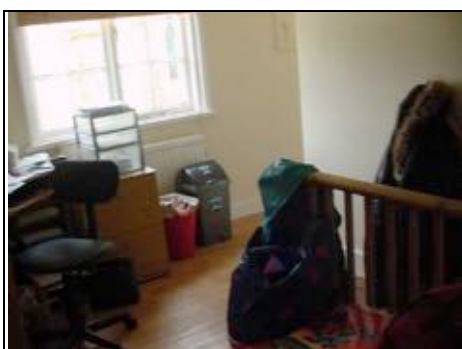
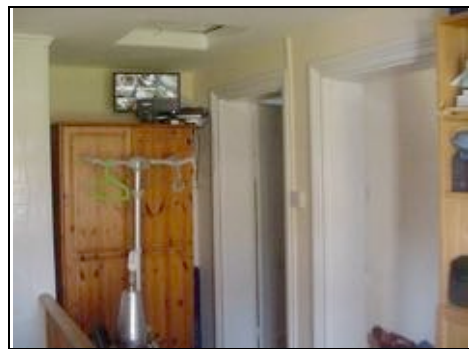
Stairs and Landing / Office

DESCRIPTION	CONDITION	ACTION REQUIRED
Ceilings: Painted modern plaster Access to roof space	Average	Repair, prepare and redecorate
Walls: Painted modern plaster Textured wallpaper	Average and marked	Repair, prepare and redecorate
Floors: Laminate	Average	Deep clean or replace
Detailing: Windows: Two painted timber casement windows Doors: Painted timber	Dated Dated	Repair, prepare and redecorate Repair, prepare and redecorate

Staircase: Carpet	 Worn	 Clean or replace
Services: Fuseboard to bottom of stairs

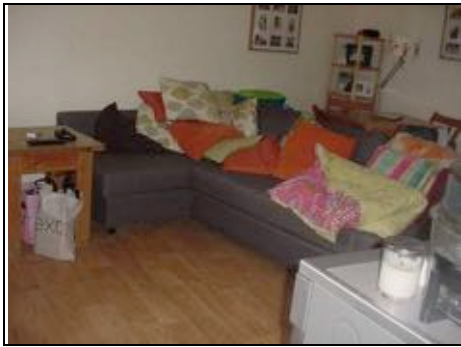
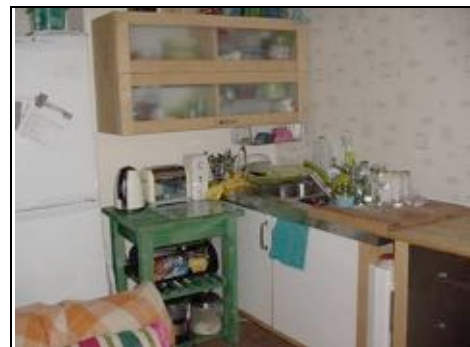
DESCRIPTION	CONDITION	ACTION REQUIRED
Ceiling: Older style textured paint Two painted beams	May have asbestos content Undulations to ceiling Condensation likely.	Asbestos report Repair, prepare and redecorate Add large good quality humidity controlled extract fan.
Walls: Painted	Considerable movement around door frame

Landlord to place an insurance claim to monitor movement for at least a year as recommended by the BRE; please see our other comments. Repair, prepare and redecorate.
Floors: Wood look vinyl	Worn	Clean or replace

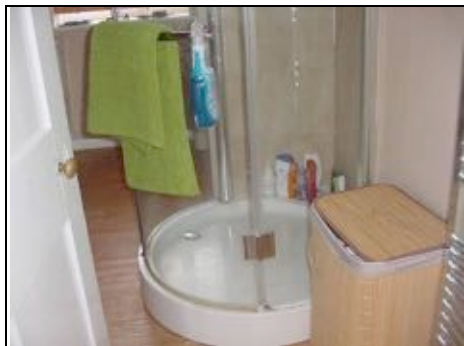
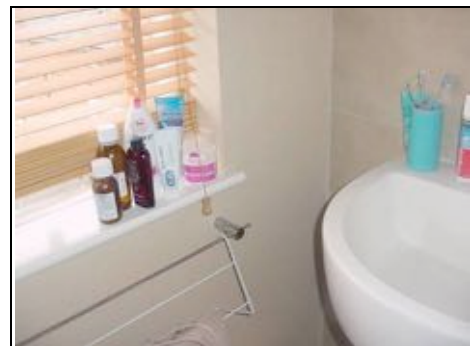
DESCRIPTION	CONDITION	ACTION REQUIRED
Ceiling: Unpainted modern plaster

Damaged and cracked Marks where ceiling has been repaired Condensation likely

Repair, prepare and redecorate. Add large good quality humidity controlled extract fan
Walls: Tiled	Some mould where mastic meets bath	Clean and re-mastic
Floors: Wood look vinyl	Average	Clean or replace.
Detailing: Windows: Timber casement	Dated	Repair, prepare and redecorate

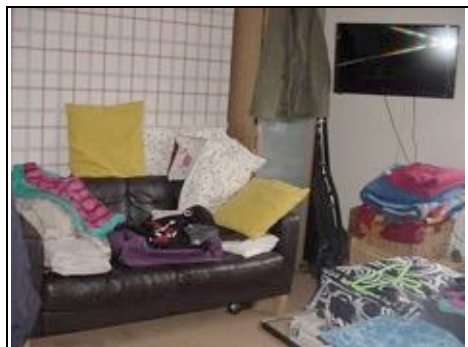
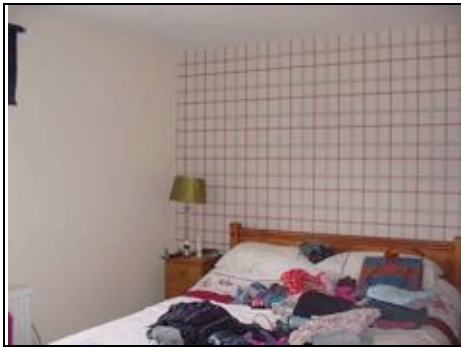
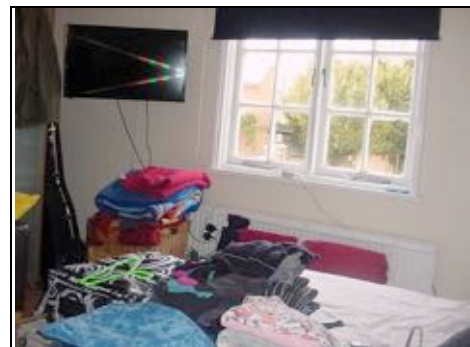
Bedroom Front Right

DESCRIPTION	CONDITION	ACTION REQUIRED
Ceiling: Painted modern plaster	Average	Repair, prepare and redecorate.
Walls: Painted modern plaster Wallpaper to feature chimney breast to right Woodchip to rear wall	Unvented	Repair, prepare and redecorate. Add vent
Floors: Carpet	Average Undulating	Clean or replace See comments on movement in property in general.
Detailing: Windows: Timber casement	Black mould	Repair, prepare and redecorate

Doors: Painted timber panel doors	Average	Repair, prepare and redecorate
Services: Lighting Single panel radiator Cables going through window		See Services Section Adjust so window can be shut.

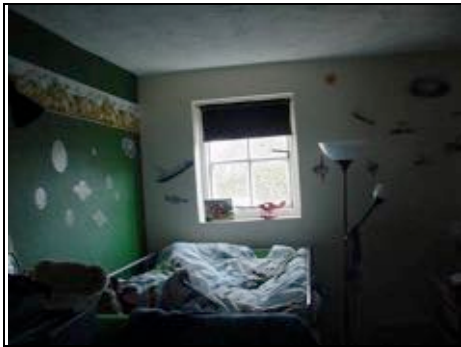
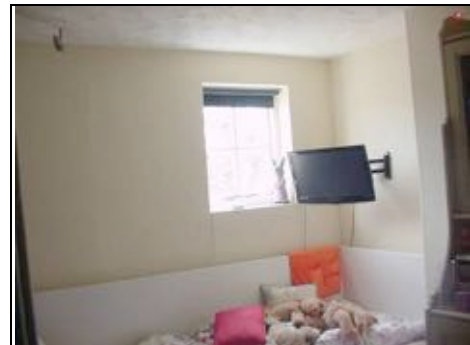
Undulations in ceiling

DESCRIPTION	CONDITION	ACTION REQUIRED
Ceiling: Textured paint	Undulating generally, dip to left side	Investigate leak/deterioration to roof structure. Repair, prepare and redecorate.
Walls: Painted modern plaster Woodchip paper Chimney breast to right side Dividing curtain down centre of room at time of inspection.	Average	Repair, prepare and redecorate. Add vent
Floors: Carpet	Average	Clean or replace
Detailing: Windows: Two timber casement windows	Black mould	Repair, prepare and redecorate

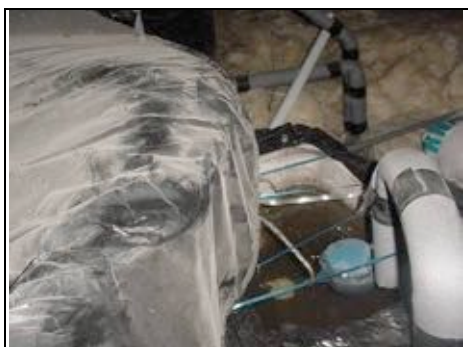
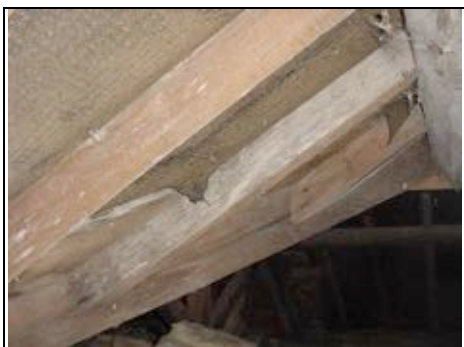
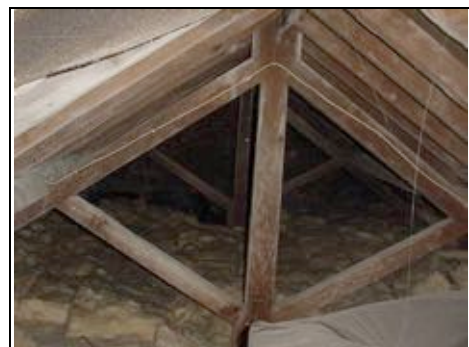
Internal Main Roof

DESCRIPTION	CONDITION	ACTION REQUIRED
Roof Access: Accessed via Landing There is no ladder, lighting or secured boards		Recommend adding safe access and lighting.
Roof Structure: Kingpost style roof, viewed from loft hatch area		
Roof Timbers: Common rafters	Minor signs of dampness coming in

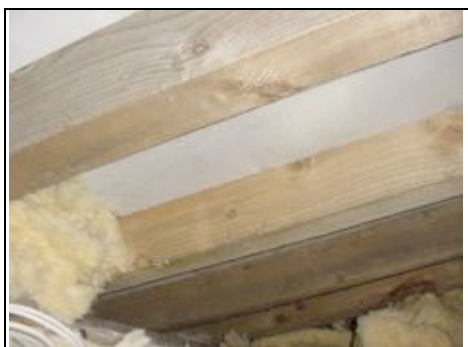
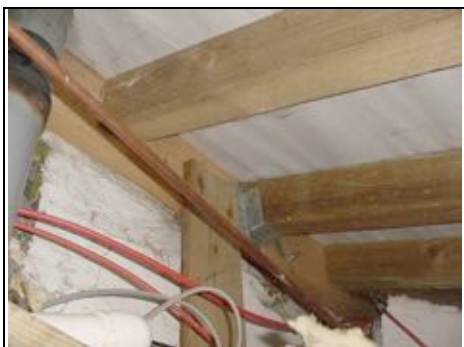
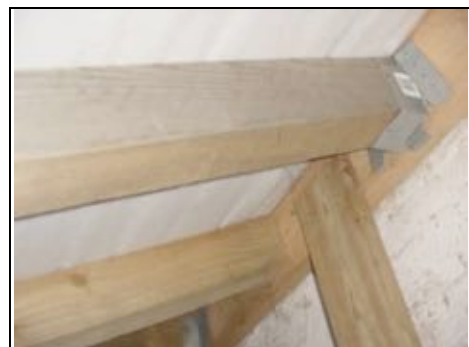
Internal Roofs Over Wash Up Area

DESCRIPTION	CONDITION	ACTION REQUIRED
Roof Access: No light, ladder, floorboards		
Roof Structure: Modern cut timber single pitched		
Roof Timbers: Modern timber Sits on joist hangers

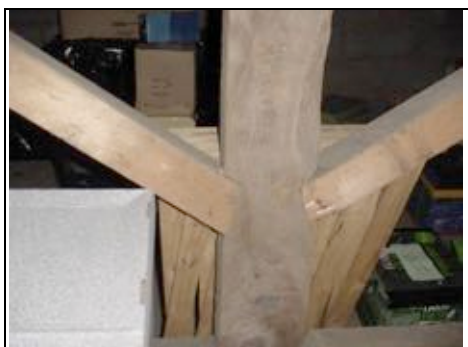
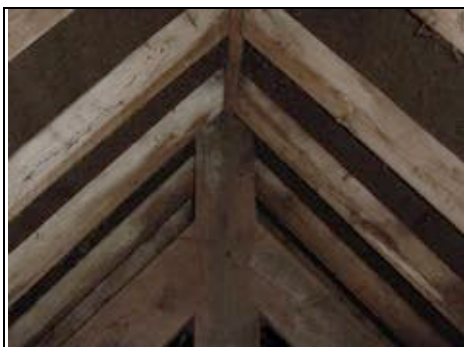
Internal Roofs Over Kitchen Area Rear Left

DESCRIPTION	CONDITION	ACTION REQUIRED
Roof Access: Accessed via double flap from Prep Area No light or ladder Boarded		
Roof Structure: Kingpost roof	Some timbers have been replaced	
Roof Timbers: Common rafters	Back to back timber repairs Woodworm visible.
