PROPERTY REPORT AND NEGOTIATION DOCUMENT

XXXX
Dunstable
Bedfordshire
LU6 XXX

INTRODUCTION

We have been instructed to inspect and prepare a Property Report and Schedule of Condition for:

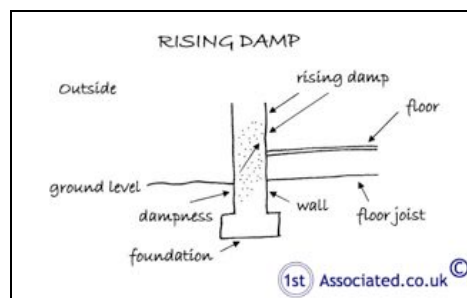
Rising damp

Rising dampness was noted and recorded with damp metres in the property, especially around the internal toilets. Dampness is also noted to the right side wall, approximately a meter in height with plants growing to the base of the property.
