## SCHEDULE OF CONDITION

**XXXX**  
**Dunstable,**  
**Bedfordshire**  
**LU6 XXX**

We have been instructed to inspect and prepare a Schedule of Condition for  
XXXX, Dunstable, Bedfordshire LU6 XXX

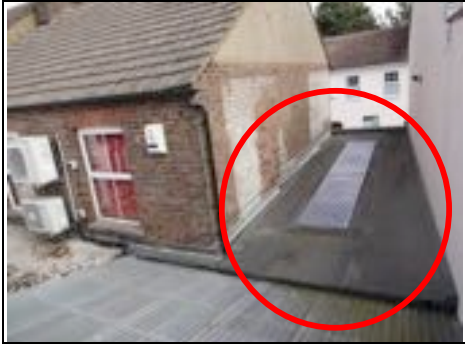
Garage Roof no: 1

DESCRIPTION	CONDITION	ACTION REQUIRED
<p><b>Garage Roof no:1</b></p> <p>Flat roof covered with mineral felt Mineral felt flashing to left side Flashband flashings to right side</p> <p>Single plastic corrugated roof window.</p>   <p>Underside of roof</p>

<p>We consider Flashband flashings to be a temporary material</p>   <p>Plastic downpipe</p>	<p>Replace Flashband flashings with a lead flashing and make water-tight</p> <p>We recommend this roof is excluded from Lease or joint high-level inspection with the landlord's surveyor to be carried out prior to signing of the lease or legal completion of the lease from high-level cherry picker or equivalent.</p>
<p><b>Main roof no:2:</b></p> <p>Pitched, clad with concrete tiles Step in roof</p>    	<p>Top coat wearing off.</p>   <p>Gap between roofs</p> <p>There is a lack of tilting fillet to the end of the roof, which may allow rainwater to discharge down the face of the property</p>	<p>We recommend this roof is excluded from Lease or joint high-level inspection with the landlord's surveyor to be carried out prior to signing of the lease or legal completion of the lease from high-level cherry picker or equivalent.</p> <p>This is an area where dampness can get into the structure.</p> <p>Resolve dampness.</p>

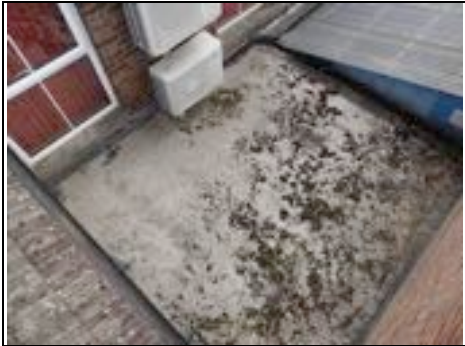
Small Flat Roof no:4

<b>Flat Roof no: 4</b>		
<p>Flat roof area in middle</p>   <p><b>Box gutter</b></p>  	<p>Moss sitting on the roof, indicating this is a flat, flat roof without a fall.</p>   <p>Box gutter between shallow roof and flat roof.</p>	<p>Add shallow fall.</p> <p>We recommend this roof is excluded from Lease or joint high-level inspection with the landlord's surveyor to be carried out prior to signing of the lease or legal completion of the lease from high-level cherry picker or equivalent.</p> <p>See comments in Roof no:3</p>
<b>Right Side Single Pitched Roof no: 5 (over Kitchenette)</b>		
  <p>Pitched with concrete tiles</p> <p>Render to end.</p>    	<p>Surface deteriorating Moss and lichens</p>   <p>Cement flashings need to be replaced with lead flashings</p> <p>Rainwater seems to be discharging down the end wall allowing dampness into the property.</p> <p>Section of plastic guttering has been removed to we assume allow the window to be opened</p>	<p>We recommend this roof is excluded from Lease or joint high-level inspection with the landlord's surveyor to be carried out prior to signing of the lease or legal completion of the lease from high-level cherry picker or equivalent.</p>

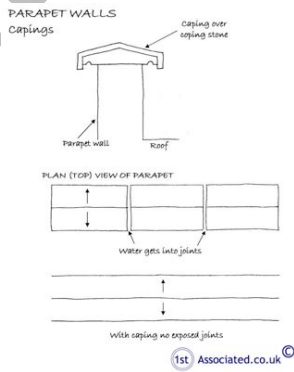
</p> <p>Coping stones have weathered joints and DIY type repairs.</p> <p>

</p>	<p>We recommend this roof is excluded from Lease or joint high-level inspection with the landlord's surveyor to be carried out prior to signing of the lease or legal completion of the lease from high-level cherry picker or equivalent.</p> <p>We recommend that the box gutters are replaced in lead and fall is added to them.</p> <p>Re-bedding of coping stones and mastic repairs require replacement using appropriate mortar</p> <p>

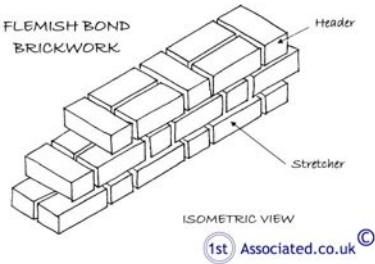
Likely to become brittle if not already brittle and will require replacement.	Likely the gutters and downpipes will need replacing during the course of the Lease.
<b>Walls:</b> Flemish bond brickwork

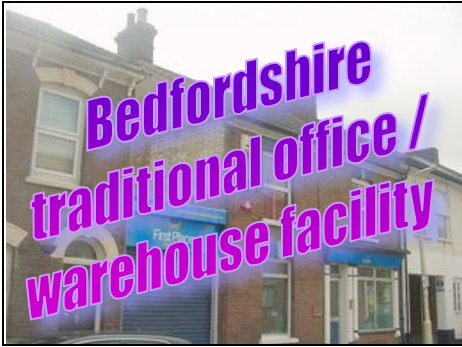
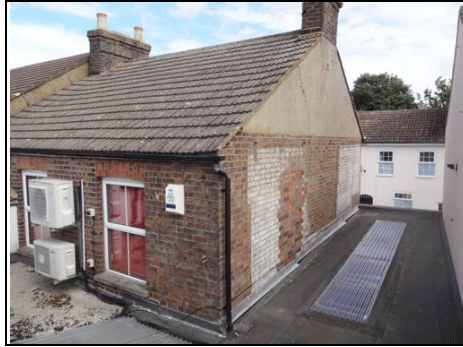
Left side

Cracking to render at left side, daylight visible when in the roof

Deterioration to render Flemish bond brickwork below Old signage Bricked up window	Diagonal cracking to rear.

Single brick wall requires major repair

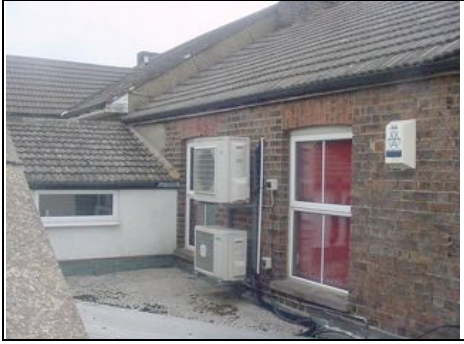
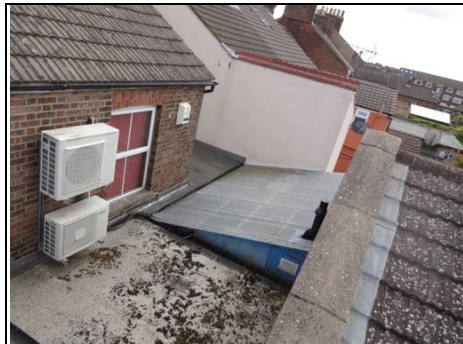
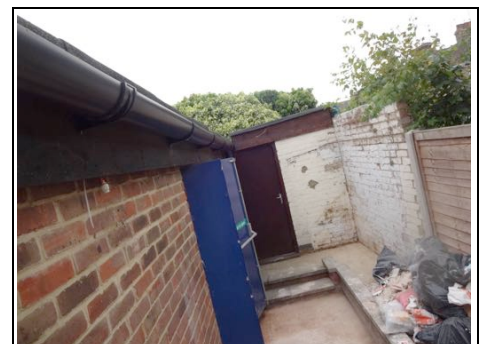
Rear of main building viewed from side

Rear of main building viewed from right side

Rear view single storey flat roofed building

<p><b>Walls:</b></p>   <p>High level: Flemish bond brickwork</p>   <p>Low level: Stretcher bond brickwork</p>	<p>Messy DIY standard brickwork finish</p>	<p>Ad hoc re-pointing in appropriate lime mortar</p>
<p><b>External Detailing:</b></p> <p><b>Windows:</b> Double glazed</p>		<p>Clean. Repair, prepare and redecorate.</p>
<p><b>Windows and Doors:</b></p> <p>Double fire doors</p>  	<p>Dated</p>	<p>Clean. Repair, prepare and redecorate.</p>

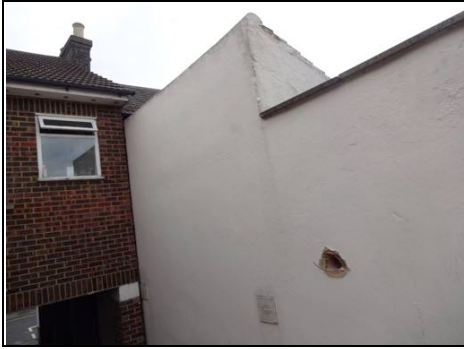
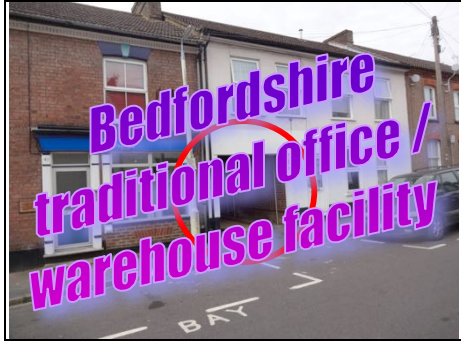
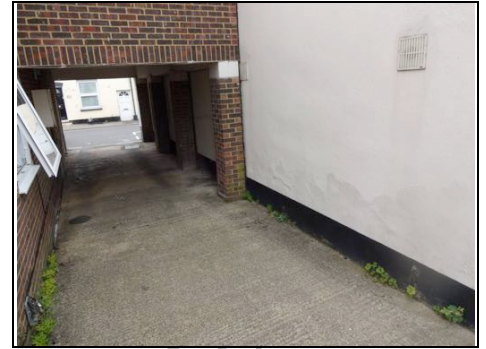
Right view looking towards the front

Coach way

Right view looking towards the coach way

<p><b>Walls:</b></p> <p>Coach arch Painted render with brick piers</p>   <p>Dampness</p>	  <p>Front right side general marks and dated</p>   <p>Dated paintwork, damp damaged and vegetation growing at the base.</p> <p>Holes where extractor fans should be.</p> <p>Spalling brickwork to retaining wall.</p> <p>Damage to parapet walls at high level</p>	<p>Repair, prepare and redecorate</p> <p>Resolve dampness at high level</p> <p>Repair, prepare and redecorate</p> <p>Make good the holes.</p> <p>Resolve dampness at low level</p> <p>Check not permanent trespass occurring on this side when/if the extract fans are added and with the fire exit</p>
<p><b>External Detailing:</b></p> <p><b>Doors:</b></p> <p>Fire Door</p>  	<p>Needs to be a safe exit from this door.</p> <p>We were unable to open the door at the time of our inspection.</p>	<p>Replace /repair, prepare and redecorate.</p> <p>Your legal advisor to check and confirm if there is a legal Right of Way.</p>

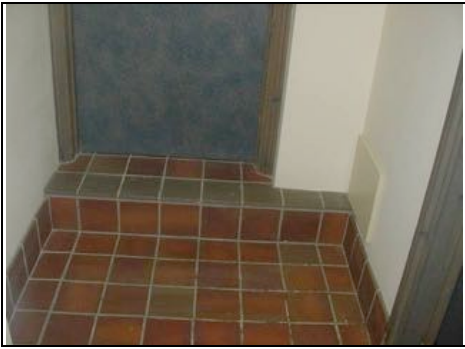
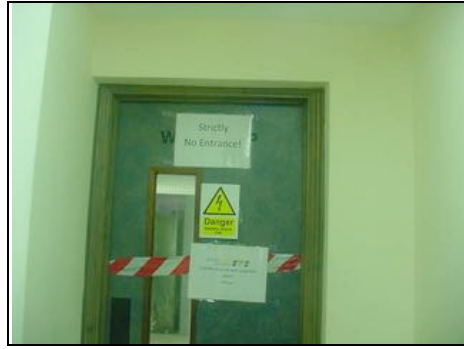
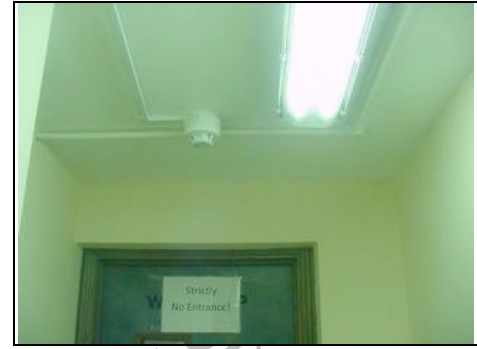
Quarry tiles

Door

Ceiling

Dampness	Resolve dampness. Make watertight. Repair, prepare and redecorate
<b>Floors:</b>  Quarry tiles	Worn	Clean or replace
<b>Detailing:</b> <b>Doors:</b>  Formica	Average	Repair and clean or replace
<b>Services:</b>		See Services Section

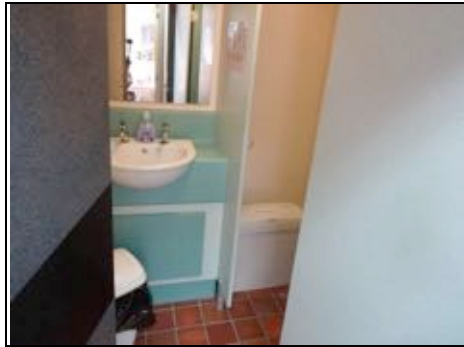
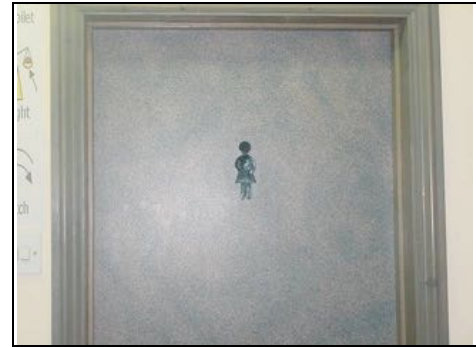
Ladies toilets

Door

DESCRIPTION	CONDITION	ACTION REQUIRED
<b>Ceiling:</b> Painted modern plaster	Damaged and dated	Repair, prepare and redecorate
<b>Walls:</b> Painted modern plaster	Marked	Repair, prepare and redecorate.
<b>Floors:</b> Quarry tiles	Damp found	Resolve dampness Deep clean.
<b>Sanitary Ware:</b> One WC	Dirty	Deep clean
One wash hand basin into a vanity unit	Dirty	Deep clean
<b>Detailing:</b> <b>Doors:</b> Formica		Repair and clean or replace
<b>Services</b>		See Services Section.

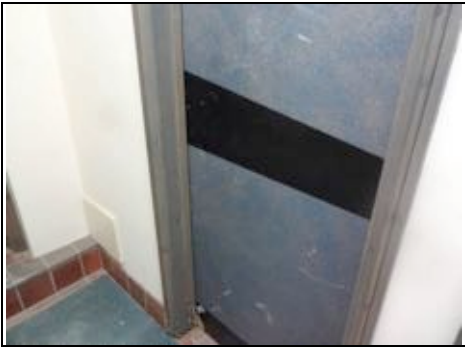
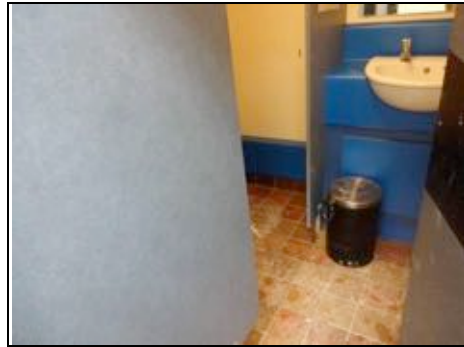
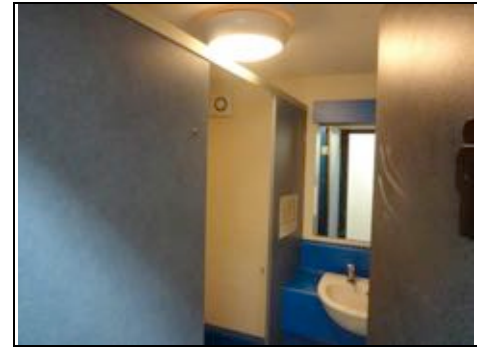
Entrance door

Wash hand basin

Gents toilets

DESCRIPTION	CONDITION	ACTION REQUIRED
<b>Ceiling:</b> Painted modern plaster	Damaged and dated	Repair, prepare and redecorate.
<b>Walls:</b> Painted modern plaster	Marked

High damp meter readings Right wall	Resolve dampness. Repair, prepare and redecorate.
<b>Floors:</b> Quarry tiles	Marked

Dampness Damaged old bolt fixing looks to have been removed	Resolve dampness  Deep clean.

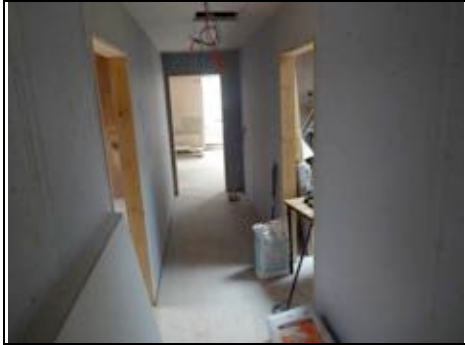
Corridor looking towards rear  
Training Room

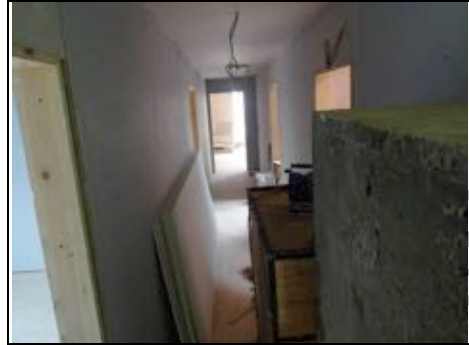
Stored items

DESCRIPTION	CONDITION	ACTION REQUIRED
<b>Ceilings:</b>  Modern plaster	Unfinished	Assumed will be finished Recommend re-visit
<b>Walls:</b>  Modern plaster	Unfinished	Assumed will be finished Recommend re-visit
<b>Floors:</b>  Timber	Unfinished	Assumed will be finished Recommend re-visit
	Stored items	Remove stored items
<b>Detailing:</b>  <b>Doors:</b>  Door openings	Unfinished	Assumed will be finished Recommend re-visit
<b>Services:</b>  Lighting Electrics at first fix stage.		See Services Section

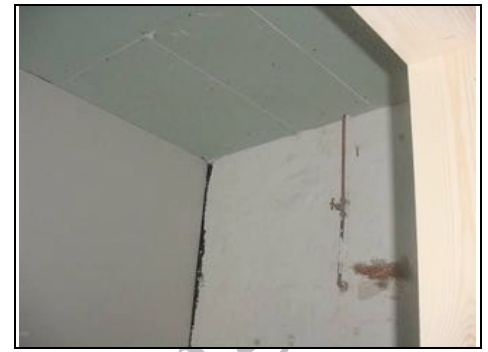
Ceiling and wall

DESCRIPTION	CONDITION	ACTION REQUIRED
<b>Ceilings:</b>  Plasterboard	Unfinished

Opening above	Assumed will be finished Recommend re-visit
<b>Walls:</b>  Plaster

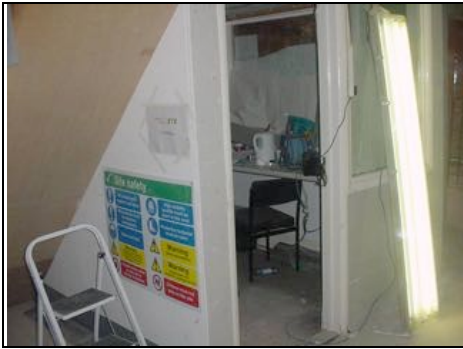
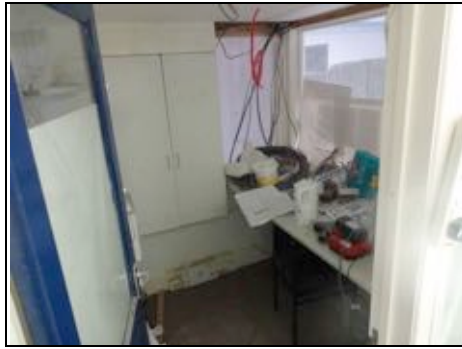
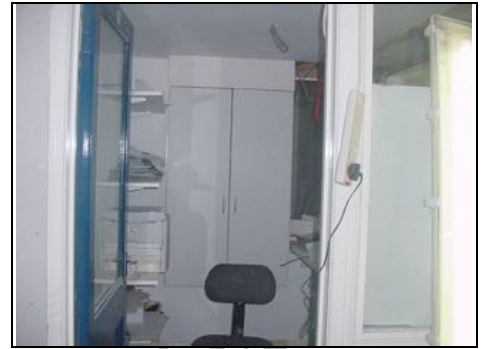
Looking into Internal office

Office one

Internal office

DESCRIPTION	CONDITION	ACTION REQUIRED
<b>Ceilings:</b>  Plasterboard	Unfinished	Assumed will be finished Recommend re-visit
<b>Walls:</b>  Plaster	Unfinished	Assumed will be finished Recommend re-visit
<b>Floors:</b>  Timber	Unfinished	Assumed will be finished Recommend re-visit
<b>Detailing:</b>  <b>Doors:</b>  Door opening	Unfinished	Assumed will be finished Recommend re-visit
<b>Services:</b>  Fuseboard		See Services Section

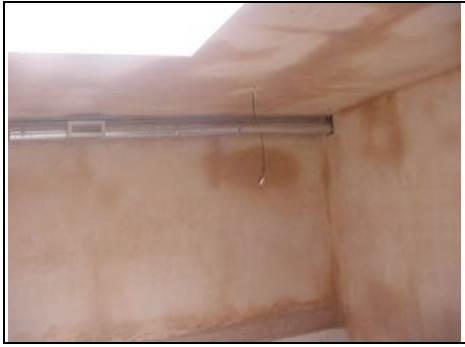
Training room one ceiling

DESCRIPTION	CONDITION	ACTION REQUIRED
<b>Ceilings:</b> Plasterboard One roof window	Unfinished	Assume will be finished Recommend re-visit
<b>Walls:</b> Plasterboard Damp proofing paint to left side	Unfinished

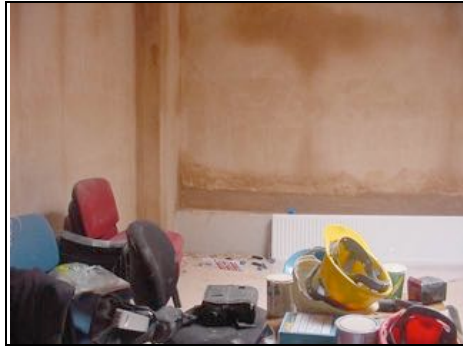
Training room one

Gap where skirting should be	Assumed will be finished Recommend re-visit
<b>Floors:</b> Suspended floor	Unfinished	Assumed will be finished Recommend re-visit
<b>Detailing:</b> <b>Roof Windows:</b> One central	Damaged at roof level	Clean and/or replace

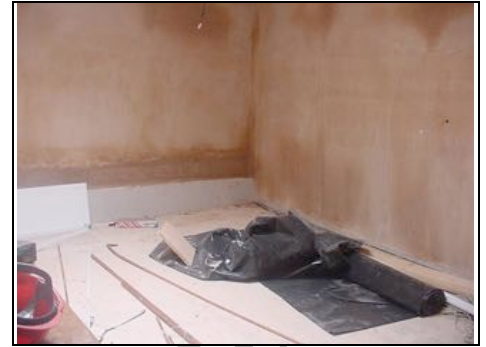
Training room one floor

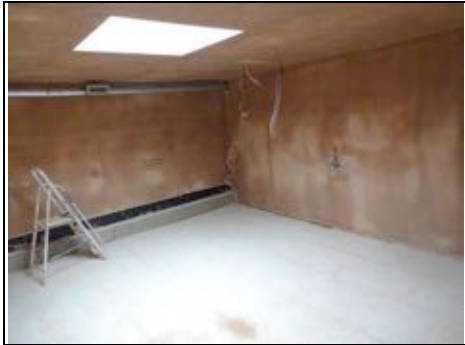
Roof light and left wall

DESCRIPTION	CONDITION	ACTION REQUIRED
<b>Ceilings:</b>  Plasterboard with skim coat of plaster	Unfinished	Assumed will be finished Recommend re-visit
<b>Walls:</b>  Plasterboard with skim coat of plaster  Damp proofing paint to left side	Unfinished	Assumed will be finished Recommend re-visit
<b>Floors:</b>  Timber	Unfinished	Assumed will be finished Recommend re-visit
<b>Detailing:</b>  <b>Roof Windows:</b>  One central	Damaged at roof level	Clean and/or replace

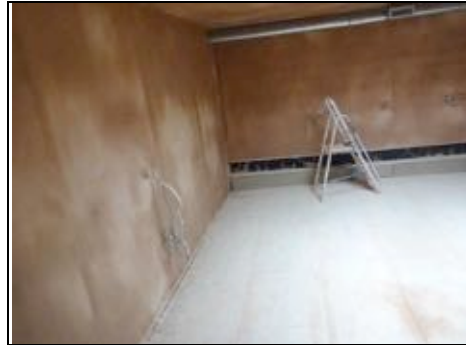
Left wall and dividing partition

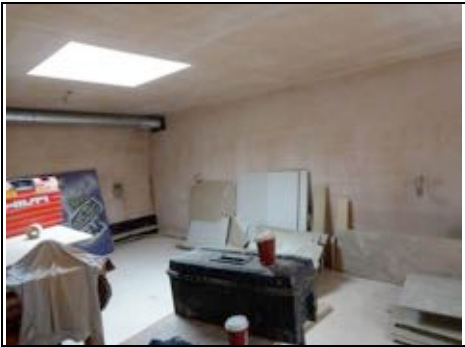
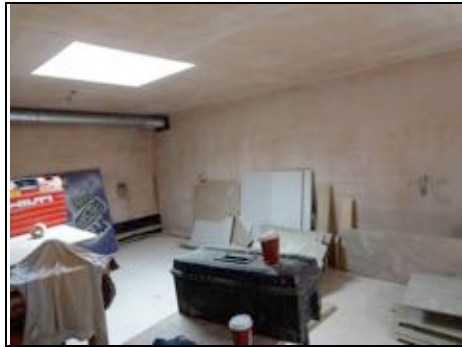
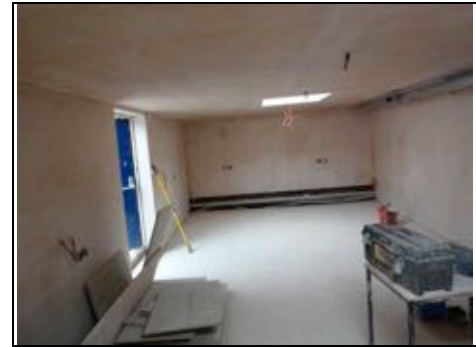
Looking towards left side

Looking towards the left side and rear

Looking towards the rear and right side

DESCRIPTION	CONDITION	ACTION REQUIRED
<b>Ceilings:</b> Modern unpainted plaster	Unfinished	Assumed will be finished Recommend re-visit
<b>Walls:</b> Modern unpainted plaster Damp proofing paint to left and right sides	Unfinished	Assumed will be finished Recommend re-visit
<b>Floors:</b> Timber	Unfinished	Assumed will be finished Recommend re-visit
<b>Detailing:</b> <b>Roof Windows:</b> Two	Damaged at roof level	Clean and/or replace

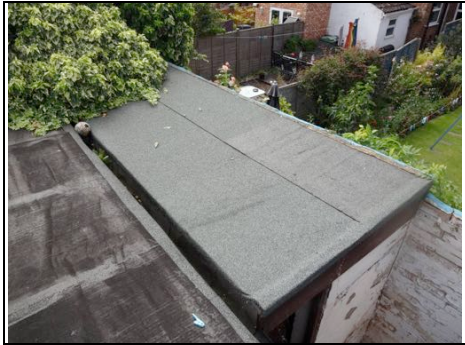
Rear left outbuilding roof  
Aerial view – 360 photo

DESCRIPTION	CONDITION	ACTION REQUIRED
<b>Roofs:</b>  Felt covered		See roof section.  We recommend excluding from the Lease.
<b>Box guttering:</b>  Plastic	Leaking

Ensure all gutters are watertight and falling towards the downpipe and clear.  Repair downpipes and secure as necessary, ensure downpipes are clean and clear.

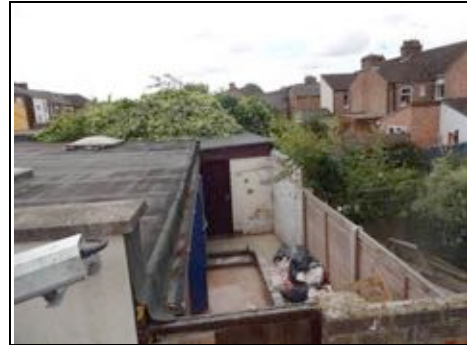
Rear yard  
Aerial view – 360 photo

<p><b>Walls:</b></p> <p>Single storey</p> <p>We could only see the brickwork on one side.</p>   <p>Rear wall of Yard</p>	<p>Dated</p>     <p>Running gully looks like builders plaster has been deposited down the gully</p>	<p>Ad hoc re-pointing.</p> <p>Repair, prepare and redecorate.</p> <p>Clean</p>
<p><b>External Detailing:</b></p> <p><b>Doors:</b></p> <p>Entrance door</p>  	  <p>Rot to door</p>   <p>Looking out into the courtyard/fire exit</p> <p>There is a big step down</p>	<p>Replace</p>

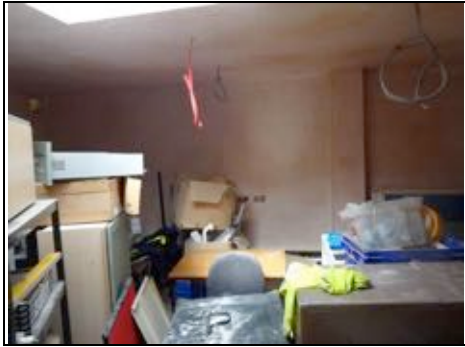
Training room four

DESCRIPTION	CONDITION	ACTION REQUIRED
<b>Ceilings:</b>  Skim coat of modern plaster	Unfinished	Assumed will be finished Recommend re-visit
<b>Walls:</b>  Skim coat of modern plaster Damp proofing paint	Unfinished	Assumed will be finished Recommend re-visit
<b>Floors:</b>  Timber	Unfinished	Assumed will be finished Recommend re-visit
<b>Detailing:</b>  <b>Windows:</b>  One roof window	Damaged at roof level	Clean and/or replace
<b>Doors:</b> Door openings	Unfinished	Assumed will be finished Recommend re-visit
<b>Services:</b>  Lighting Electrics: awaiting second fix at time of survey.		See Services Section

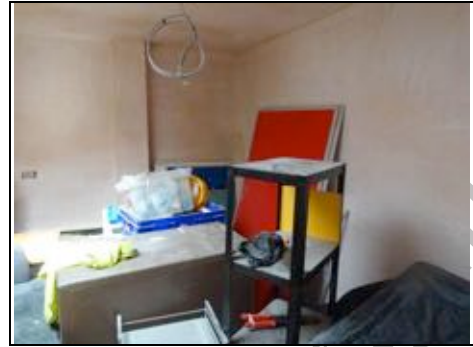
Stored items

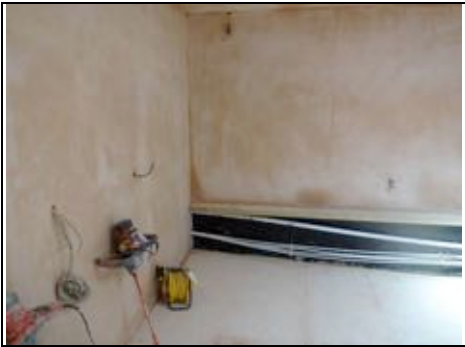
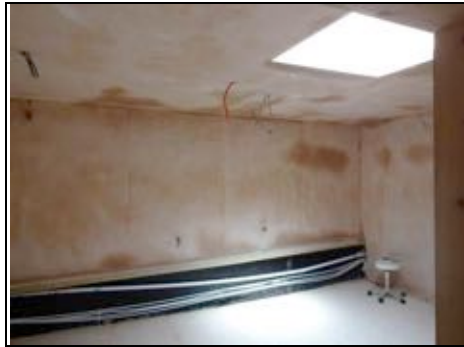
Partition right side

Right side

DESCRIPTION	CONDITION	ACTION REQUIRED
<b>Ceilings:</b> Modern plaster	Unfinished	Assumed will be finished Recommend re-visit
<b>Walls:</b> Modern plaster Damp proofing paint	Unfinished	Assumed will be finished Recommend re-visit
<b>Floors:</b> Timber	Unfinished	Assumed will be finished Recommend re-visit
<b>Detailing:</b>  <b>Windows:</b> One roof window	Damaged at roof level	Clean and/or replace
<b>Doors:</b> Door opening	Unfinished	Assumed will be finished Recommend re-visit
<b>Services:</b> Lighting Plastic service pipes

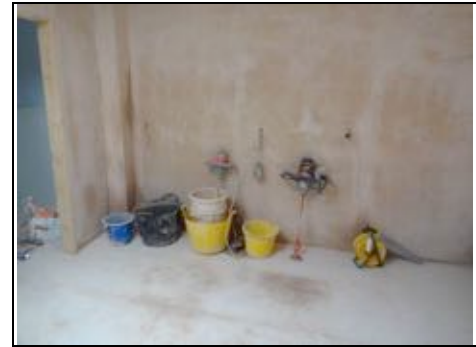
Room being used at the time of our inspection for mixing plaster

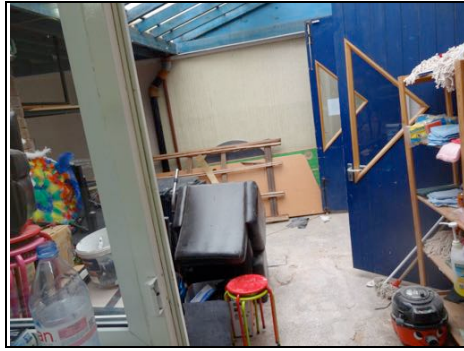
Stored items

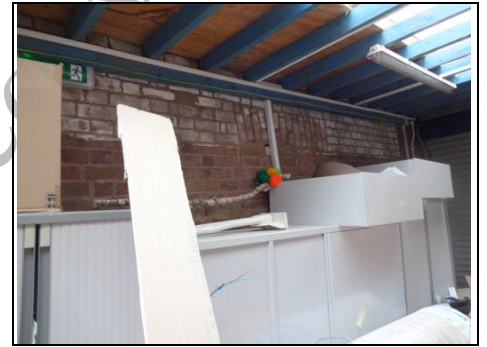
Internal view of roof and wall

DESCRIPTION	CONDITION	ACTION REQUIRED
<b>Ceilings:</b>		
Underside of flat roof area	Dirty and Dated	Clean. Repair, prepare and redecorate
Roof window	Dirty and Dated	Clean. Repair, prepare and redecorate
Underside of single pitched roof exposed timbers	Dirty and Dated	Make watertight. Clean. Repair, prepare and redecorate
<b>Walls:</b>		
Render and Brickwork	Hidden in part by stored items	Re- inspection recommended  Render to be repaired, prepared and redecorated
<b>Floors:</b>		
Concrete	Hidden in part by stored items	Re- inspection recommended  Remove stored items
<b>Services:</b>		See Services Section

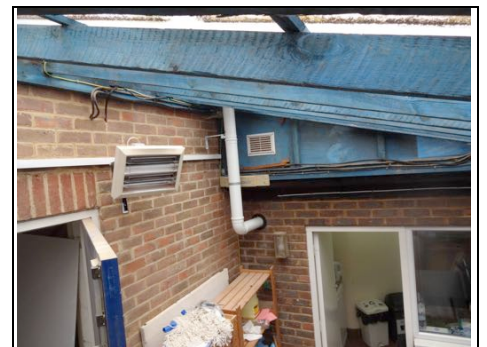
Underside of roof

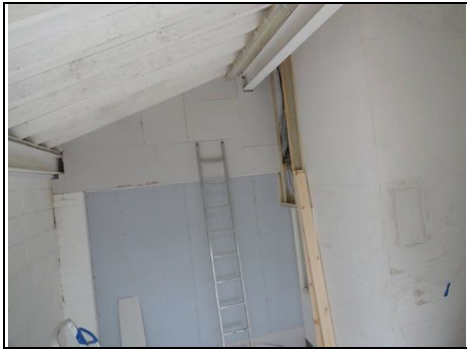
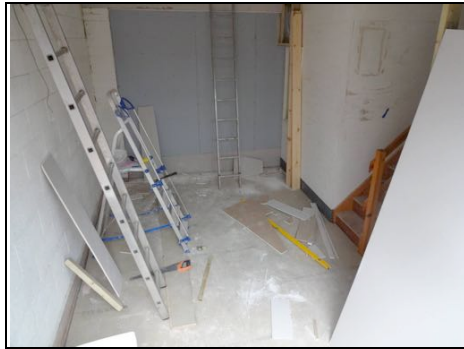
Rear garage internal view

General view

DESCRIPTION	CONDITION	ACTION REQUIRED
<b>Ceilings:</b>  Cathedral style ceiling Metal I-beam Exposed painted common rafters Boarding between rafters	Unfinished	Assumed will be finished  Recommend re-visit or joint high-level inspection with the landlord's surveyor to be carried out prior to signing of the lease or legal completion of the lease from high-level cherry picker or equivalent.

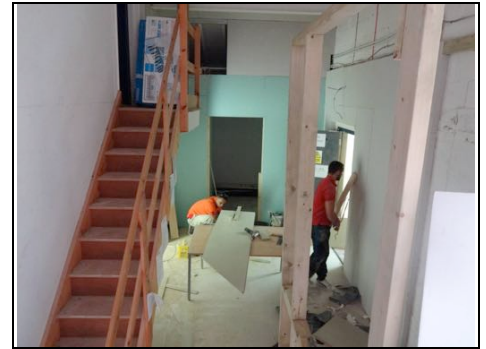
Stairs

<b>Walls:</b>  Painted blockwork Painted timber internally	Unfinished	Assumed will be finished Recommend re-visit
<b>Floors:</b>  Timber	Unfinished	Assumed will be finished Recommend re-visit
<b>Staircase to first floor:</b>	Unfinished	Assumed will be finished Recommend re-visit
<b>Services:</b>		See Services Section

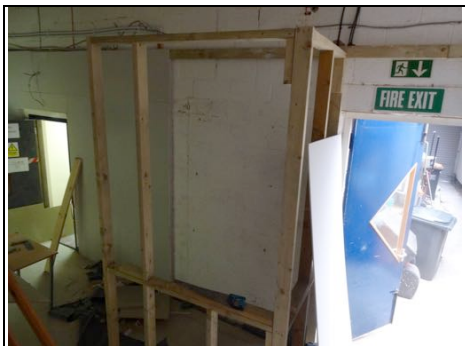
Unfinished partition

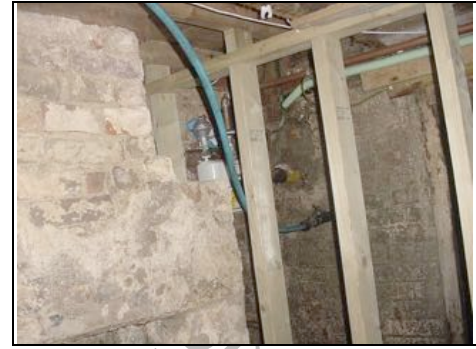
Front right side of cellar

<p>Woodworm Dampness reading 57</p>	<p>We recommend excluding from the Lease</p>

<p><b>Walls:</b> Brickwork</p>   <p>Looking towards steps at right side wall</p>	<p>Unfinished</p> <p>Dampness</p>   <p>Front left wall</p>	<p>Resolve dampness and make watertight.</p> <p>Repair, prepare and redecorate</p>
<p><b>Floors:</b> Concrete</p>	<p>Average</p>   <p>Manhole cover towards the front where the old coal shoot used to be dampness is likely to get into the structure here</p>	<p>Clean.</p>
<p><b>Detailing:</b> Cellar flaps:</p>		<p>Hidden within the floor behind reception area</p>
<p><b>Cooker range:</b></p>

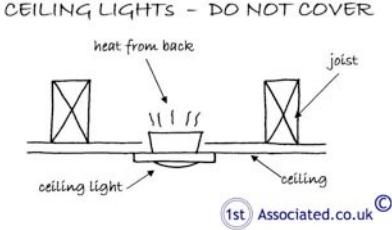
<b>Staircase:</b> Metal handrail	Worn	Repair, prepare and redecorate
<b>Services:</b> Lighting  <p>CEILING LIGHTS - DO NOT COVER</p>

Older style lights

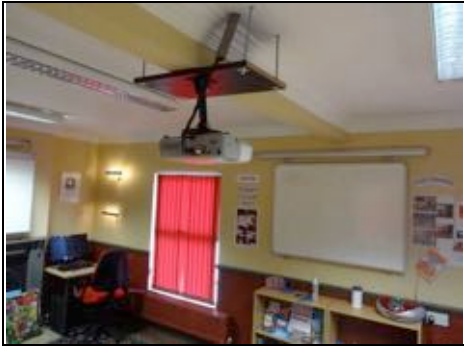
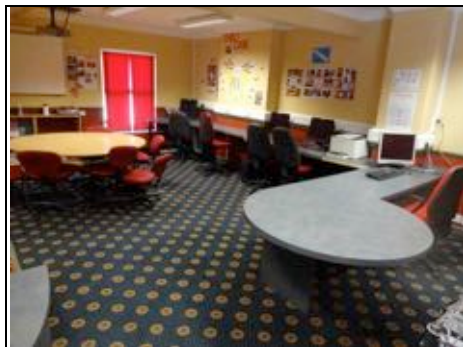
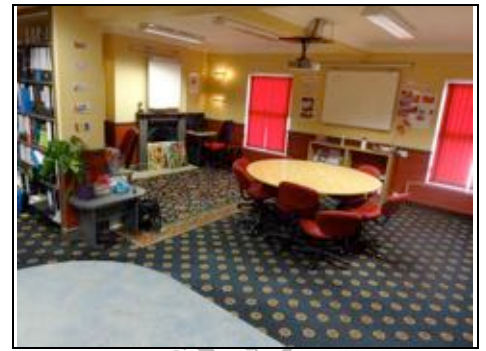
Marks where lights have been removed	Repair, prepare and redecorate
<b>Walls:</b>  Painted  Fireplaces to left and right

Repair, prepare and redecorate
<b>Floors:</b>  Carpet	Marked	Deep clean/replace.

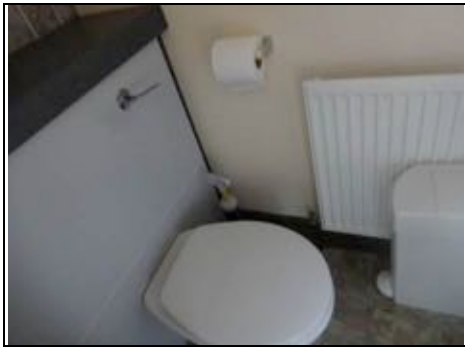
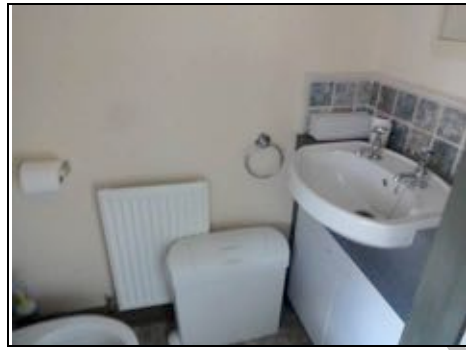
Dampness Stained	Resolve dampness. Make watertight.  Repair, prepare and redecorate.
<b>Floors:</b> Vinyl	Average	Deep clean.
<b>Sanitary Ware:</b>  One WC  One wash hand basin into a vanity unit.	Average  Average	Deep clean  Deep clean

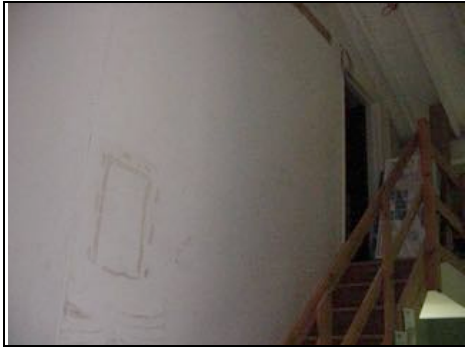
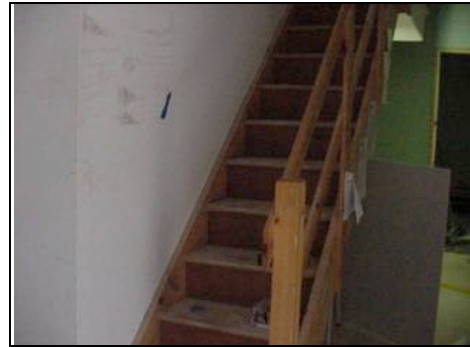
DESCRIPTION	CONDITION	ACTION REQUIRED
<b>Ceilings:</b>  Unfinished Support beams	Unfinished	Assumed will be finished Recommend re-visit
<b>Walls:</b>  Unfinished	Unfinished	Assumed will be finished Recommend re-visit
<b>Stairs:</b> Timber

Unfinished	Assumed will be finished Recommend re-visit  Clean
<b>Services:</b>		See Services Section

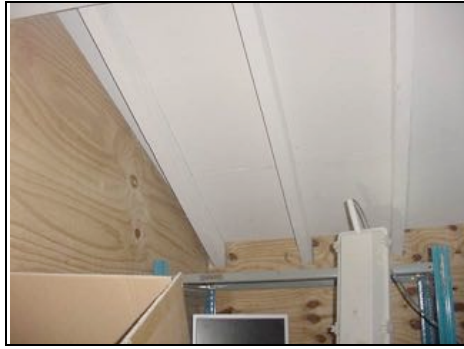
Ceiling

DESCRIPTION	CONDITION	ACTION REQUIRED
<b>Ceilings:</b>  Painted Cathedral ceiling	Dark areas/staining	Resolve dampness. Make watertight. Repair, prepare and redecorate
<b>Walls:</b>  Unfinished wood decking Steels visible	Unfinished	Assumed will be finished Recommend re-visit
<b>Floors:</b>  Timber	Unfinished	Assumed will be finished Recommend re-visit
<b>Detailing:</b>  <b>Doors:</b>  Painted	Dated	Clean.
<b>Services:</b>		See Services Section

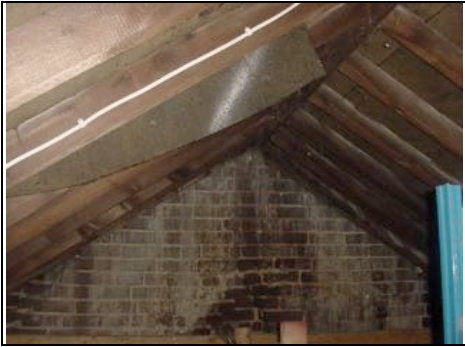
Main roof right side chimney dampness

Daylight visible	Make watertight and repair. Consider dry lining.
<b>Roof Timbers:</b>

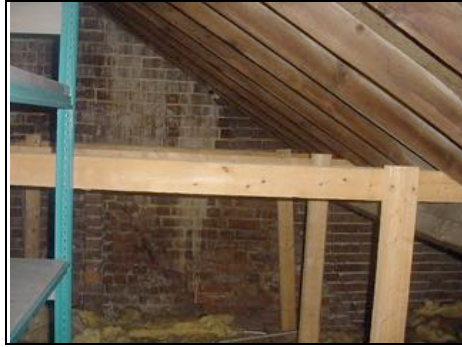
Constraint added likely to be roof spread

Damp staining visible	Landlord to confirm what work has taken place and/or to place an insurance claim to check there is no longer any roof spread
