RESIDENTIAL BUILDING SURVEY

Ravensden,
Bedfordshire
MK44 XXX

INDEPENDENT CHARTERED SURVEYORS

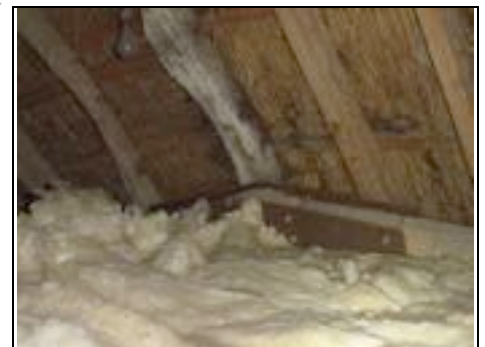
We have divided the roof structure into three areas, the left, middle and right side. We had reasonable access to the middle roof although much of it was covered with insulation, we had no access to the left roof and we could only view it from the middle roof as there was no direct access into it from what we could see. The right roof had a limited view due to both the insulation and lots of stored items although we did move some of them. From what we can see the roof structure has been replaced and repaired over the years.

Brace at base of timber to left roof

ACTION REQUIRED: We would recommend that your solicitor specifically asks in writing is there any more information with regard to the metal plates/structural work which effectively are tying/holding the building together. Unfortunately, metal plates add a relative stiffness to what is traditionally a fairly soft building on a timber frame so they can in themselves cause problems if not designed appropriately.

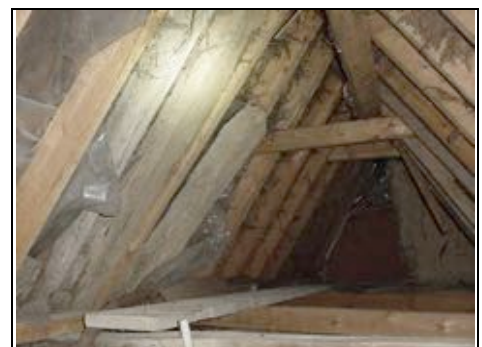
Mixture of new and older timbers to the centre roof

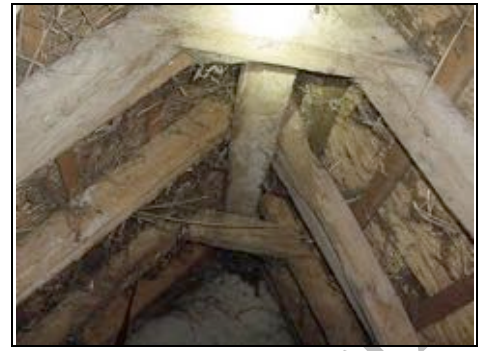
Timber to the right roof

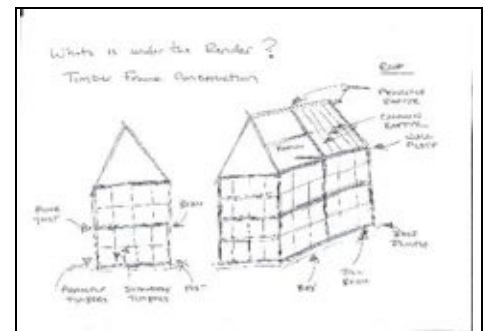
This is likely to have originally been a traditional timber frame building with primary structures and additional secondary structures then infill panels between which can be seen in the adjoining sketch. Infill panels normally start out and then over the years are replaced.

What's under the render?

1. The left roof area and allow proper access to re-gain. The owner has specifically asked in writing by your legal adviser when they are aware of any rebuilding of the walls.
2. We recommend areas of render is removed so you can see the existing structure. We would add that unfortunately it is difficult to be conclusive if the usual indicators are not consistent.

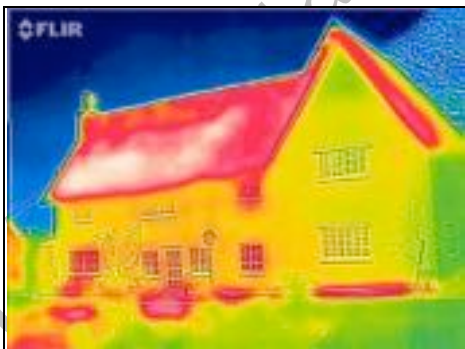
In addition to this we have also thermal imaged the property to see if this gives us any further clues and our evidence shows relatively low heat loss from the wall structure indicating that there is considerable replacement of the walls. Without opening up the walls we cannot confirm this but we do believe the thermal imaging information and the visual information in the roof give a good indication that over fifty percent of the walls have been replaced.

Heat coming out of floor, windows and roof to rear of property and little sign of the timber frame

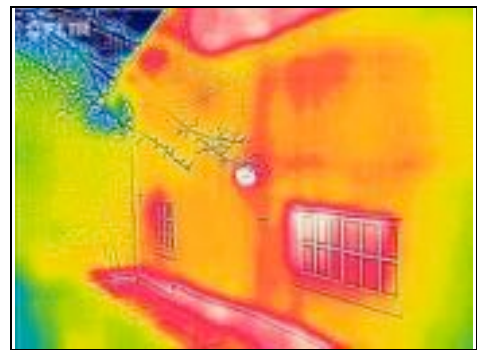
Thermal image indicates left side may be timber frame

ACTION REQUIRED: We recommend opening up:

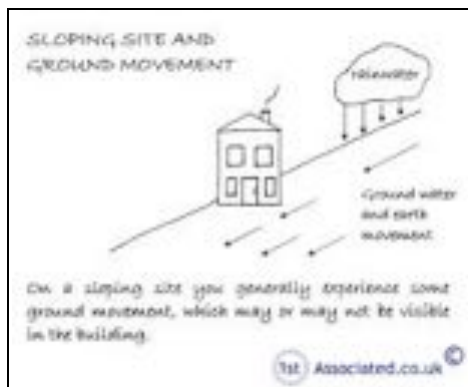
Historically this building has had a considerable amount of movement leaning from side to side. Also as it is on a sloping site it is integrally more unstable than the property on a level site.

Sloping site

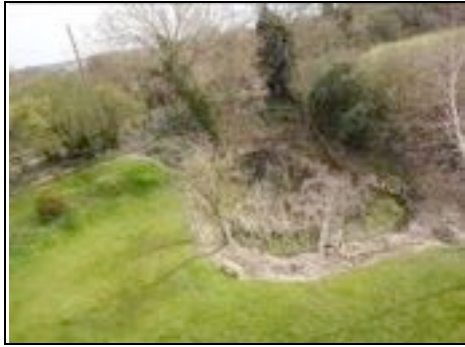
Sloping site
~ Aerial View - 360 Photo ~

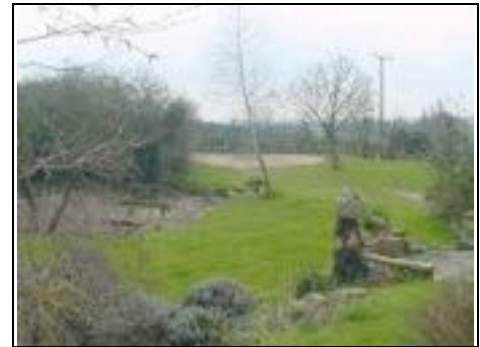
Slope towards pond

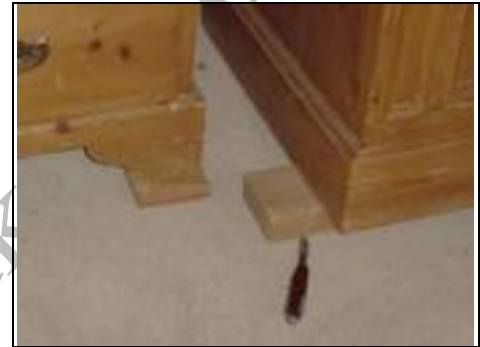
When you are in the property you can see the extent of the slop on the property, in particular you can see that there has been a considerable amount of packing under the furniture.

Furniture propped on uneven floors

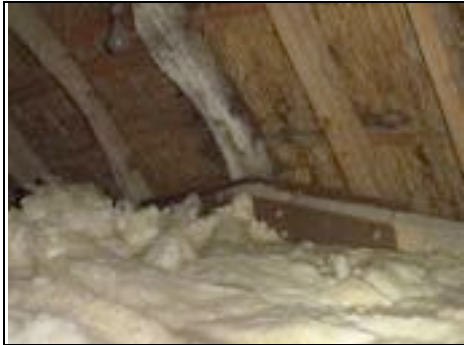
We can also see metal brackets in some areas of the property. Specifically, we can see them in the left roof and we can also see them in the middle wall of the left hand room. These indicate there has been historic movement in this property. It is very difficult from a one off inspection to conclude whether it is still what is known as progressive.

Brace at base of timber in left roof

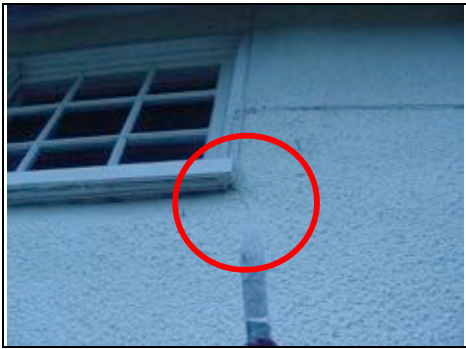
There is hairline cracking visible to some of the internal walls where the wall and ceiling joists meet and there is also hairline cracking to the gable end of the property. You do have to remember that the whole of this property has been repainted in the last few years hiding any usual indications. Again, these cracks are indicating sideways movement left to right.

Cracking to the window

ACTION REQUIRED: Ideally we would recommend the existing owners take out an insurance claim, advising that the cracking has been noted by a structural surveyor (this should cost them nothing other than time to write the letter). This usually means that the insurance company will carry out a monitoring exercise (the Building Research Establishment recommend monitoring any cracks for a minimum of one year) to establish if there is any progressive movement. Your future liability will be limited to the cost of the excess on the insurance providing the insurance company is happy for you to take over the insurance claim.

Monitoring is the only true way of establishing in this particular case of whether it is still moving (which it probably is not due to the amount of wall replacements although it is very difficult to confirm without opening up the walls, etc).

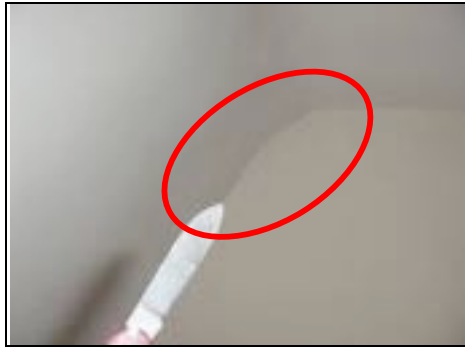
Hairline cracking in master bedroom

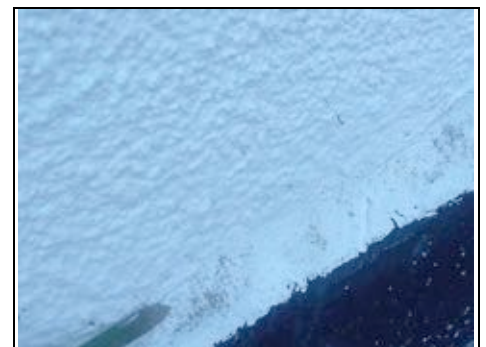
We can see that the render has been painted over. When discussed during our question and answer session the owner advised that it was the last few years. We can see moss where it has not been painted over properly. The painting of the render has hidden a lot.

Moss visible

ACTION REQUIRED: Ideally as mentioned we would like to open up a section of the render just to see what it is made of. We would also be able to see what is behind it. We would be looking for opening up to be on the left hand side of the property.

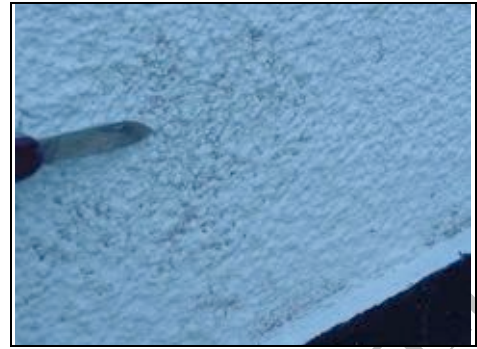
Moss showing through painted render

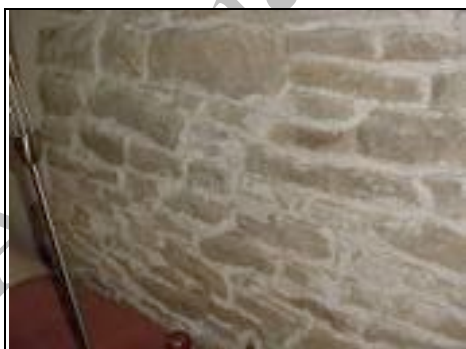
In various areas we found dampness coming in through the stonework for example and we can also see sulphate where there is orange/brownish staining where the soot is being drawn through.

Dampness coming through and various repairs

ACTION REQUIRED: We would recommend the adding of a French drain around the property. Currently there are paving slabs around the property, which unfortunately discharge water against the building.

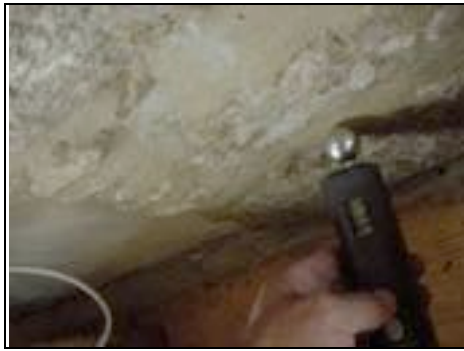
Testing for dampness in fireplace stonework

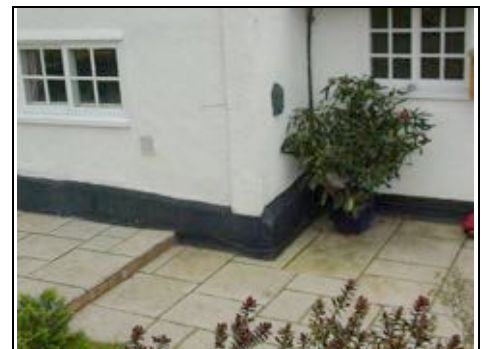
Paving around property

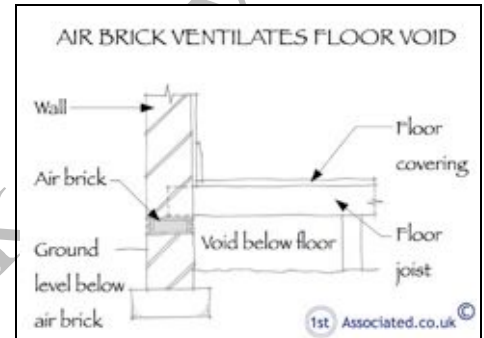
We are advised there is a timber floor in the lounge area, which is typically a suspended timber floor. We cannot see anywhere where this has been vented which in a building such as this can lead to wet rot, dry rot deterioration.

Suspended timber floor

ACTION REQUIRED: Add vents. We would also recommend opening up a section of the floor. The owner advised that the timbers used in this area were the original timbers but in our experience they would not have been that size or that cleanly cut. He did then comment that he had had them sanded, planed and then put back.

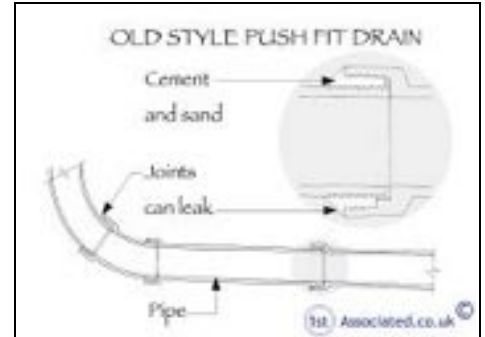
In older properties, such as this, drainage was often push fitted together rather than bonded together which means that they may leak over the years. Whilst we ran the tap for 15 minutes without any build up or blockages the only way to be 100% certain of the condition of the drains is to have a closed circuit TV camera report.

Push fit drain

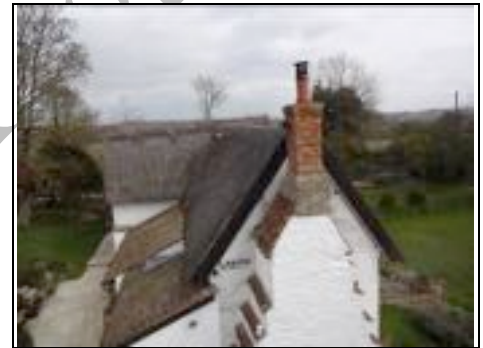
This chimney is a predominantly stone built chimney which has been finished in brick and has one chimney pot. There are tiles running down the side of the property in various stages, where it meets the main building there is a lead flashing. The problems were there is dampness getting in between the chimney and the main building into the stonework which forms the gable.

Chimney

ACTION REQUIRED: The whole of the chimney would benefit from appropriate repair work as we can see there has been inappropriate repair work using cement mortar. We can also see that the lead work detailing could be improved to reduce the amount of water getting into the right gable end. From our experience we don't think this will ever be completely dry but it could be we feel improved. We can also see that the render that adjoins the chimney would benefit from being pre-paired, repaired and redecorated.

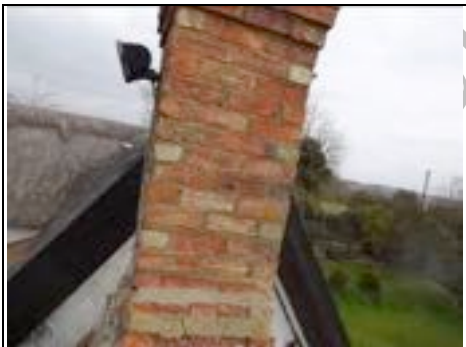
Close up of chimney

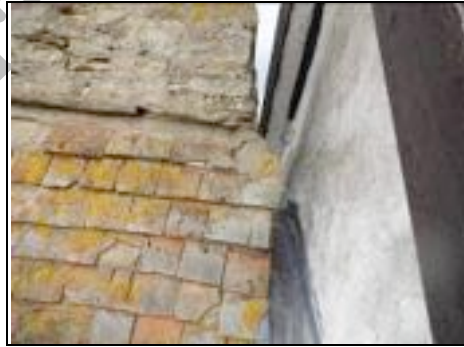
Gap between chimney and main building

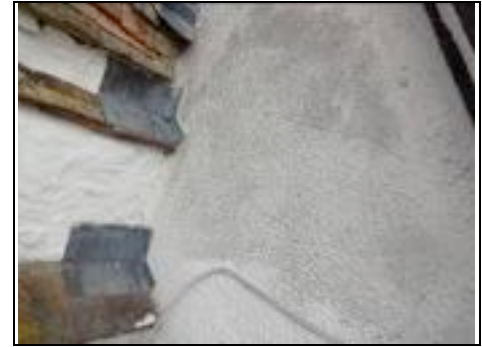
Mastic on lead to right gable

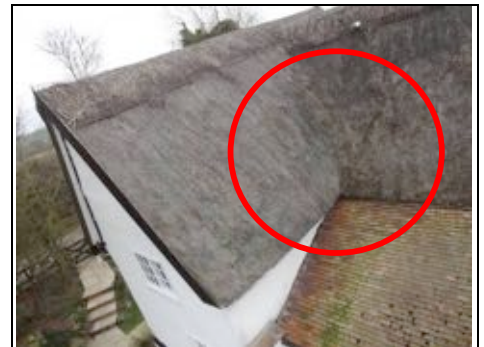
When we went partly into the left roof we were able to see what once may have been a chimney or a smoke hood which interestingly in years gone by were made out of timber. It is very difficult to confirm. It seems a logical place for a chimney to be however we have to add that we have had a very limited view.

Hidden chimney

ACTION REQUIRED: Further investigation required. As a general comment in an older property such as this all rooms would have originally been heated with a coal fire.

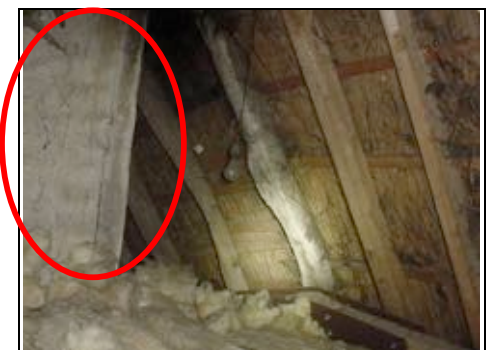
Hidden chimney/smoke hood

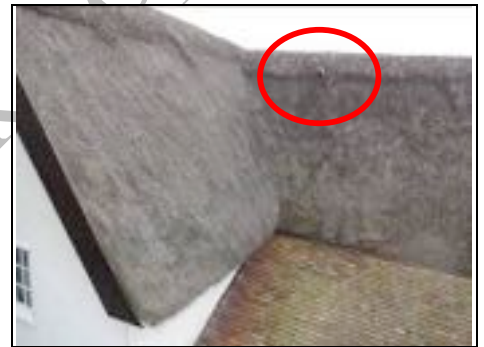
We are not sure whether this is a flue or a vent from the soil and vent pipe. We could see a plastic pipe within the roof which may well relate to this.

Flue
~ Aerial View - 360 Photo ~

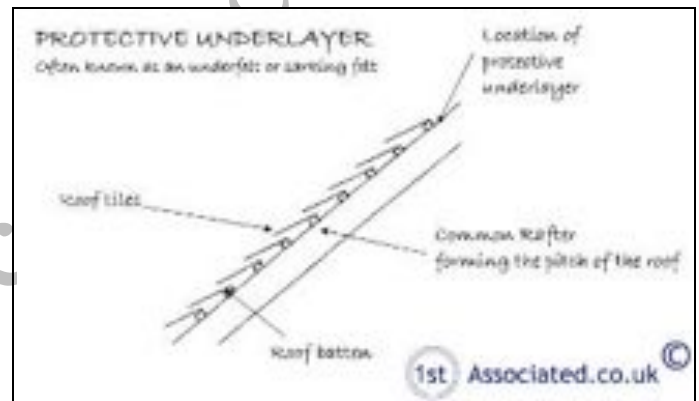
Protective underlayer

We did not expect to see a protective underlayer under the thatch however we can see some areas where a plastic sheet has been used which we thought was unusual and indicates that part of the thatch has been repaired more recently. We spoke to the owners about this in our question and answers session and they could not recall any specific repairs to the thatch in their time at the property.

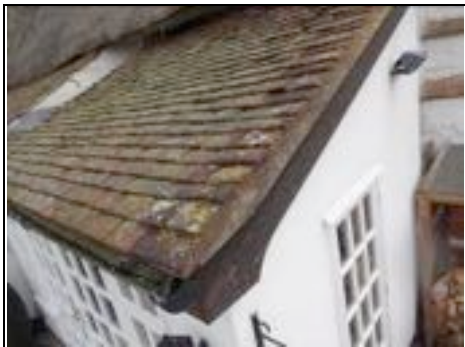
Spalling to tiles
~ Aerial View - 360 Photo ~

ACTION REQUIRED: Please see our comments in the Executive Summary.

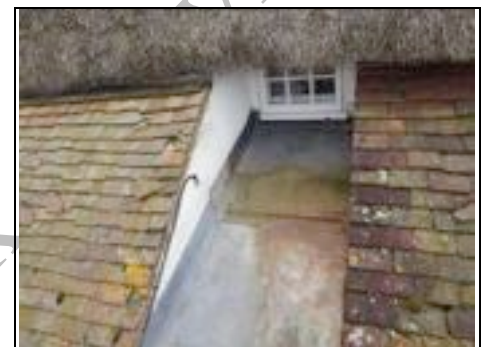
Lead valley to bathroom window
~ Aerial View - 360 Photo ~

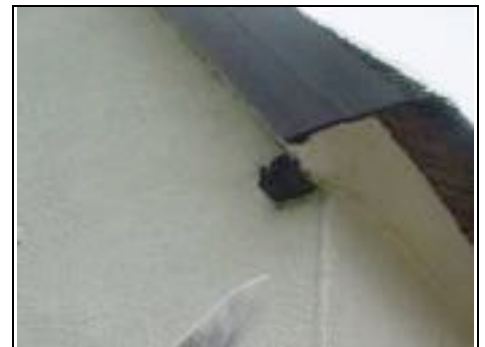
Purlins can be seen protruding out of walls which can lead to rotting

Further investigation is needed as we can see that metal brackets have been used to the left hand side roof and also in the walls structure below.

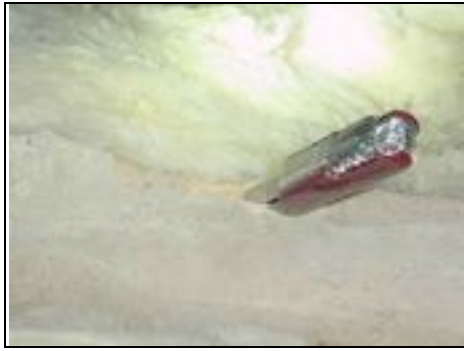
Woodworm/rot in timer in middle roof where it meets left roof

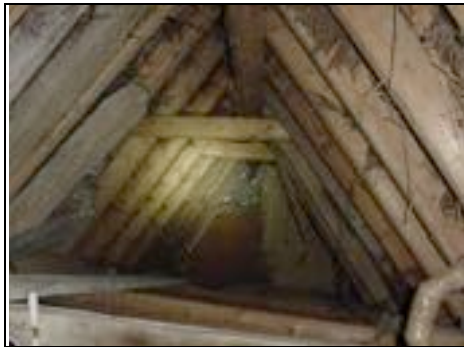
Most of timbers replaced in main part of roof

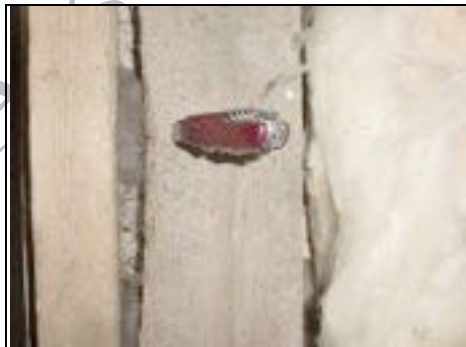
Woodworm

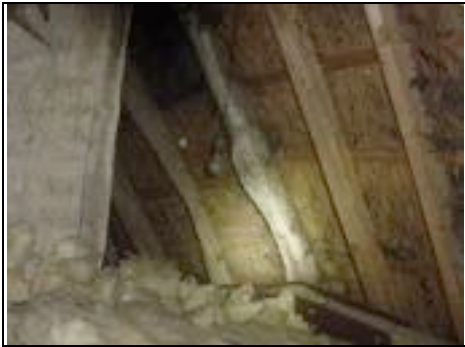
New and old timbers

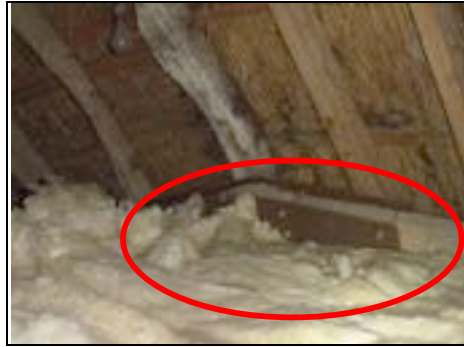
Brace at base of timber

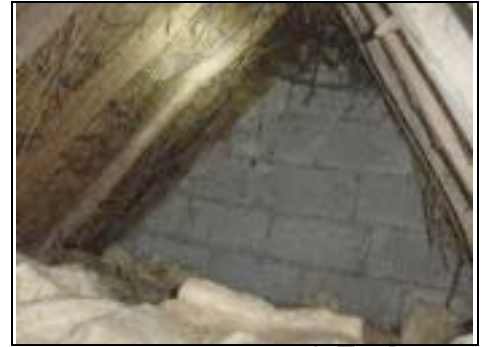
Stonework or blockwork?

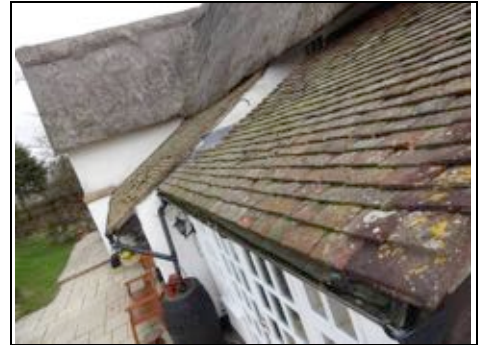
There are no gutters and downpipes to the thatch, they are only present to the tiled area which are plastic gutters and downpipes. Our concern always with gutters and downpipes on older properties is that they may be discharging into the ground nearby and causing dampness as traditionally they discharged on the ground.

Gutters and downpipes to tiled roof

ACTION REQUIRED: We would recommend you stand outside the property next time it rains heavily and see how well the drains cope with the rainwater particularly looking at the guttering and the joints and where they discharge onto the ground.

We also recommend that the gutters and downpipes are cleaned out, the joints are checked and the alignment checked to ensure that the gutters fall towards the downpipes.

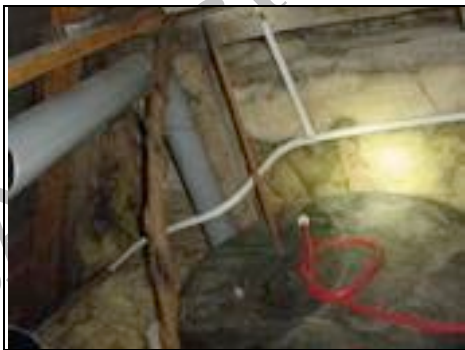
The property has a plastic cast iron soil and vent pipe.

Soil and vent pipe

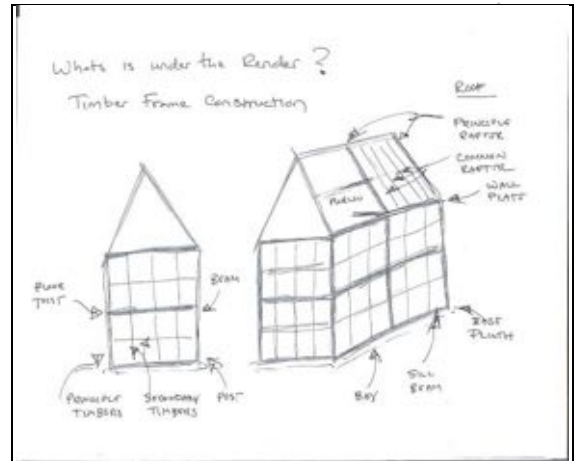
The walls are finished in a painted roughcast render; we cannot be 100 percent certain onto what. We would normally expect a timber structure throughout in older properties although in stone areas it is common to build in stone if it is readily available. It is often known as vernacular architecture where you build with local materials.

What is under the render?

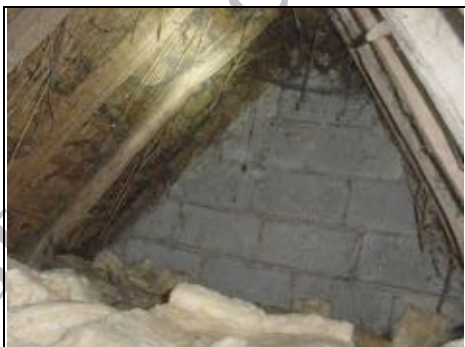
From the hollowness when we carried out our tap test to the centre of the property we do believe the majority of this is timber framed however to the left side of the property we are not completely sure of the construction particularly as within the roof we have seen what looks like stonework or blockwork (we could not physically get into this roof as we were not happy that the timbers would take our weight particularly bearing in mind the metal bracing that we could see and there was no direct access into it). However, we will first of all assume that the property is timber framed and discuss this.

Stonework or blockwork?

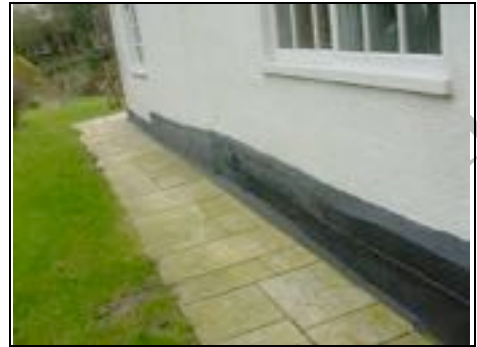
Stone or brick base

Unfortunately, the render is not appropriate for this type of construction. A cement render has been used rather than a lime based render indicating that it has been replaced in recent times. It is very common to replace lime base renders in the post war period up until around the 1970's when we started to understand the damage that it can cause.

The question that we always ask of these is how much damage the cement render is doing to the timber frame. We do believe in this instance that there is movement in the property and a considerable lean on it so it is well worth carrying out investigations.

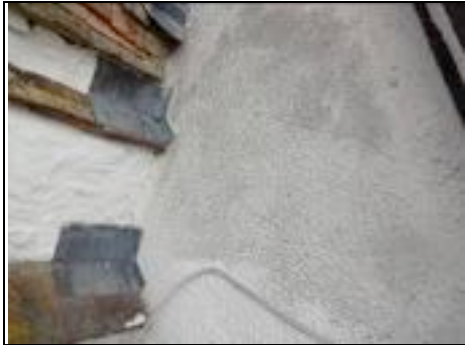
Hairline cracking to right gable
~ Aerial View - 360 Photo ~

We would remind you that any hairline cracks that appear need to be sealed as soon as possible to stop dampness and water getting in.

ACTION REQUIRED: Please see our comments in the Executive Summary.

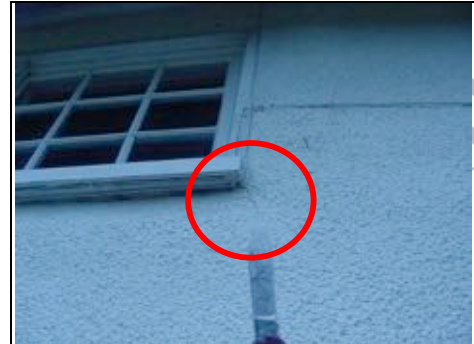
Cracking

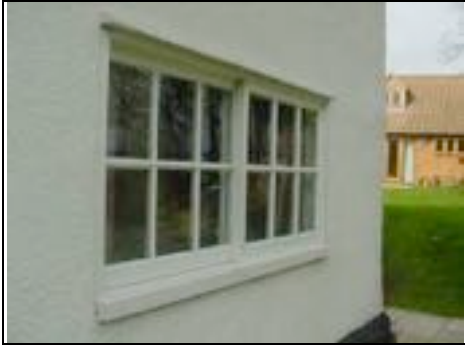
The property has timber single glazed windows with secondary glazing, many are horizontal sliding sash otherwise known as York windows. We noted rot to one of the windows.

York windows

ACTION REQUIRED: General repairs and easing and adjusting of the windows and doors.

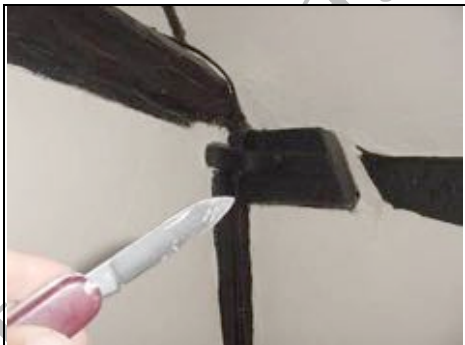
The infill panels can be made from a mixture of materials such as lime plaster or replaced as in this case we believe with a modern plaster.

Infill panel with metal brace

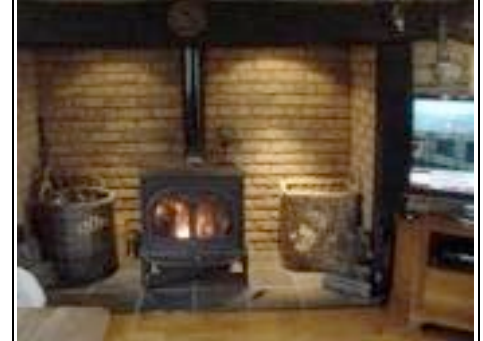
At the time of the survey the chimney was in use and burning brightly. We spoke to the owners about this and they advised that they had lined the inside of the chimney with brickwork which we would be surprised if the Conservation Officer was keen on this and they may well when reviewing the whole property when they look at the thatched work and comment on this. Generally, it would be argued we feel that a stone chimney should have a stone inner. As with lots of things in this property further investigation needs to take place.

Ingenook fireplace

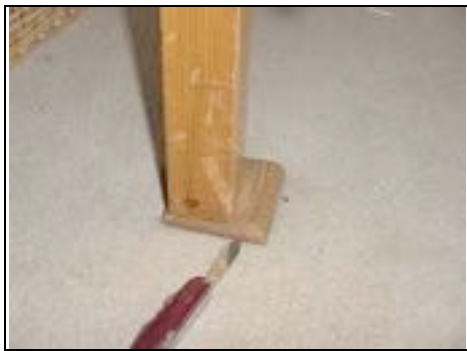
Floor undulating

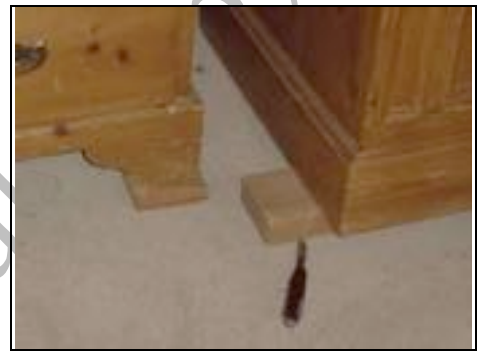
Floors undulating

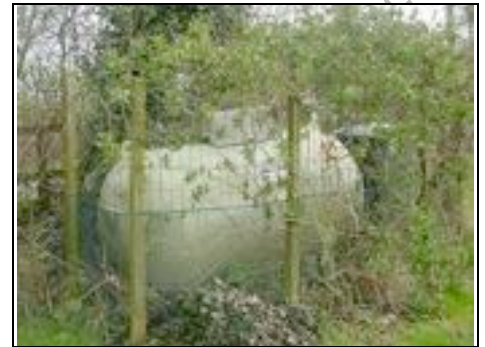
The property has propane gas. There are wood burners as well; we are not sure whether these are multi-burners or not.

Propane gas

ACTION REQUIRED: As a matter of course it is recommended that the entire gas installation is inspected and made good, as necessary, by a Gas Safe registered contractor. Thereafter the installation should be serviced annually.

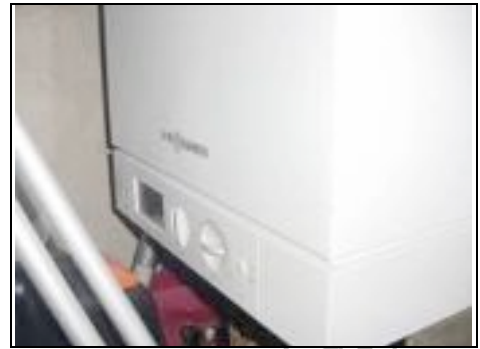
The boiler is a model that we rarely come across so it may be difficult to obtain spare parts.

Our limited inspection of the hot water and central heating system revealed no evidence to suggest any serious defects but we would nevertheless recommend that the system be tested and overhauled before exchange of contracts and that a regular maintenance contract be placed with an approved heating engineer.

Viemann Boiler in services room

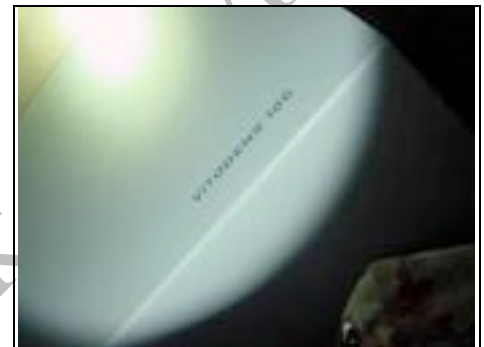
Model type - Vitodens 100

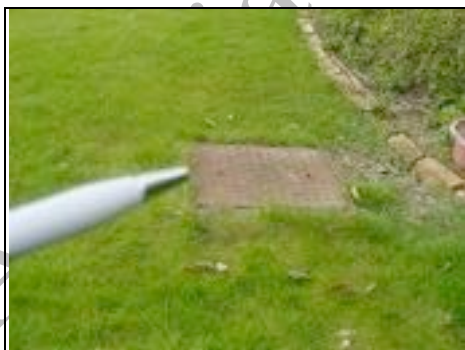
We duly lifted the cover and found it to be free flowing at the time of our inspection. From what we could see it is concrete built.

Manhole adjacent to garage

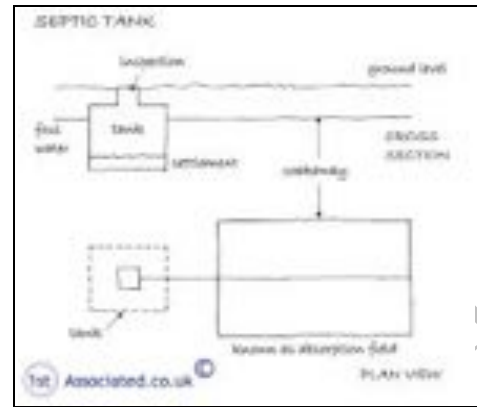
Septic tank

We have been unable to determine the adequacy of treatment or the effectiveness of the disposal arrangements. The surface water discharges onto the ground.

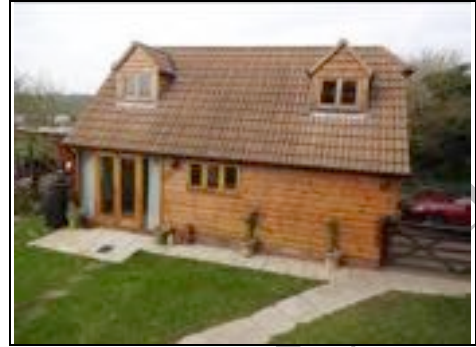
It was noted that the windows to the garage would benefit from re-staining.

Double garage and annexe
~ Aerial View - 360 Photo ~

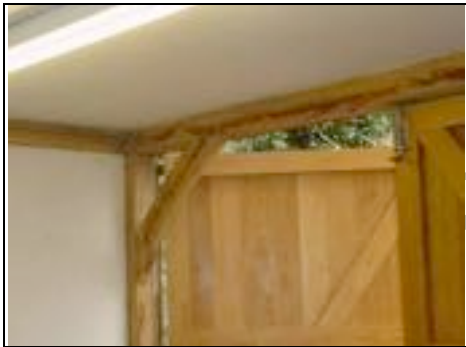
Dampness coming into garage

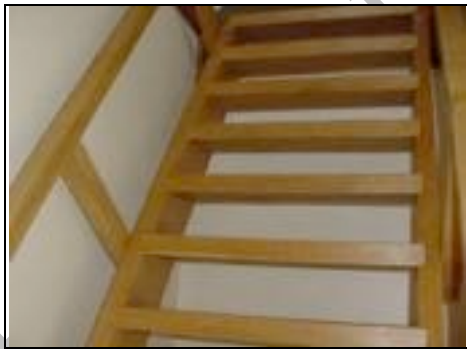
Steep steps

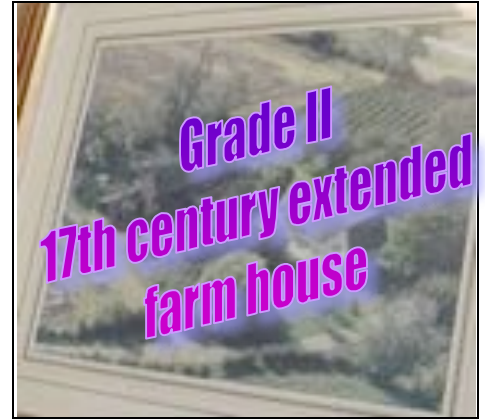
During our question and answer session with the owners we were advised about the barns that fell down which have now been replaced with the garage and annex and the office area. In our experience it takes a lot for these type of barns to fall down.

Barns that no longer exist

We would recommend you speak to the Listed Building Officer with regard to this property to see if they have a photographic record of its condition as many local authorities do have. It will then be worth comparing this against the condition and way the building presently is, as we do feel a lot of alterations and amendments have been carried out.

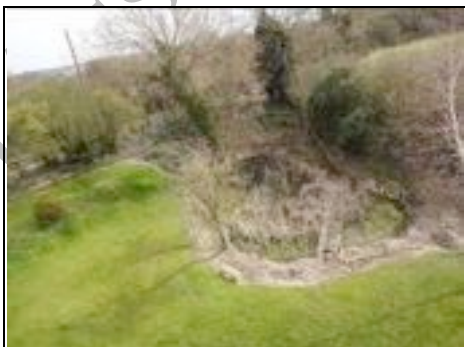
The property surrounds the building and there is a pond. It is on a quiet steep sloping site although it doesn't feel as if it is and is very well landscaped. There are a number of trees; please see our comments in the tree section.

Garden on sloping site
~ Aerial View - 360 Photo ~
