RESIDENTIAL BUILDING SURVEY

**Newbury
Berkshire
RG14**

Mr H

INDEPENDENT CHARTERED SURVEYORS

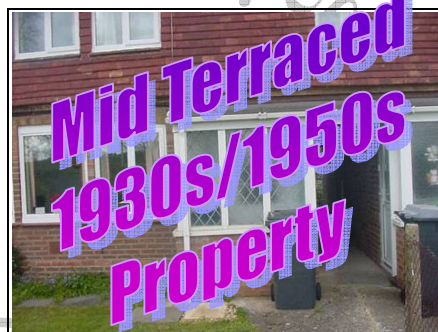
More a point of information than bad – do you have a flying freehold? We have noticed that you seem to have the area over the top of the alleyway; sometimes this is known as a flying freehold as you do not actually own the alleyway beneath as it is a shared right.

Room over alleyway

ACTION REQUIRED: Your legal adviser needs to check and confirm exactly what your rights, responsibilities and liabilities are with regard to this.

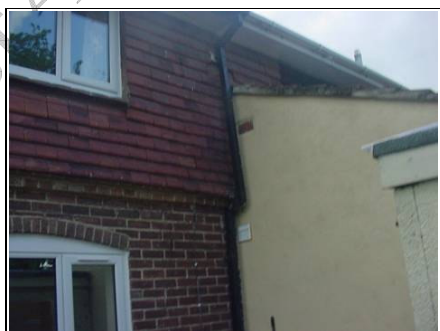
Again, more a statement of fact. Next door have extended on the boundary line; possibly over the boundary line, depending on where the boundary line is within the hedge. There should be a Party Wall Notice with this.

Next door's extension

ACTION REQUIRED: Your legal adviser needs to check that all Local Authority Approvals are in place and that a Party Wall Notice has been signed and agreed.

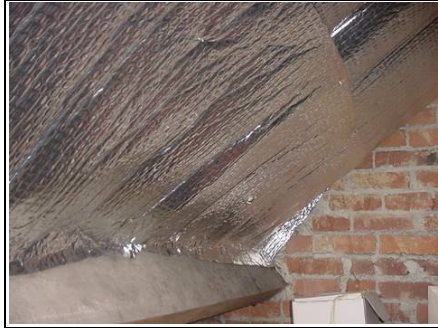
Many areas of the roof have been hidden with the DIY adding of different membranes.

A foil membrane

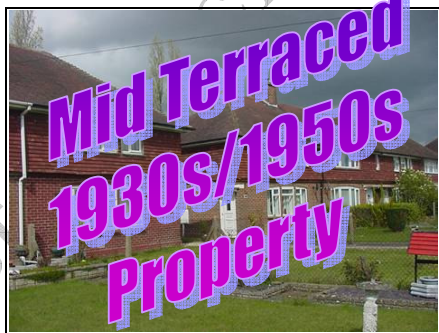
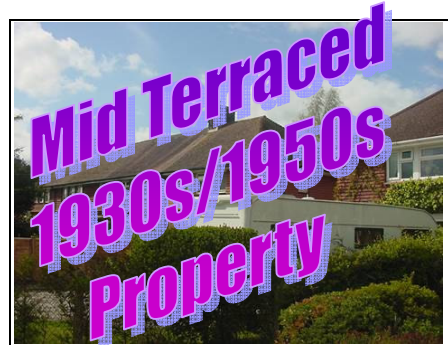
Having said all of that, not many of the nearby roofs seem to have been changed.

Nearby roofs

ACTION REQUIRED: we would recommend in this case that you consider what we call a stitch in time measure. This is to use a solid insulation board (which you can stand on) with a board over the top and fix this within the roof, thereby forming a storage surface and also an extra layer of protection within the building.

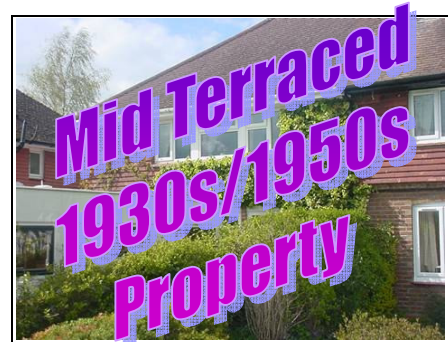
Next door has had a new roof

ACTION REQUIRED: We would recommend a roofer spends a day on your roof repositioning the tiles and making sure it is watertight for the winter (we would also get them to quote at the same time). You need to then carry out periodic inspections with this type of roof, and mend the roof as soon as any problems are noted. Please see our comments in the Executive Summary.

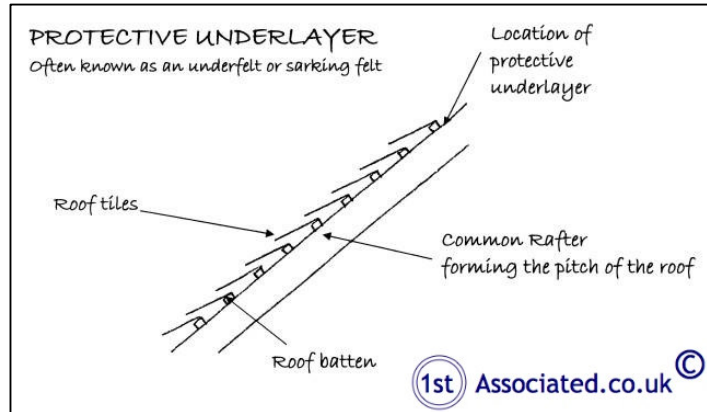
New Roof – Catch 22

We noted there is no protective underlayer. This means that wind driven rain can get underneath the tiles and indeed we can see that this is happening from the staining within the roof. We are always in a Catch 22 with regard to this type of roof as although it is letting in some rain water it is not letting in that much due to the protective foil and insulation membranes that have been put in place.

ACTION REQUIRED: Our view has been very limited by the stored items in the roof and the foil insulation and the bagged insulation. We would nevertheless say that we feel you should be budgeting for a new roof and that this should be reduced from the asking price. Please see our comments in the Executive Summary.

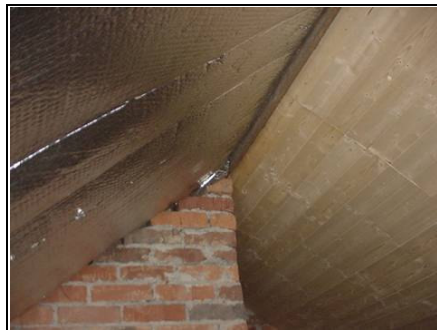
Foil insulation which has been put on at a later date

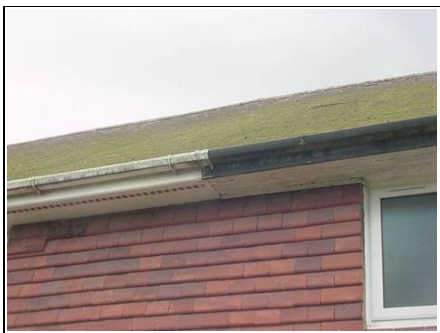
Vented soffit to left hand neighbour

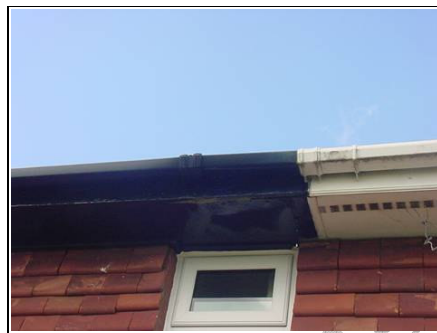
Vented soffit to right hand neighbour

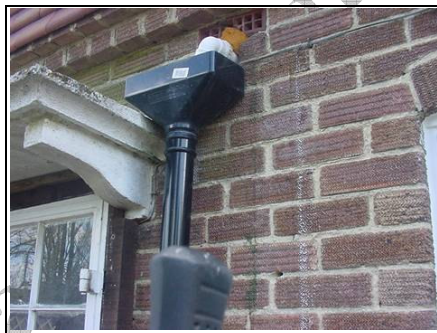
Overflowing hopper head

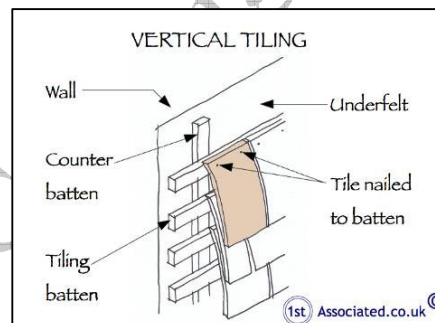
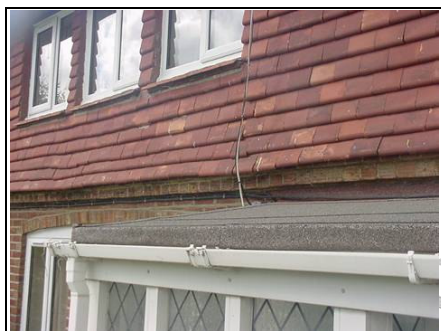
Vertical tiling

There is vertical tiling to the top half of the property in we believe a nibbed clay tile. There are a few tiles missing and displaced, as is often the case. The vertical tiles are feature of the look of this property.

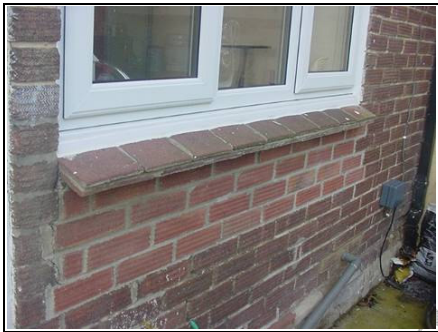
Brickwork amended under
kitchen window

Pen indicating minor hairline cracking where some work has been carried out around the rear kitchen window

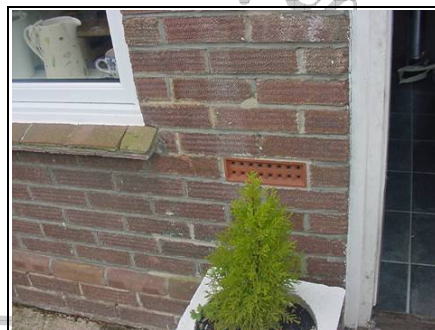
All modern properties should incorporate a damp proof course (DPC) and good building practice dictates that a differential of 150mm (6 inches) should be maintained between the damp proof course and ground levels. To the base of the property there was a thickening out which we believe is a DPC, although we could not physically see it.

Thickening out at base of property

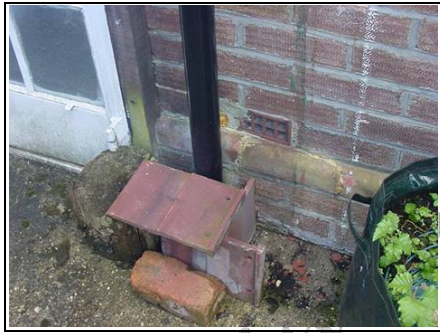
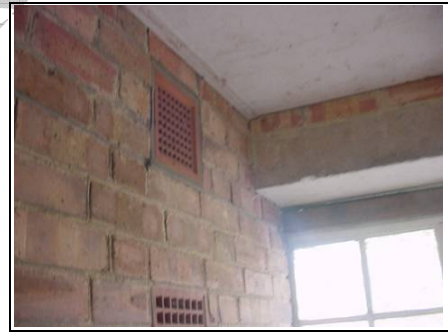
We noticed air bricks in the walls. In this era of property they were often added to help reduce condensation. As mentioned, please see our comments with regard to cold bridging, which is effectively condensation occurring on and in the structure.

Middle level air brick

High level air vent

ACTION REQUIRED: We recommend humidity controlled extra fans are used in the bathroom and kitchen to help reduce the amount of condensation in the property. Please see our comments in the Executive Summary.

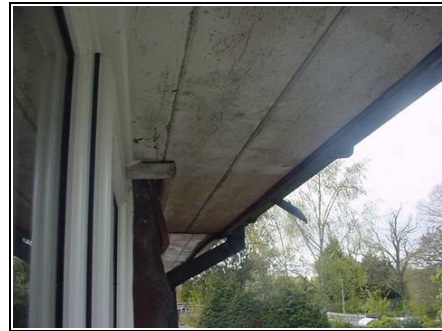
The fascias and soffits are painted timber and we would comment they are in below average condition for their age, type and style. More interestingly, we would comment that your adjoining neighbours have vented fascias and soffits indicating that they have been re-roofed and have a protective underlayer.

Close up of soffit

Note vented soffit on left hand neighbour's property.

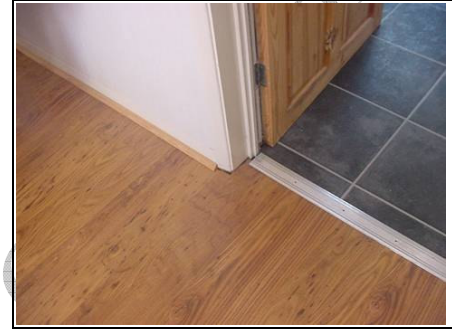
Quadrant bead not finished properly on laminate flooring

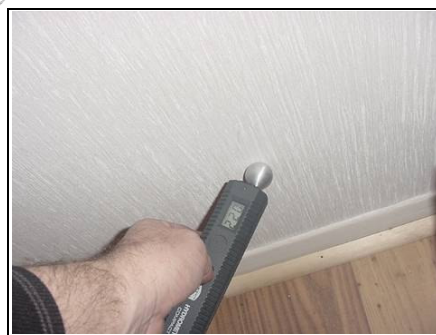
A visual inspection and tests with a moisture meter have been taken to the perimeter walls. In this particular case the damp levels were average for this age, type and style of property.

Testing for rising damp

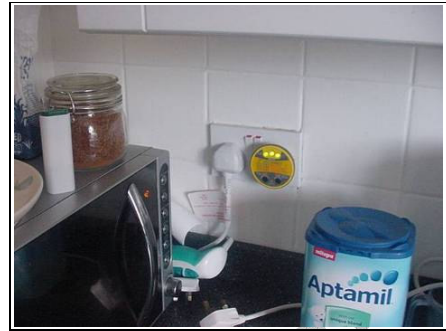
Earth Test

We carried out an earth test in the kitchen area to the socket point that is normally used for the kettle, this proved satisfactory.

ACTION REQUIRED: We would recommend that more socket points are added. As the property is changing occupancy an Institute of Electrical Engineers (IEE) test and report should be carried out by a NICEIC registered and approved electrical contractor or equivalent.

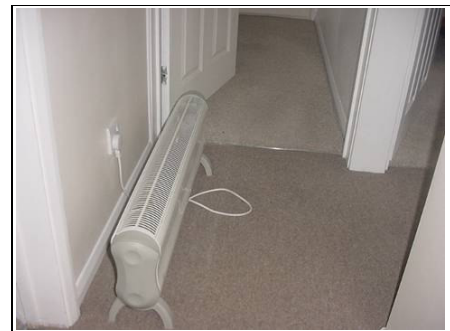
We noted some supplementary heaters.

Supplementary heater

ACTION REQUIRED: Please see our comments in the Executive Summary.

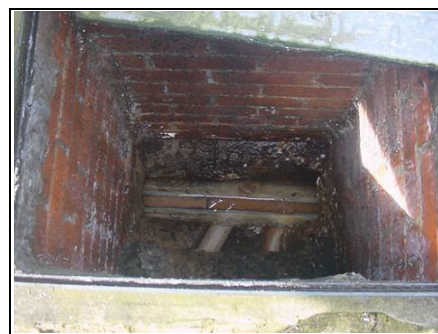
We duly lifted the cover and found it to be free flowing / blocked at the time of our inspection.

From what we could see it is brick built.

Manhole to rear right hand side

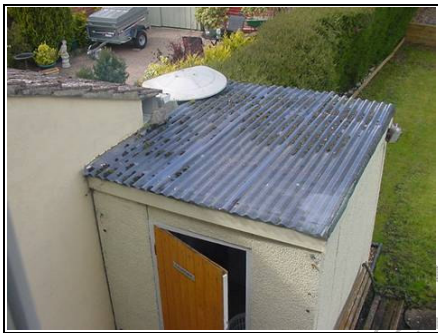
There is a single outbuilding which is a prefabricated concrete construction, with what looks like a corrugated roof, although from our experience these often have asbestos roofs.

Prefabricated outbuilding

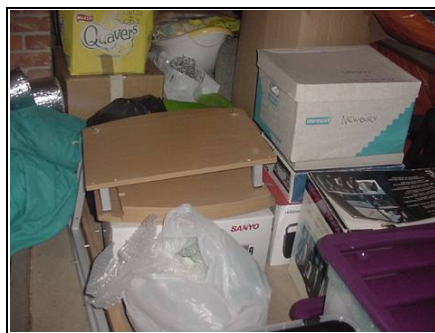
1. The mass of stored items in the roof space and the foil and insulation in a bag that has been fixed to the roof pitches.
2. We also have not opened up the ground floor or the first floor.
3. We did not have the benefit of meeting you at the property to talk about your specific requirements.

Mass of stored items
