RESIDENTIAL BUILDING SURVEY

XXX
XXX
Clophill,
Bedfordshire
MK45 XXX

FOR
Mr X

INDEPENDENT CHARTERED SURVEYORS

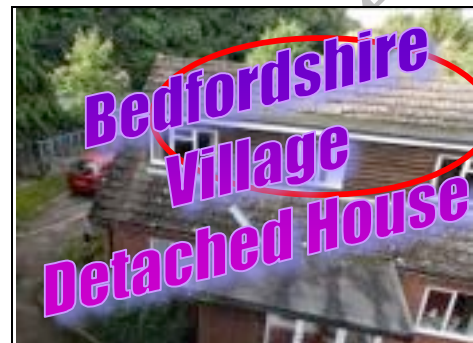
At high level a number of concrete tiles have been displaced and some of the battens that we could see had rotted through.

Concrete tiles have come away

ACTION REQUIRED: The protective underlayer, the battens and the concrete tiles need replacing as soon as possible to make the property watertight and also the concrete tiles surface is starting to deteriorate where moss has been sitting on them for some time.

We would recommend that you budget for replacement of the roof. We would recommend you use a lighter weight roof tile such as a tile (subject of course to manufacturer's recommendations, etc.)

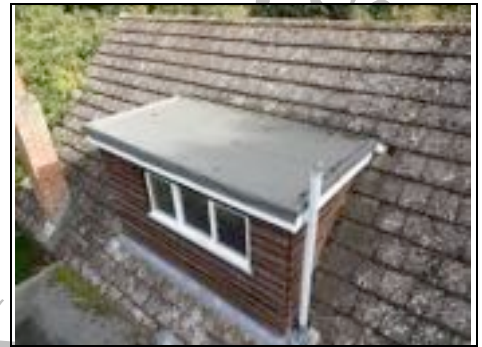
Rear dormer

The flat roofs have a problem, they seem to be discharging towards the building rather than away from it. It is very difficult to be certain, you really need to see the roofs when it is raining. You also need to have already carried out basics such as clearing the moss from the pitched concrete tile roof, clearing the gutters, etc. and giving the surrounding trees a trim back would help.

High level dormer roofs front and rear

ACTION REQUIRED: Ultimately we recommend re-roofing with an insulated roof that is cut to falls towards the gutters. The mineral felt that is present looks relatively new, we think the leaks that can be seen inside may be either old leaks or what is known as cold bridging which we explain more about later on.

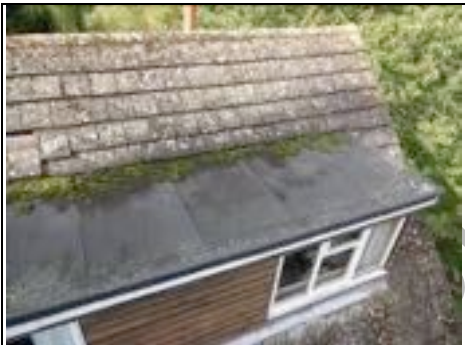
Moss sitting against pitched roof to front dormer

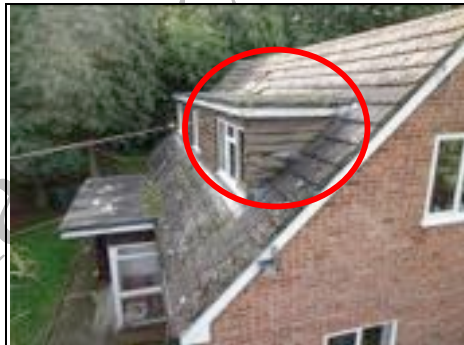
Flat roofs
Timber cladding rotting and coming away on dormer

ACTION REQUIRED: A lot of the timber is probably saveable although whether it is worth saving we would question and it may be more economical to replace in some areas.

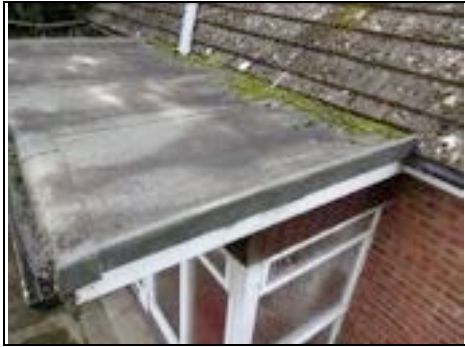
Flat roof over entrance

Again, with the low level flat roofs moss is sitting against the tiles. It may be moss that is coming off the roof or it may be that the flat roofs discharge backwards. We also noted hairline cracking and staining beneath these roofs which does indicate there has been leaks, whether these are old leaks or not is difficult to say as the mineral felt above looks relatively new.

ANTICIPATED COST: For new roofs with insulation known as warm roofs (please see sketch) £1,000 - £2,000 per roof plus scaffolding if required; quotations required.

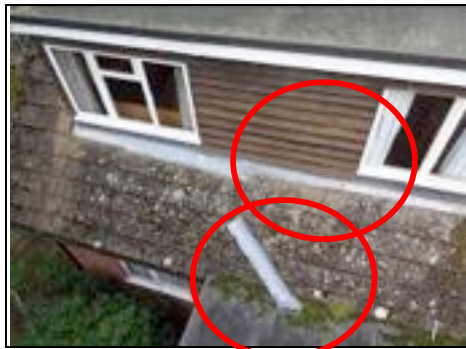
Whilst the building may look reasonably standard construction from the outside you need to appreciate in the front and rear that there is a timber frame construction and as such there is very little between you and the outside world. There was an area where the lead had come away and this was a section that we opened up. The section we opened up did not have any insulation so it is likely that the whole of the building does not have insulation and will be very inefficient energy wise.

Area we opened up
Lead come away

ACTION REQUIRED: Consider adding insulation to the property but be aware that it can cause interstitial condensation. This is very important in a property where there is a large element of timber construction.

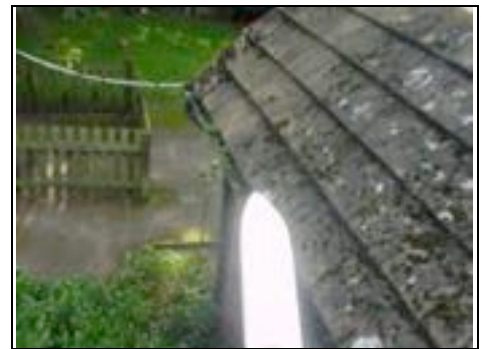
A house such as this has the advantage of having lots of mature trees around it which will help give you shade and dry out the land (which in this instance is fairly wet) but also they will have the disadvantage of cutting out some light and also leaves and branches forever falling onto the roofs and getting in the gutters and also moss growth.

Gutters full of vegetation

ACTION REQUIRED: A constant maintenance of the trees and also clearing of branches and leaves. There are various sorts of gutter protectors but we personally do not think there is anything as good as actually getting humans to clear out the gutters.

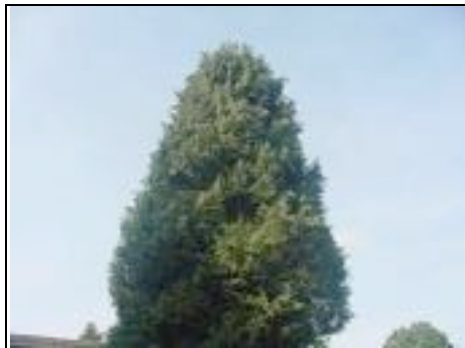
The trees look to have been left unmaintained and unmanaged for a long time. Having said that, the trees are also doing the job of removing a lot of the ground water and holding the ground together.

Large trees

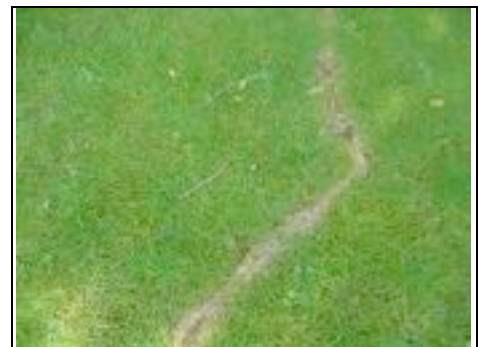
Roots showing through the grass

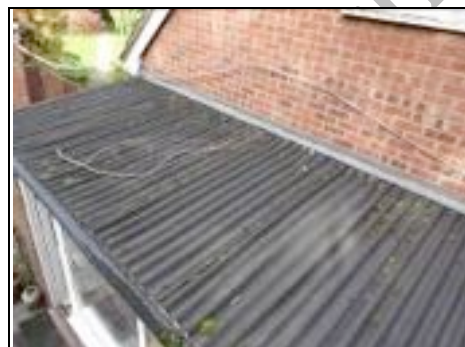
We are not one hundred percent certain whether or not there is asbestos to the lean-to on the left hand side of the property. We believe it is a modern replacement corrugated asbestos style material but we cannot be one hundred percent sure. We can see there is asbestos stored near the oil tank.

Possible asbestos roof

ACTION REQUIRED: The only way to be a hundred per cent certain with regards to Asbestos in a property is to have an asbestos survey carried out by a specialist asbestos company.

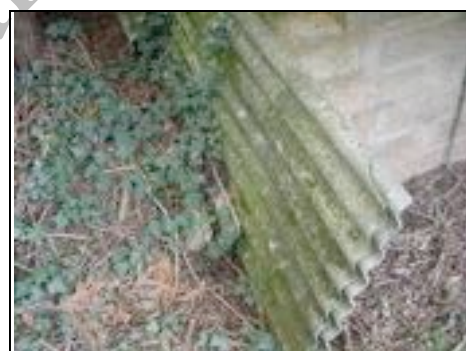
Asbestos

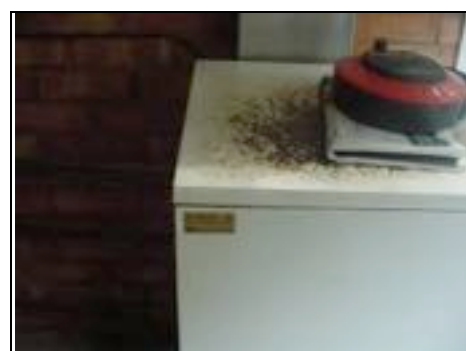
The boiler looked relatively old. Any information obtained from the owners and/or the company that maintains it would be a benefit.

Boiler

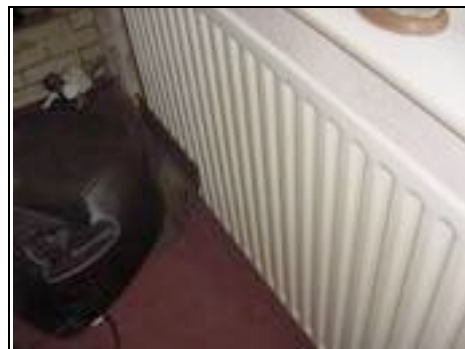
We also noted that lots of the radiators were single panel. We would recommend these are upgraded to double panel convection radiators.

Single older style radiators

ACTION REQUIRED: Upgrade to a modern double panel convection radiator.

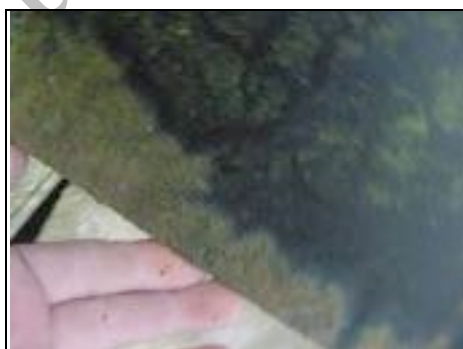
There is a metal oil tank without a bund wall which can cause problems if there is an oil leak. We can see rusting starting to occur to the metal container. You need to periodically check this particularly to the base.

Oil tank rusting

ACTION REQUIRED: We recommend you budget for a replacement oil tank; the sooner the better.

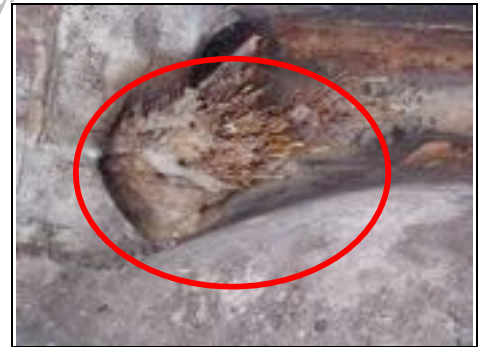
There is what looked to be roots in the drain to the front right hand side manhole.

Roots in drain

ACTION REQUIRED: We would recommend a closed circuit TV camera report of the drains.

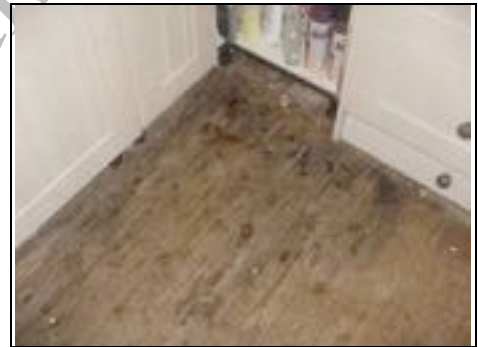
Ground floor

There is more deflection to the ground floor than we would expect. In this particular case it could be due to dampness getting into the suspended timber floor, either the supporting timbers or the ends of the joists, or it could given the conditions also be woodworm or even there is an outside chance of wet rot. It is very difficult to tell from the surface that we could see (from the kitchen).

ACTION REQUIRED: We recommend that you have a section opened up by a carpenter and photographed and then we would be more than happy to comment.

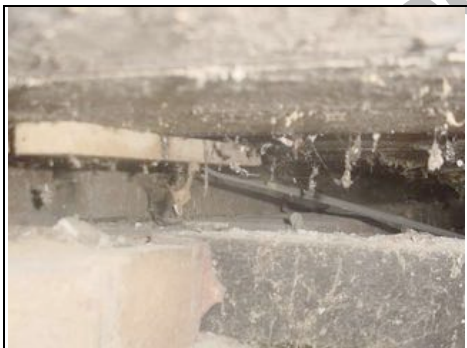
Cobwebs underneath floor
indicating it is dry-ish. New piece
of timber which are often added
when floorboards are lifted for
putting in central heating and
wiring

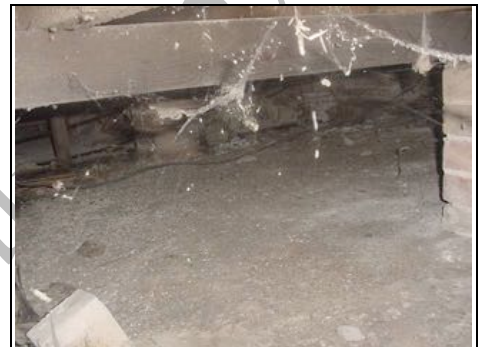
Looking to right side of property we can see brick piers and darker areas which indicate some dampness is getting in.

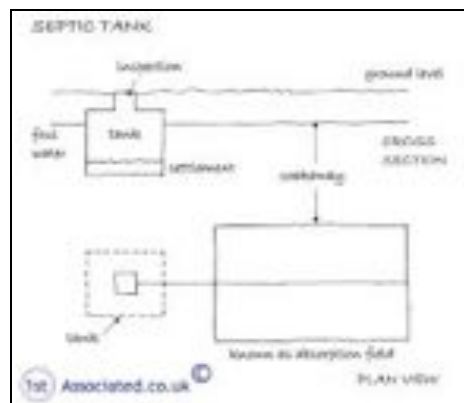
Septic tank

The property has a septic tank. There are various different forms of septic tank from the container type septic tank to ones that feed into the ground; we do not know which system this is.

ACTION REQUIRED: You should make enquiries with the owners as to what system this is.

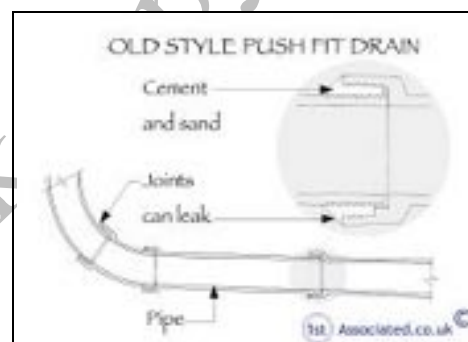
In older properties, such as this, drainage was often push fitted together rather than bonded together which means that they may leak over the years.

Whilst we have lifted two manhole covers and one septic tank the only true way to find out the condition of the drains is to have a closed circuit TV camera report to establish the condition of the drains. In this age of property there have often been leaks over the years.

Push fit drains

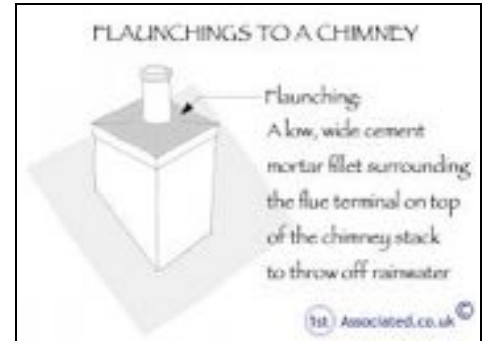
Flaunching

Unfortunately we were unable to see the top of the chimney properly known as the flaunching, we therefore cannot comment upon them.

ACTION REQUIRED: Periodically inspect the chimney.

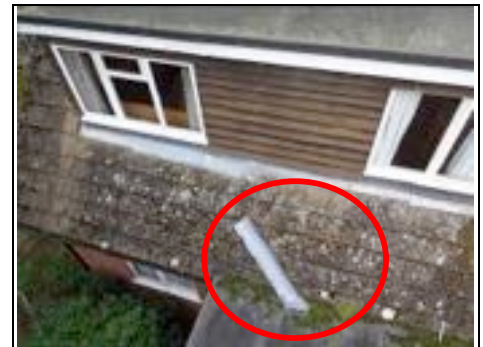
Again, this is a pitched roof clad in concrete tiles. The lead flashing has come away.

Lead has come away to front

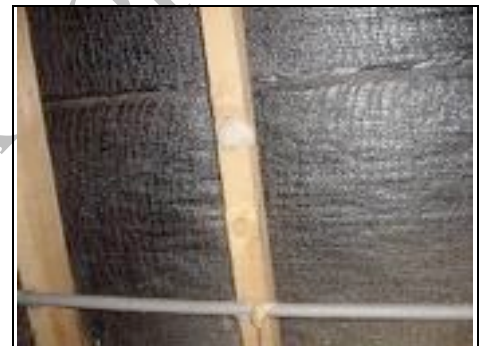
When we inspected the loft space we found a Hessian base Bitumen membrane. This type of membrane has been used since the 1960s. We generally found it to be in average condition, with damage in some areas which is what we typically find.

This photo shows the common rafters (the ones that form the pitch of the roof) and the dark area between is the underlayer.

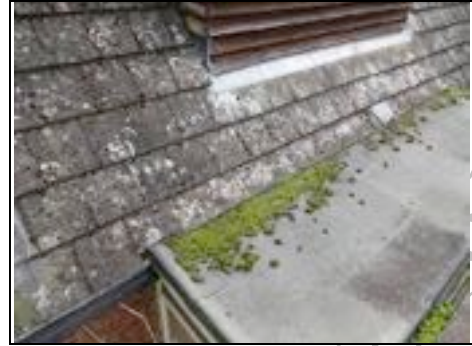
Moss sitting on roof

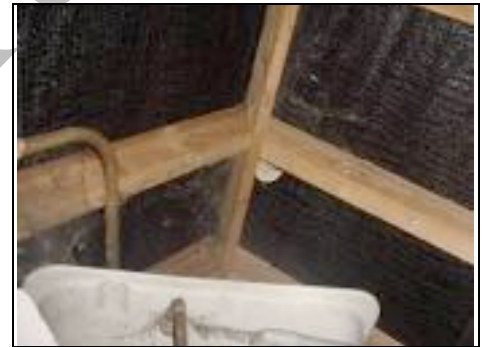
There looked to be a wasp's nest to the rear of the bathroom roof.

Old and new wasps nest

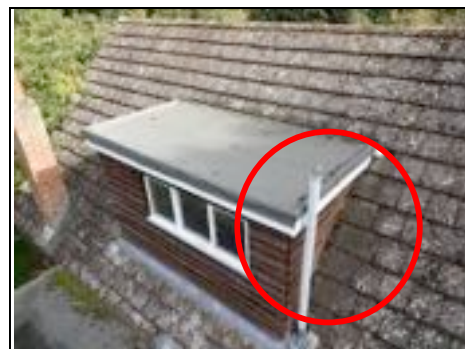
Soil and vent pipe

The property has plastic soil and vent pipes.

There should also be a soil and vent pipe to the downstairs cloakroom.

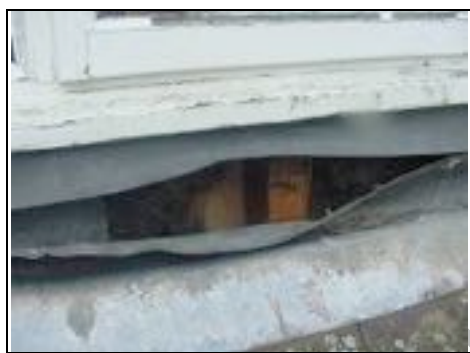
The property has a timber frame structure to the front and rear.

Exposed part at front of property
shows timber frame

ACTION REQUIRED: Please see our comments in the Executive Summary.

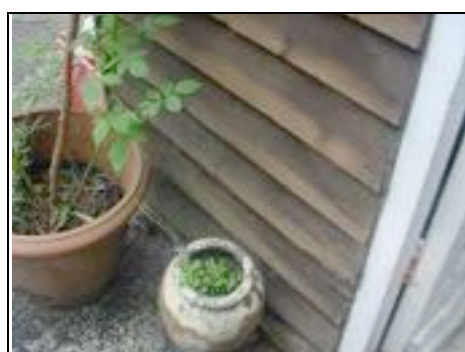
Parts of the property are clad in shi lap boarding which is weathered and in need of redecoration.

Weathered shi lap boarding

ACTION REQUIRED: Secure and redecorate. In some areas it will need replacing.

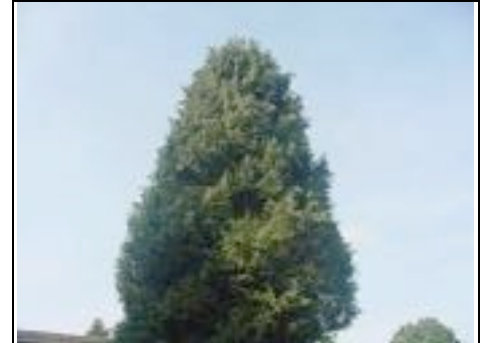
There are trees within what we would term as influencing distance.

Large trees

ACTION REQUIRED: You need to speak to an arboriculturalist (not a tree surgeon but a tree specialist) and have a ten year plan with regard to the trees. This is not something to be carried out by an amateur. Please see our comments in the Executive Summary.

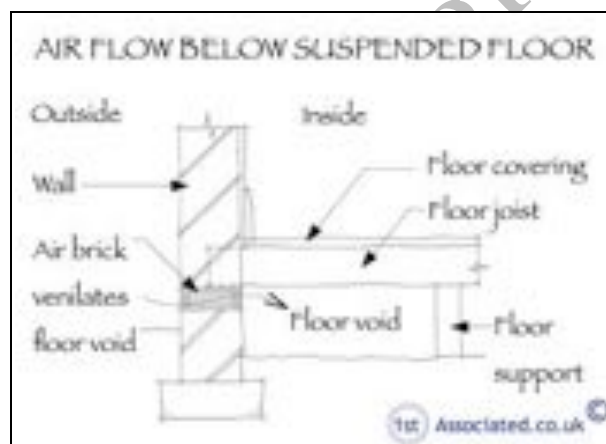
Air bricks are essential to have a through flow of air as this helps to reduce the chances of wet rot, dry rot and woodworm. In this case there are no airbricks.

Suspended timber floor

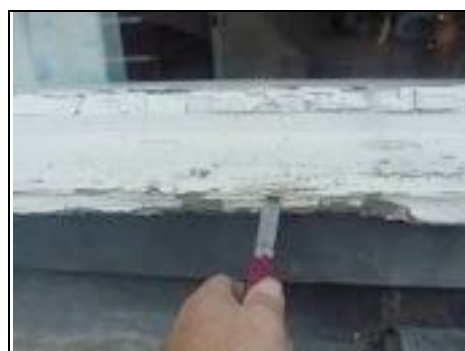
We have tested the windows by pushing a screwdriver into a random selection. We generally tend to do the lower windows as access is easier.

Knife test to windows

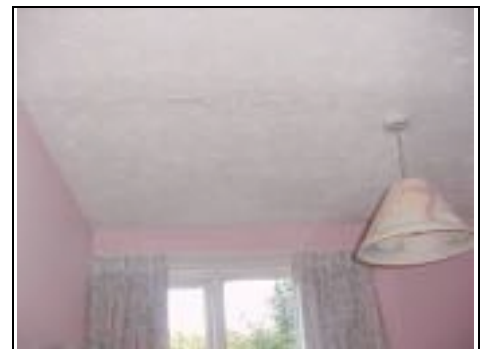
There are a mixture of different styles of textured paint including some older textured paint, commonly known by its trade name as artex which can hide defects and has an outside chance of asbestos; we cannot be 100% certain.

Textured paint

Our insurance company requires us to advise we are not asbestos surveyors and advises us to recommend asbestos surveyors are instructed and that you have your own asbestos survey carried out.

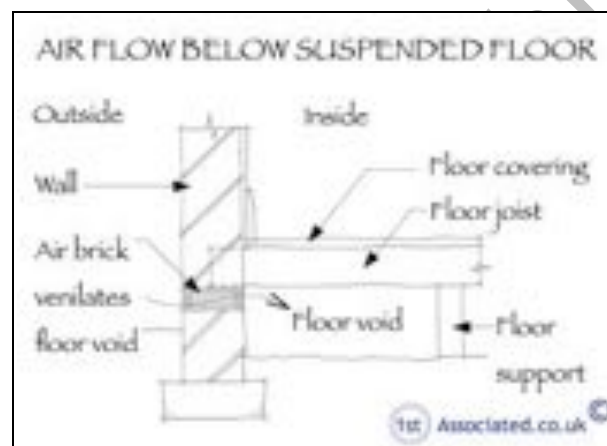
Deflection was noted to the floors.

The floor has been opened up in two areas; please see our specific comments in relation to this in the Executive Summary. We would have liked the floor to be opened up in different areas and larger openings.

Suspended timber floor

ACTION REQUIRED: Please see our comments in the Executive Summary.

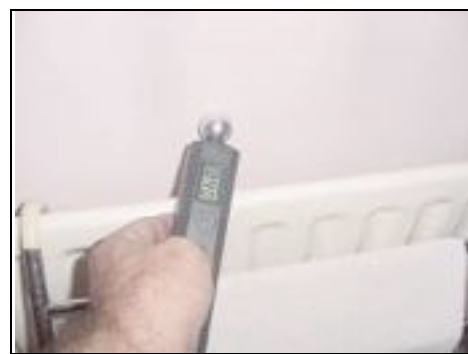
We used a resistance meter on the external walls.
We have not found significant dampness.

Testing for lateral dampness

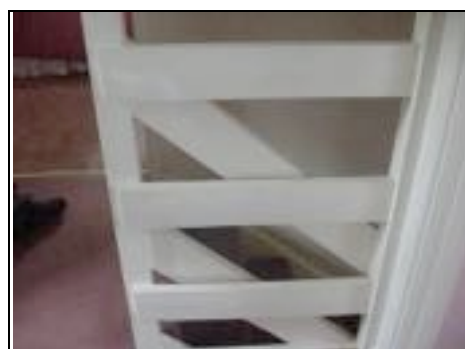
Balustrade needs redecoration

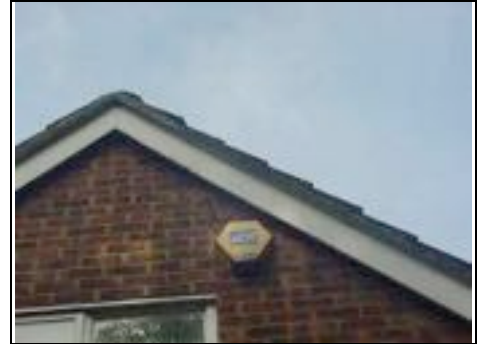
The property has an alarm box but we did not note an alarm internally. A good alarm system should not only help reduce break-ins but also help reduce your insurance. We are not experts in this field and therefore cannot comment further.

Alarm box

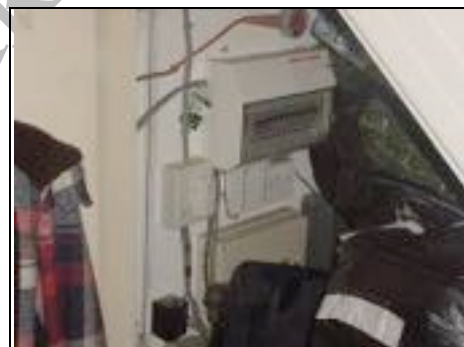
The electric fuses and consumer units were located under the stairs. The fuse board looked 1970's/1980's and better are now available.

Fuse Board

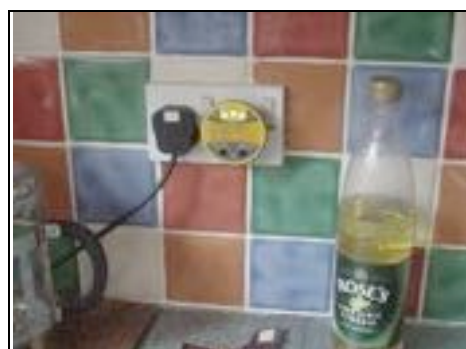
We carried out an earth test in the kitchen area to the socket point that is normally used for the kettle, this proved satisfactory.

Earth test

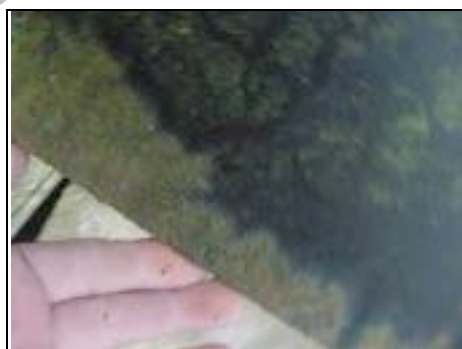
Oil tank rusting

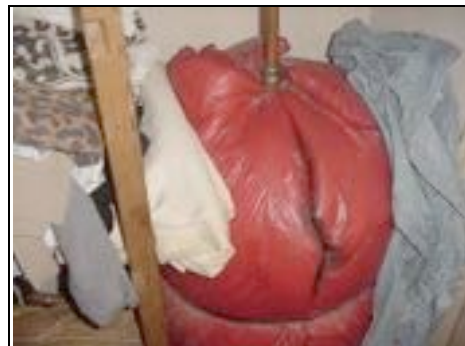
The hot water cylinder has an insulation jacket rather than factory lagged which indicates that it is relatively old. This cylinder will therefore not have the same thermal properties as a modern factory insulated cylinder. The problem with these is that they can leak at any time.

Older style hot water cylinder

ACTION REQUIRED: We recommend replacement with a modern insulated hot water cylinder. You should at the very least budget for a new one.

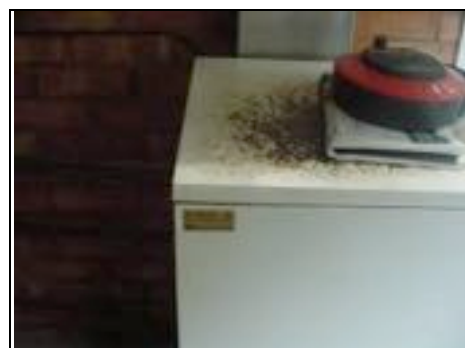
The boiler was located in the entrance area/office on the ground floor. We have been advised the boiler has been there over thirty years.

Boiler

ACTION REQUIRED: Budget for a new boiler. Please see our comments in the Executive Summary.

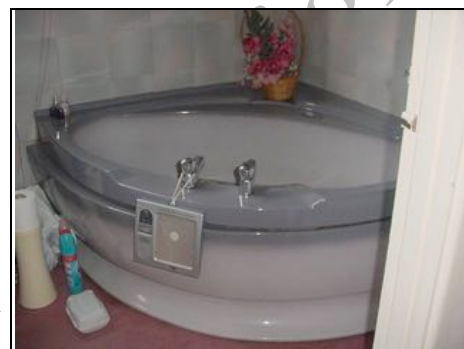
The property has a four piece bathroom suite, consisting of a bath, shower, wash hand basin and WC, which looks dated. We would comment that any colour bathroom suite but white (or close to it) tends to date fairly quickly.

Grey bathroom suite

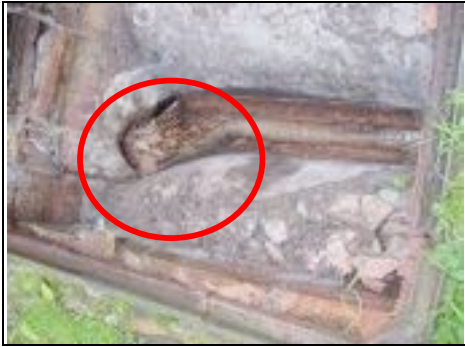
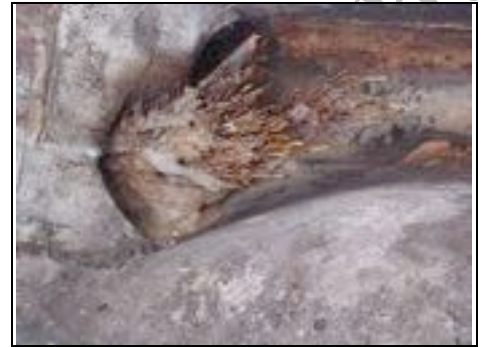
Front right drain

We duly lifted the cover and found it to be blocked with tree roots at the time of our inspection.

Roots in drain

ACTION REQUIRED: Please see our comments in the Executive Summary.

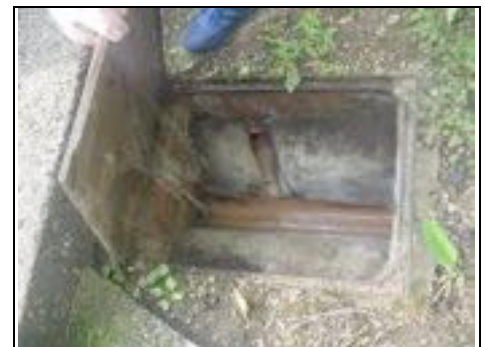
Manhole rear right

We duly lifted the cover and found it to be clear at the time of our inspection.

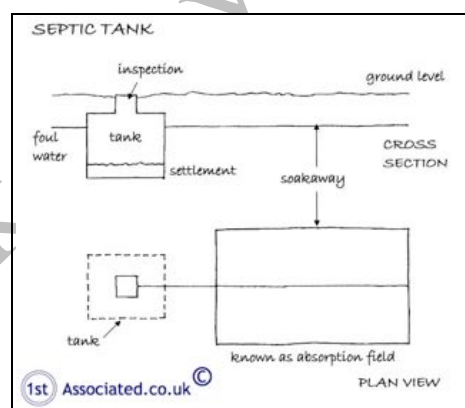
Septic tank

ACTION REQUIRED: Your legal advisor to obtain any details whatsoever with regard to installation of the septic tank. We normally find the best way forward is to contact the cleaning company which in this case we are advised are MW Cleaning Ltd who emptied it on 4th December 2014, their telephone number is 01525 405095. We suggest you have a chat with them. It is likely your demands will be greater than the original occupier that we believe was a lady living on her own, possibly with the other people living in the nearby static caravans.

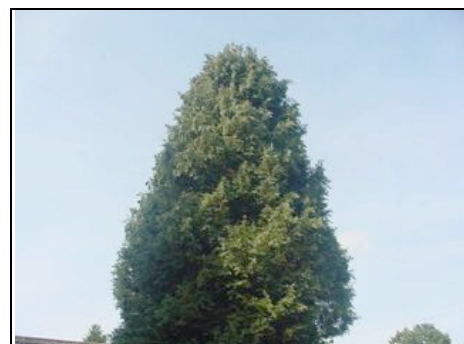
Some of the trees are relatively high and close to the building to the rear as well as of course the conifers to the front.

Large conifers

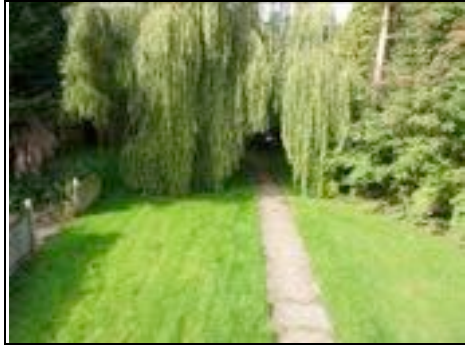
Willow tree to rear

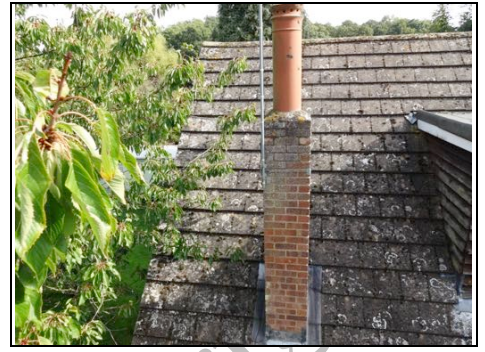
Trees high and close to building

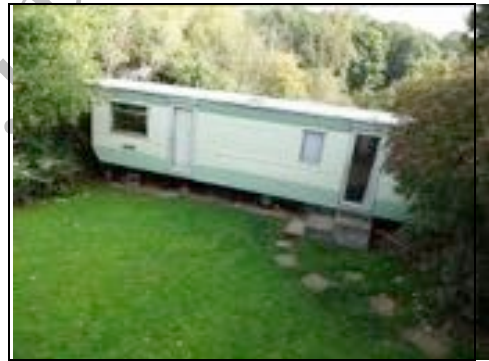
Caravan to front right side

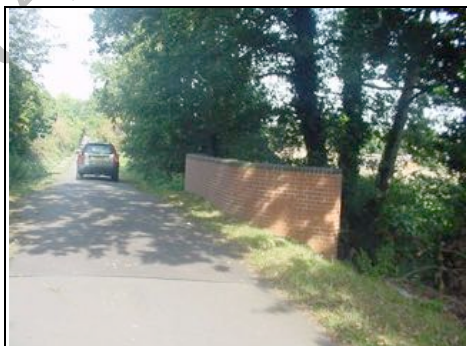
Bridge and road

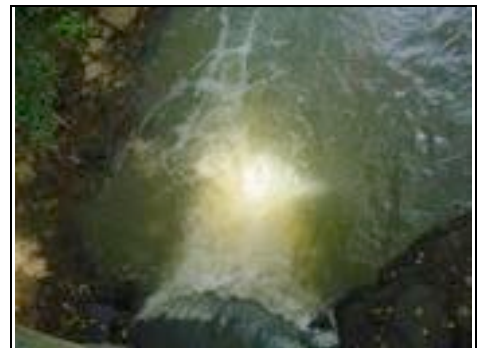
Fast moving river

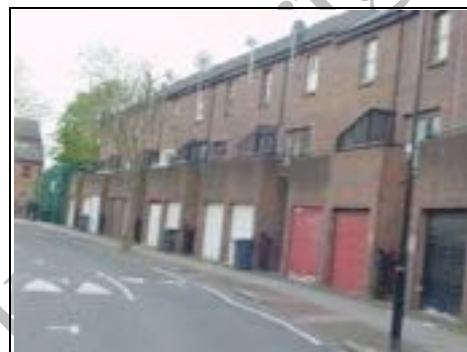
1960's properties built with concrete lintels that can cause Cold Bridging

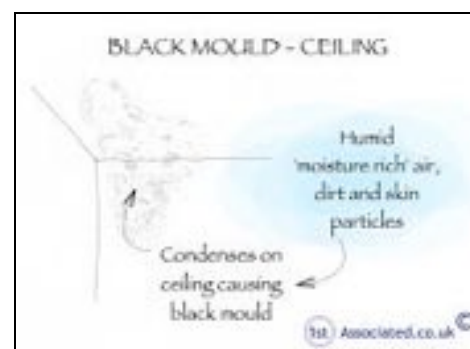
Mould to ceiling

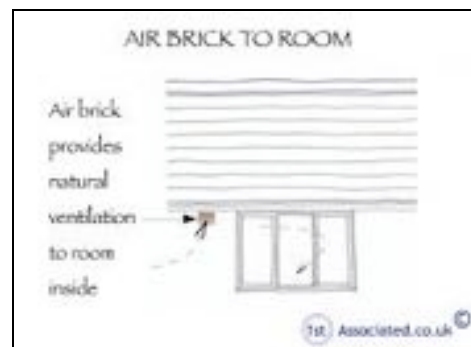
Air brick may not ventilate room enough

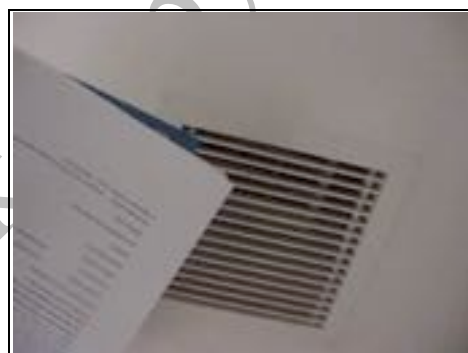
Testing the extract fan which in this case had poor extraction

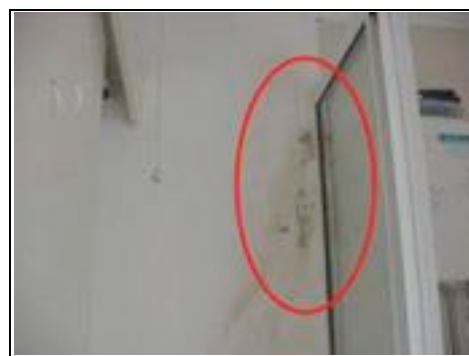
Condensation from a shower where a nearby window was never opened
