RESIDENTIAL BUILDING SURVEY

Ely
Cambridgeshire
CB6 XXX

FOR

Mr X

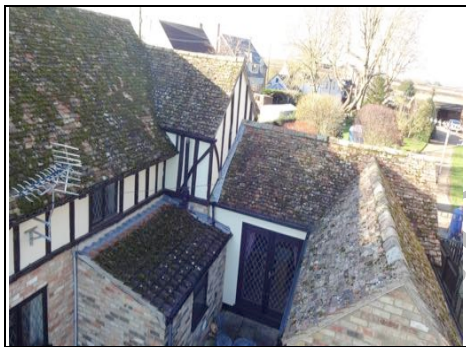
We can see that there is a heavy moss covering to the tiles which could cause deterioration and spalling to the tiles beneath. We are also concerned, given the roof construction that we can see, that there may be dips in the tiles that have been hidden by the sheer amount of moss on the roof.

General view of rear roofs

ACTION REQUIRED: We would recommend during the summer months using a soft brush to remove small areas of the moss to see the condition of the tiles. We would then, based upon this, either carry out an overhaul of the roof replacing damaged tiles, etc and leave watertight or it may be more economical and better in the long term to actually partly re-roof. It is difficult to comment further without further investigation.

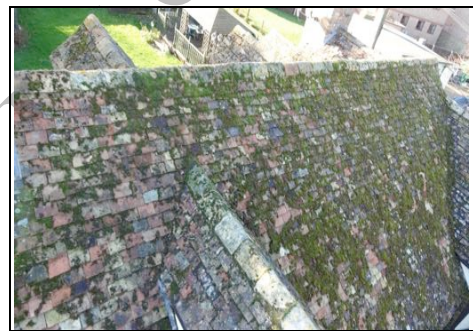
Rear right roof

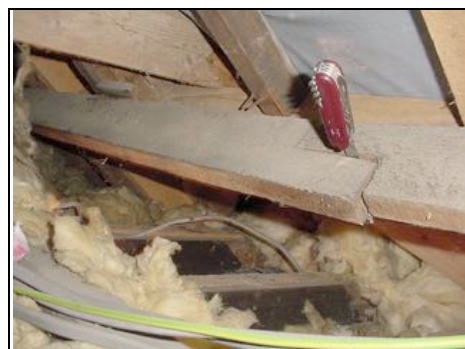
Purlin opening up

ACTION REQUIRED: Ultimately in the long term the entirety of this main roof will have to be re-roofed and at the same time we would recommend adding a new roof structure.

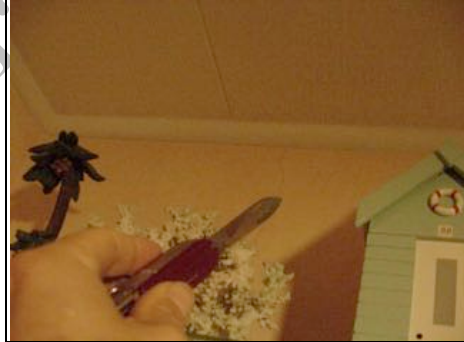
Crack in bathroom

ACTION REQUIRED: On reflection we feel that there is likely to be progressive movement. If you are happy to take on a building with movement a way of resolving it is for the existing owners to take out an insurance claim, advising that the cracking has been noted by a structural surveyor (this should cost them nothing other than time to write the letter). This usually means that the insurance company will carry out a monitoring exercise (the Building Research Establishment recommend monitoring any cracks for a minimum of one year) to establish if there is any progressive movement. Your future liability will be limited to the cost of the excess on the insurance providing the insurance company is happy for you to take over the insurance claim.

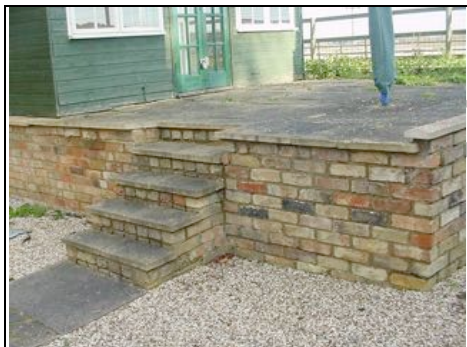
Retaining wall

There is a good sized retaining wall to help level out the rear of the property. We did note that the retaining wall does not have weepholes.

ACTION REQUIRED: Add weepholes.

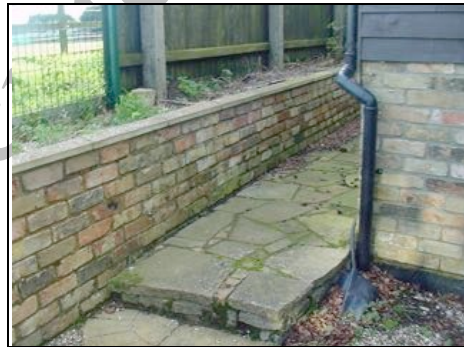
No weepholes to retaining wall

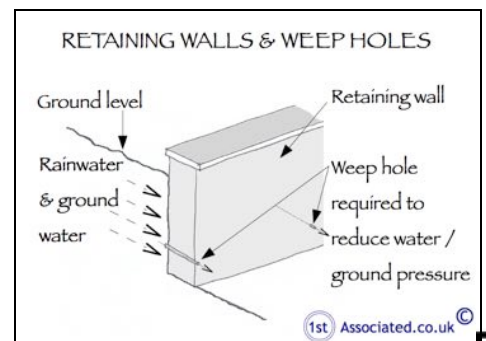
Retaining wall needs weep holes

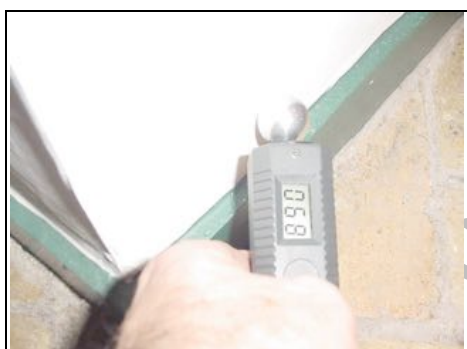
The ground is generally high around some parts of the property and there is a sloping site. We found dampness within the property. We believe it is coming up through the floor as well as through some of the walls. We can see in some areas that there is a low damp proof course and we can see in other areas there does not appear to be a damp proof course although we have been advised by the owner that they did put a damp proof course in (as he was a damp proof contractor).

High damp reading

ACTION REQUIRED: The property is on a slight sloping site and as such generally we find that a french drain around the property is the best way to help reduce the dampness but in this case if you wanted to be completely dry you may also have to take up sections of the floor and put in a damp proof membrane.

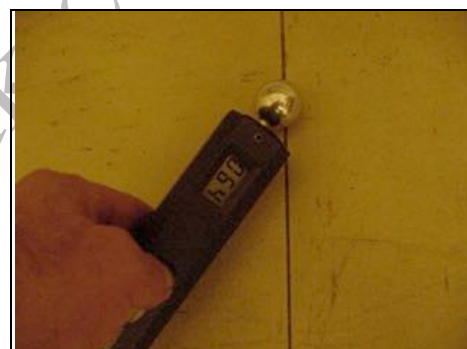
High damp meter readings in utility room

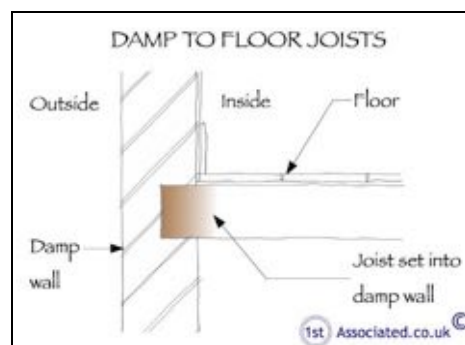
It was noted in the front bedroom there is considerable deflection in the floor. It seems very strange considering it is a relatively short span.

Embedded timbers

ACTION REQUIRED: We would recommend the floors are opened up. We did lift the carpets. It could be the joists had rotted where they are embedded into the walls, it could simply be that they are not big enough (note our comments on the roof timbers) or it could be that they have woodworm or some other similar problem.

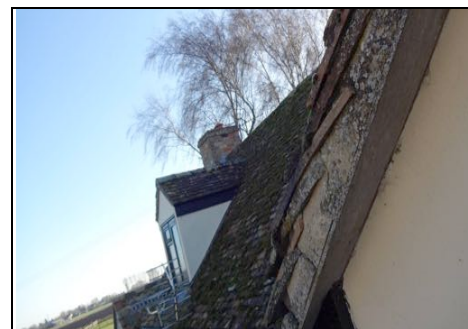
We found asbestos to the verge of the roof which does mean there could be asbestos to the rest of the property.

Asbestos to verge

ACTION REQUIRED: The only way to be a hundred per cent certain with regards to Asbestos in a property is to have an Asbestos report with samples taken and the recommended action carried out.

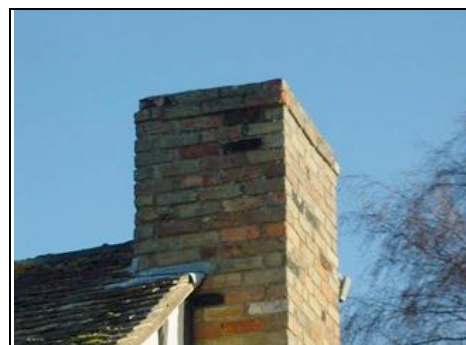
Front right chimney

This chimney is brick finished with a lead flashing. From what we could see from ground level it looked in average condition considering its age, type and style. This chimney has been capped.

ACTION REQUIRED: Periodically inspect the chimney.

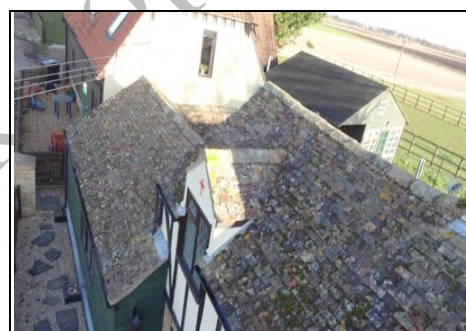
Main roof

The main roof is pitched and clad with tiles, and, from ground level, this looks in below average condition considering the roofs age type and style with major repairs required. We can see that there is a heavy moss covering to the tiles and we can also see that some of the tiles are spalling

ACTION REQUIRED: Please see our comments in the Executive Summary.

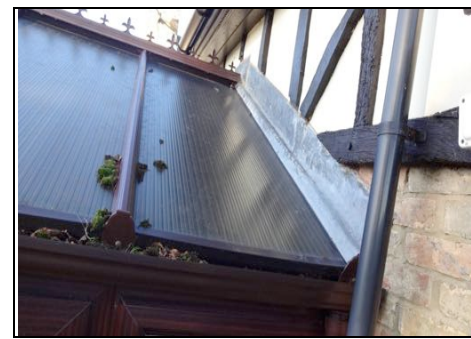
Moss is coming off main roof (right side) landing on the conservatory and then filling up the gutters

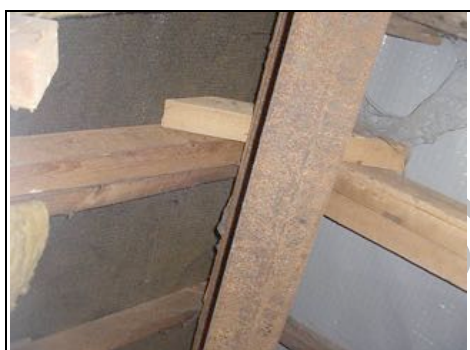
When we inspected the loft space we found a reinforced plastic sarking felt and a hessian underlayer. Reinforced plastic sarking felt was used in the 1970s/1980s and its use was generally stopped because it was susceptible to causing condensation unless the roofs are adequately vented, which they are usually not. Please see our further comments as a combination of a protective underlayer that causes condensation and thin roofing timbers is a problem.

Plastic sheet and hessian

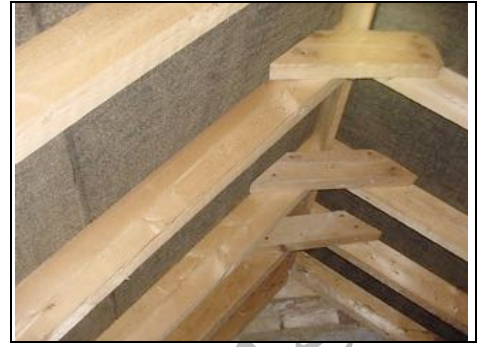
Within the main roof there is a roofing felt rather than a protective underlayer.

Roofing felt rather than protective underlayer

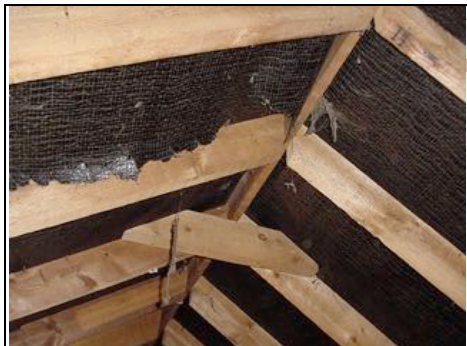
When we inspected the loft space we found a Hessian base Bitumen membrane. This type of membrane has been used since the 1960s. We generally found it to be in average condition, with damage in some areas which is what we typically find.

Torn

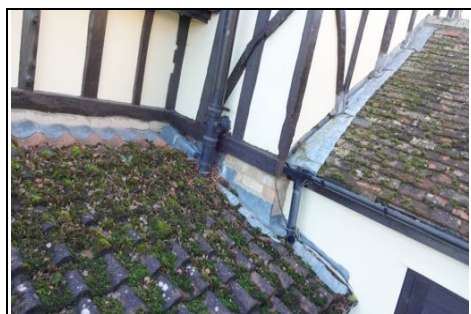
The roof is pitched and clad with roman tiles, and, from ground level, this looks in below average condition with moss and spalling tiles. We would recommend the moss is cleared.

Single pitched roof covered in moss

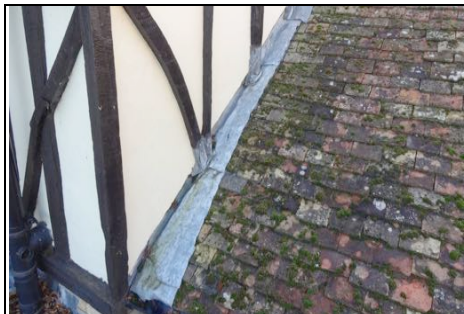
Leadwork to single pitched roof

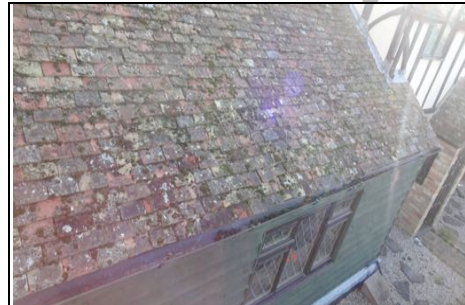
Tiles spalling and ending in gutters of single storey roof

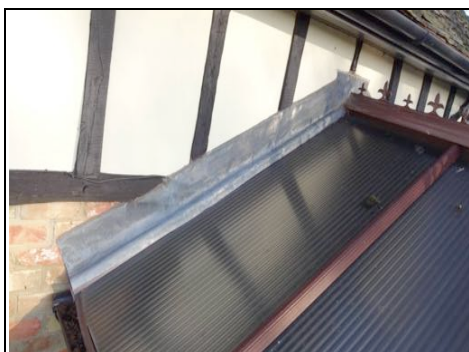
Conservatory roof

The conservatory has a polycarbonate roof which looks in average condition.

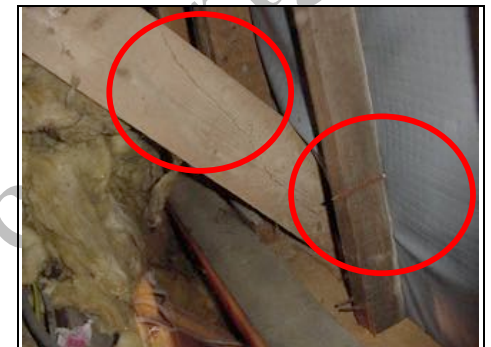
Split in timber in main roof
Nails puncturing through the
protective underlayer

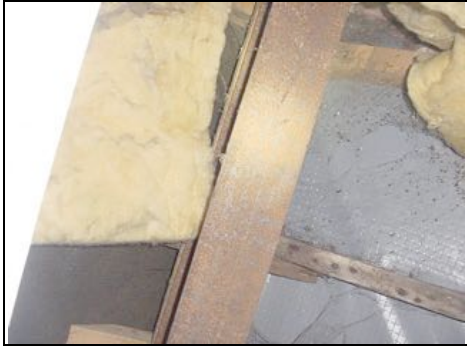
Very thin common rafters

ACTION REQUIRED: The only way to be 100 per cent certain is to have the roof cleared and checked.

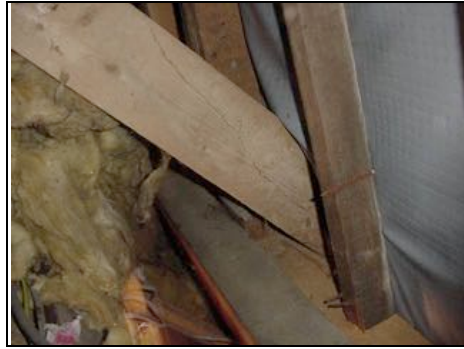
Split in common rafter

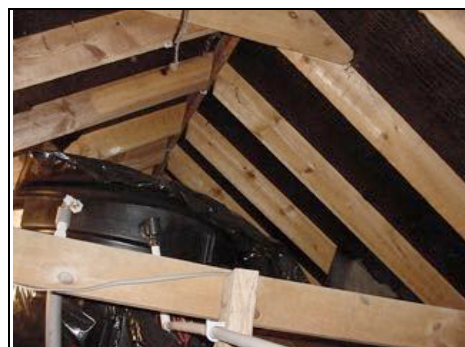
Water tank in roof of front left cloakroom

There was a water tank in the roof above the front left cloakroom.

We would always recommend that water tanks be drained down and cleared of any debris etc. (we have seen dead birds and other unmentionable things in these tanks). As you are often cleaning your teeth with this water it is best that it is as clean as possible!

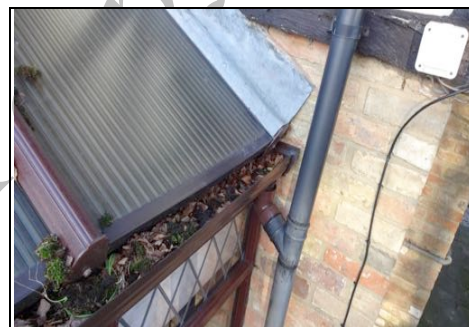
The gutters and downpipes are plastic. They are in below average condition for their age, type and style due to:

- 1) The amount of moss in them from the roof which is not surprising, they do not look to have been cleared for some time.
- 2) Battle against the leaves – there are mature trees in the area and you will have a constant battle year in, year out with clearing the gutters. You do need to be aware of this.

Gutters need a clean

ACTION REQUIRED: We would recommend you stand outside the property next time it rains heavily and see how well the drains cope with the rainwater particularly looking at the guttering and the joints.

We also recommend that the gutters and downpipes are cleaned out, the joints are checked and the alignment checked to ensure that the gutters fall towards the downpipes.

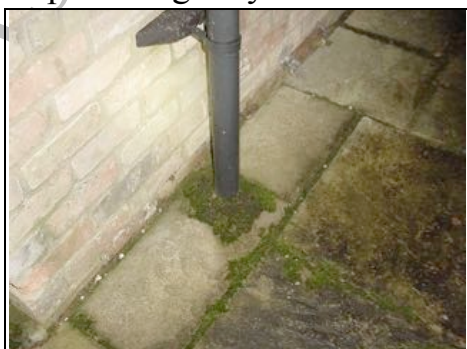
The downpipes feed directly into the ground so if there is a blockage then the drain would have to be opened up. This is a practice we are not particularly keen on; we would much prefer a gulley.

Downpipe feeding directly into ground with moss around it indicates that it gets blocked

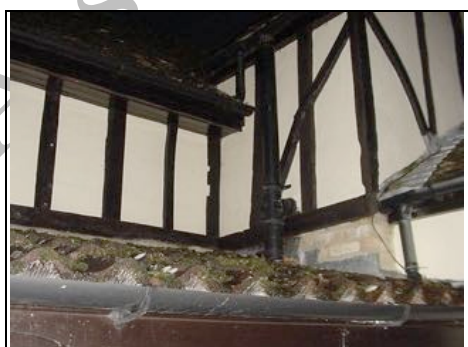
Plastic soil and vent pipe does not discharge high enough

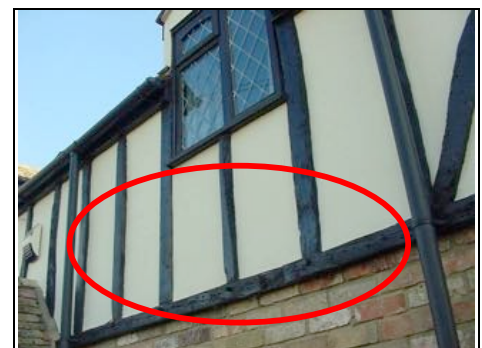
Timber to base

We would prefer to see a bell mouth type detail at the base of the render but tradition has it that timber is used which can often rot.

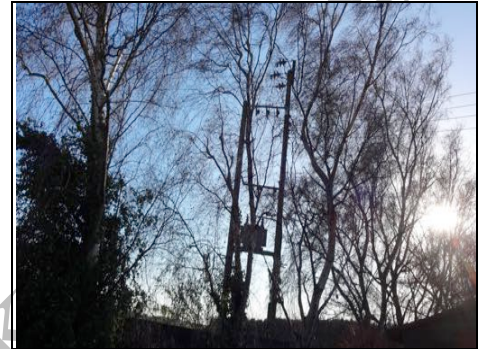
Tree

There are lots of trees, some of which are particularly close to the building within what we would term as influencing distance but you do need to speak to your insurance company as they may have a different interpretation for insurance reasons. They do not look like they have been maintained for a long time. We did notice that one tree had been cut down. This looked to have been some time ago.

ACTION REQUIRED: We would recommend an arboriculturalist (not a tree surgeon) is asked to view the property and give a ten year plan for maintenance.

ANTICIPATED COST: In the region of £250 - £750; quotations required.

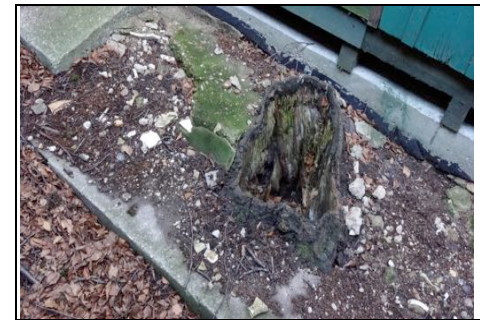
Tree cut down

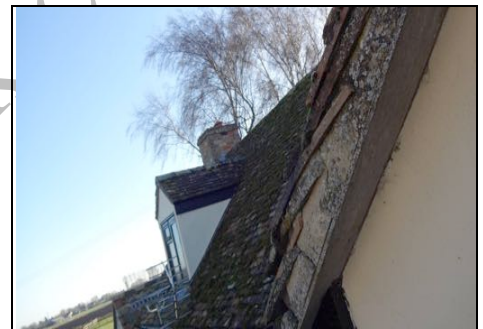
The fascias and soffits are timber. They are painted and we would comment they are in average condition for their age, type and style. We noted the verge is asbestos.

Asbestos to verge

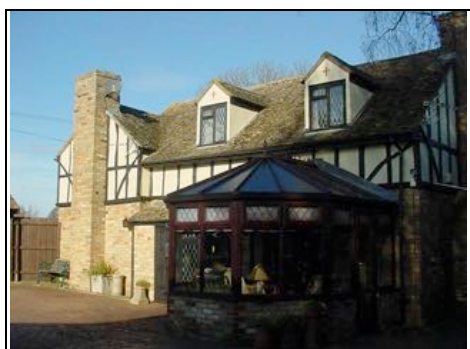
Front right chimney breast sits partly externally

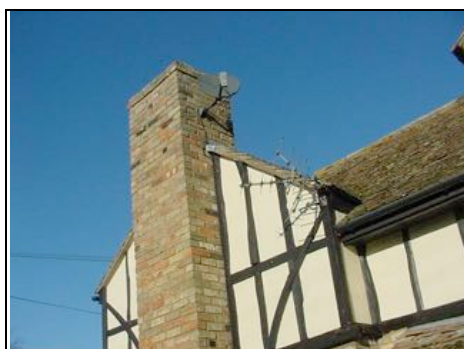
Rear chimney breast sitting externally

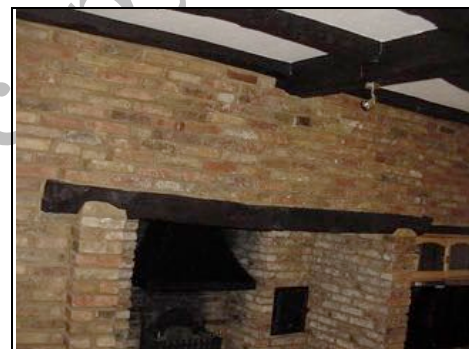
Inglenook fireplace

A chimney may have been removed on the left side of the property.

It is strongly recommended that flues be cleaned and checked for obstructions prior to use to minimise the risk of hazardous fumes entering the building.

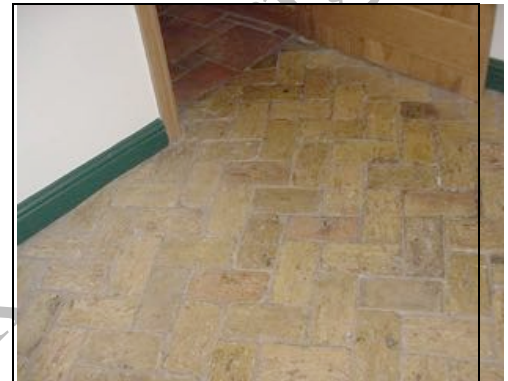
The floors felt solid under foot so we have assumed that they are constructed in concrete. Originally we are advised by the owner the floor was trodden earth and tiles which is something we have come across a few times in this sort of cottage.

Bricket and tiled floor

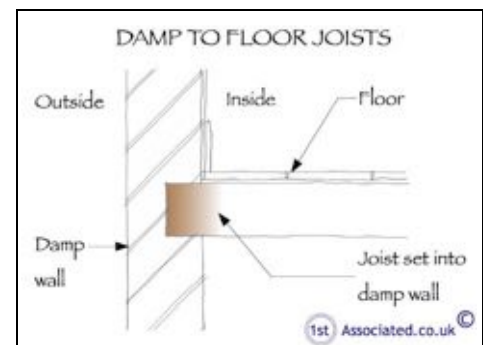
We have assumed that the first floor construction is a mixture of traditional timber and joist and floorboards with embedded timbers, as this is typical in this age of property.

Embedded timbers

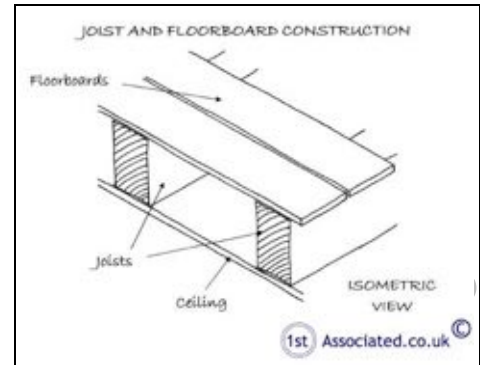
Joist and floorboards

ACTION REQUIRED: Please see our comments in the Executive Summary with regard to opening up the floors. Possibly the wrong sized timbers have been used and possibly there has been some deterioration to the end joists.

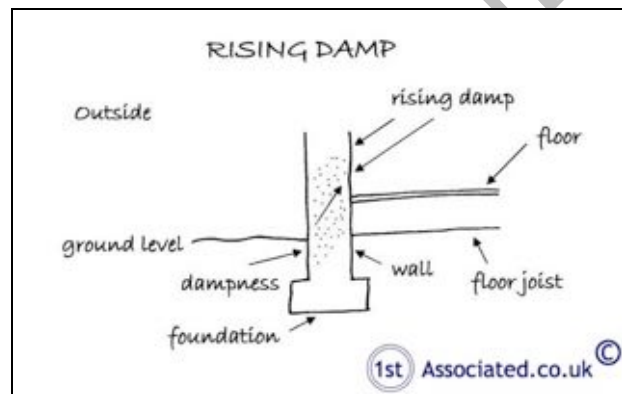
Rising damp

A visual inspection and tests with a moisture meter have been taken to the perimeter walls. In this particular case we have found significant rising damp.

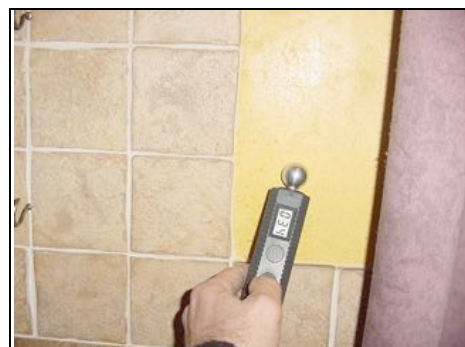
We used a resistance meter on the external walls.
We have not found significant dampness.

Testing for lateral dampness

ACTION REQUIRED: Please see our comments in the Executive Summary.

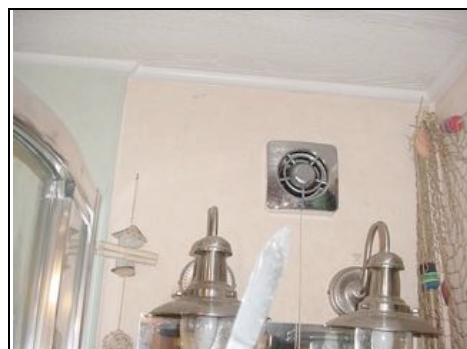
Extract fan in cloakroom

ACTION REQUIRED: We would recommend large humidity controlled extract fans be added to kitchens, bathrooms and any rooms where you intend to dry clothes.

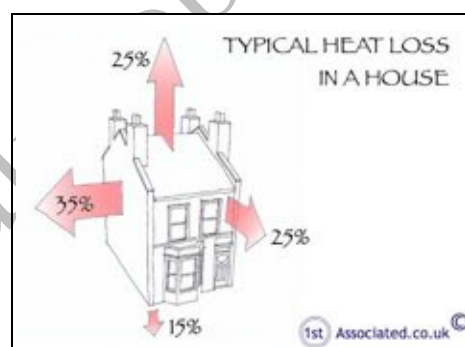
Some roof insulation was present although not to current Building Regulations requirements of 300mm. In this instance it ranges from 100mm to 300mm.

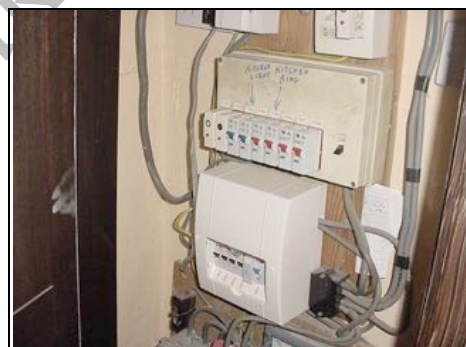
Fuse Board

The electric fuses and consumer units were located in the dining room. The fuse board looked 1970's/1980's and better are now available.

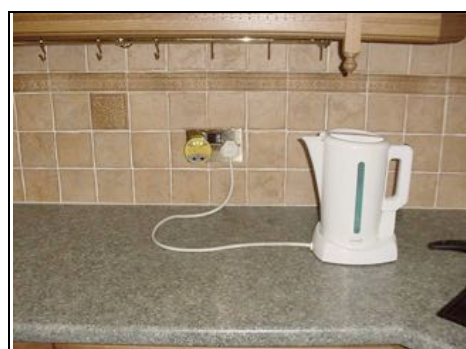
We carried out an earth test in the kitchen area to the socket point that is normally used for the kettle, this proved satisfactory.

Earth test

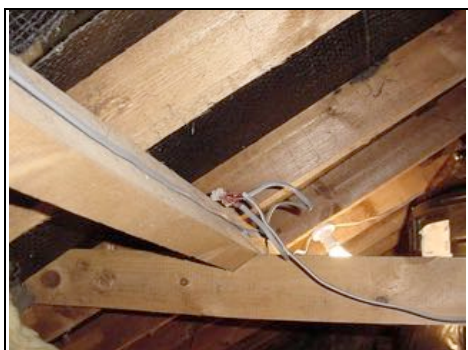
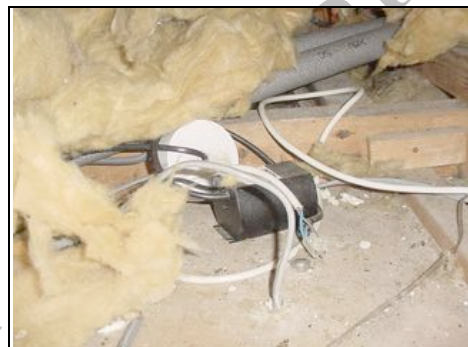
Our concern is if this sort of wiring is visible, what other wiring is there which is hidden.

Wiring in the roof

ACTION REQUIRED: As the property is changing occupancy an Institution of Engineering and Technology (IET) test and report and any recommendations should be carried out by a NICEIC registered, or equivalent, approved electrical contractor or similarly approved.

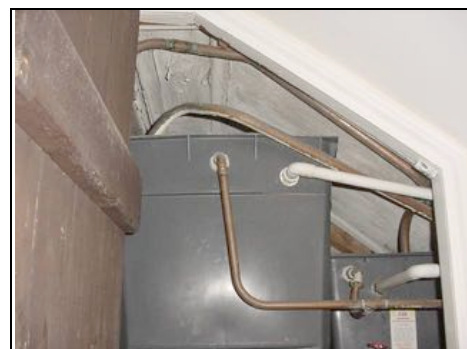
The water tank is located in the bathroom and requires a lid.

Water tank

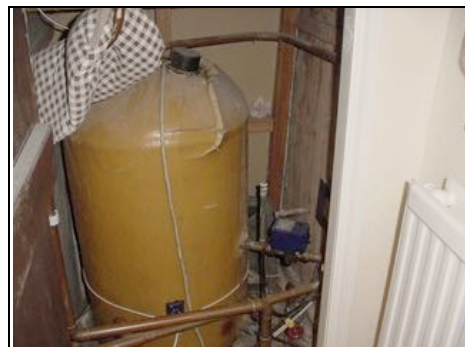
There is a hot water cylinder located in the bathroom. It is factory insulated, which indicates that it is relatively new (in this case we mean in the last 30 years). This cylinder will therefore have a good thermal efficiency, although not as good as the more modern hot water cylinders.

Factory lagged hot water cylinder

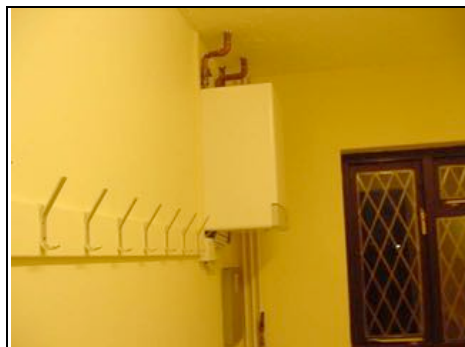
There is a Glow worm wall mounted Micron boiler located within the utility room.

Our limited inspection of the hot water and central heating system revealed no evidence to suggest any serious defects but we would nevertheless recommend that the system be tested and overhauled before exchange of contracts and that a regular maintenance contract be placed with an approved heating engineer.

Boiler

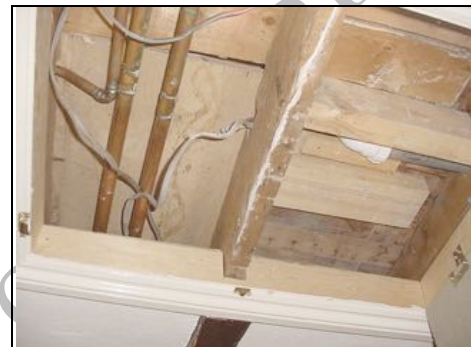
Unusually there is an access to the drainage to the bathroom in the entrance lobby underneath the bathroom area.

Roof space in entrance area

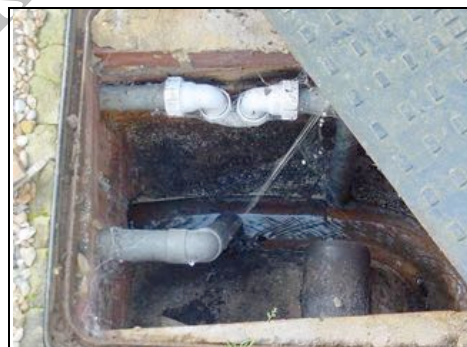
Manhole one

We duly lifted the cover and found it to be free flowing at the time of our inspection.

From what we could see it is brick built.

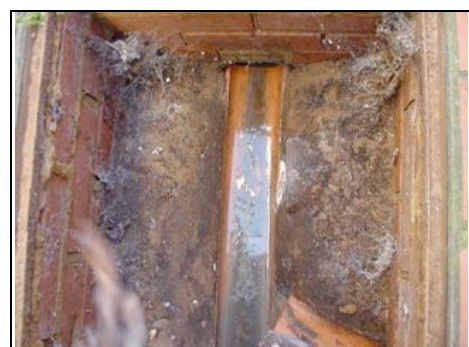
Manhole two

We duly lifted the cover and found it to be free flowing at the time of our inspection.

From what we could see it is brick built.

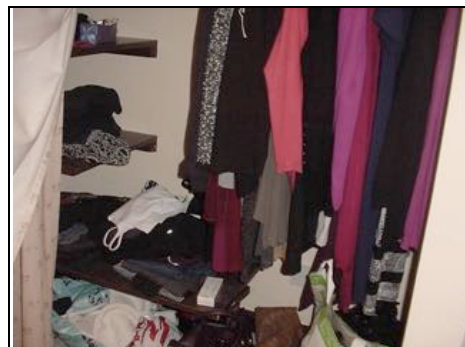
Stored items limited view
