JOB REFERENCE: XXXXX

RESIDENTIAL BUILDING SURVEY

XXXX
Henlow
Bedfordshire
SG16 XXX

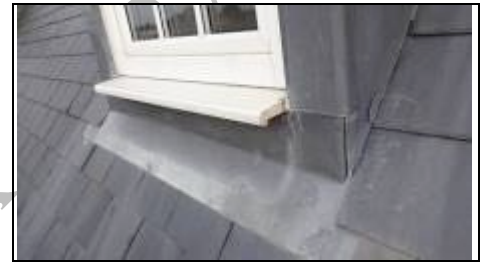
We can see that the front right dormer roof (all directions given as you face the property) is allowing some water in. There does seem to be a crack in the window sill board. We would not have expected so much rain in because of this however if it is in a high prevailing wind area as mentioned this could be the reason. The dormer looks to be clad with lead which is usually a good material for dormers but this may not have been lapped correctly; we simply cannot see from ground level. It is also possible there may be a defect in the slates around the dormer that is allowing wind driven rain in.

Close up of front right dormer
Aerial view – 360 photo

ACTION REQUIRED: When the roofer is on the roof he needs to check the dormers particularly closely.

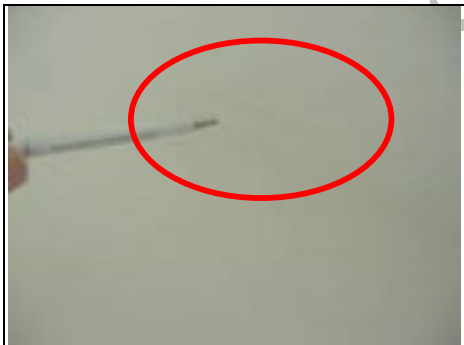
Dampness coming through around front dormer

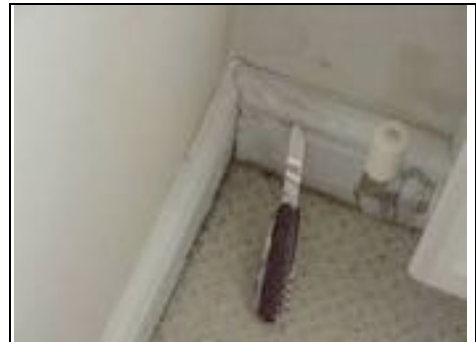
Dampness to skirting to base of front right dormer

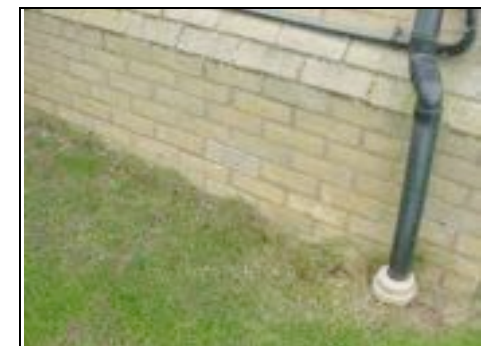
Whilst we are on the subject of gutters and downpipes, the downpipes feed directly into the ground which is a practice we are not keen on, and we much prefer to see a gulley as without a gulley where there is a blockage it can cause a back-up of water in the downpipes which can ultimately come out of the joints and allow dampness to get into the walls.

Downpipe going directly into the ground

ACTION REQUIRED: Clear and clean gutters, check joints and ensure they are falling towards the downpipes.

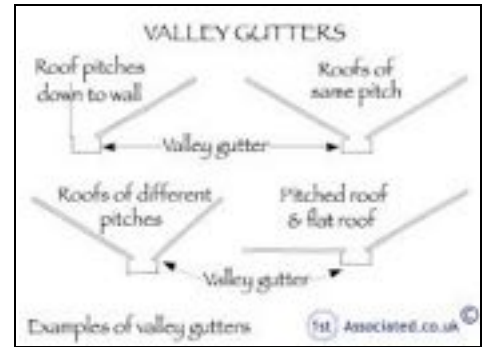
There is an awkward valley roof detail where the conservatory meets the main property wall. There tends to be problems with back up of water which ultimately can lead to dampness getting into the building.

Valley gutters

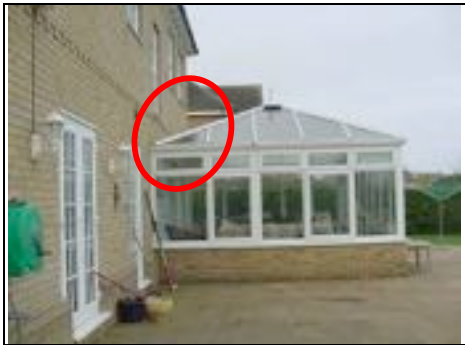
Awkward roof detail

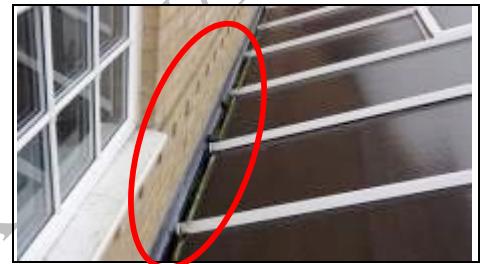
Moss to base of conservatory showing there has been back up on this area and more tennis balls
Aerial view – 360 photo

ACTION REQUIRED: We recommend you add a French drain around the conservatory. We would ideally recommend it around the whole of the property to ensure that water is kept away.

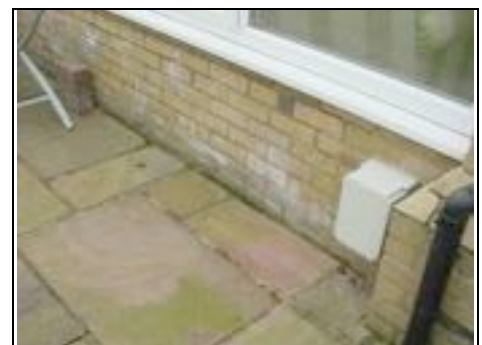
Efflorescence and moss

It is unusual to have efflorescence on brickwork of this Era. It may be that the brick is particularly porous but you do need to be aware that you may get the efflorescence in the form of a white powder/salt on the bricks forever and a day and it will be very difficult to remove. Even such products as a brick clean tend to be a temporary removal of such staining if the bricks are porous.

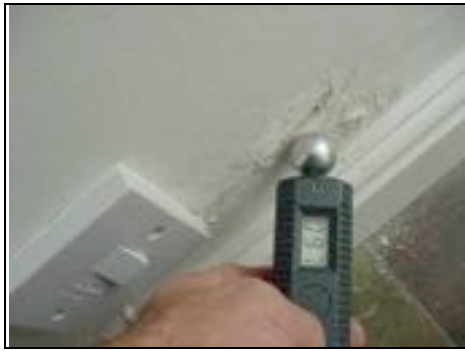
We noted dampness in the conservatory and we obtained high damp readings with our electronic damp meter and also thermal image pictures showed there was dampness in the area.

High damp readings of 97 in conservatory. They should be between 30 to 60

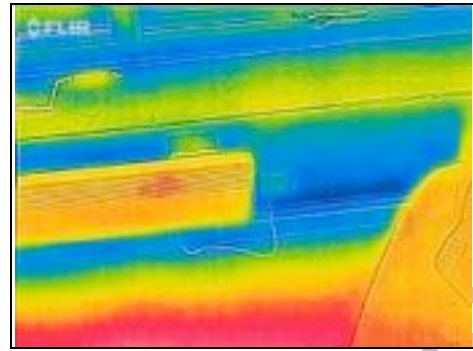
Thermal imag photo of same area. The blue shows the coldness in it, coldness can also relate to dampness

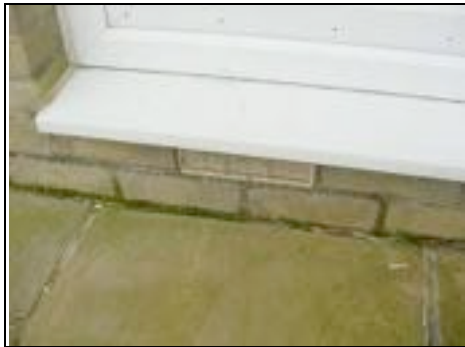
Moss around base of property

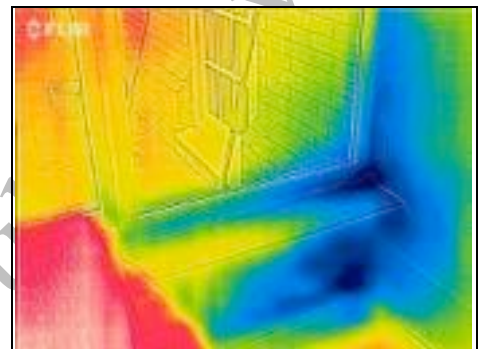
Conservatory, where meets main building on the right side corner (all directions given as you face the property). We can see the coldness/dampness

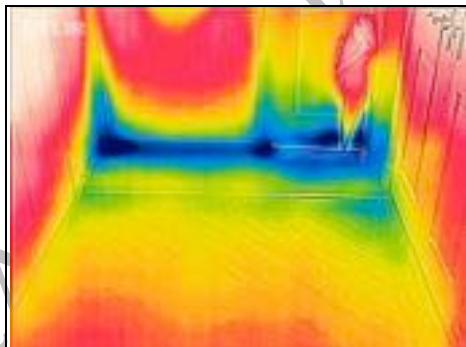
As a contrast, the entrance hallway, showing coolness coming under the front door

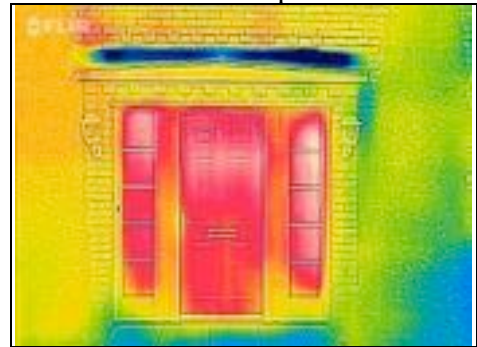
The front door from the outside showing heat from within on doors and windows, with the coolness to lead roof above entrance and paving in front of door

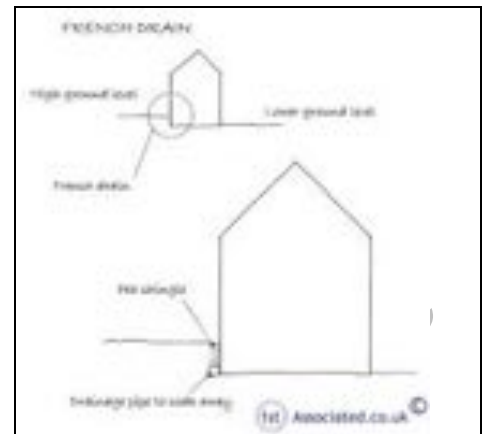
French drain

ANTICIPATED COST: £2,500 - £5,000, this should go into its own soakaway; please obtain quotations.

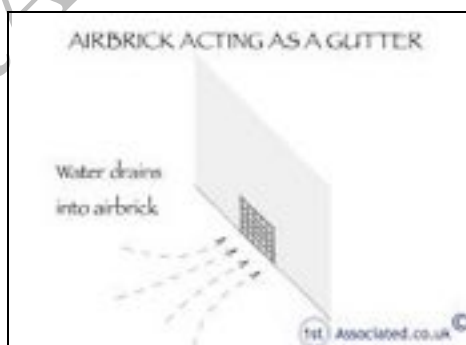
Air bricks are essential to have a through flow of air. In this case the airbricks to the rear conservatory are acting as gutters due to the high ground level from the patio.

Airbrick acting as a gutter

ACTION REQUIRED: Ensure the airbricks are clear and protected.

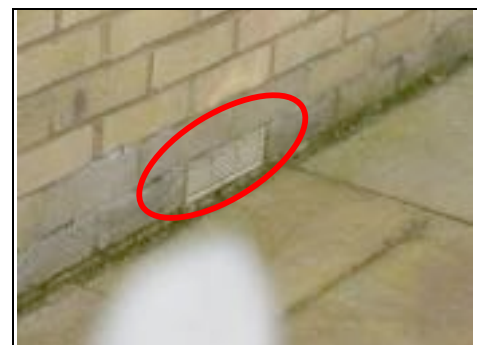
Airbrick acting as a gutter to conservatory

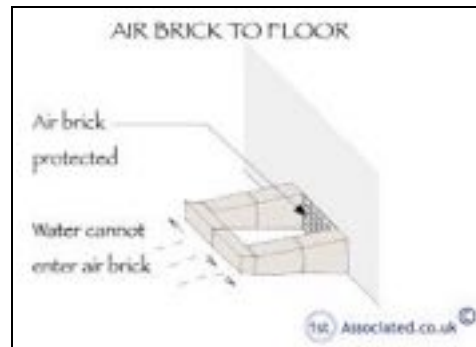
Protected airbrick

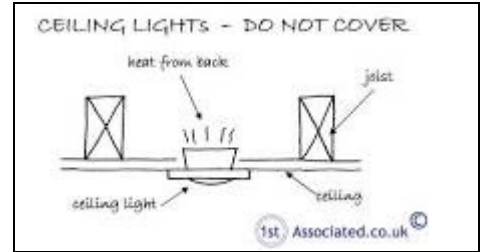
You need to be aware that there can be problems with ceiling lights particularly where dampness is getting into them.

Do not cover ceiling lights

ACTION REQUIRED: Ensure that the ceiling lights are not covered in the loft space.

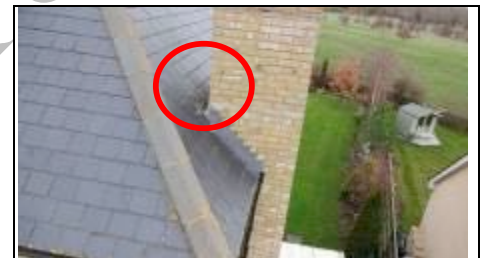
Trap behind chimney where dampness tends to get in

ACTION REQUIRED: Periodically inspect the chimney.

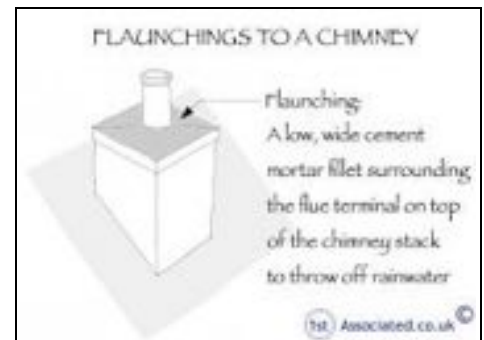
On both chimneys the flaunchings look relatively thin, we are used to seeing a thicker flaunching to hold the chimney pot in place.

Flaunching

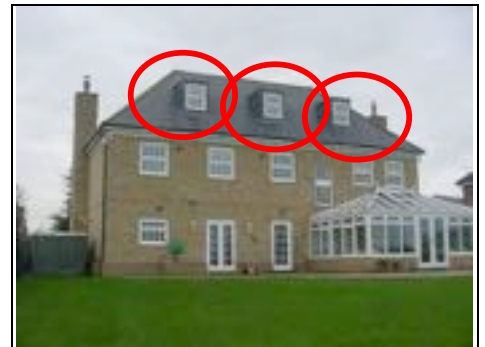
There are missing and lifting slates to some of the dormers.

Rear dormer windows

ACTION REQUIRED: The dormers may be susceptible to wind driven rain getting in around them particularly bearing in mind our comments on the slates and what seemed to be a relatively strong prevailing wind in the area. Please see our specific comments on the front right dormer in the Executive Summary.

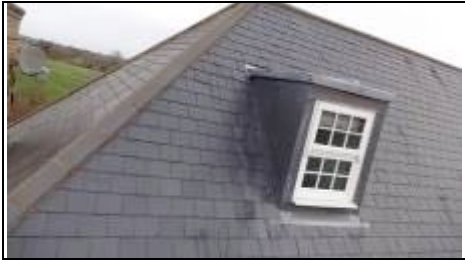
Very slight lift in slates to left side of front left dormer

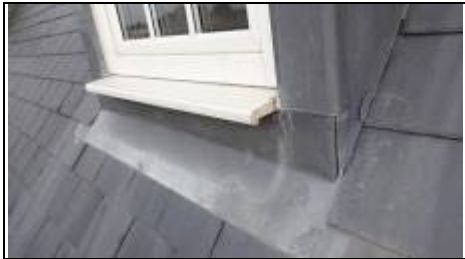
Close up of front right dormer where dampness is coming in
Aerial view – 360 photo

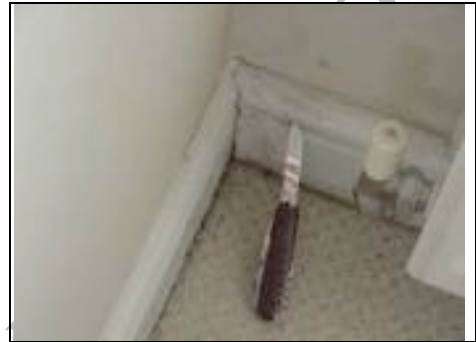
Dampness internally to skirting next to front right dormer

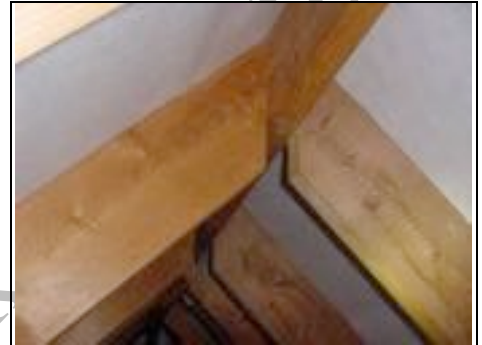
Our examination was limited by the general configuration of the roof and the mass of insulation. What we could see was generally found to be in average condition for its age, type and style with the minor exception of the unusual way the ridgeboard has been built onto smaller timbers and the staining on the timbers. It is, however, feasible that there are problems in the roof that are hidden.

Unusual ridge board
– partially pre-fabricated

ACTION REQUIRED: The only way to be 100 per cent certain is to have the roof cleared and checked.

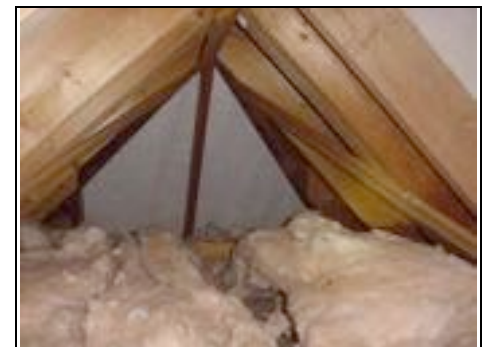
Mass of insulation

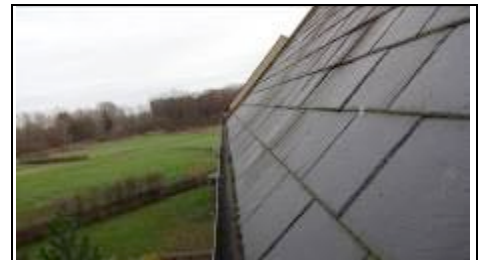
There may be some minor leaks but most people would be happy to live with these providing repairs are carried out within the next six to twelve months.

High level guttering

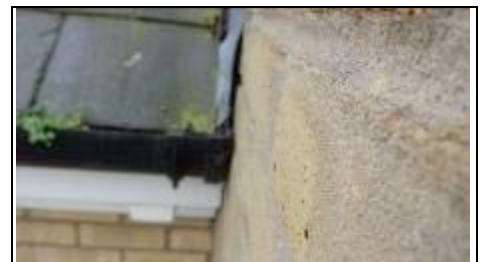
Close up

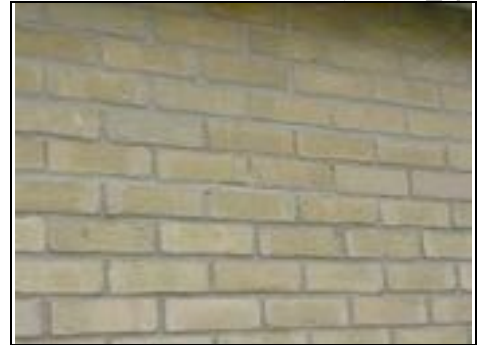
Some areas of repointing to brickwork

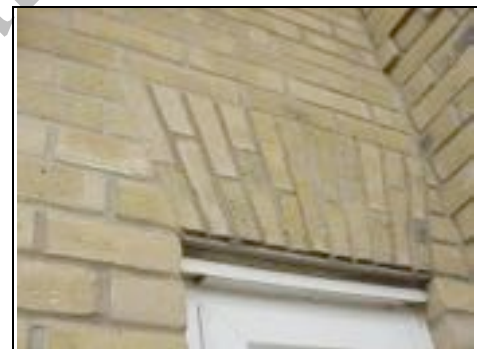
Strange soldier course detail

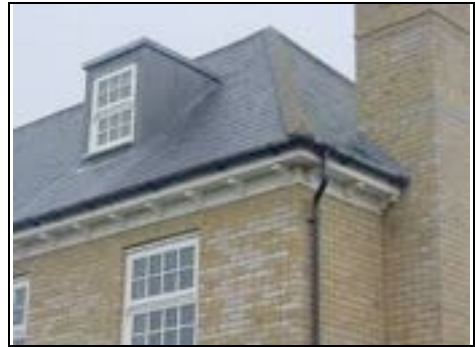
The brickwork has efflorescence, which many people find visually unattractive. It is very difficult to get rid of particularly in this instance where it appears to be a characteristic of the brickwork. We would normally expect it to go within a year of a new property being built; there is obviously some characteristic of the brickwork in this instance that is keeping the efflorescence.

Efflorescence on brickwork

ACTION REQUIRED: Please see our comments in the Executive Summary.

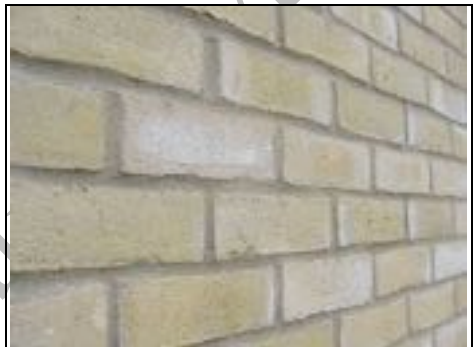
Close up

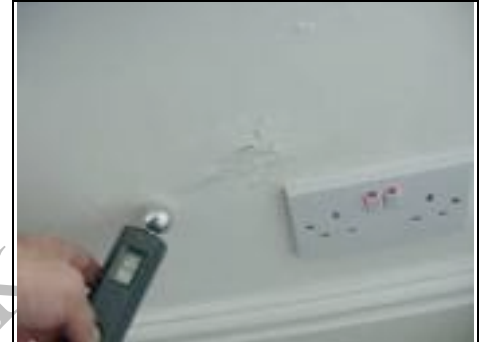
All modern properties should incorporate a damp proof course (DPC) and good building practice dictates that a differential of 150mm (6 inches) should be maintained between the damp proof course and ground levels. In this case, we cannot see a DPC. We assume given its age, type and style that it has been built in as work continues. There are problems with dampness coming into the conservatory.

Efflorescence and moss

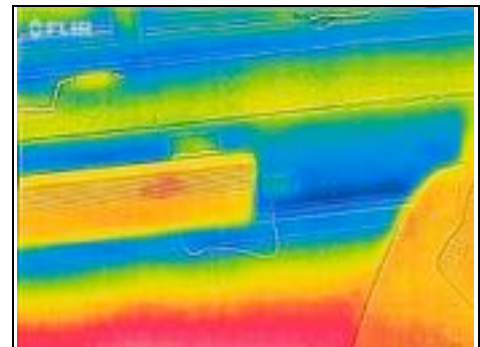
Thermal image photo of same area.
The blue shows the coldness in it, coldness can also relate to dampness

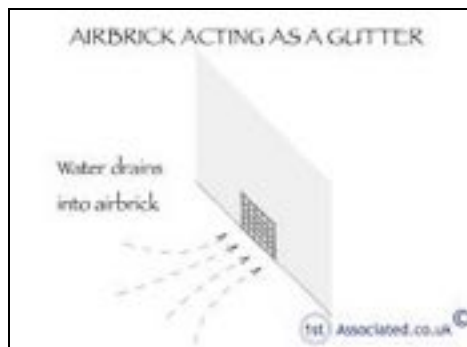
Airbrick acting as a gutter

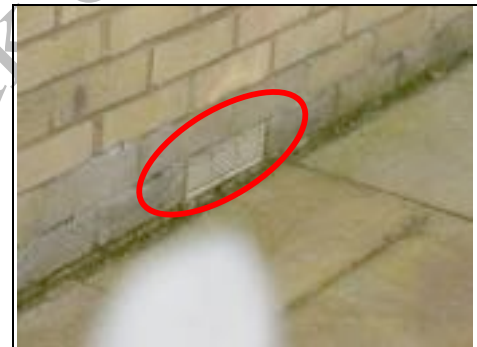
Airbrick acting as a gutter to conservatory

ACTION REQUIRED: Ensure the airbricks are clear and protected.

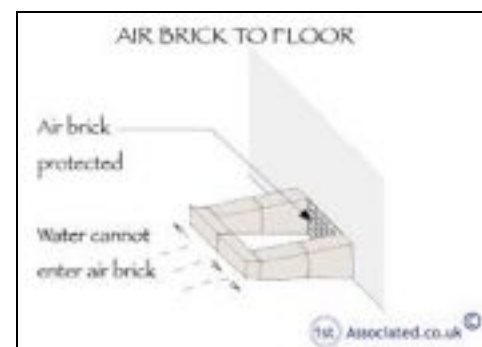
Protected airbrick

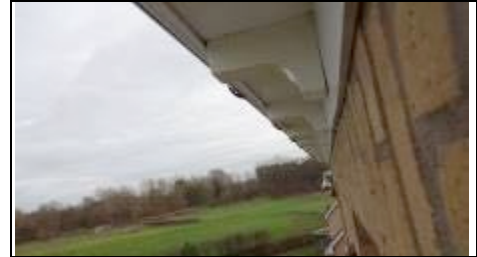
The fascias and soffits and rafter feet are plastic and we would comment they are in average condition for their age, type and style.

Plastic fascias and soffits with rafter feet

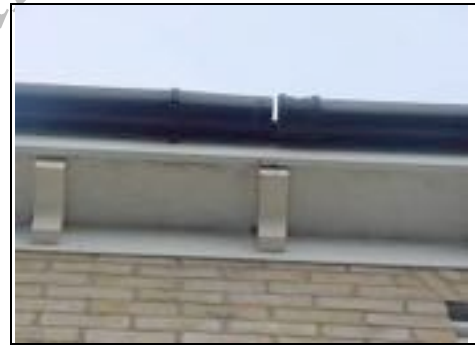
Rafter feet
Also note gap in gutter

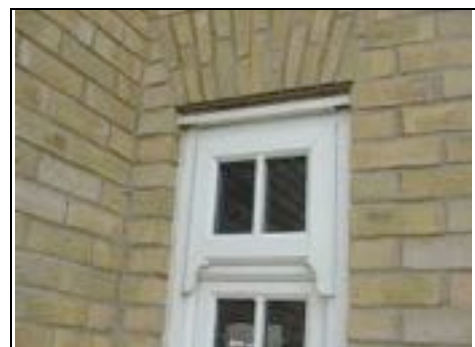
Window with hidden trickle vent

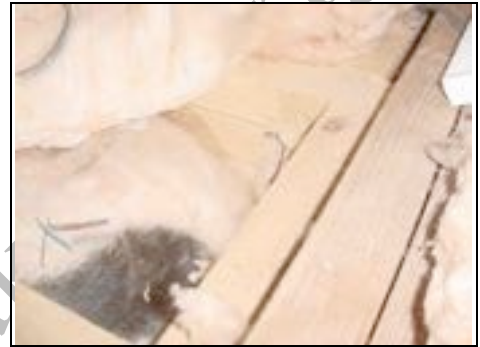
Backing to plasterboard

Damp staining

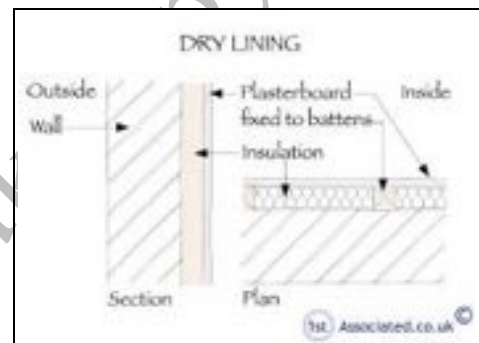
There is an outside chance that this property is timber framed. Our comments are made particularly due to the amount of efflorescence on the property.

Dry lining/false walls

ACTION REQUIRED: Your legal Advisor needs to specifically ask if this property is timber framed. Please see our comments in the Executive Summary.

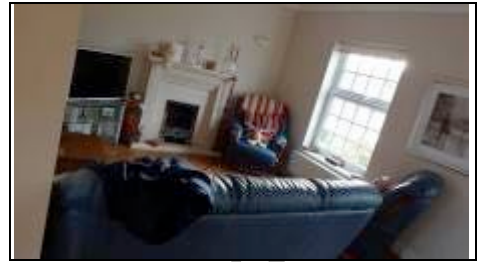
Fireplace in reception room

At the time of the survey no chimneys were in use. Any chimneys that you do not propose to use should be capped and ventilated to prevent dampness.

Any chimneys you do intend to use should be swept and a check should be carried out that a lining is in place.

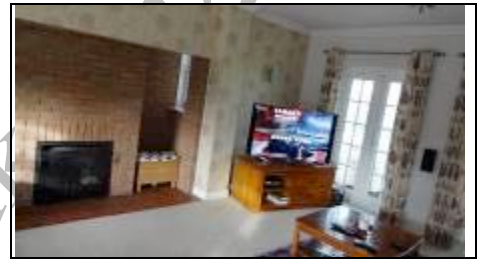
Fireplace in through lounge

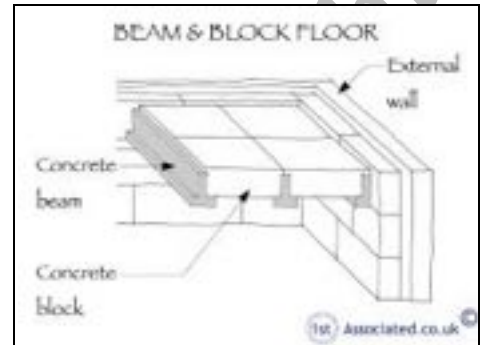
The property has a suspended floor. We believe it to be a concrete suspended floor, known as a Beam and Block floor, although we have not opened it up to check, as this is typical of this Era of property.

Beam and block floors are often used in areas where there are fairly poor soil conditions and you need to be aware of this.

Beam and block floor

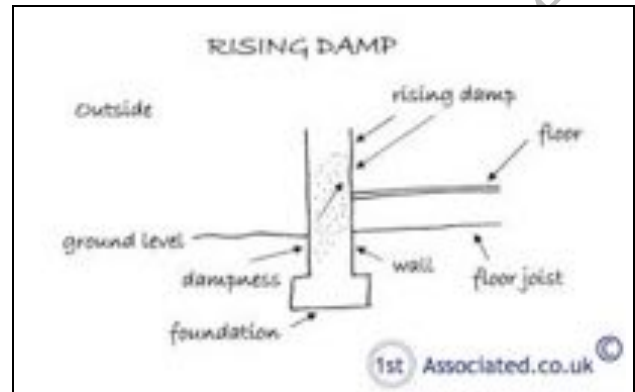
Rising damp

A visual inspection and tests with a moisture meter have been taken to the perimeter walls. In this particular case we have found significant rising damp particularly in the rear conservatory.

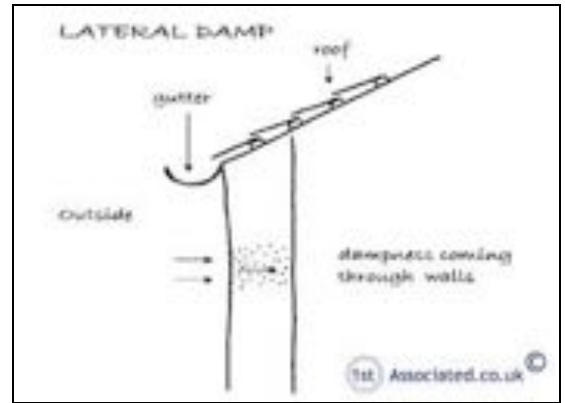
Lateral damp

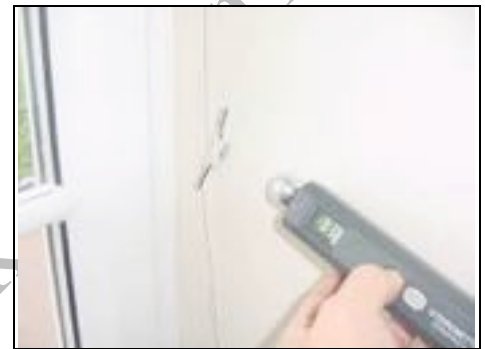
We used a resistance meter on the external walls. We found it to be in line with what we would expect for this age, type and style of property. It also indicated there is some dry lining in the property.

Testing for lateral dampness

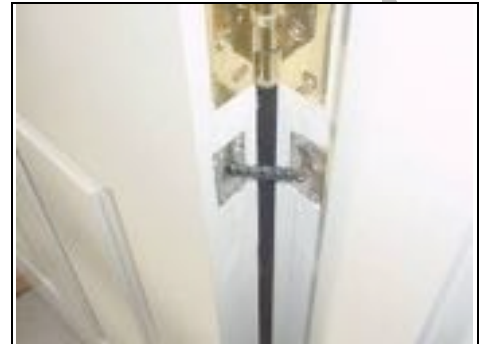
We noted that some of the doors were fire doors and we could see that they had internal door closers (often known by their trade name of perco door closers) which are generally required on buildings over two storey as protection from fire spreading from one floor to the next where the staircase is used like a chimney.

Perco door closer

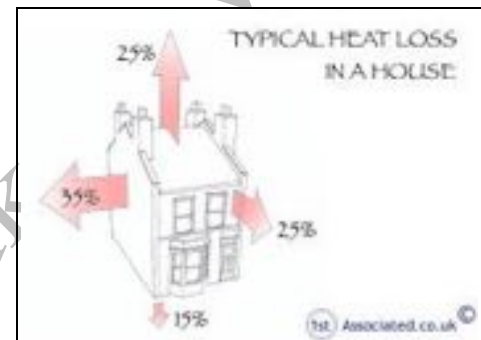
Some roof insulation was present although not to current Building Regulations requirements of 300mm. In this instance there was approx. 300mm in the roof.

Typical heat loss

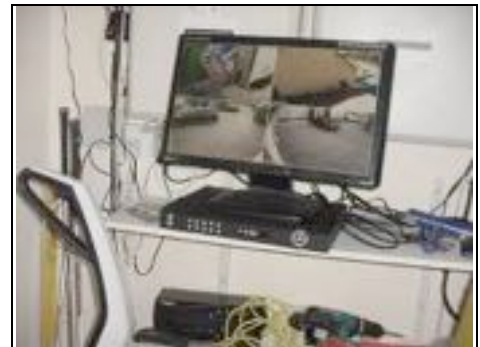
CCTV system in hallway cupboard

ACTION REQUIRED: Further information should be obtained from the vendor and the installer.

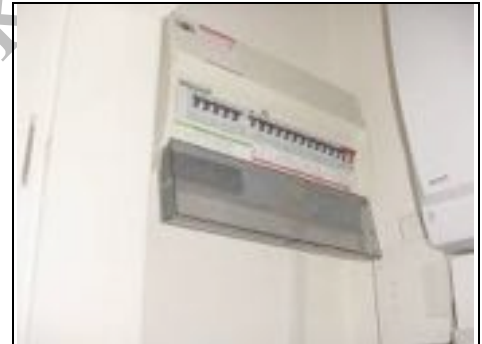
The electric fuses and consumer units were located in the hallway. The fuse board looked original.

Fuse Board

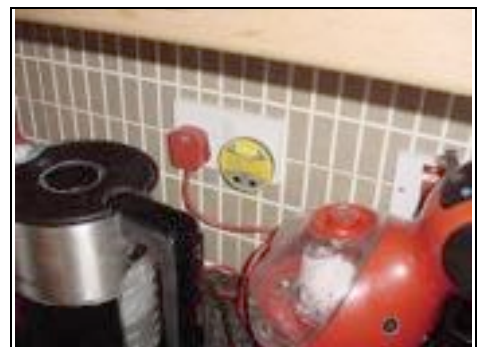
We carried out an earth test in the kitchen area to the socket point that is normally used for the kettle, this proved satisfactory.

Earth test

ACTION REQUIRED: As the property is changing occupancy an Institution of Engineering and Technology (IET) test and report and any recommendations should be carried out by a NICEIC registered, or equivalent, approved electrical contractor or similarly approved.

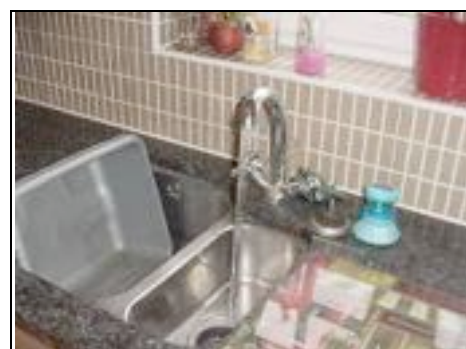
When the taps were run to carry out the drainage test we checked the pressure literally by putting a finger over the tap and this seemed average. The Water Board have to guarantee a certain pressure of water to ensure that things like boilers, particularly the instantaneous ones have a constant supply of pressured water (they would blow up if they didn't!).

Testing water pressure

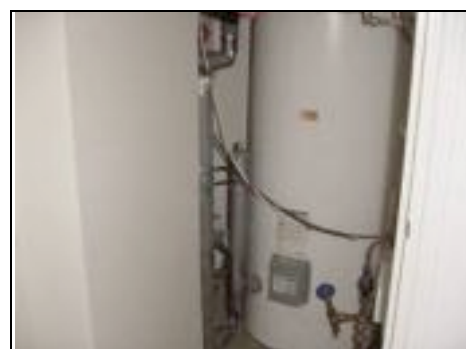
There is a Megaflo hot water cylinder located in the first floor airing cupboard. It is factory insulated, which indicates that it is relatively new (in this case we mean in the last 30 years). This cylinder will therefore have a good thermal efficiency, although not as good as the more modern hot water cylinders.

Megaflo cylinder

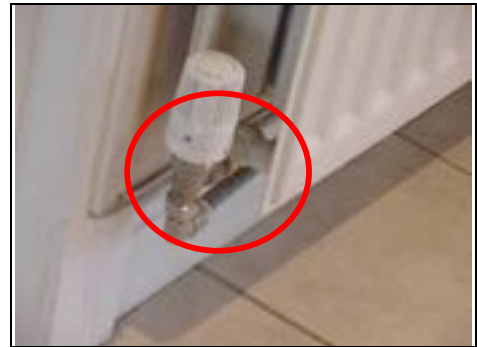
The plumbing, where visible, comprises a mixture of plastic and copper piping, which we do not like as there may be leaks where the two meet. No significant leakage was noted on the surface, although most of the pipework is concealed in ducts and floors.

Mixture of plastic and copper pipes on radiator

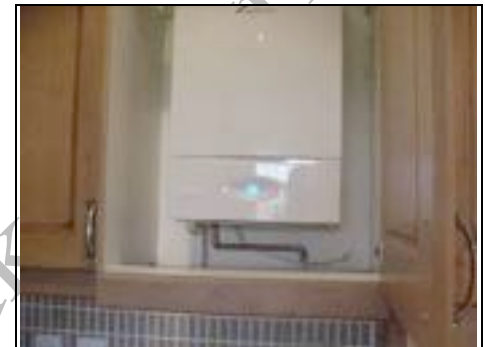
The wall mounted Worcester boiler was located in the kitchen. We are advised this is less than a year old.

Our limited inspection of the hot water and central heating system revealed no evidence to suggest any serious defects but we would nevertheless recommend that the system be tested and overhauled before exchange of contracts and that a regular maintenance contract be placed with an approved heating engineer.

Worcester boiler

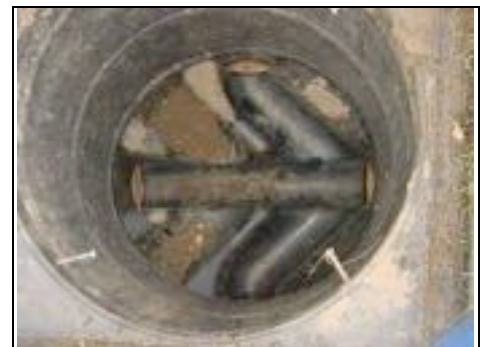
We duly lifted the cover and found it to be dry/clear at the time of our inspection.

From what we could see it is plastic built.

Rear right manhole

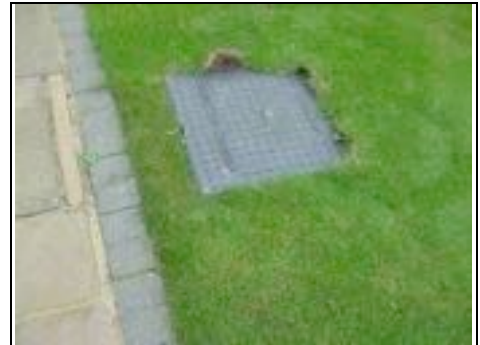
We were unable to open this manhole due to it being covered with grass so are unable to comment upon it.

Rear left manhole

ACTION REQUIRED: We recommend a CCTV camera report of all the drains to check their condition.

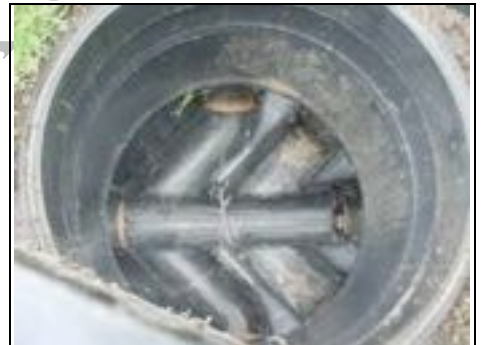
Manhole Three, located to rear near left fence

We duly lifted the cover and found it to be dry/clear at the time of our inspection.

From what we could see it is plastic built.

Rear manhole near to left fence

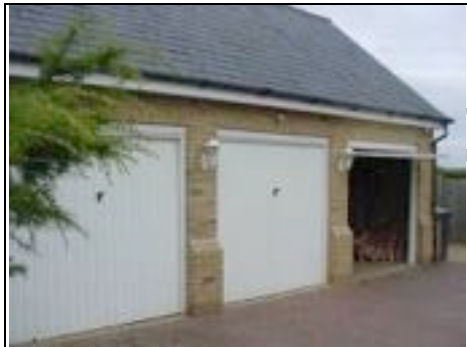
The garage has a slate roof. We noted areas of missing and damaged slates. The slates were very patchy as were the main roof, almost as if defective slates have been used.

Treble garage

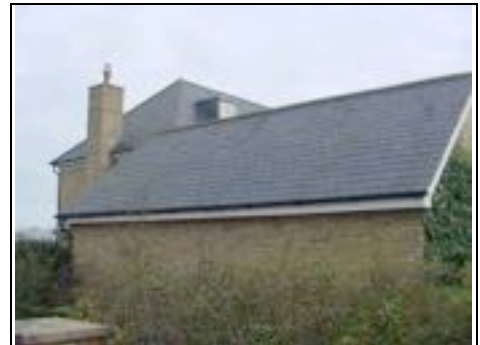
Rear of garages
