# RESIDENTIAL BUILDING SURVEY

Leighton Buzzard,  
Bedfordshire  
LU7 XXX

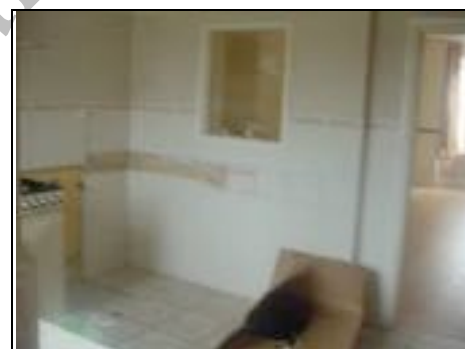
Kitchen/lounge dividing wall (the wall you are looking at removing in part or fully)

**ACTION REQUIRED:** If it is an essential part of this purchase that you carry out the alterations in the kitchen then we would recommend a structural engineer has a look who can provide costs as our experience has found that you can remove practically any wall, it is just the amount of noughts in the end bill that changes considerably so the structural engineer needs to also be able to give you an indication of costs.

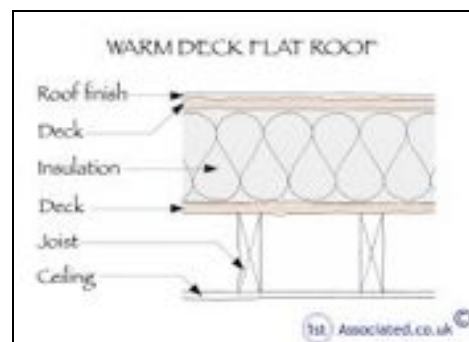
Warm roof

**ACTION REQUIRED:** Ideally replace with a pitched roof. You can put an insulated roof on that is cut to falls and then this would both add a fall to the roof and also insulation to keep you warmer. We recommend a modern high performance elastomeric felt. Add lead flashings and amend parapet wall detail to the right hand side (all directions given as you face the front of the property).

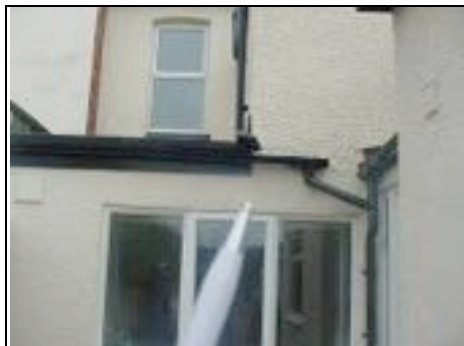
There is an awkward/unusual lintel in the kitchen which is supporting the wall of the bathroom above which is a main wall. It does sit onto the middle of the window which is unusual.

Beam supporting outside wall

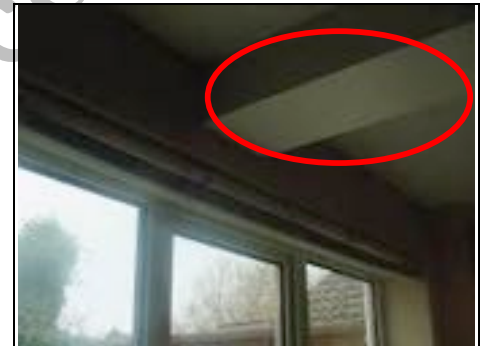
Beam in kitchen over top of window

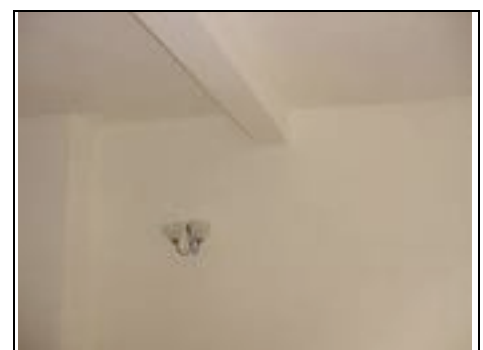
The beam in the through lounge is taking all of its support off the wall rather than having a pier which would be more usual and has been a requirement of the building regulations for approximately the past sixty to seventy years. When the owner was questioned about this they advised that they had not been the ones to carry out that alteration.

Beam in lounge has not got a pier support

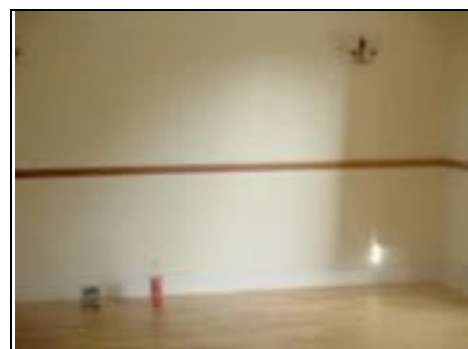
There has been a chimney removed to the lounge and also up into the bedrooms above (see floor plans). This is something that we come across a lot in the London area where there is a need to gain every inch/centimetre of space and not normally in places like Leighton Buzzard. We do find there are people that are not keen on chimneys that remove them. The important thing is to make sure the chimney is supported correctly. In years gone by gallows brackets were often used, these are no longer required and now a lintel is a requirement. Unfortunately we simply cannot see the wall properly as it has been dry lined. Our concern/suspensions are that the dry lining may be hiding something. Read on to find out more about dry lining

Chimney removed in lounge

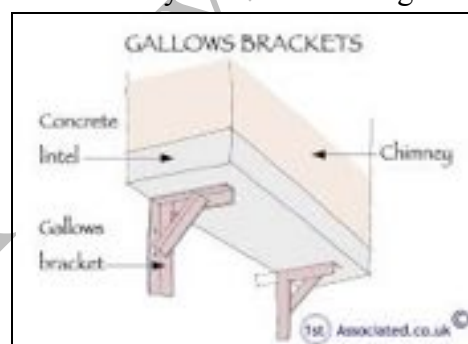
Gallows brackets

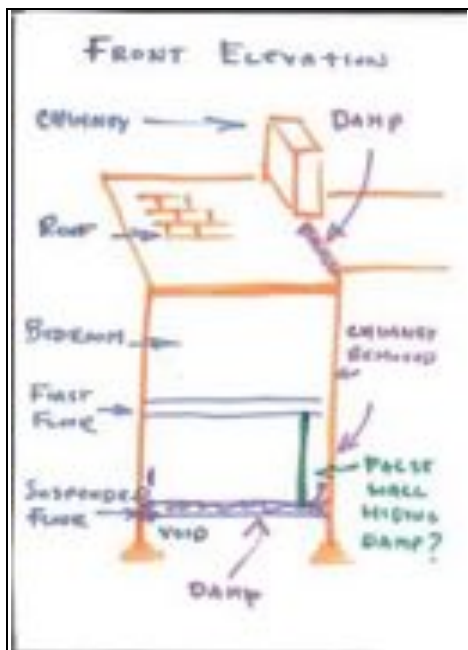
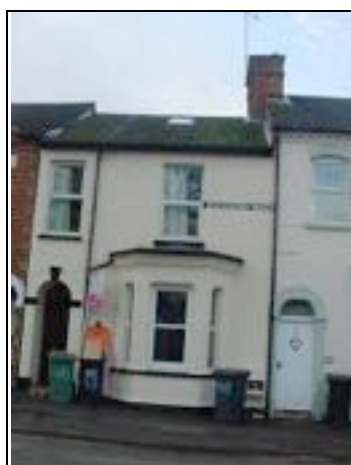
Dry lining (also known as false walls) is often carried out to hide dampness and other problems which is why we are highlighting this on the ground floor. We are also aware on the right hand wall if you look at roof level where it steps we believe dampness is getting in (see sketch below) and we noted the plaster key was loose beneath.

Roof steps to right

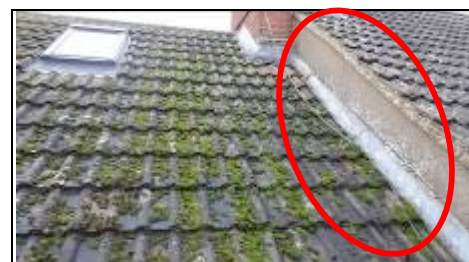
We can see the cement mortar has come away from the flashing. This needs repairing.

Cement mortar come away from flashing

**ACTION REQUIRED:** Repair/replace flashing. Unfortunately as it is high level you will need a set of long ladders or preferably a tower scaffolding.

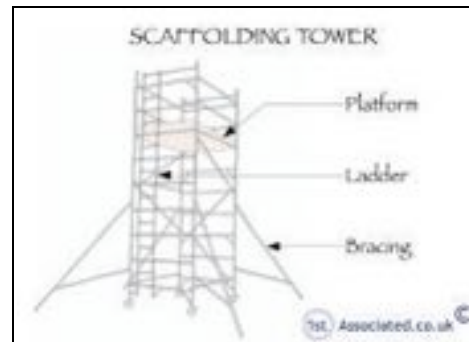
Tower scaffold

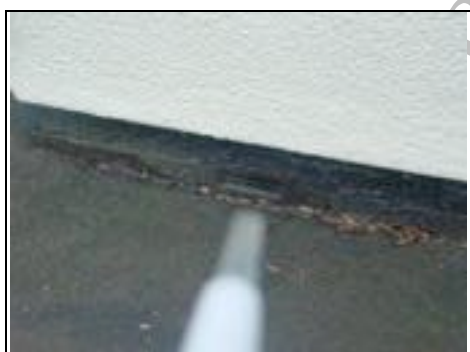
Airbrick to front acting as gutter

A way of improving things would be to ensure you have an airflow underneath the suspended timber floor. We would recommend adding airbricks to ensure this. You also have to ensure the airbricks are not acting as gutters so we would also protect them. This can be difficult as you would need to do this on a public footpath.

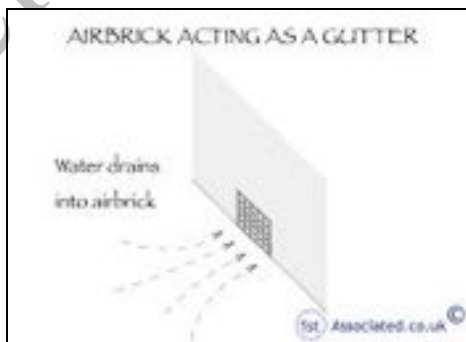
Airbrick acts as gutter

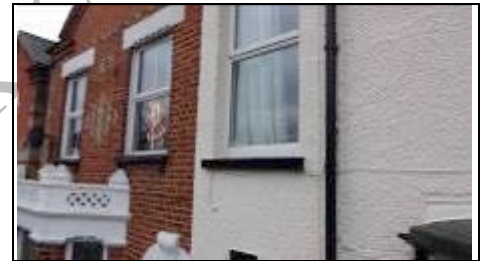
In buildings of this era the walls were meant to breathe which is what they typically did with the softer red brick and a lime mortar (see next door neighbours property to left side). Over the years people have added things such as the cement render that there is in this particular case so there is a seal on the outside of the building particularly as it looks to have been painted with a modern plastic based paint.

Cement based roughcast render to your property,  
Flemish bond brickwork next door

**ACTION REQUIRED:** As we discussed the ideal solution would be to remove the render and expose the bricks but often doing this would just result in a layer of damaged brickwork. Therefore you do need to make sure that the rest of the building breathes as much as possible so such things as:

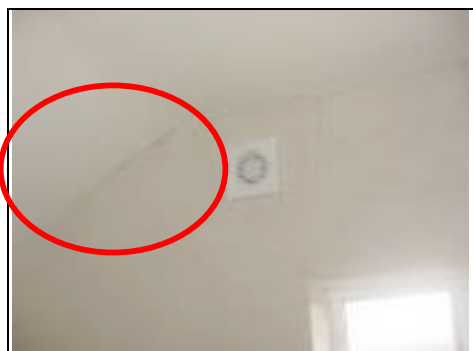
The ceilings are sloping in areas which mean they are being formed by the roof. Please also see our comments with regards to condensation and black mould. This would lead to cold bridging.

Cold bridging

**ACTION REQUIRED:** This is a characteristic of this property. You need to consider this. Particularly you should note our first comments with regard to the valley gutter as this is the area where the water would get into the bathroom.

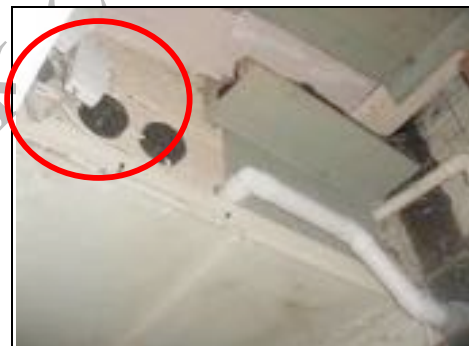
We noted what we would term as DIY electrics throughout the property and a lack of socket points to the kitchen and also in some of the rooms.

DIY electrics

**ACTION REQUIRED:** We recommend an Institution of Engineering and Technology (IET) test and report to be carried out by an NICEIC registered and approved electrical contractor or equivalent.

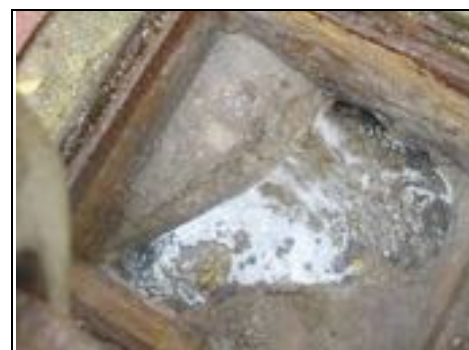
Just to reiterate the drains are blocked. It may well be a lot more than just being blocked. The owner advised the drains had been blocked by the tenants and they would get the tenants to clear them. You need to ensure this definitely happens.

Drain blocked. Looks DIY as haunchings not formed properly.

**ACTION REQUIRED:** We would recommend a closed circuit TV camera report of the drains.

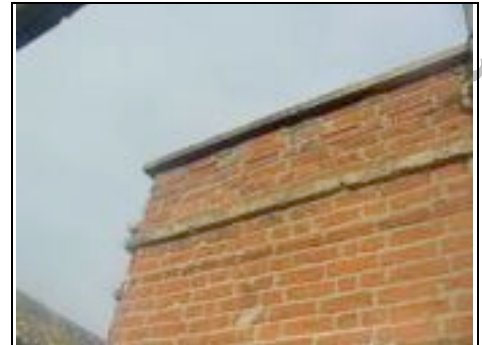
We discussed opening up the chimney to have a real fire in the property. Currently the chimney has been closed up and vented so you will need chimney pots on it as well as lining the chimney breast. We would add that we are always surprised at how much it costs to reinstate a chimney. The last time we were quoted on this we were quoted £3,000 on a Victorian property that had not had a chimney removed!

Chimney closed up and vented

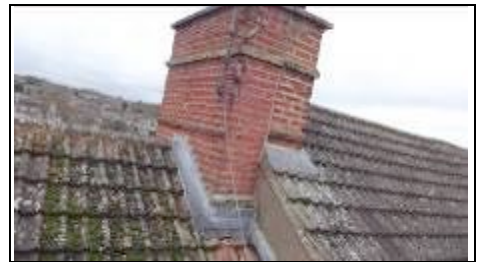
Chimney wrongly repointed in cement mortar

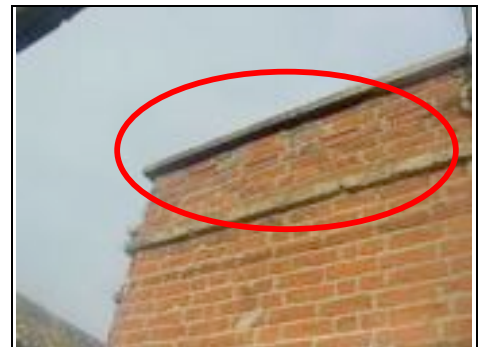
This chimney is brick finished with a lead flashing. The chimney has been closed up and vented known as capping. From what we could see from ground level it looked in average condition considering its age, type and style.

Chimney closed up and vented

**ACTION REQUIRED:** If you wish to get the chimney back into working order then quite a lot of work is needed, rebuilding the chimney as well as lining it.

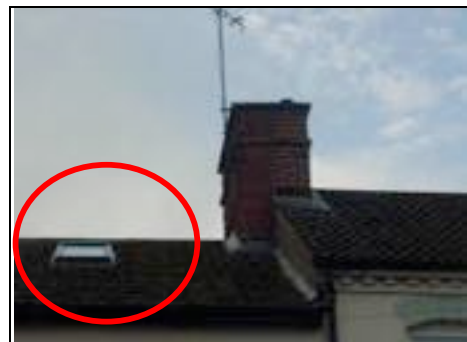
The property has a purpose made roof light to the front, which looked in average condition, as it should as we assume it is relatively new. The important factor with roof lights is the flashing around them, in this instance we would comment they looked to be incorrectly fitted. As you commented the roof window does open a long way, it may also be classified as a fire exit. Restrainers are available for roof windows, you just need to make sure you are able to undo it in an emergency such as a fire.

Roof window to front

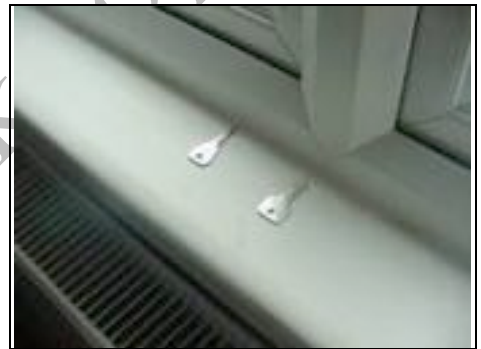
Key to window for room in roof does not work

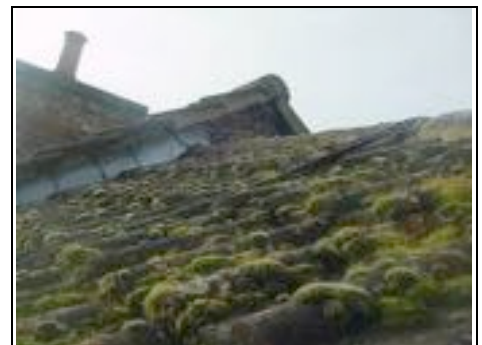
The main roof is pitched and clad with concrete tiles and, from ground level, this looks in average condition considering the roofs age type and style with slightly more moss than we would expect which can lead to blockages of gutters, etc.

Moss on roof

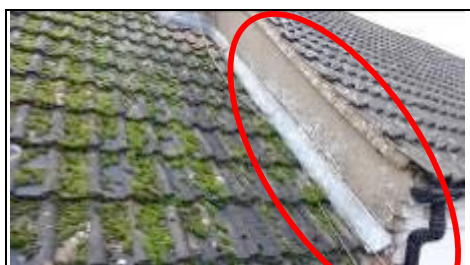
The property sits on a sloping site, both left to right and front to back. The left to right slope means there are steps in the roof. These steps are rendered with a lead flashing. We can see that the lead flashing is coming away and also there is cracking to the right hand side.

Flashings starting to come away  
pointing coming out

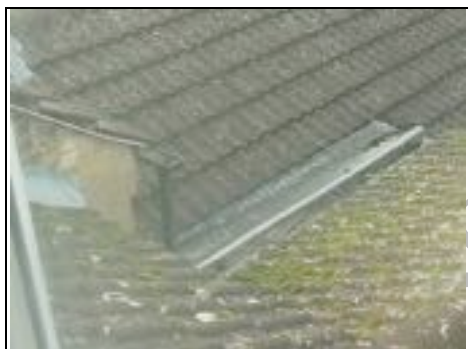
This property has valley gutters. Valley gutters are formed where two roofs meet and these are generally problematic. Typical problems you can get with valley gutters is shown in our sketch below.

Rear valley gutter

**ACTION REQUIRED:** Unfortunately this valley gutter will have to be considered a feature of the property. What we are really intrigued by is how it drains.

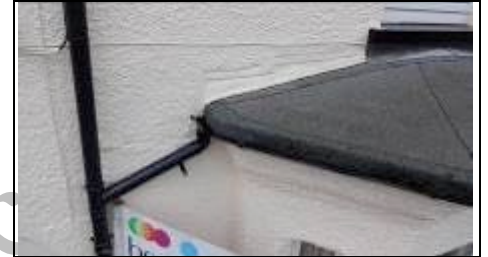
Guttering and downpipe from bay window roof, this could overflow and leak onto the wall causing dampness

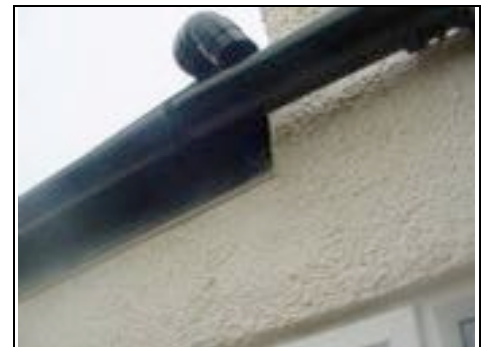
Water is being transferred from the main pitched roof and the flat roof onto the guttering adjacent to the kitchen window. This does look like it would overflow on a rainy day.

Gutters likely to overflow to kitchen

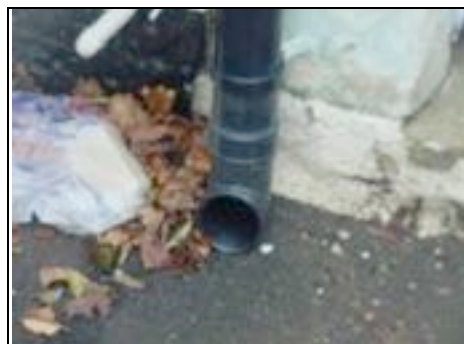
The downpipes discharge directly onto the ground. This is a practice we are not particularly keen on but in this instance there looks to be little choice, normally there would be a drain going under the pavement or even a gully.

Downpipes discharge directly onto ground

**ACTION REQUIRED:** We would recommend you stand outside the property next time it rains heavily and see how well the drains cope with the rainwater particularly looking at the guttering and the joints.

We also recommend that the gutters and downpipes are cleaned out, the joints are checked and the alignment checked to ensure that the gutters fall towards the downpipes.

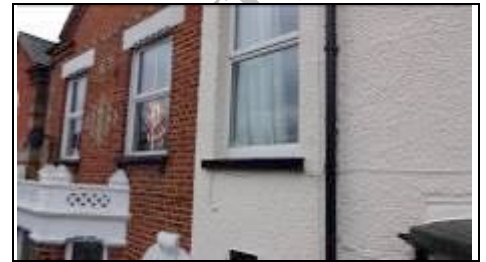
The external walls are finished in a cement based roughcast render which is painted, originally they would have been brickwork like your neighbour. The paintwork looks in reasonable condition (painted to sell?).

Cement based roughcast render to your property,  
Flemish bond brickwork next door

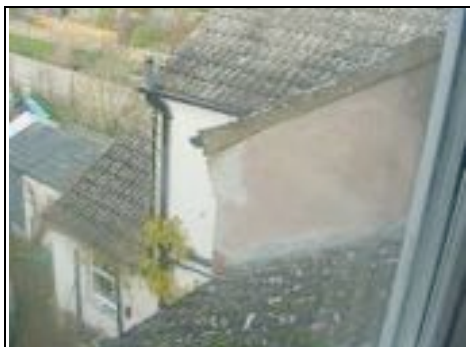
The colour and texture of the render on the right hand parapet wall leaves us to believe that it is an inside render plaster that has been added rather than an exterior one. We would also add that it is interesting that there has been a need to re-render it which we believe means that the parapet wall is leaking, possibly because the drip detail is not correct. Unfortunately this will lead to dampness getting into the walls and then into the bedrooms below.

Inside plaster/render used outside

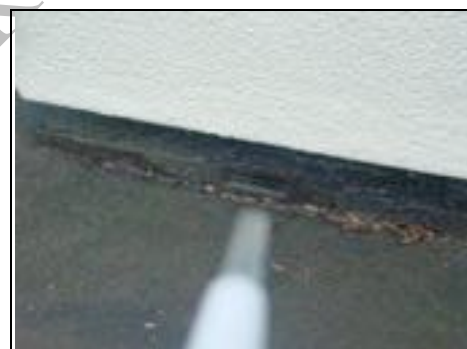
Air bricks are essential to have a through flow of air as this helps to reduce the chances of wet rot, dry rot and woodworm. In this case the airbrick to the front is acting as a gutter.

Airbrick to front acting as gutter

**ACTION REQUIRED:** Please see our comments in the Executive Summary.

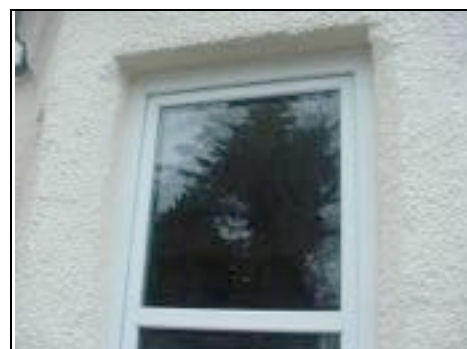
The property has older style plastic double glazed sash windows without trickle vents probably from the cheaper end of the market.

Windows without trickle vents

**ACTION REQUIRED:** Investigate price of installing windows. You can spend a few thousand pounds to many thousands of pounds.

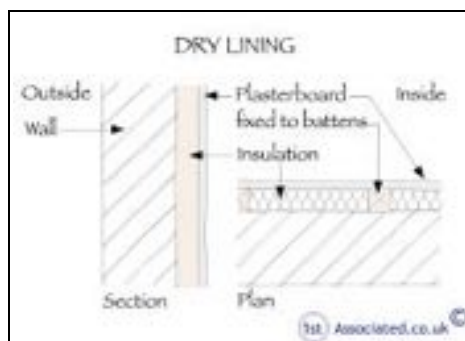
Dry lining

There is dry lining to the ground floor and also dry lining within the roof areas. Our concern with the dry lining particularly in the ground floor is that it may be hiding dampness and/or poor quality repairs where the chimney has been removed.

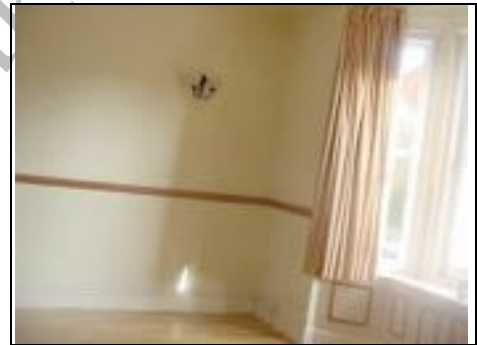
In addition to the missing chimney it has also been dry lined in this area.

Chimney removed in lounge

**ACTION REQUIRED:** The existing owner should be asked for details with regard to what has happened in this area. He should really have understood the alterations and implications of the removal of the chimney to carry out the roof extension.

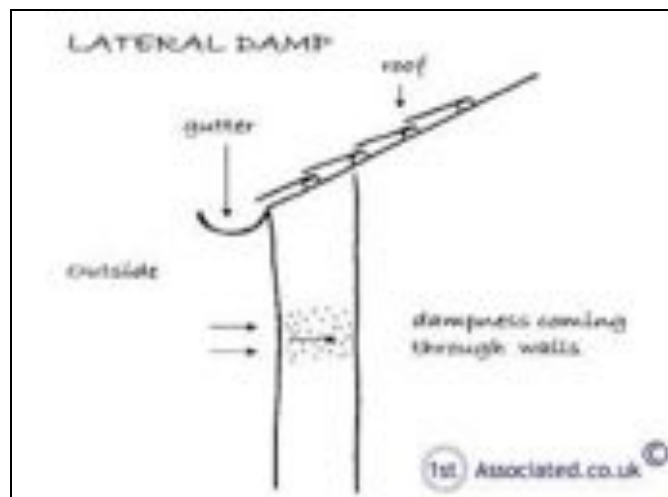
We used a resistance meter on the external walls. We have found significant dampness.

Lateral damp

**ACTION REQUIRED:** Please see our comments in the Executive Summary.

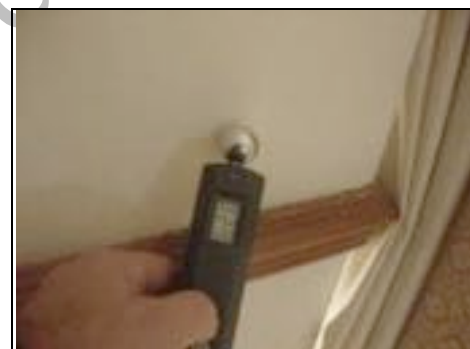
High damp reading of 62  
Should be 30-60

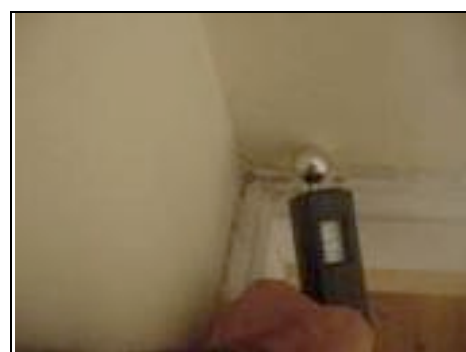
At the time of the inspection there were signs there had been condensation in the property such as black mould in the bathroom and to some of the rooms such as the utility room.

Signs of black mould

**ACTION REQUIRED:** We would recommend large humidity controlled extract fans be added to kitchens, bathrooms and any rooms where you intend to dry clothes.

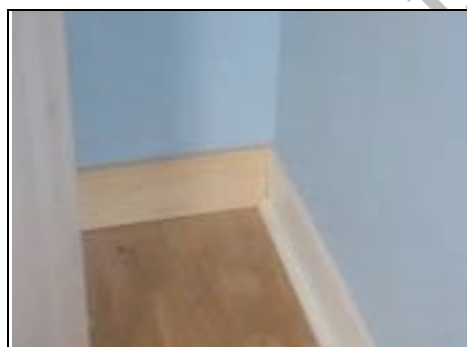
We do not normally comment on skirtings however in this case we would comment that we do not believe this is a double profile skirting (we were impressed that you knew about them!). The property has basic butt jointed skirtings as opposed to mitre skirtings which usually have a 45 degree angle to form a corner.

Butt jointed skirting

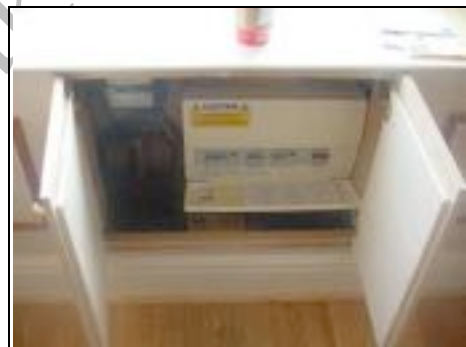
The electric fuses and consumer units were located in front of the bay. The fuse board looked 1980's/1990's and better are now available.

Fuse Board

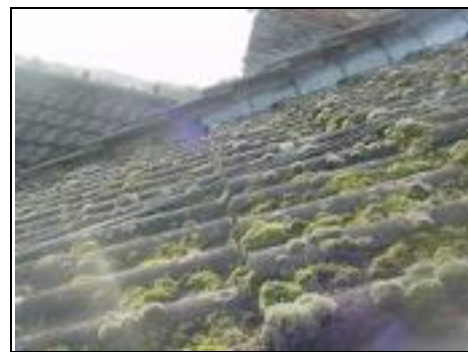
We noted cables running across the roof. We are not keen on this practice particularly where they are sitting on damp moss.

Cables on roof

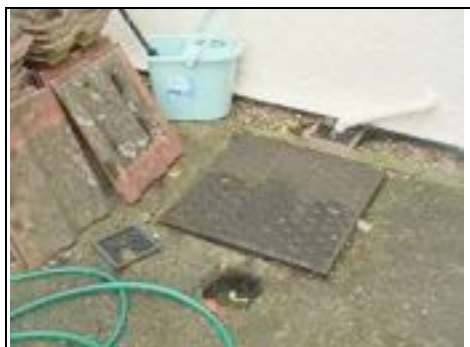
We duly lifted the cover and found it to be blocked at the time of our inspection.

From what we could see it is concrete built.

Manhole outside kitchen

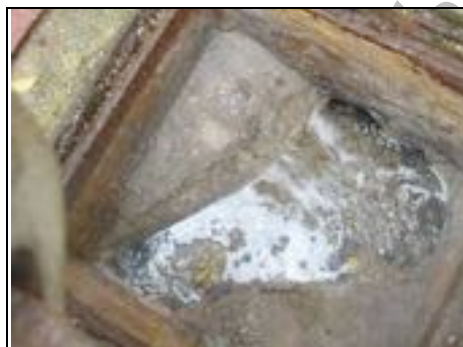
Drain blocked. Looks DIY as haunchings not formed properly.

**ACTION REQUIRED:** Please see our comments in the Executive Summary.

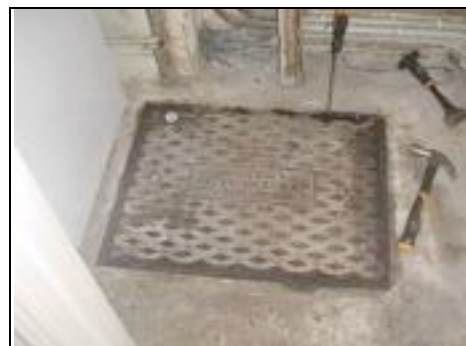
We were unable to lift this manhole therefore are unable to comment.

Couldn't lift drain

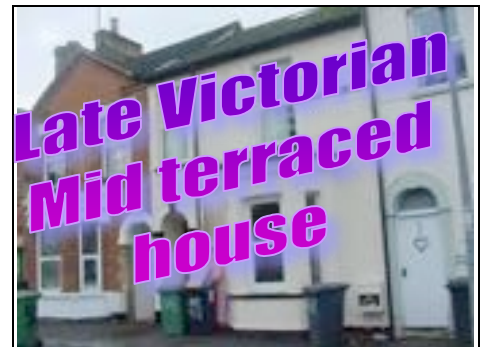
The front of the property sits directly onto the pavement/road. At the time of our several visits there were wheelie bins outside the properties. We are not sure where the wheelie bins are supposed to go.

Wheelie bins

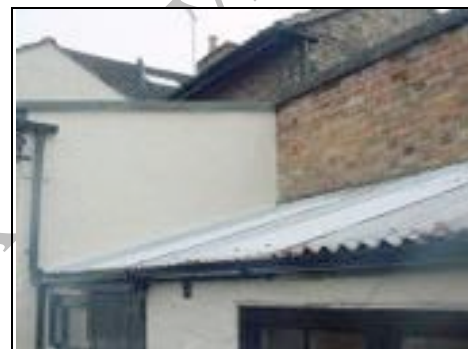
Outbuilding

Single storey outbuilding with pitched corrugated metal roof which is rusting and corrugated plastic.

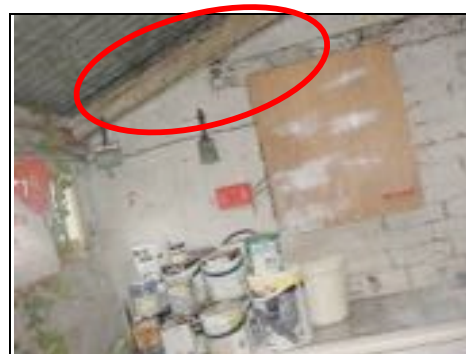
There looked to be some bonding timbers in the outbuilding which also means there may well be some in the actual house as well. These can be problematic.

Bonding timber/lintel

Structural supports. Bonding timbers were meant to hold the walls together but can often rot and cause problems.
