RESIDENTIAL BUILDING SURVEY

XXXX
Ravensden,
Bedfordshire,
MK44 XXX

FOR
Mr X

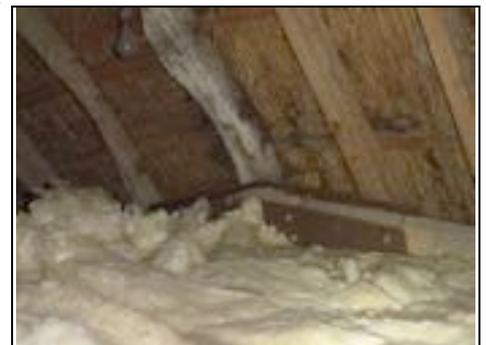
Brace at base of timber to left roof

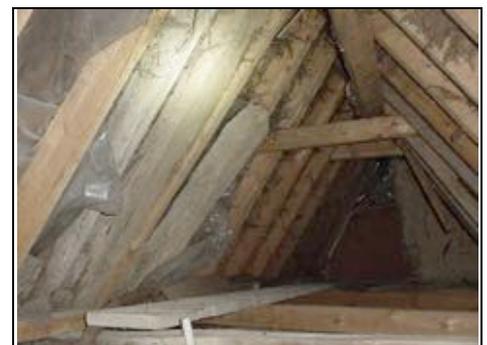
Mixture of new and older timbers to the centre roof

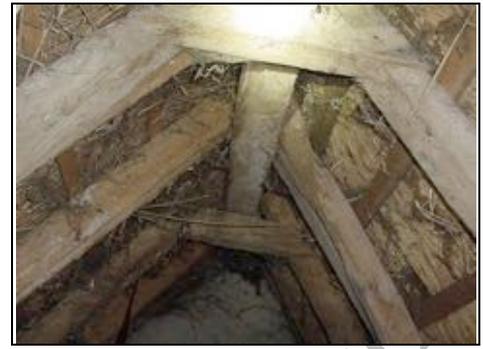
Timber to the right roof

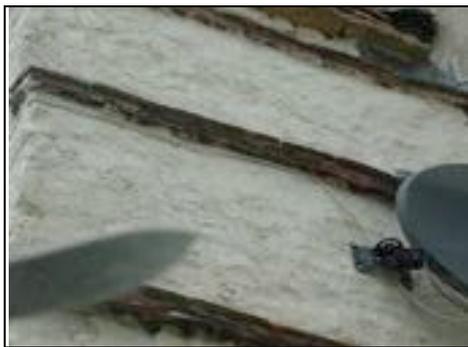
Over the years there have been many alterations, some of which we can see that the builders at the time did not understand the implications of what they were doing using modern materials on older buildings such as the cements that have been used as well as being against the legal requirements of a Listed building. We can also see some relatively recent work to the stone chimney with cement which again is not appropriate and will harm the building (see comments on lime every time within the Walls Section of this report).

Cement repairs on stone chimney

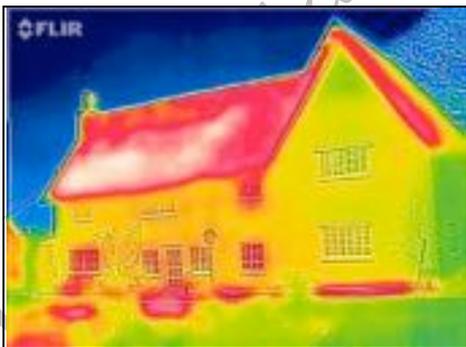
Heat coming out of floor, windows and roof to rear of property and little sign of the timber frame

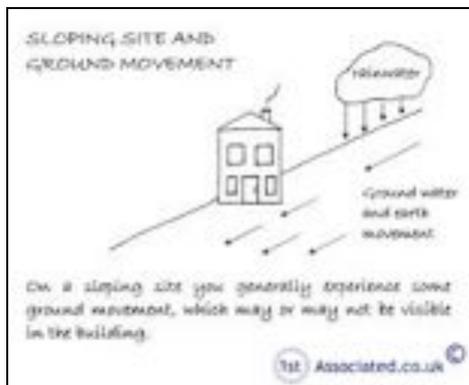
Historically this building has had a considerable amount of movement leaning from side to side. Also as it is on a sloping site it is integrally more unstable than the property on a level site.

Sloping site

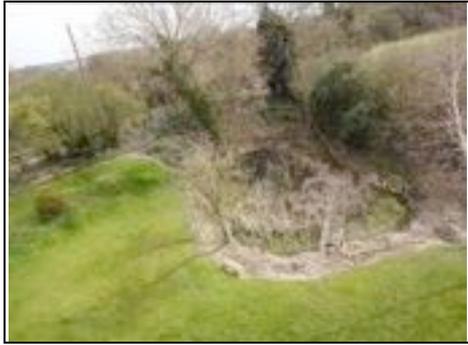
Sloping site
~ Aerial View - 360 Photo ~

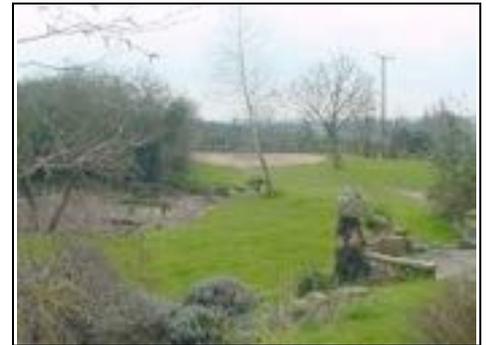
Slope towards pond

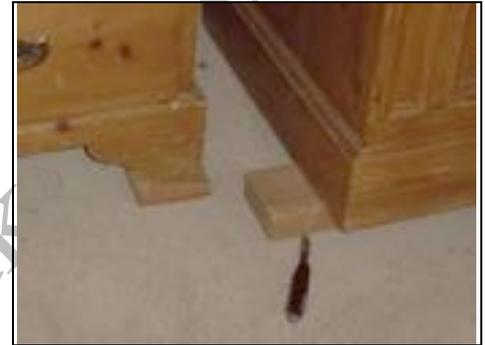
When you are in the property you can see the extent of the slop on the property, in particular you can see that there has been a considerable amount of packing under the furniture.

Furniture propped on uneven floors

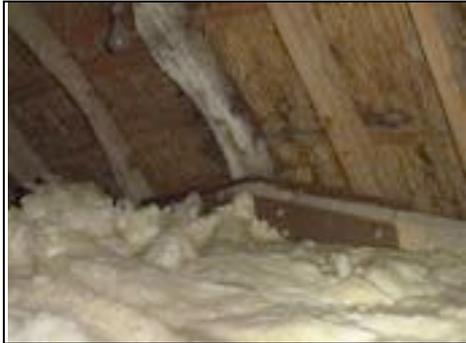
We can also see metal brackets in some areas of the property. Specifically, we can see them in the left roof and we can also see them in the middle wall of the left hand room. These indicate there has been historic movement in this property. It is very difficult from a one off inspection to conclude whether it is still what is known as progressive.

Brace at base of timber in left roof

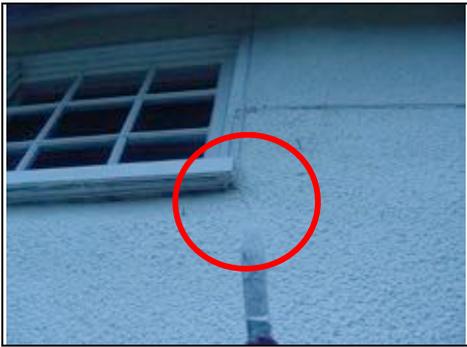
There is hairline cracking visible to some of the internal walls where the wall and ceiling joists meet and there is also hairline cracking to the gable end of the property. You do have to remember that the whole of this property has been repainted in the last few years hiding any usual indications. Again, these cracks are indicating sideways movement left to right.

Cracking to the window

ACTION REQUIRED: Ideally we would recommend the existing owners take out an insurance claim, advising that the cracking has been noted by a structural surveyor (this should cost them nothing other than time to write the letter). This usually means that the insurance company will carry out a monitoring exercise (the Building Research Establishment recommend monitoring any cracks for a minimum of one year) to establish if there is any progressive movement. Your future liability will be limited to the cost of the excess on the insurance providing the insurance company is happy for you to take over the insurance claim.

Monitoring is the only true way of establishing in this particular case of whether it is still moving (which it probably is not due to the amount of wall replacements although it is very difficult to confirm without opening up the walls, etc).

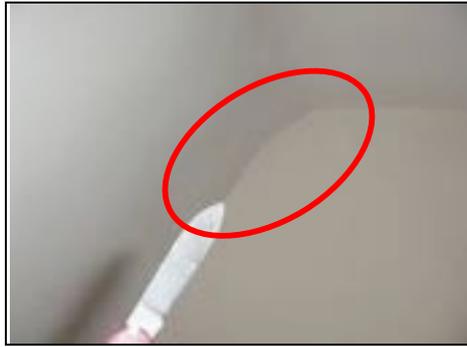
Hairline cracking in master bedroom

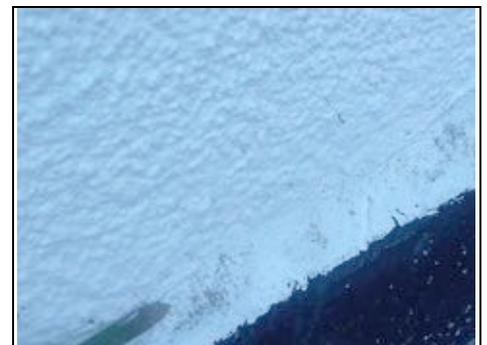
We can see that the render has been painted over. When discussed during our question and answer session the owner advised that it was the last few years. We can see moss where it has not been painted over properly. The painting of the render has hidden a lot.

We would also comment that the render appears to be a cement based render. The owner, during our question and answer session, advised this was already present when they bought the property.

Moss visible

ACTION REQUIRED: Ideally as mentioned we would like to open up a section of the render just to see what it is made of. We would also be able to see what is behind it. We would be looking for opening up to be on the left hand side of the property.

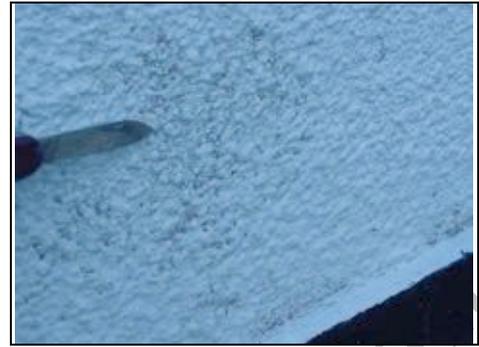
The listing describes a rough cast render which normally relates to a lime based render and this is certainly not the case as far as we can see.

Moss showing through painted render

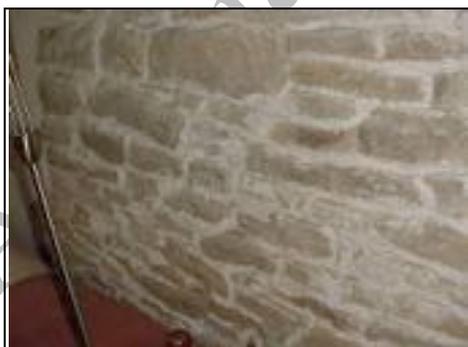
In various areas we found dampness coming in through the stonework for example and we can also see sulphate where there is orange/brownish staining where the soot is being drawn through.

Dampness coming through and various repairs

ACTION REQUIRED: We would recommend the adding of a French drain around the property. Currently there are paving slabs around the property which unfortunately discharge water against the building.

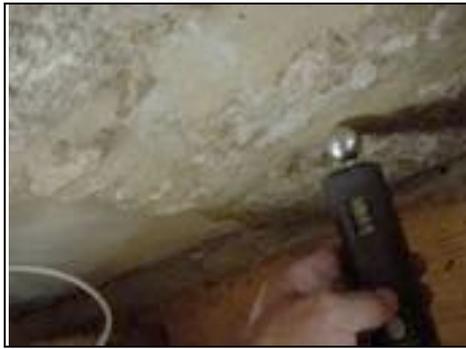
Testing for dampness in fireplace stonework

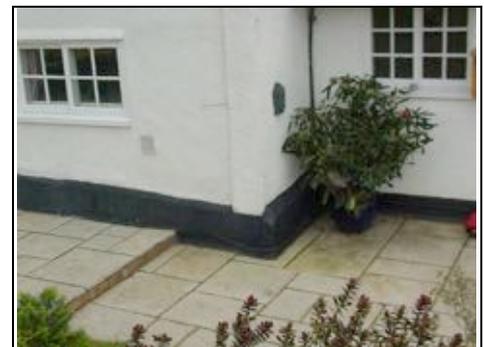
Paving around property

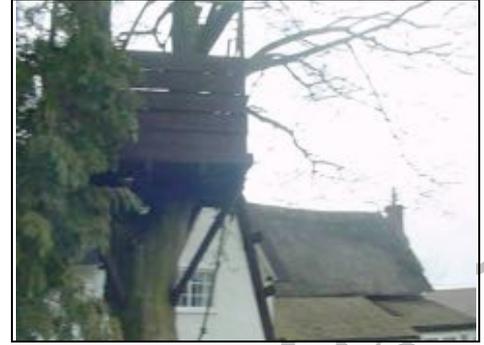
There is a tree in close proximity to the house. It does not look to have been maintained for many years, when we spoke to the owner he advised us that he had had advice with regard to the tree but in the end decided to do it himself.

A large tree close to the property

ACTION REQUIRED: Advice from an arboriculturalist (not a tree surgeon) is asked to view the property and give a ten-year plan for maintenance.

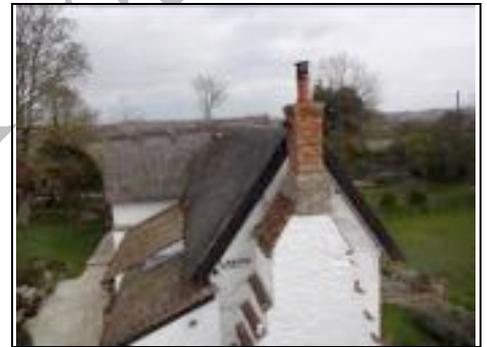
This chimney is a predominantly stone built chimney which has been finished in brick and has one chimney pot. There are tiles running down the side of the property in various stages, where it meets the main building there is a lead flashing. The problems were there is dampness getting in between the chimney and the main building into the stonework which forms the gable.

Chimney
~ Aerial View - 360 Photo ~

ACTION REQUIRED: The whole of the chimney would benefit from appropriate repair work as we can see there has been inappropriate repair work using cement mortar. We can also see that the lead work detailing could be improved to reduce the amount of water getting into the right gable end. From our experience we don't think this will ever be completely dry but it could be we feel improved. We can also see that the render that adjoins the chimney would benefit from being pre-paired, repaired and redecorated.

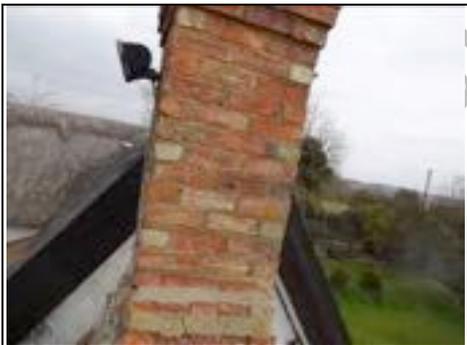
Close up of chimney
~ Aerial View - 360 Photo ~

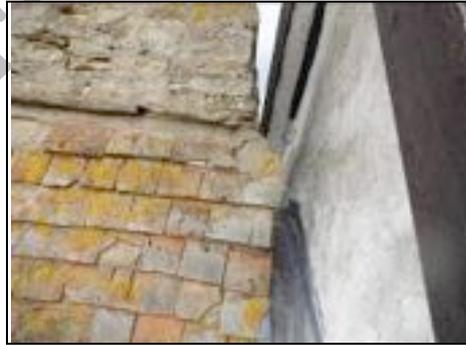
Gap between chimney and main building
~ Aerial View - 360 Photo ~

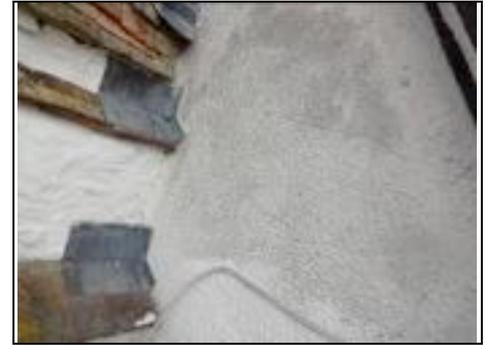
Mastic on lead to right gable
~ Aerial View - 360 Photo ~

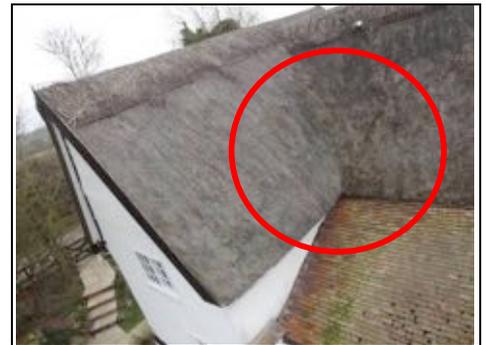
When we went partly into the left roof we were able to see what once may have been a chimney or a smoke hood which interestingly in years gone by were made out of timber. It is very difficult to confirm. It seems a logical place for a chimney to be however we have to add that we have had a very limited view.

Hidden chimney

ACTION REQUIRED: Further investigation required. As a general comment in an older property such as this all rooms would have originally been heated with a coal fire.

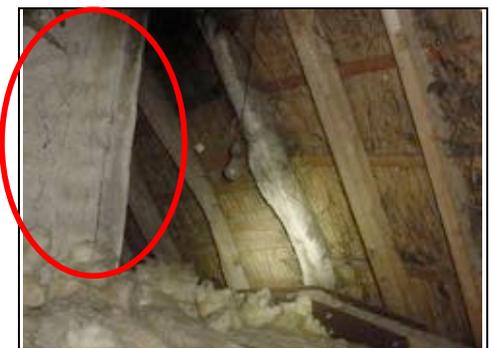
Hidden chimney/smoke hood

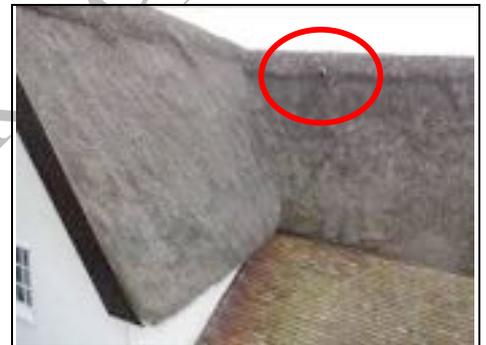
We are not sure whether this is a flue or a vent from the soil and vent pipe. We could see a plastic pipe within the roof which may well relate to this.

Flue
~ Aerial View - 360 Photo ~

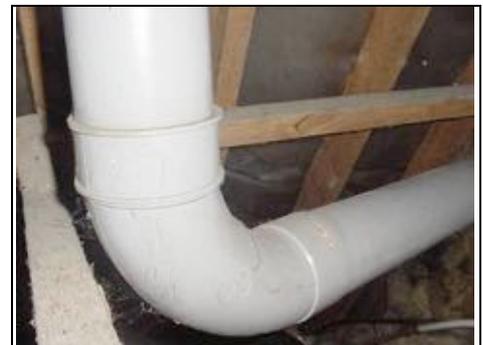
Plastic pipe within roof

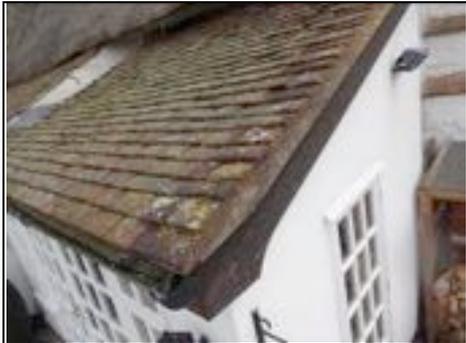
Spalling to tiles
~ Aerial View - 360 Photo ~

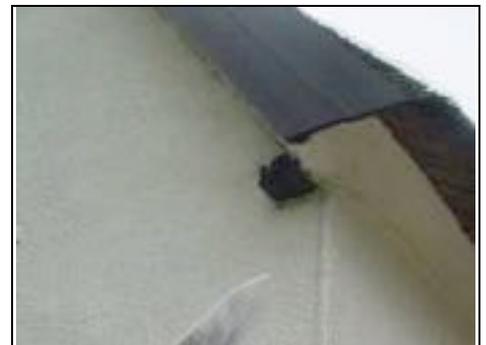
Purlins can be seen protruding out of walls which can lead to rotting

Further investigation is needed as we can see that metal brackets have been used to the left hand side roof and also in the walls structure below.

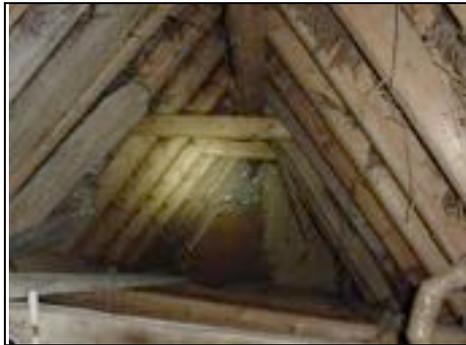
Most of timbers replaced in main part of roof

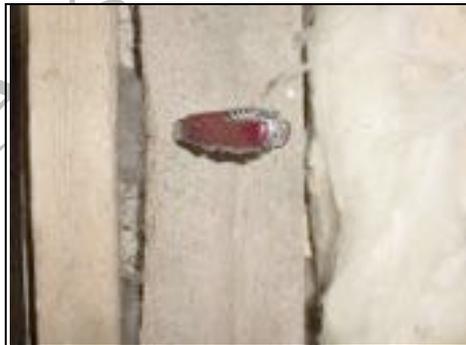
Woodworm

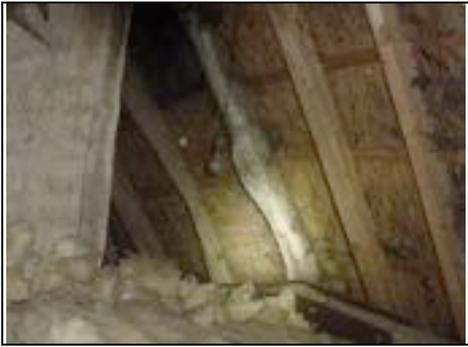
New and old timbers

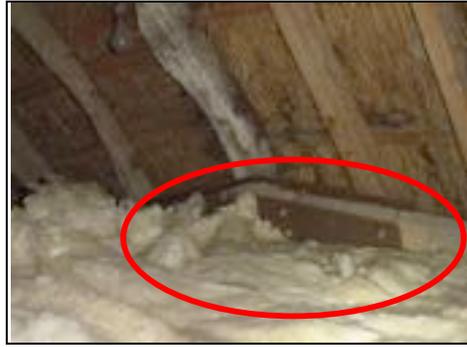
Brace at base of timber

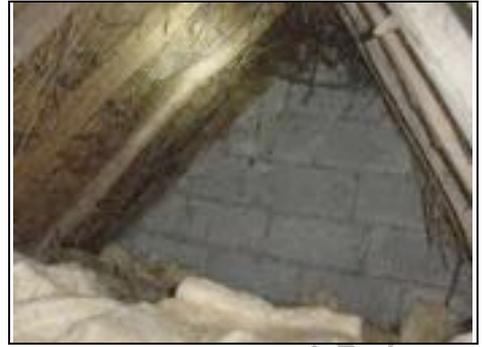
Stonework or blockwork?

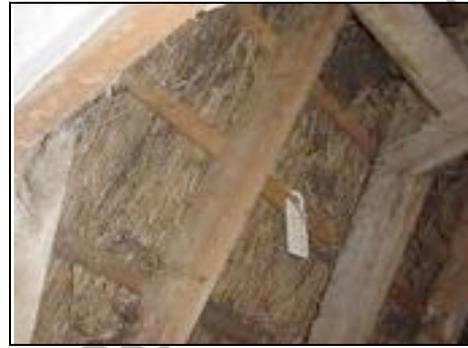
Right roof

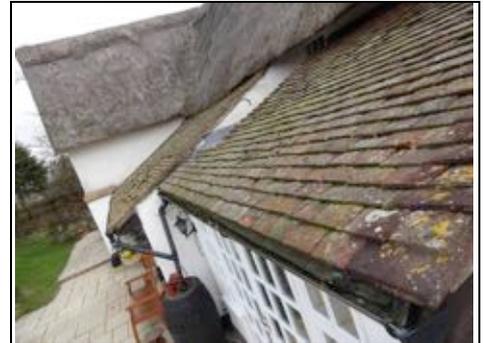
There are no gutters and downpipes to the thatch, they are only present to the tiled area which are plastic gutters and downpipes. Our concern always with gutters and downpipes on older properties is that they may be discharging into the ground nearby and causing dampness as traditionally they discharged on the ground.

Gutters and downpipes to tiled roof

ACTION REQUIRED: We would recommend you stand outside the property next time it rains heavily and see how well the drains cope with the rainwater particularly looking at the guttering and the joints and where they discharge onto the ground.

We also recommend that the gutters and downpipes are cleaned out, the joints are checked and the alignment checked to ensure that the gutters fall towards the downpipes.

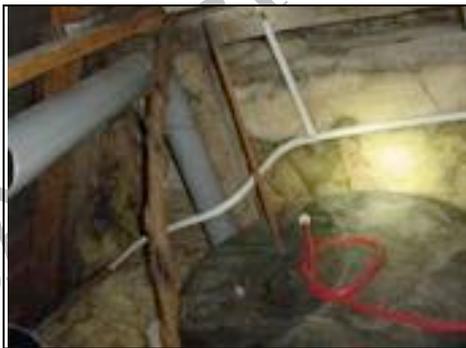
The property has a plastic cast iron soil and vent pipe.

Soil and vent pipe

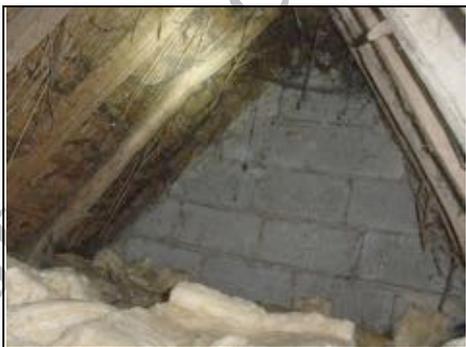
Stonework or blockwork?

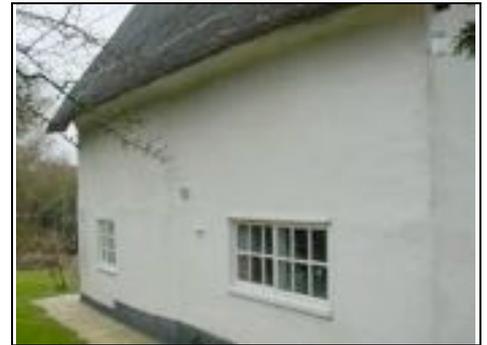
Render

We have carried out a tap test (literally hitting the render with the back of a hammer). We found it to be in average condition with some hollow areas but not what we would term as excessive.

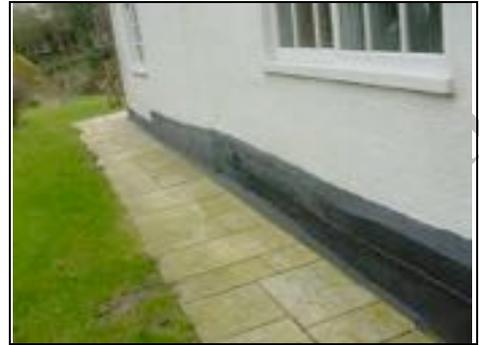
Stone or brick base

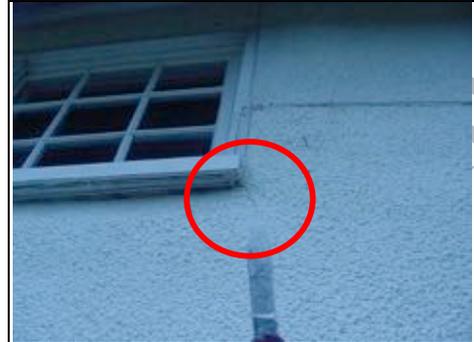
Cracking

ACTION REQUIRED: Please see our comments in the Executive Summary.

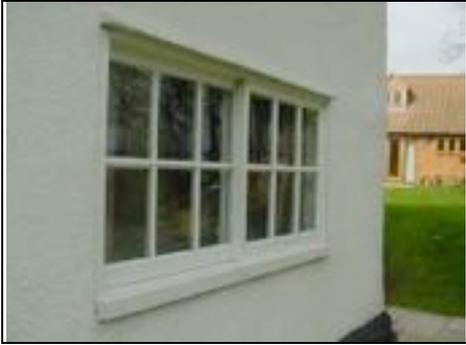
The property has timber single glazed windows with secondary glazing, many are horizontal sliding sash otherwise known as York windows. We noted rot to one of the windows.

York windows

ACTION REQUIRED: General repairs and easing and adjusting of the windows and doors.

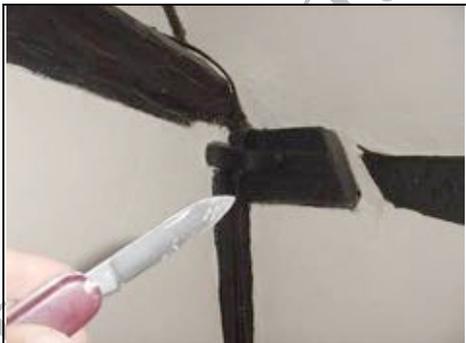
Infill panel with metal brace

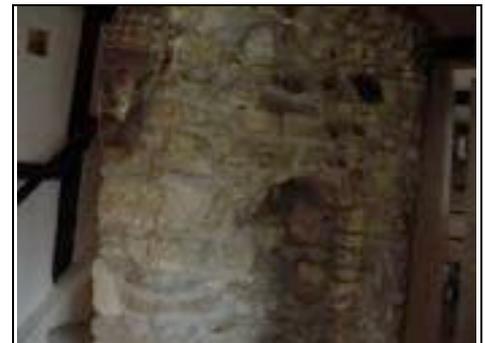
There also looks to be a central chimney built in stonework and one found within the roof. With further investigate it may well be what is known as a smoke hood which is one of the earlier chimneys which would be another historic element in the building.

Old chimney?

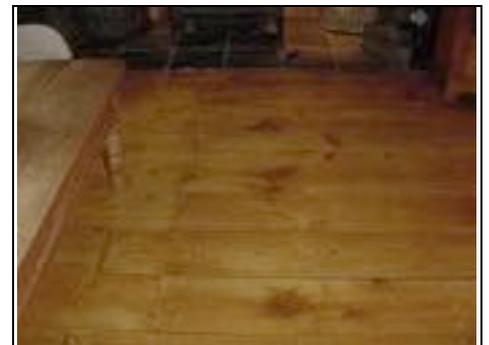
Over the years this has been replaced with various different floors including a suspended timber floor to the lounge area. We were advised the original boards were lifted and re-laid. We think the original boards were unlikely to have been cut that well, lifted, sanded, varnished and re-laid. We also think it is unlikely the original boards would have been so well cut. Our concern is the lack of ventilation to this timber floor. The solid floors as far as we could see throughout the rest of the property these can draw in cold.

New floor made out of old flooring in main reception room

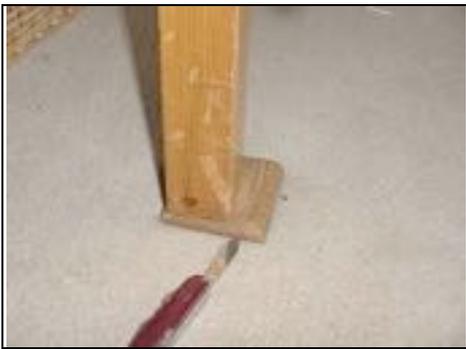
Floor undulating

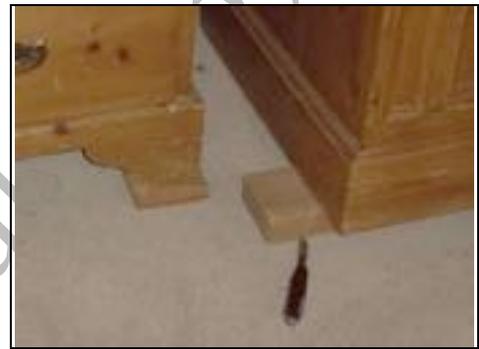
Floors undulating

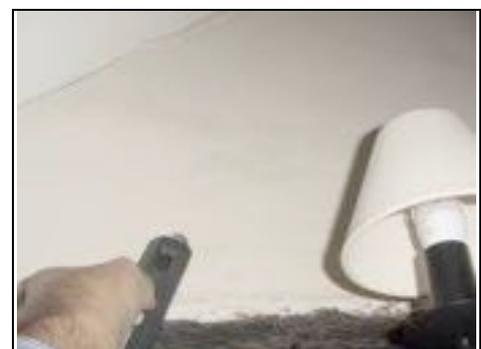
Dampness coming through plaster in right bedroom

ACTION REQUIRED: Please see our comments in the Executive Summary.

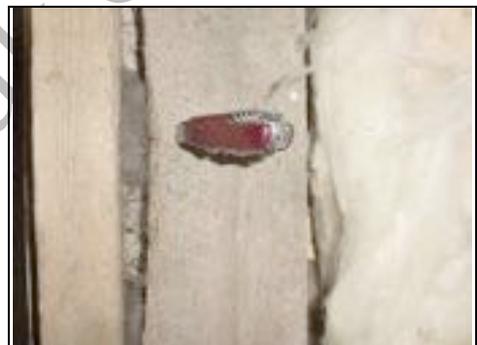
Woodworm

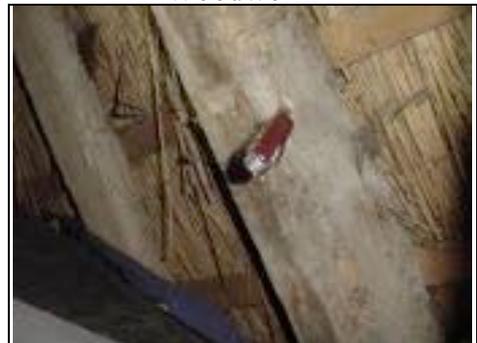
Woodworm and soft rot

Finally, when you move into the property, floor surfaces should be carefully examined for any signs of insect infestation when furniture and floor coverings are removed together with stored goods. Any signs that are found should be treated to prevent it spreading. However, you need to be aware that many damp and woodworm treatment companies have a vested

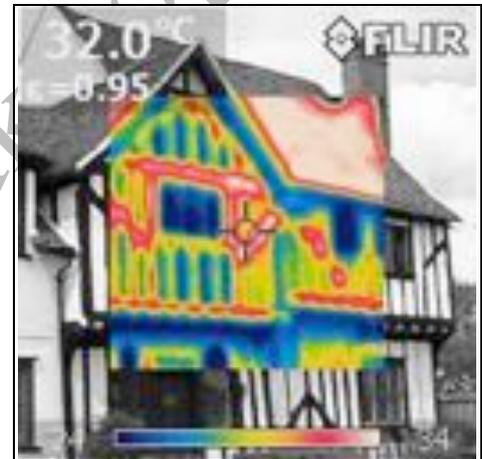
Timber framed Public House
Thermal image showing heat loss

It is difficult to know what the walls are but there is likely to be timber frame walls and possibly some elements of stone walls and possibly more modern materials. We thermal imaged the building and found the majority of the heat was coming out of the floor, windows and the roof at the time of our inspection.

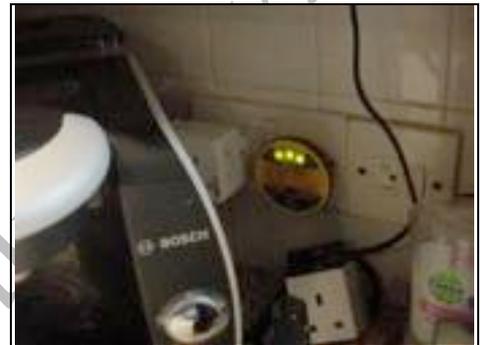
We carried out an earth test in the kitchen area to the socket point that is normally used for the kettle, this proved satisfactory.

Earth test

ACTION REQUIRED: As the property is changing occupancy an Institution of Engineering and Technology (IET) test and report and any recommendations should be carried out by a NICEIC registered, or equivalent, approved electrical contractor or similarly approved.

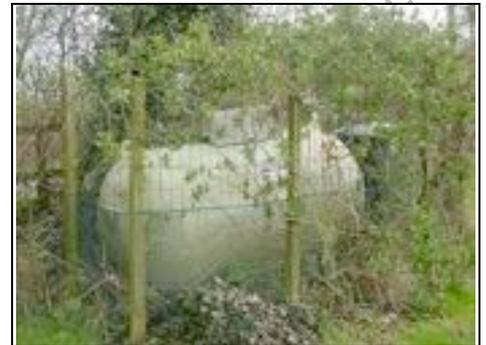
The property has propane gas. There are wood burners as well; we are not sure whether these are multi-burners or not.

Propane gas

ACTION REQUIRED: As a matter of course it is recommended that the entire gas installation is inspected and made good, as necessary, by a Gas Safe registered contractor. Thereafter the installation should be serviced annually.

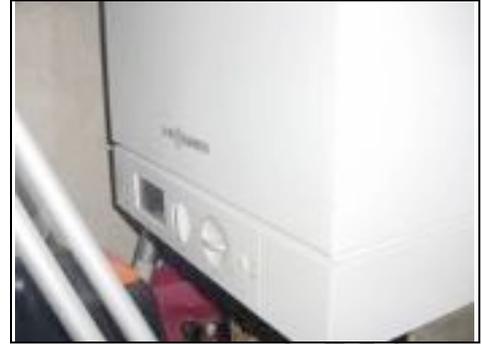
The boiler is a model that we rarely come across so it may be difficult to obtain spare parts.

Viemann Boiler in services room

Our limited inspection of the hot water and central heating system revealed no evidence to suggest any serious defects but we would nevertheless recommend that the system be tested and overhauled before exchange of contracts and that a regular maintenance contract be placed with an approved heating engineer.

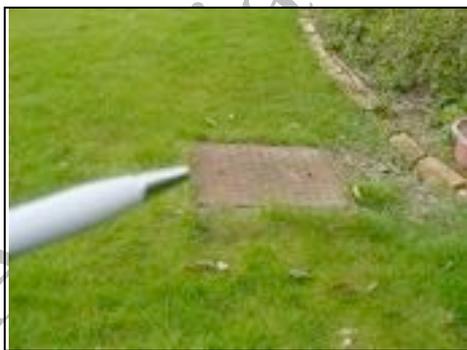
We duly lifted the cover and found it to be free flowing at the time of our inspection. From what we could see it is concrete built.

Manhole adjacent to garage

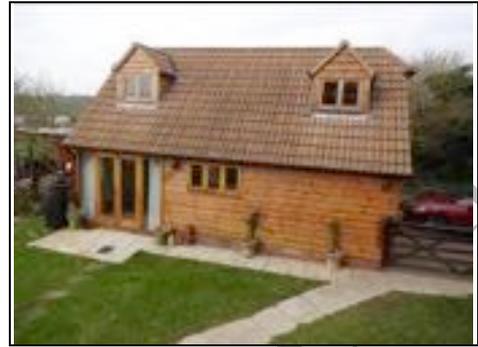
It was noted that the windows to the garage would benefit from re-staining.

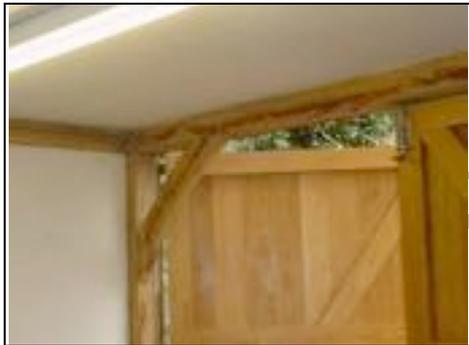
Dampness coming into garage

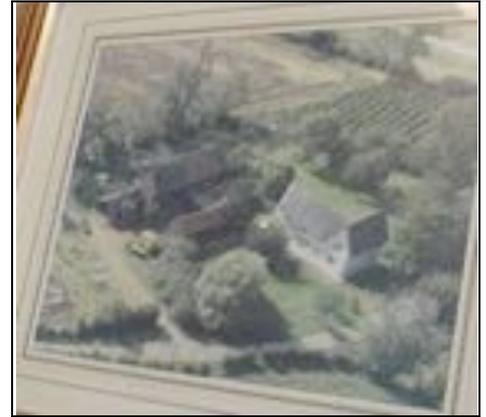
During our question and answer session with the owners we were advised about the barns that fell down which have now been replaced with the garage and annex and the office area. In our experience it takes a lot for these type of barns to fall down.

Barns that no longer exist

We would recommend you speak to the Listed Building Officer with regard to this property to see if they have a photographic record of its condition as many local authorities do have. It will then be worth comparing this against the condition and way the building presently is, as we do feel a lot of alterations and amendments have been carried out.

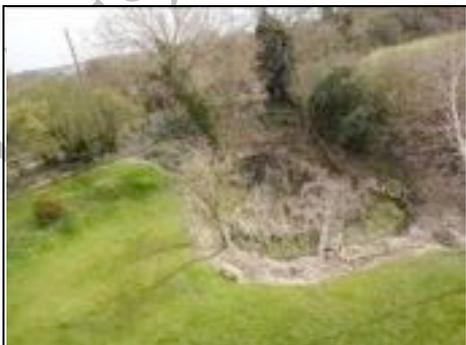
Garden on sloping site
~ Aerial View - 360 Photo ~
