PROPERTY REPORT AND NEGOTIATION DOCUMENT

Biggleswade
Bedfordshire
SG18 XXX

We have been instructed to inspect and prepare a Property Report and Schedule of Condition for:

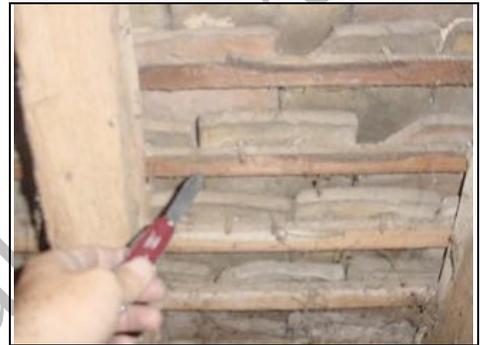
Rear of peg tiles from within the roof space

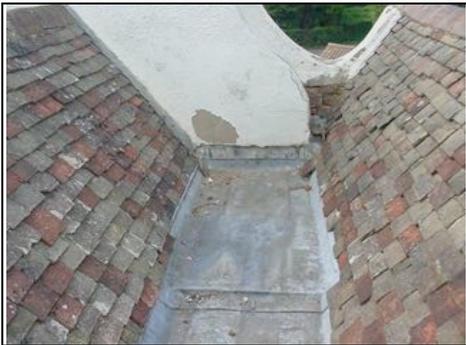
Leaded hidden valley gutter

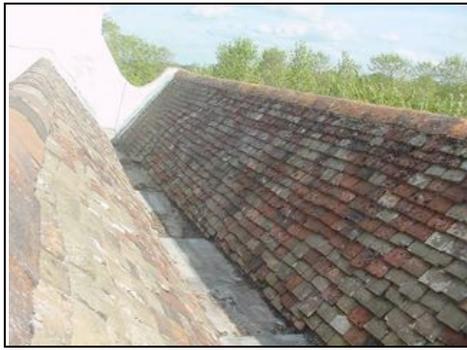
Second valley gutter

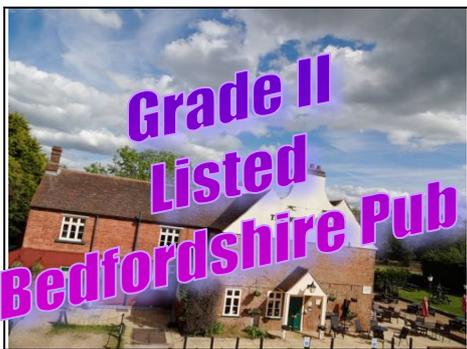
Pitched roof to left

We could see that the left side pitched roof has roof tiles, which are spalling to the ridge and various other areas. With a Full Repairing and Insuring Lease you will be asked to replace these which is likely to be expensive as this will require high-level access and possibly scaffolding.

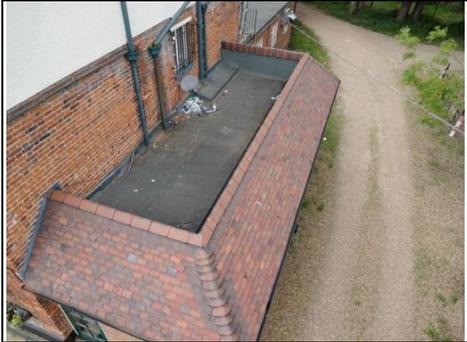
The rear right pseudo-pitched roof has modern tiles which are starting to spall and need repair and making good. We also noted the flat roof is full of rubbish.

Aerial 360 photo of rear right pseudo pitched roof

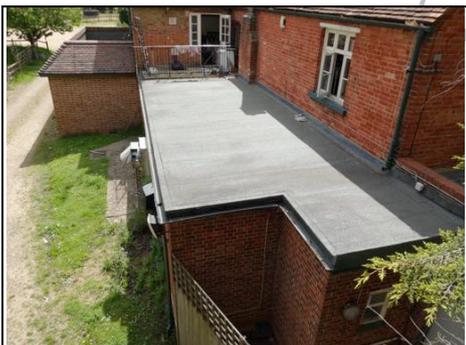
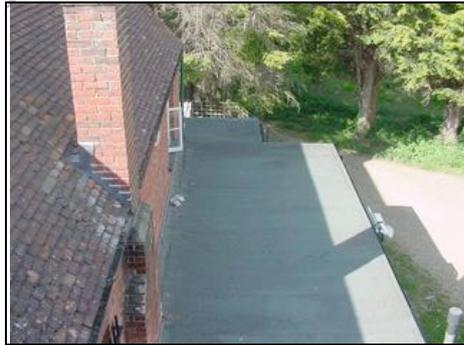
There is an access onto the left flat roof which is partly protected by a rail however there is a rail missing to the end of the flat roof.

Aerial 360 photo of rear left flat roof

Rear left flat roof

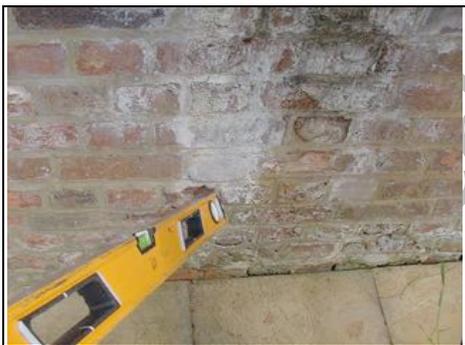
Dampness in brickwork

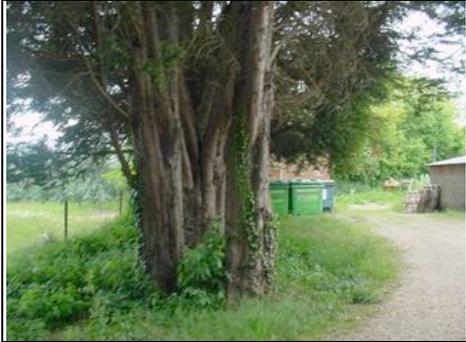
There are many mature trees surrounding the property, which require a maintenance plan.

Large mature trees

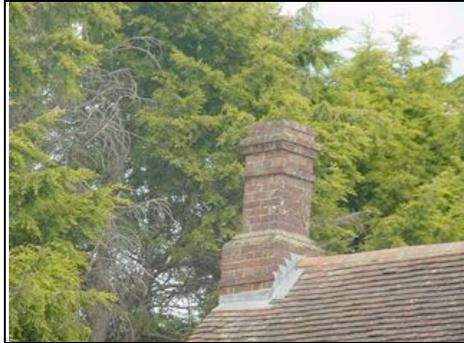
Top of large mature trees, close to property

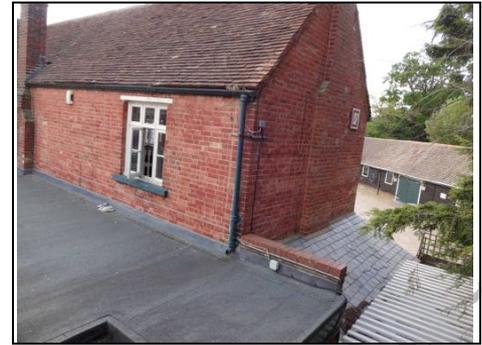
Left side of property
Aerial photo 360 view which we were unable to access
